# Jacobsville Elementary School Safe Routes to School Accessibility Study: Existing Conditions and Recommendations

August 17, 2023

# Anne Arundel Safe Routes to School Accessibility Study

# Jacobsville Elementary Accessibility Study

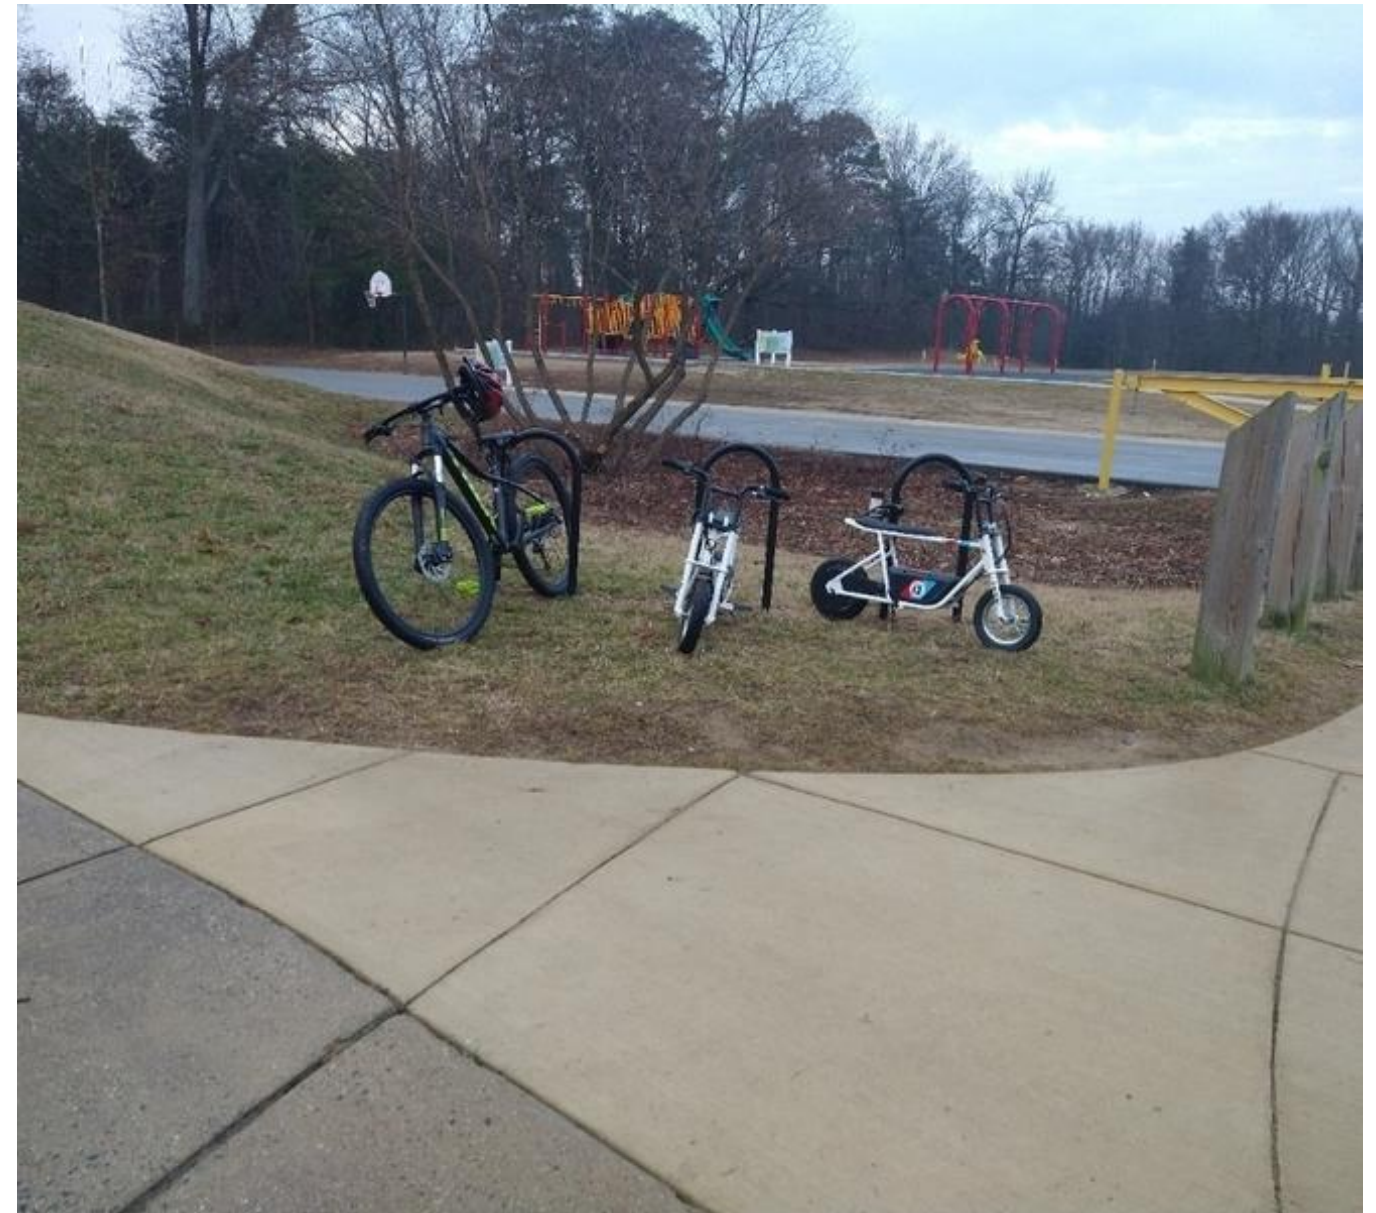
- Approximately 15 student walkers and three bicyclists were observed during arrival. All arrived via the path from Deering Road.

Several bikes parked at the racks behind the school.

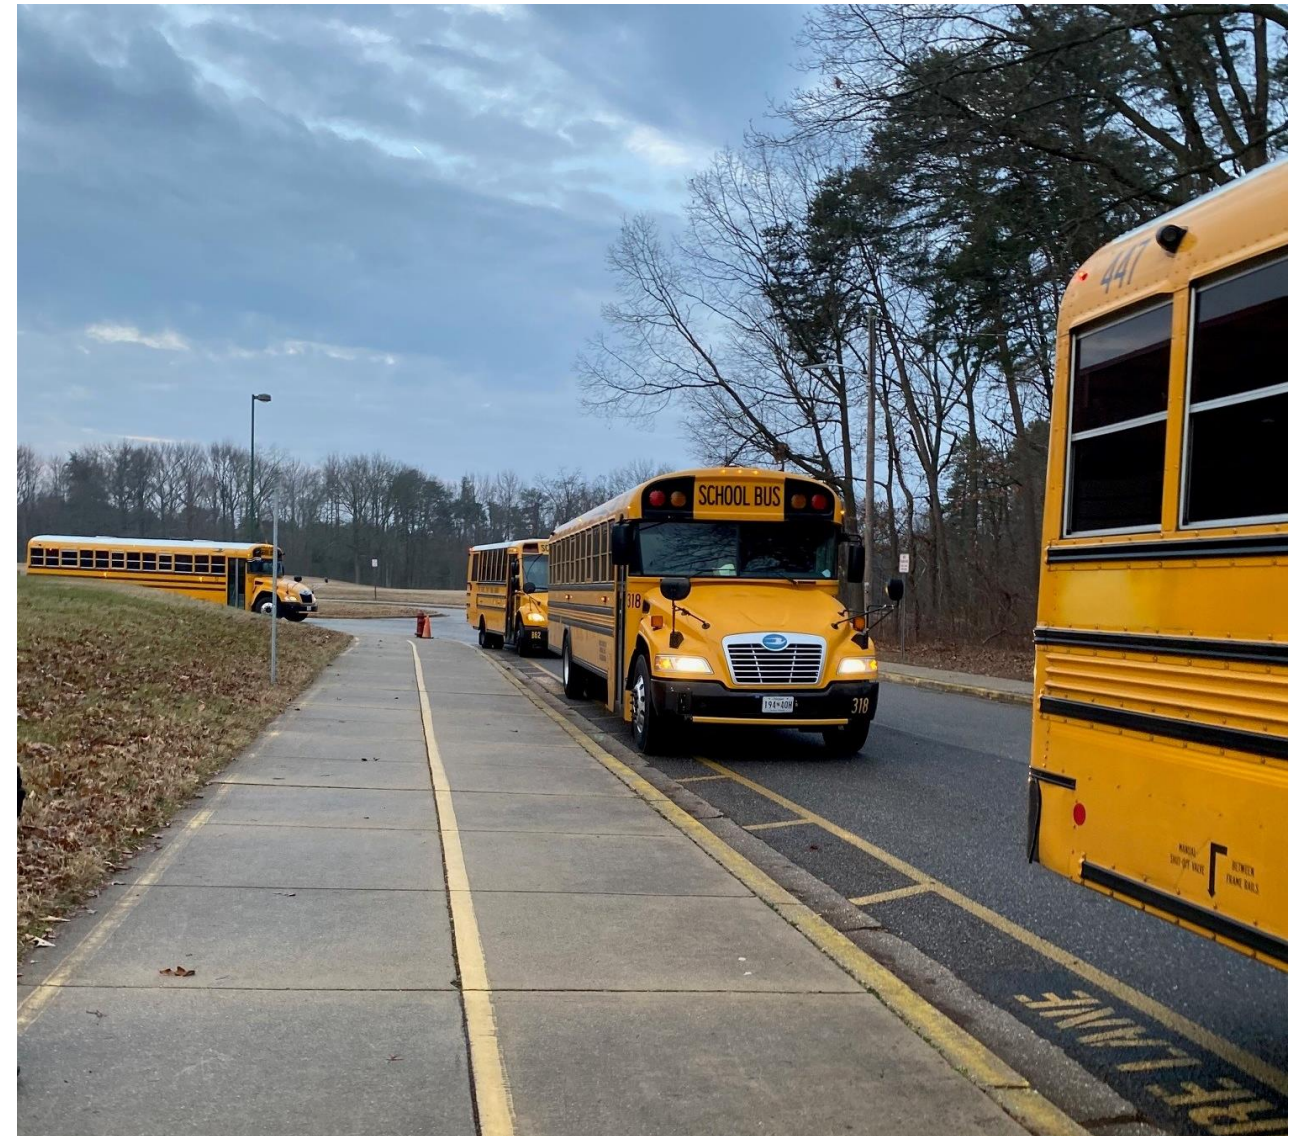
Buses drive past the school, go around a circle beyond the building, and return to drop off students.

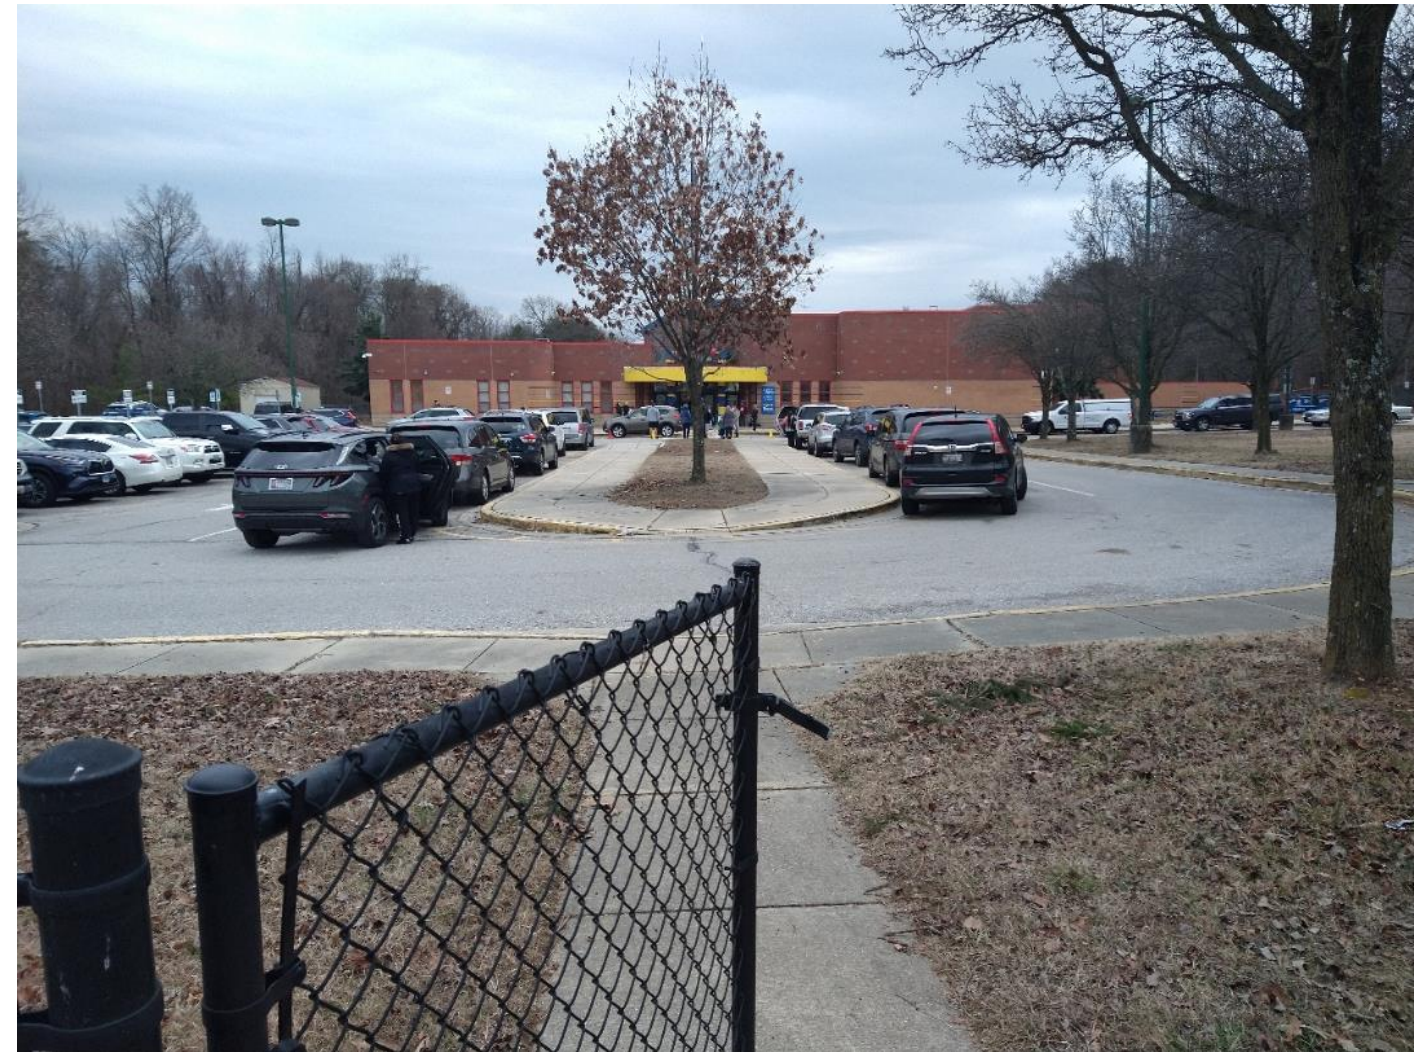
- The pick-up loop was busy prior to dismissal — 40 cars were in line at 2:20 PM.
- Drivers loop the staff parking lot and line up along both sides of an island across from the school entrance.
- The line of cars waiting to get into campus frequently backed up onto Mountain Road.

Parents drive past the front entrance, loop around the parking lot, and line up on either side of the front island to pick up students.

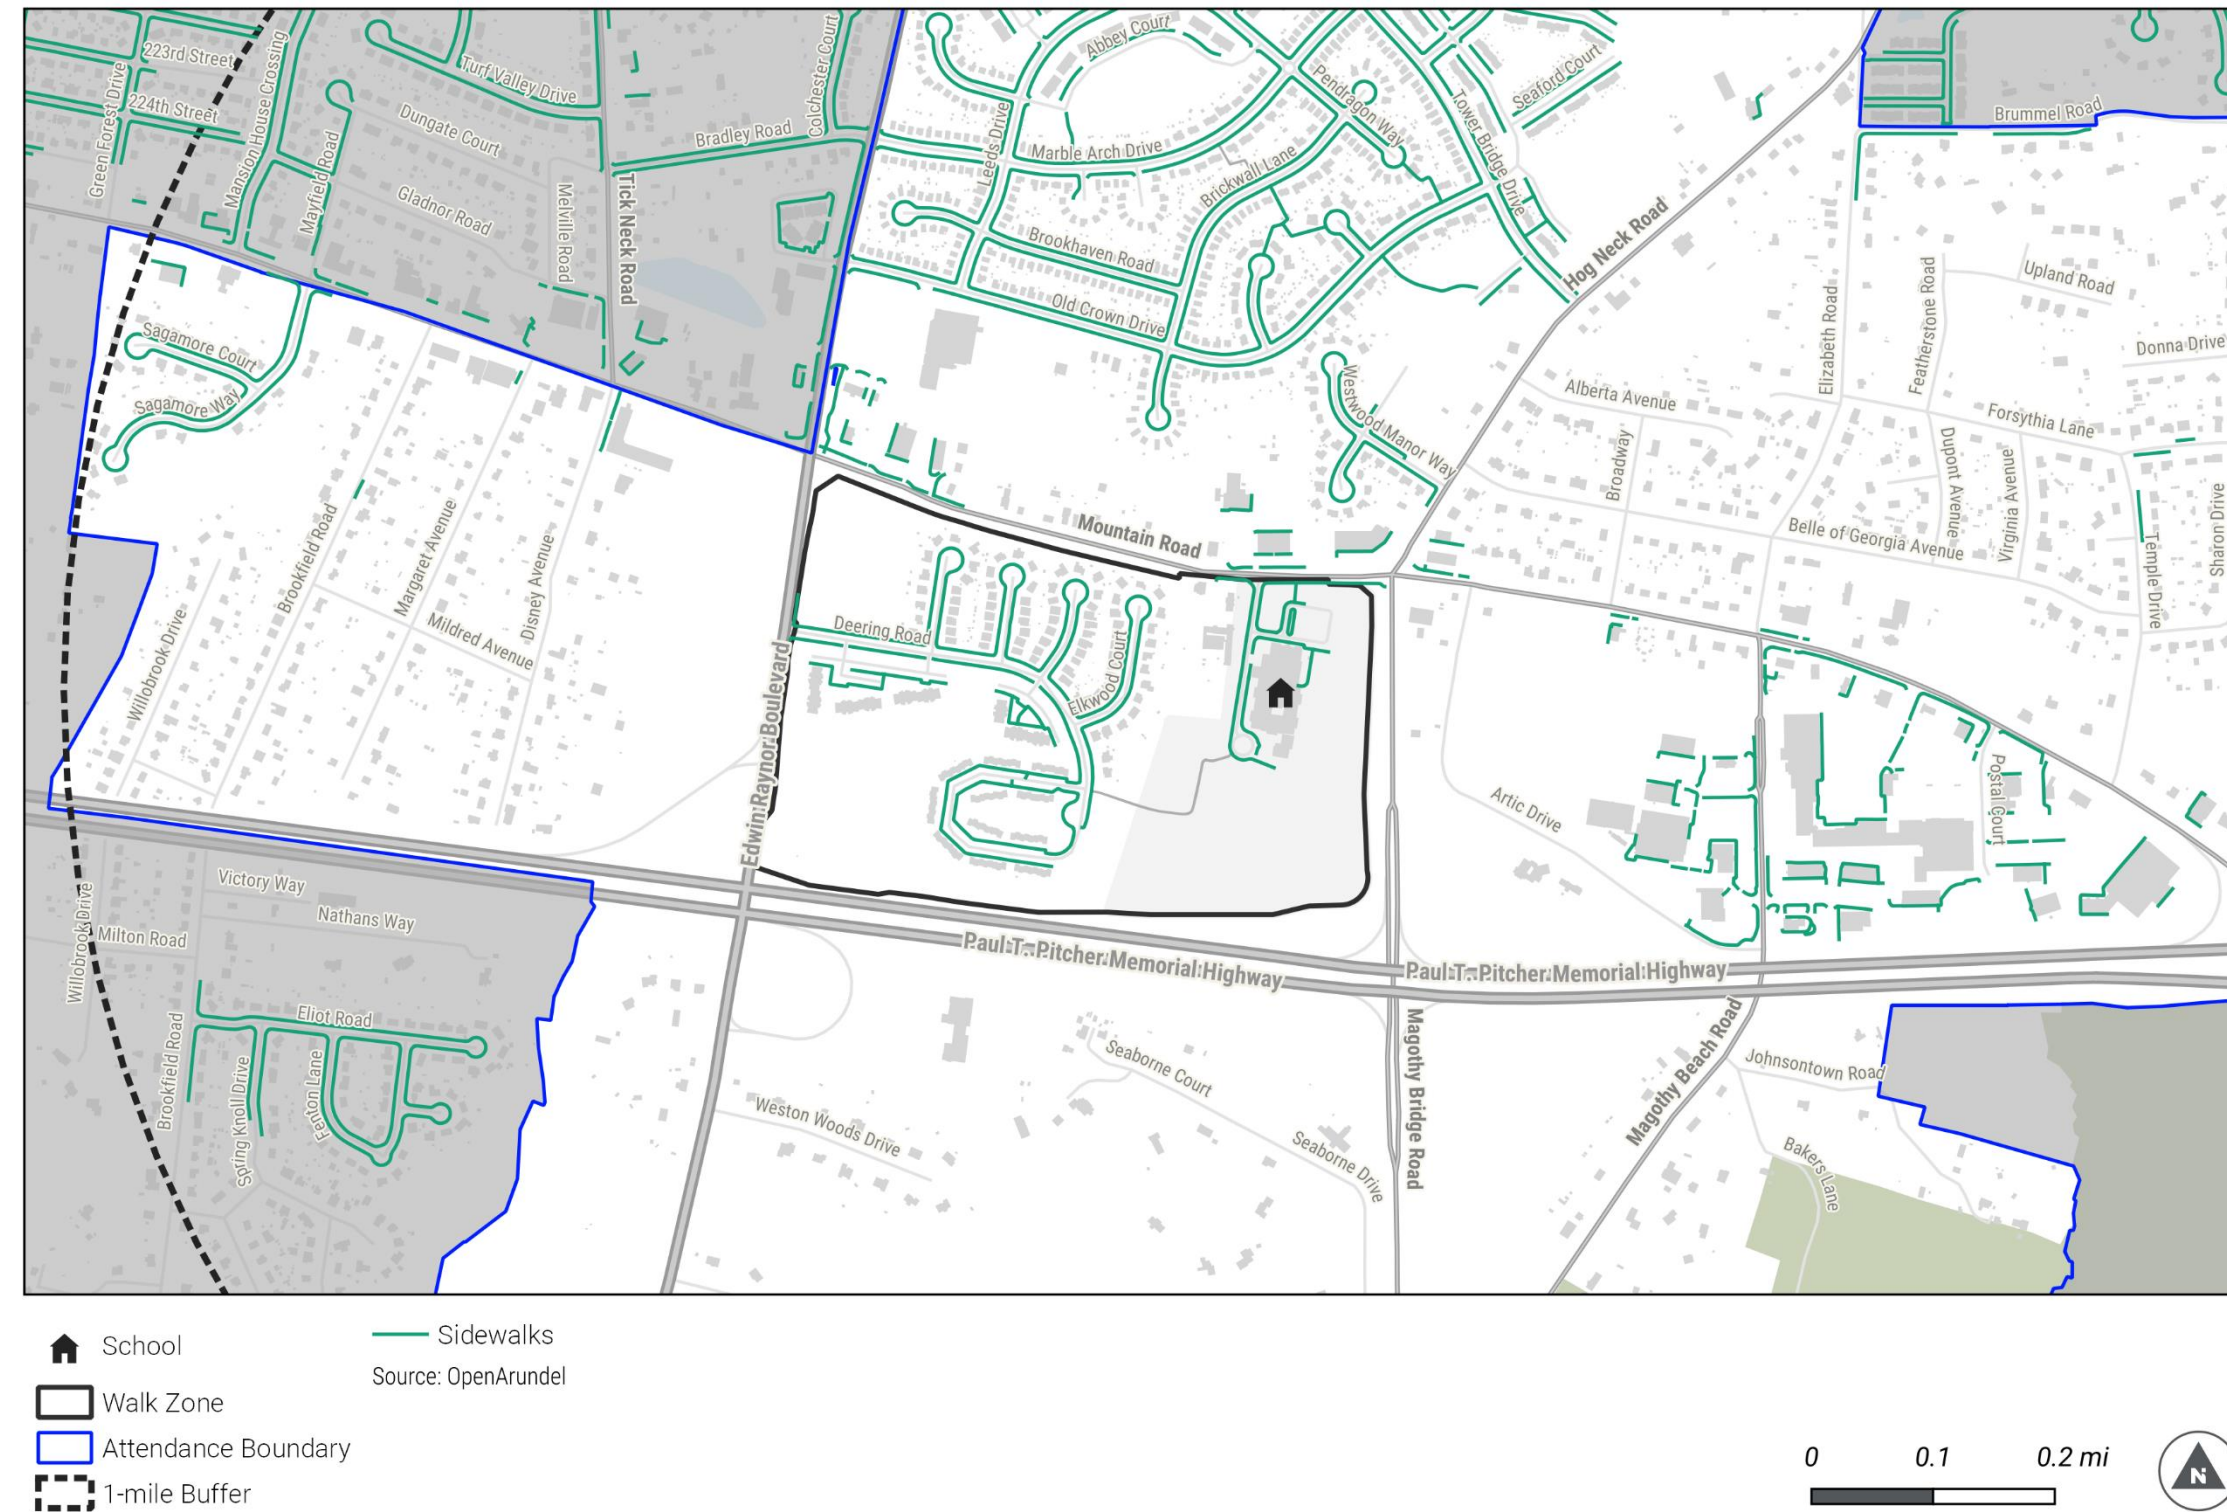
Jacobsville Elementary School - Existing Sidewalk Network

All streets within the walk zone have sidewalks; outside of the walk zone the sidewalk network is non-existent or incomplete.

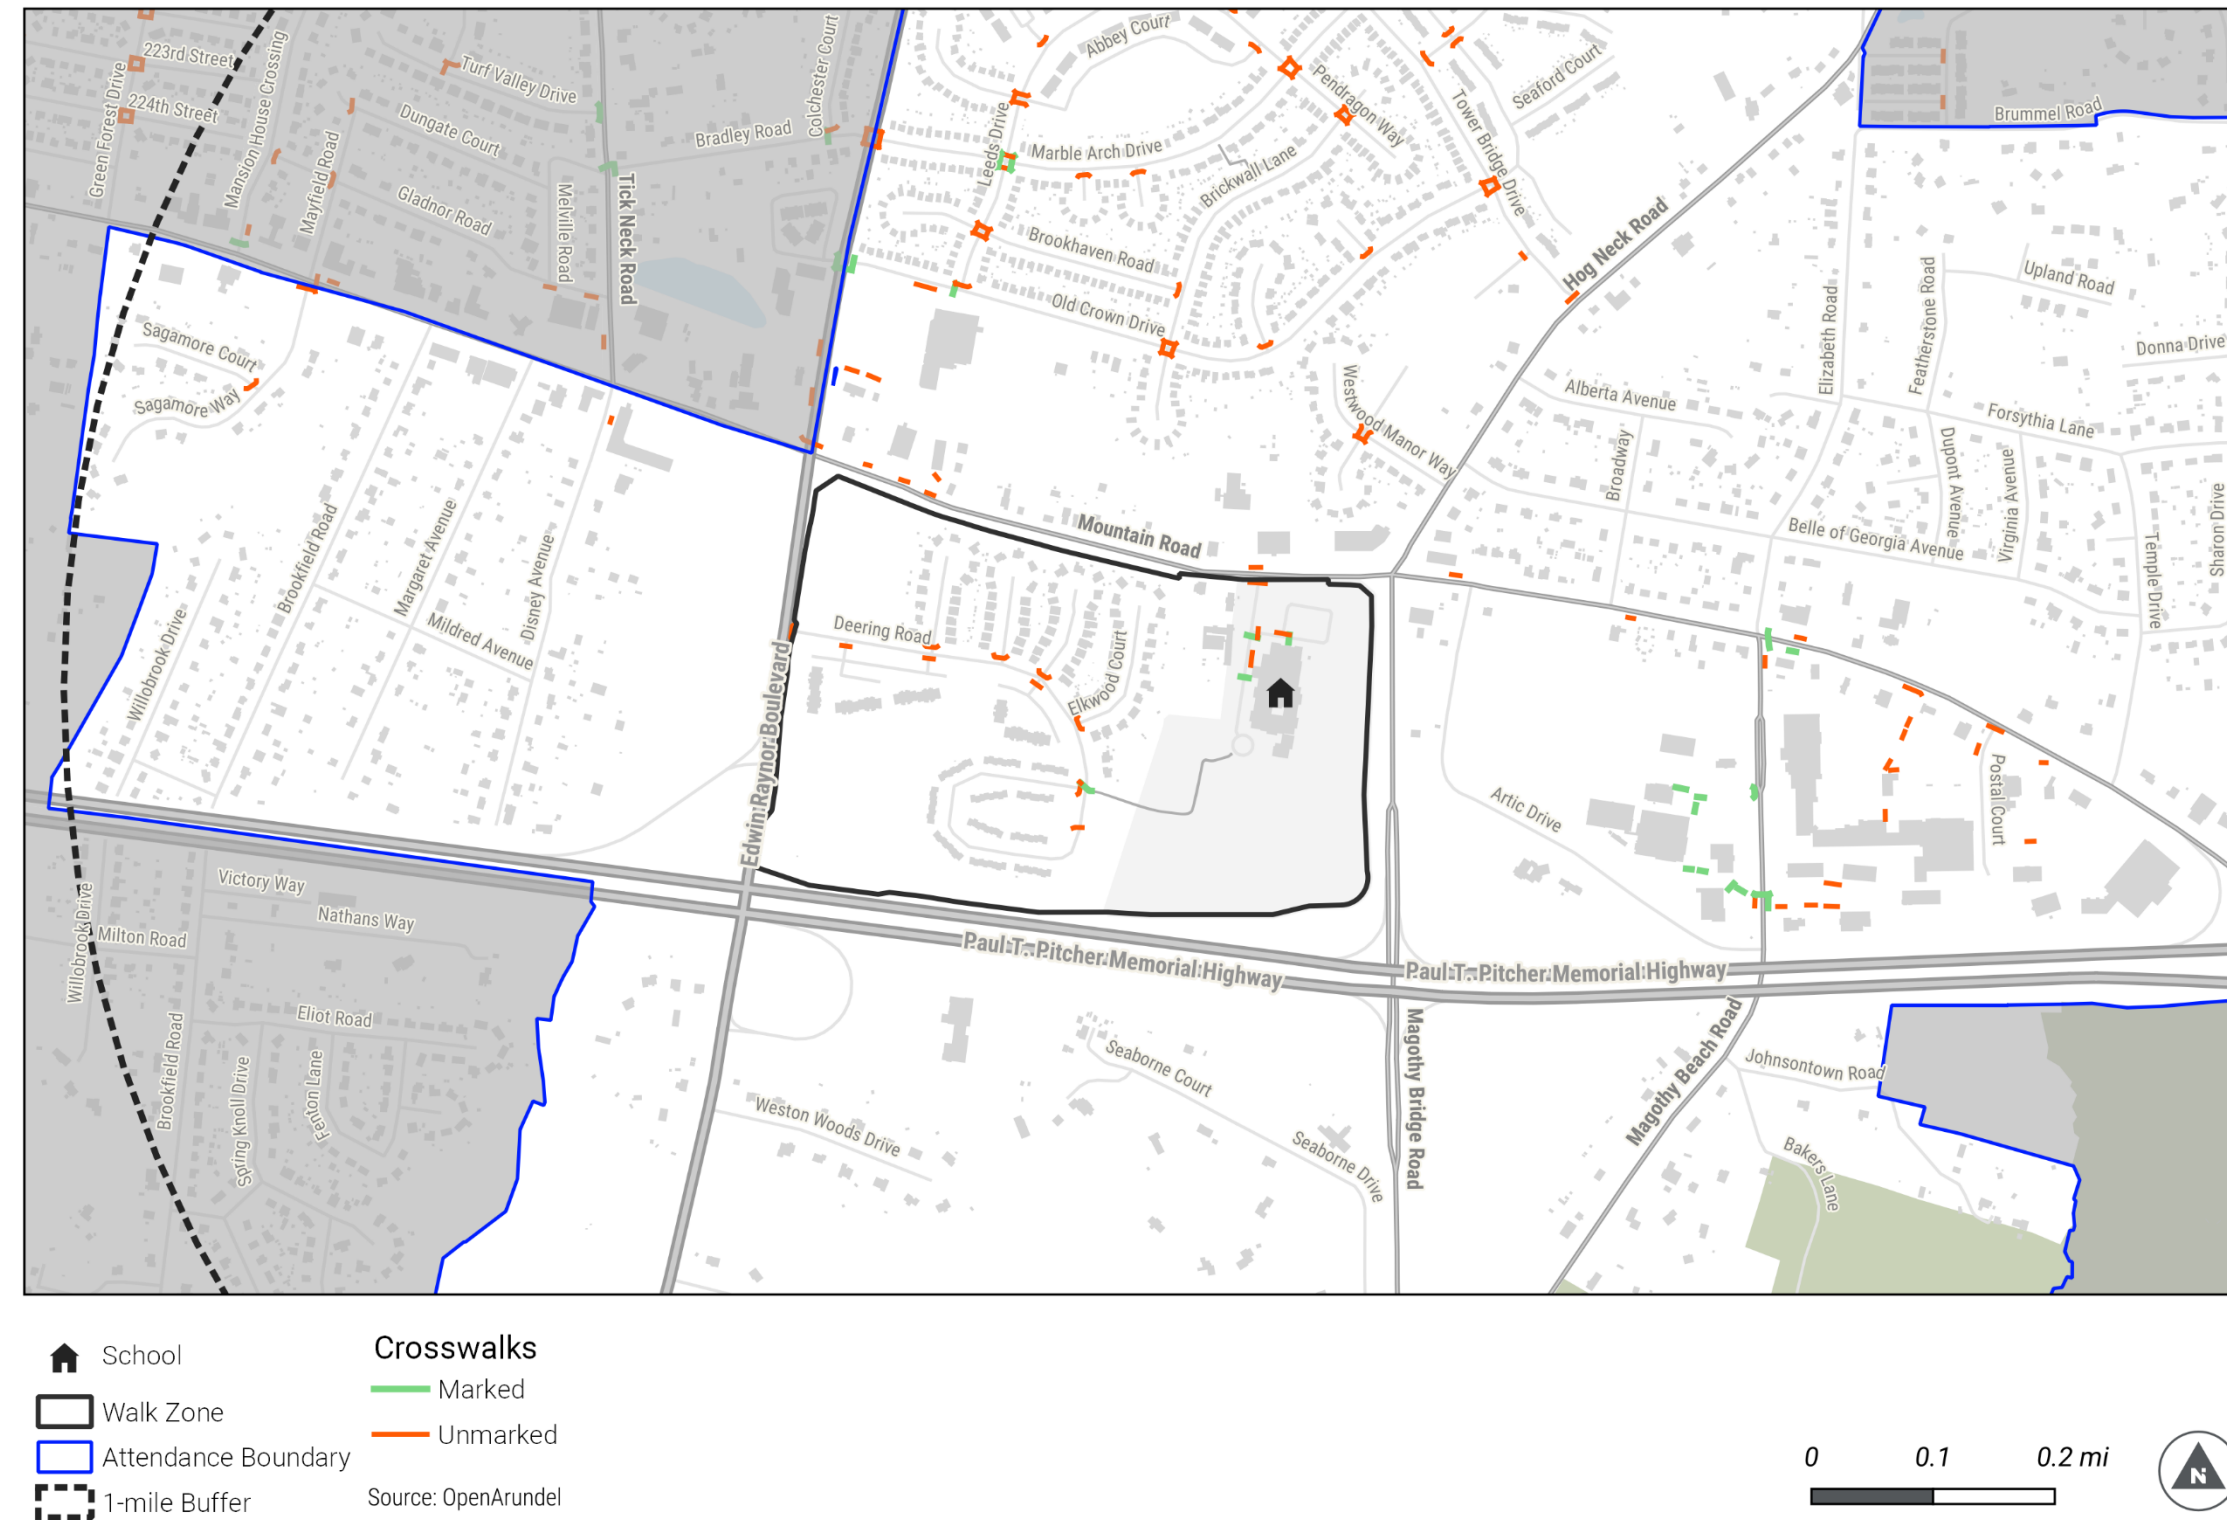
Jacobsville Elementary School - Existing Crosswalks

There is one marked crosswalk across Deering Road/Willowby Run at the intersection with the path.

The crossings of remaining intersections within the school walk zone are unmarked, including on campus across the main driveway and the parking lot entrance.

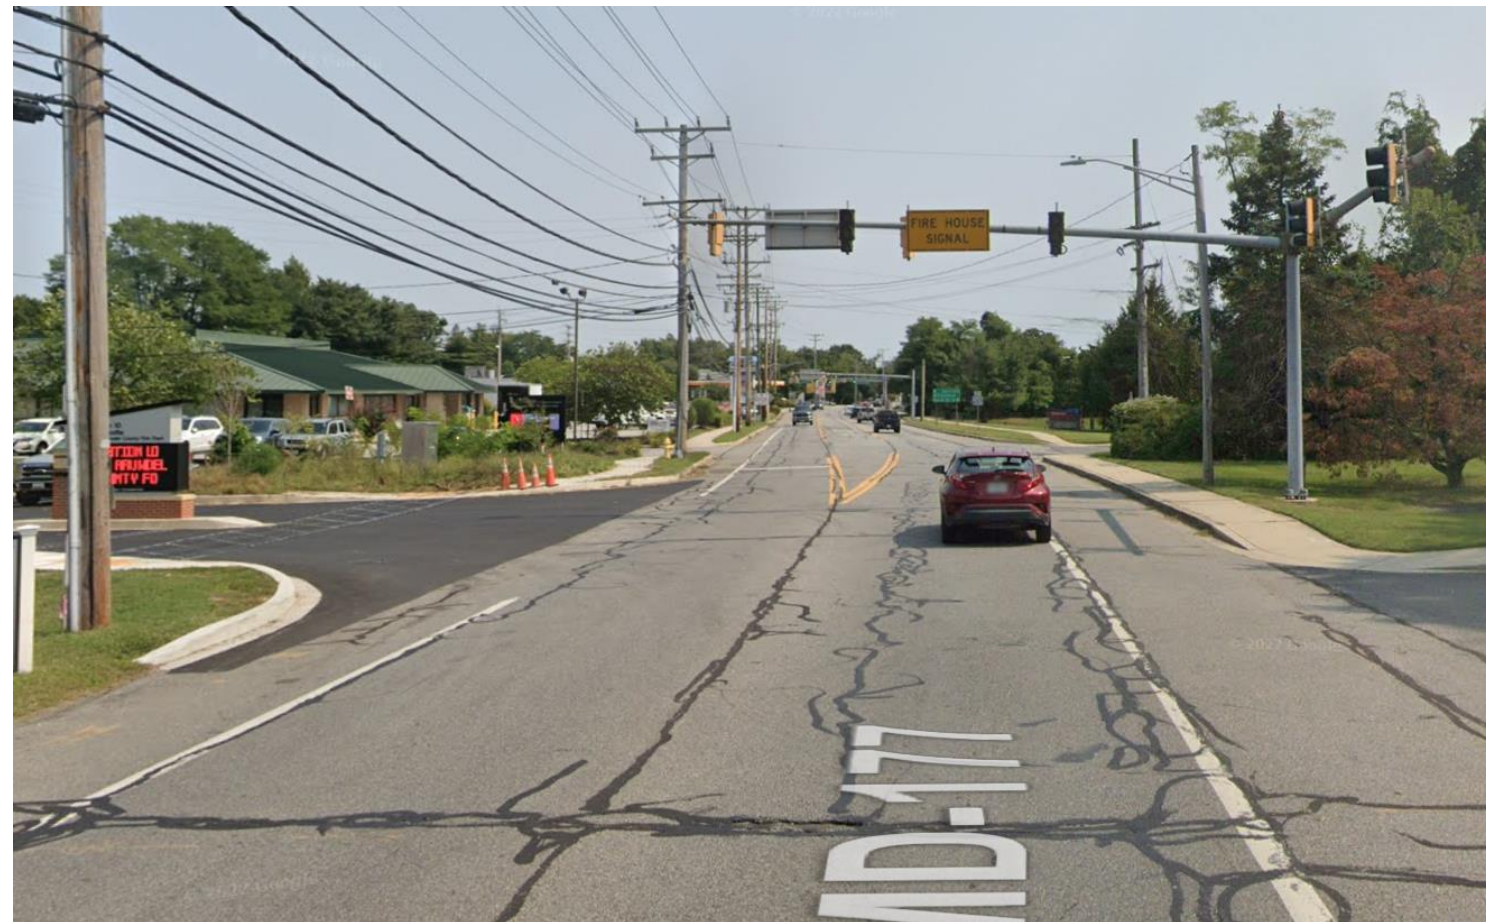
There are many homes to the north and northwest of the school that are less than 0.75 miles away but lack appropriate pedestrian and bicycle facilities. With the County owned fire station being location nearby, it is worth exploring the feasibility of a trail connection from the end of Cokesbury Court to Mountain Road. This would require a HAWK signal to be placed at the existing fire signal, as well as the potential consolidation of driveways along the north side of Mountain Road.

Intersection of Mountain Road and the fire station, where a HAWK signal could potentially be located.

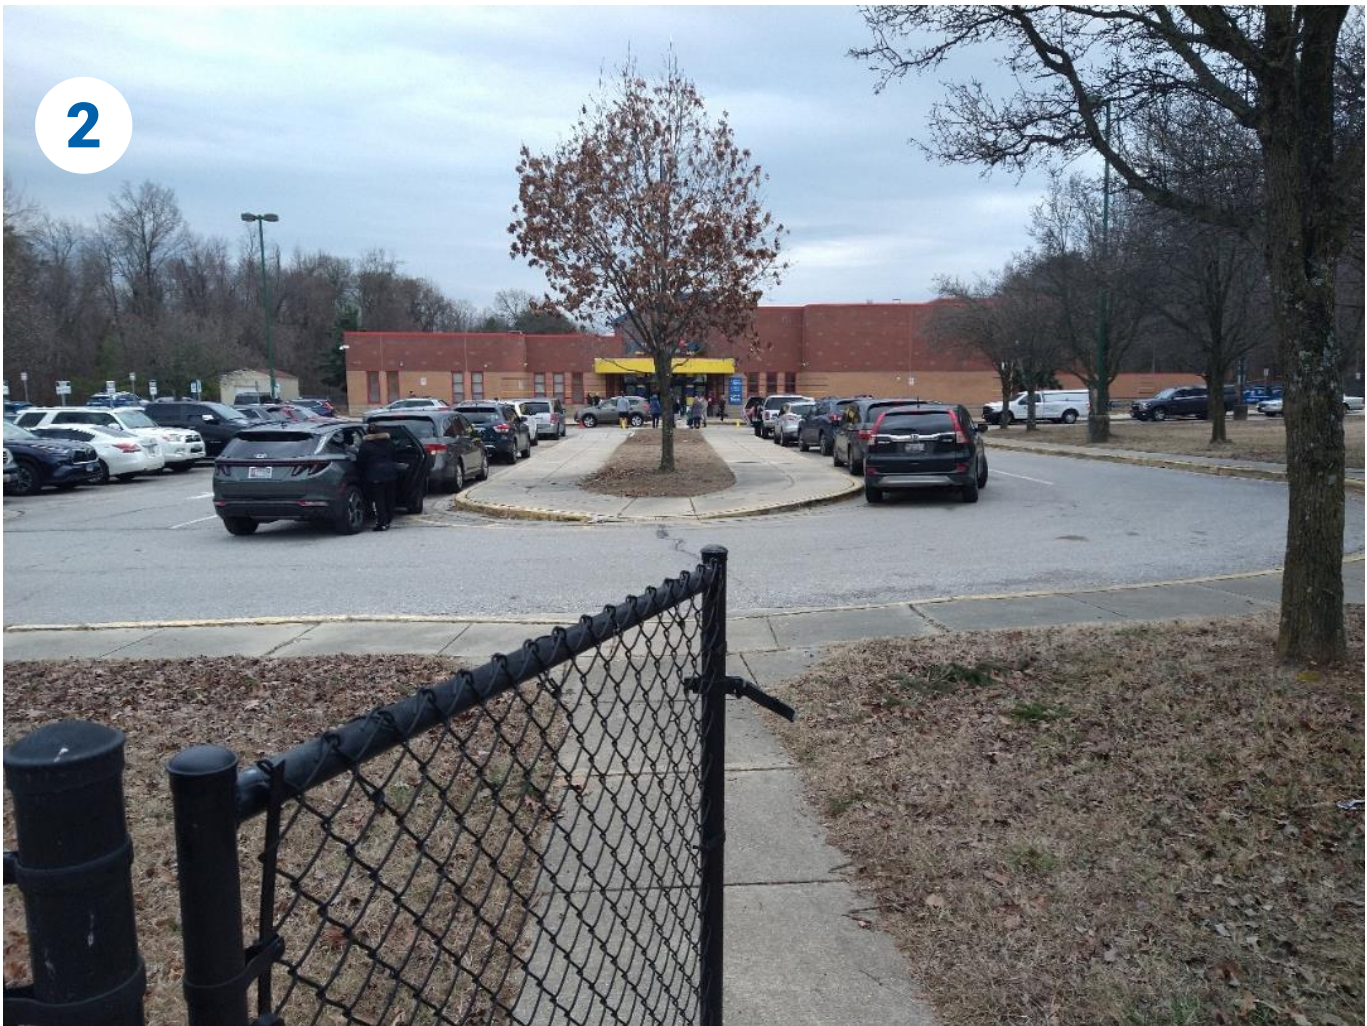
The north end of the school loop and sidewalk out to Mountain Road gate.

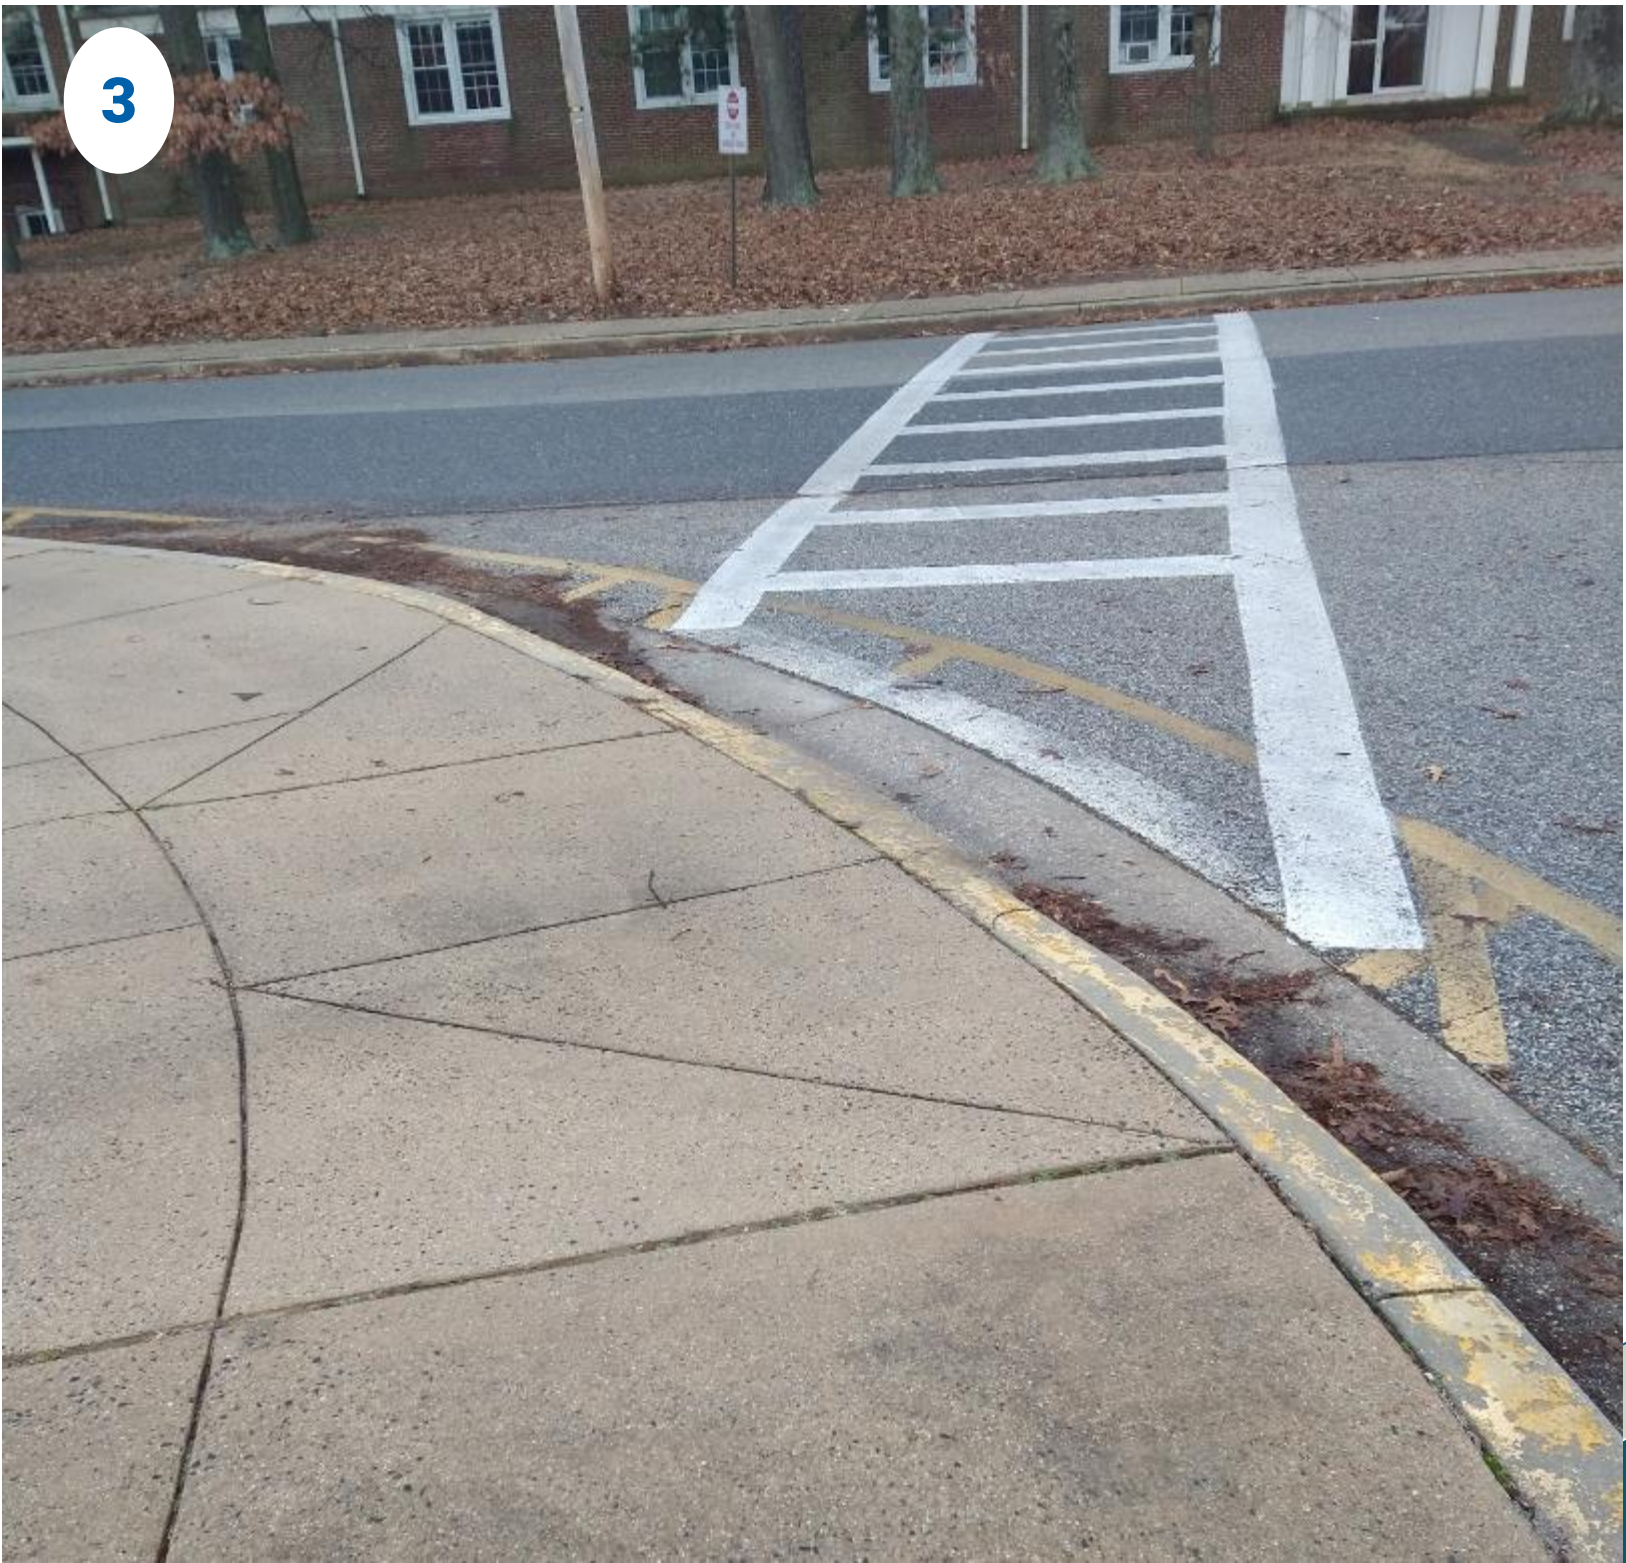
| Map ID | Location | Facility Type | Issue | Recommendation | Potential Cost | Timeframe* |
|---|---|---|---|---|---|---|
| 3 | School Driveway at Parking Lot (On school campus) | Curb ramp | East, West ramps missing | Install new ramps | \$8,000 | Medium |

Crossing the entrance to the bus lane and parking lot.

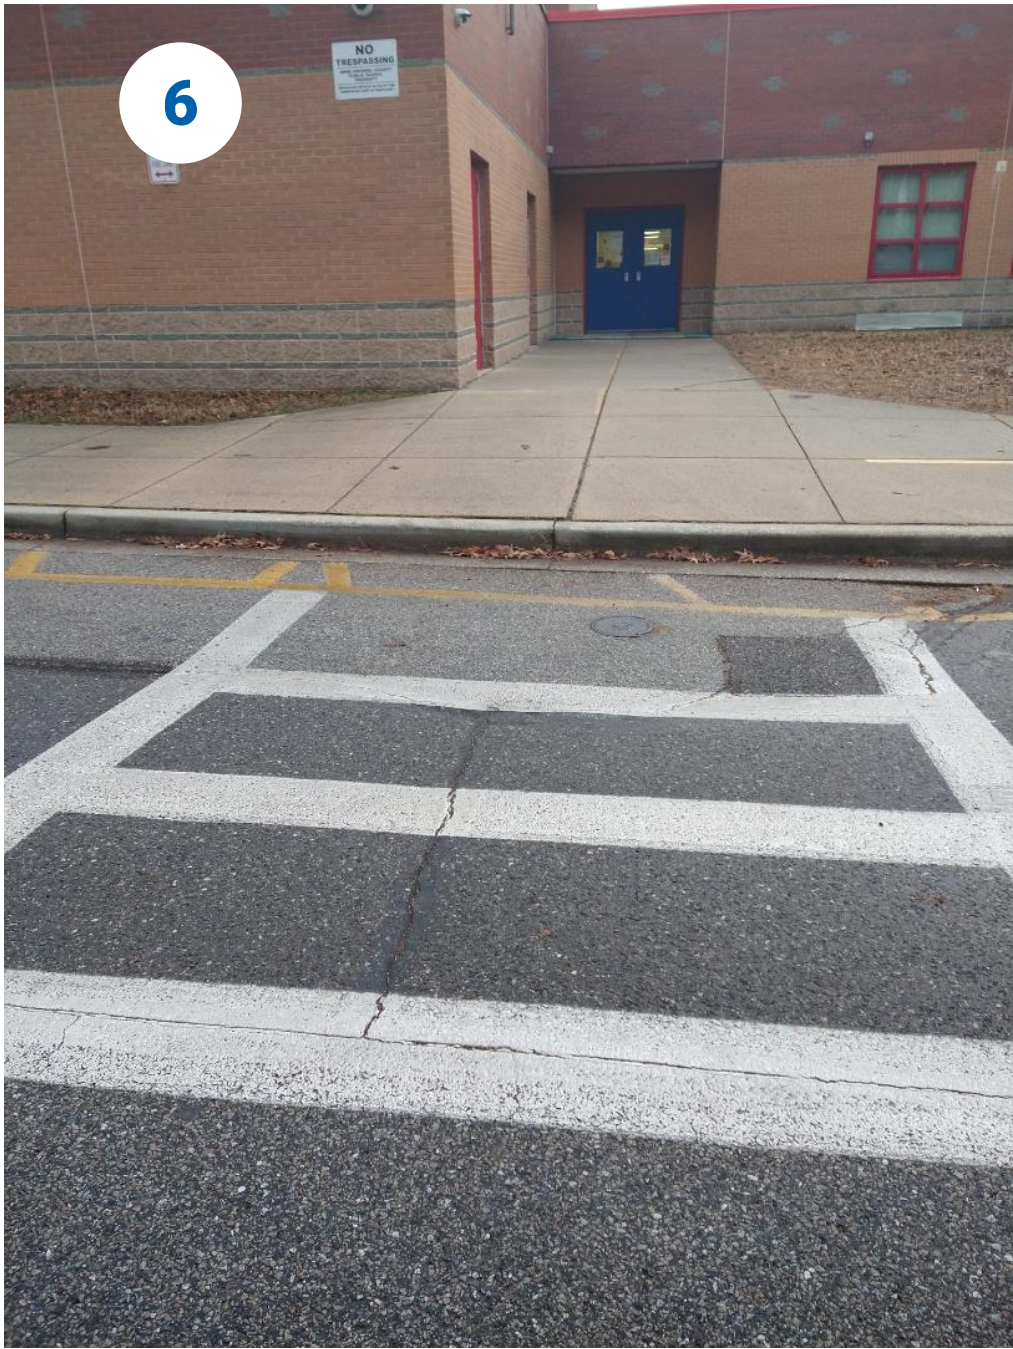
| Map ID | Location | Facility Type | Issue | Recommendation | Potential Cost | Timeframe* |
|---|---|---|---|---|---|---|
| 6 | School Driveway at Bus Rider/Walker/ Bicyclist Entrance (Along key student walking and bicycling route, On school campus) | Curb ramp | East, West ramps missing | Install new ramps | \$8,000 | Medium |

Crossing the bus lane to the side entrance used by walkers and bike and bus riders

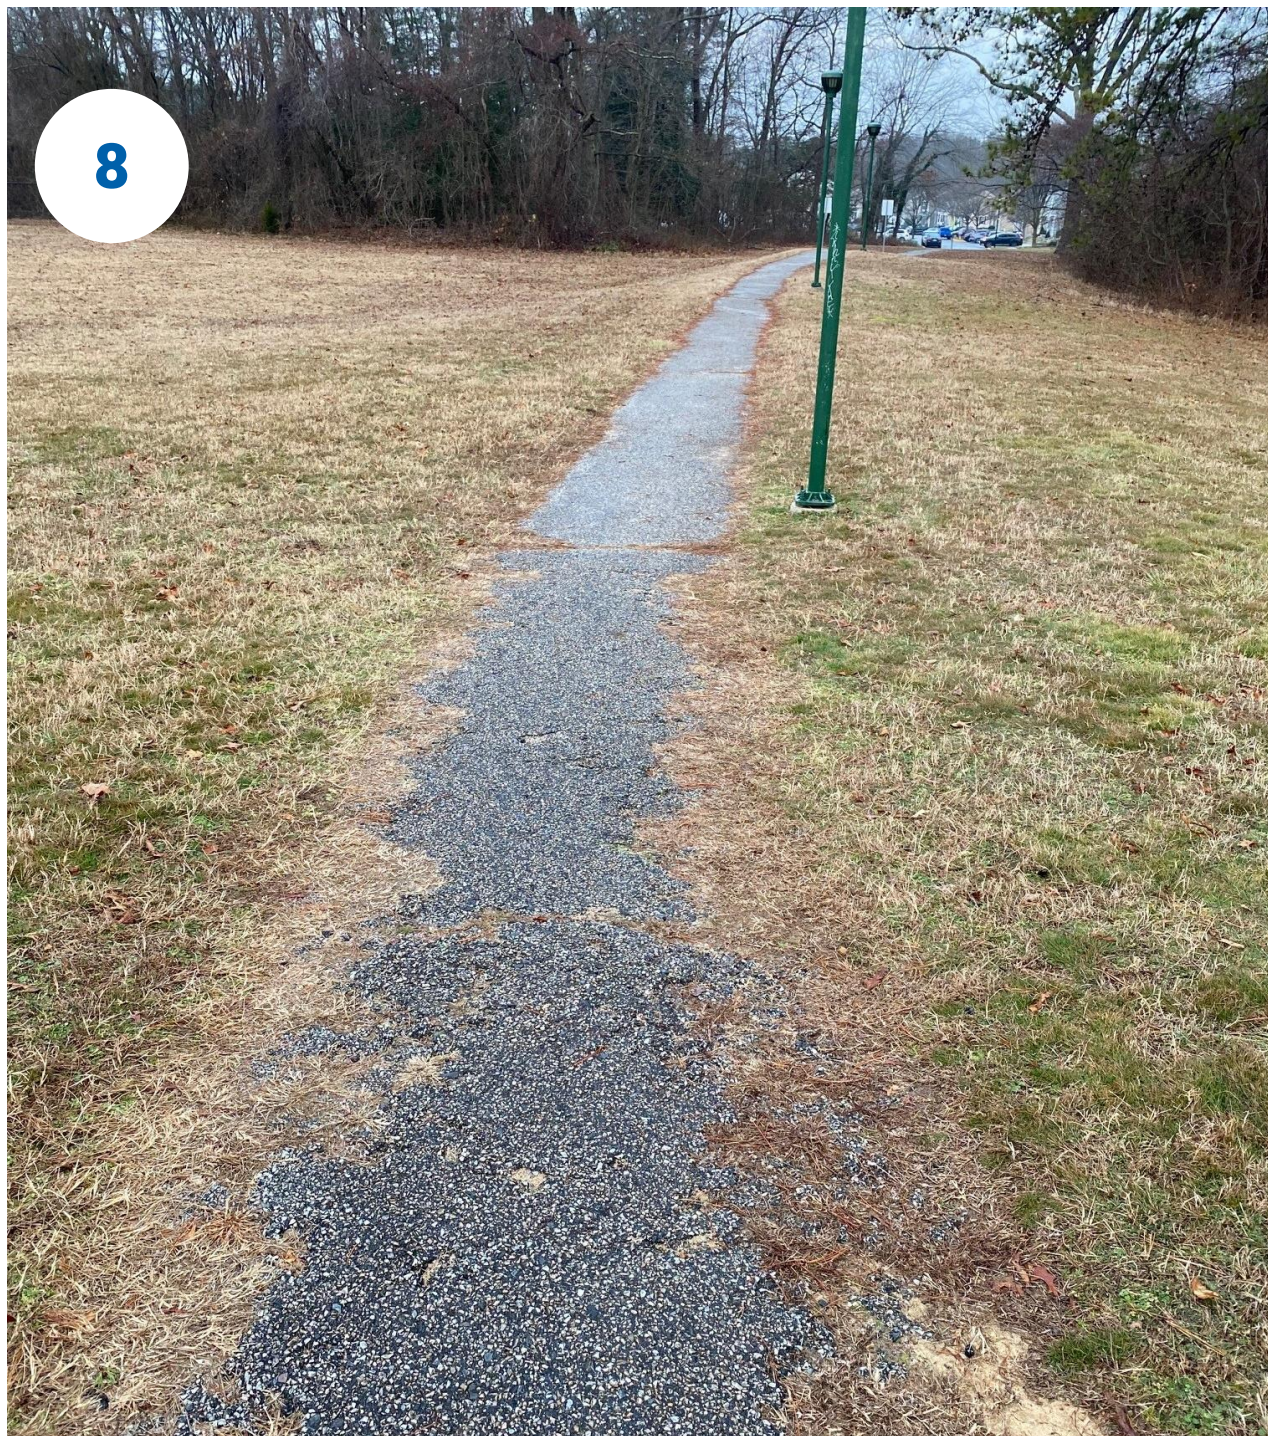
| Map ID | Location | Facility Type | Issue | Recommendation | Potential Cost | Timeframe* |
|---|---|---|---|---|---|---|
| 8 | Trail to School (Willowby Run to School) (Along key student walking and bicycling route, Inside school zone, On school campus) | Sidewalk | Path is cracked, overgrown, and too narrow | Reconstruct or repair path | \$32,440 | Long |

The path from the school to Deering Road

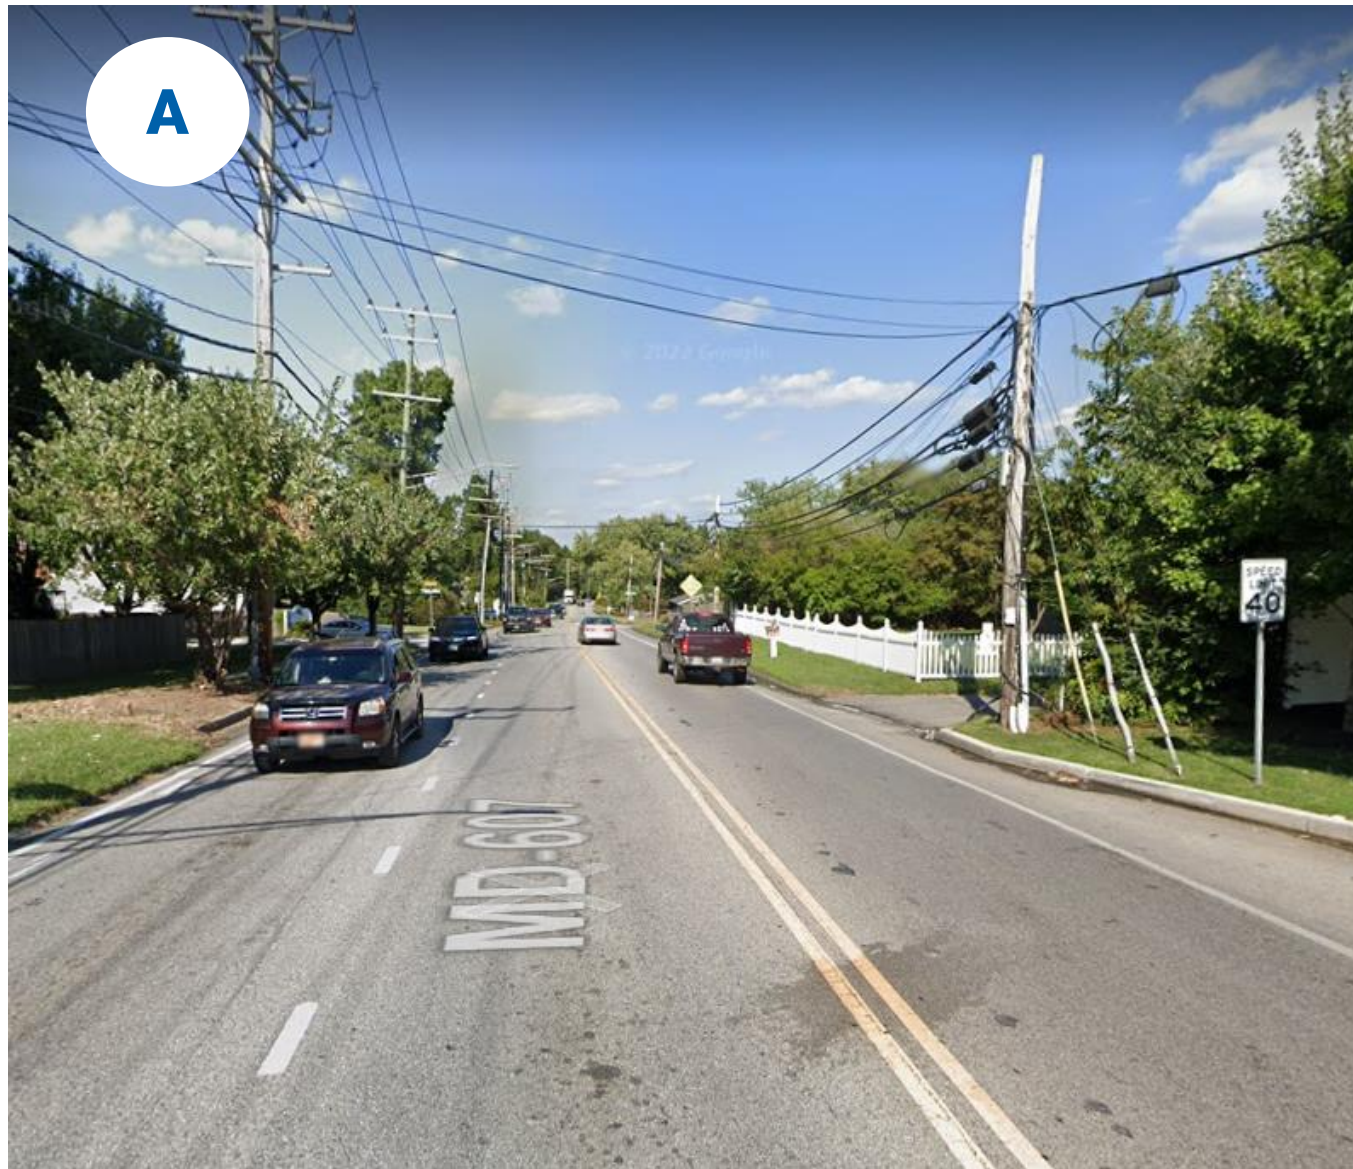
Hog Neck Road

| Map ID | Location | Facility Type | Issue | Recommendation | Potential Cost | Timeframe* |
|---|---|---|---|---|---|---|
| A | Hog Neck Rd (Mountain Rd to Tower Bridge Dr) | Sidewalk | Missing Sidewalk (both sides) | Install new sidewalk** | \$116,074 | Long |
