# Jacobsville Elementary School Safe Routes to School Accessibility Study: Existing Conditions and Recommendations

August 17, 2023

# Anne Arundel Safe Routes to School Accessibility Study

# Jacobsville Elementary Accessibility Study

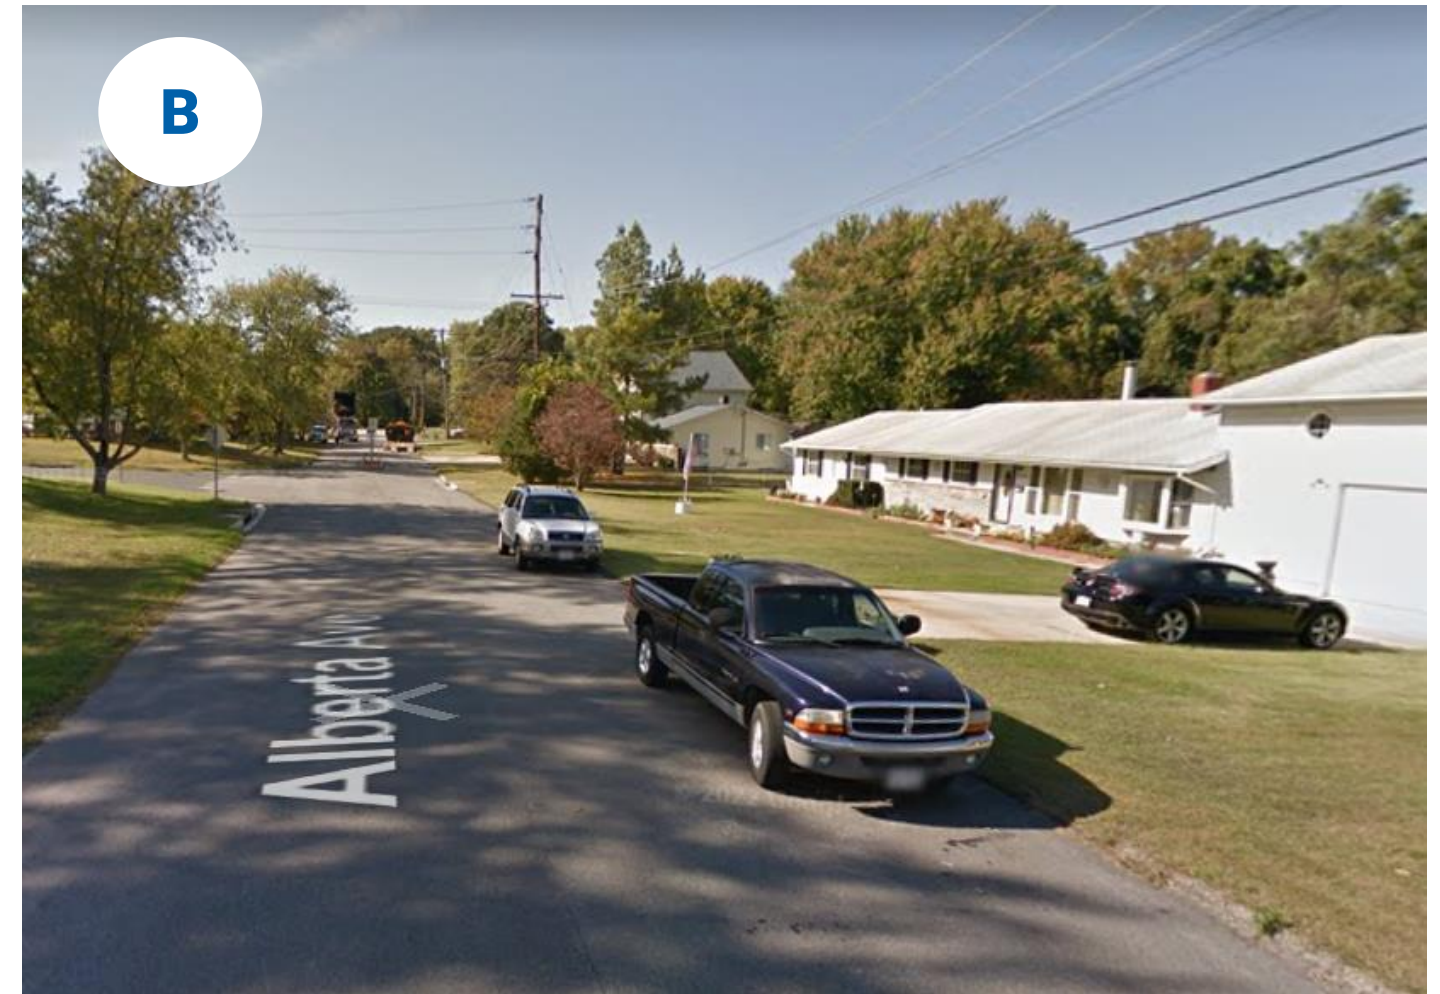
Albert Avenue

| Map ID | Location | Facility Type | Issue | Recommendation | Potential Cost | Timeframe* |
|---|---|---|---|---|---|---|
| B | Albert Ave (Hog Neck Rd to cul-de-sac) | Sidewalk | Missing Sidewalk (both sides) | Install new sidewalk** | \$77,768 | Long |

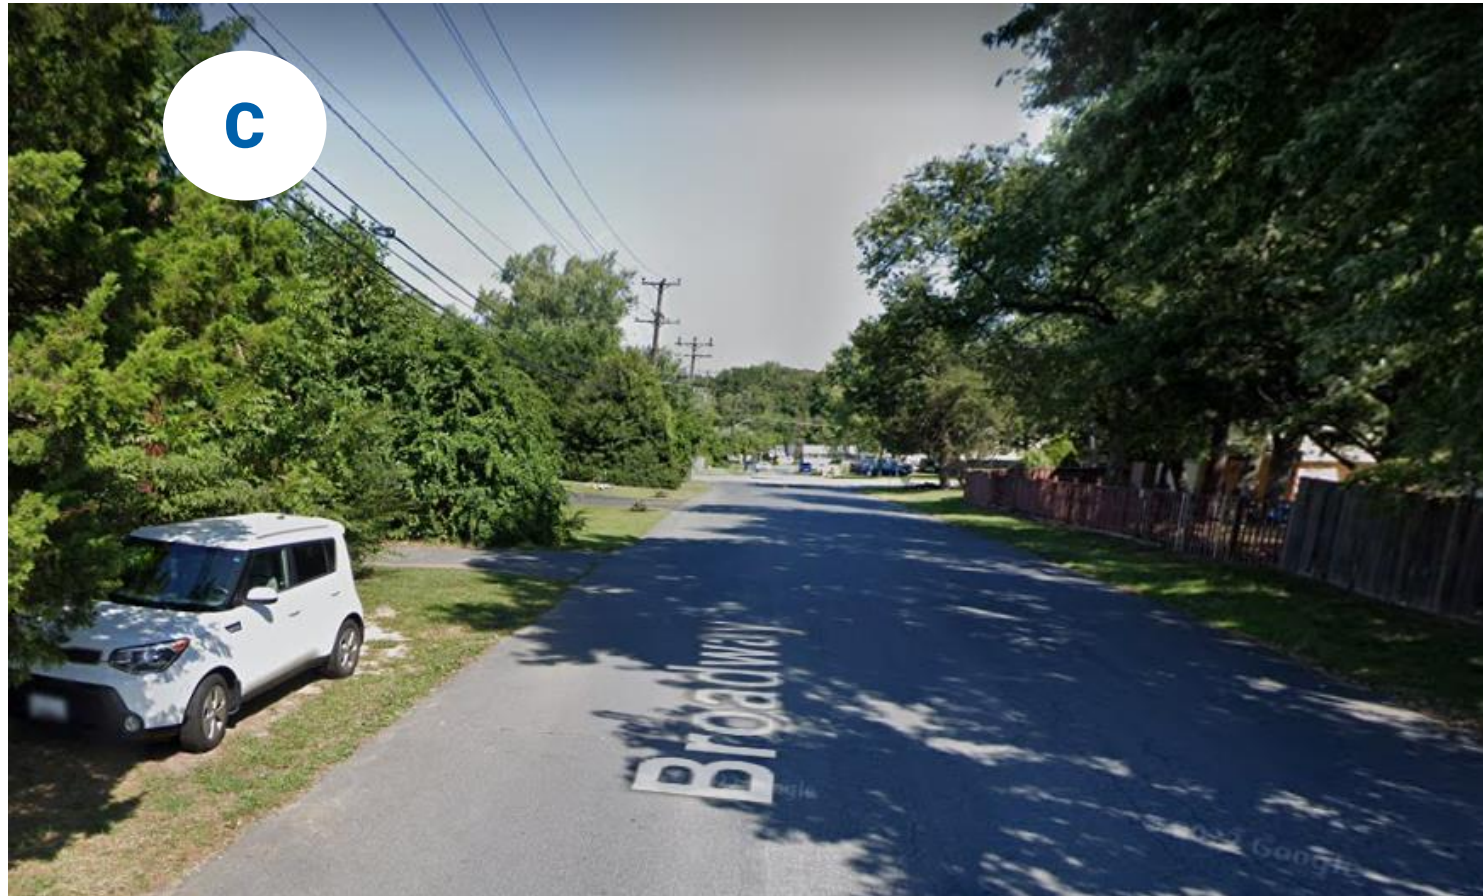
| Map ID | Location | Facility Type | Issue | Recommendation | Potential Cost | Timeframe* |
|---|---|---|---|---|---|---|
| C | Broadway (Alberta Ave to Mountain Rd) | Sidewalk | Missing Sidewalk (both sides) | Install new sidewalk** | \$66,970 | Long |

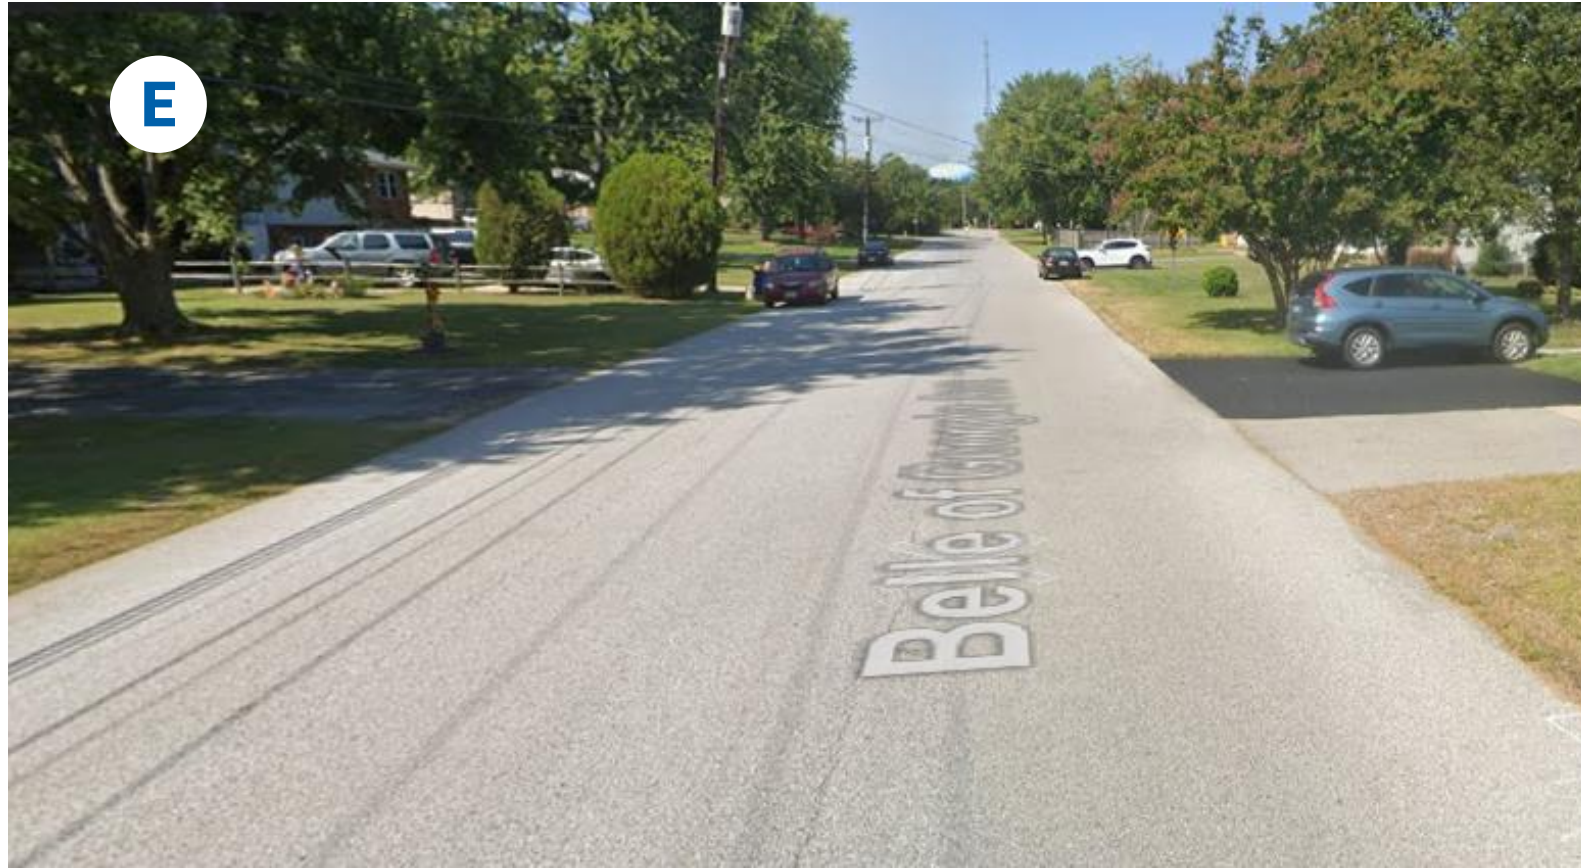
Belle of Georgia Avenue

| Map ID | Location | Facility Type | Issue | Recommendation | Potential Cost | Timeframe* |
|---|---|---|---|---|---|---|
| E | Belle of Georgia Ave (Hog Neck Rd to Elizabeth Rd) | Sidewalk | Missing Sidewalk (both sides) | Install new sidewalk** | \$112,351 | Long |

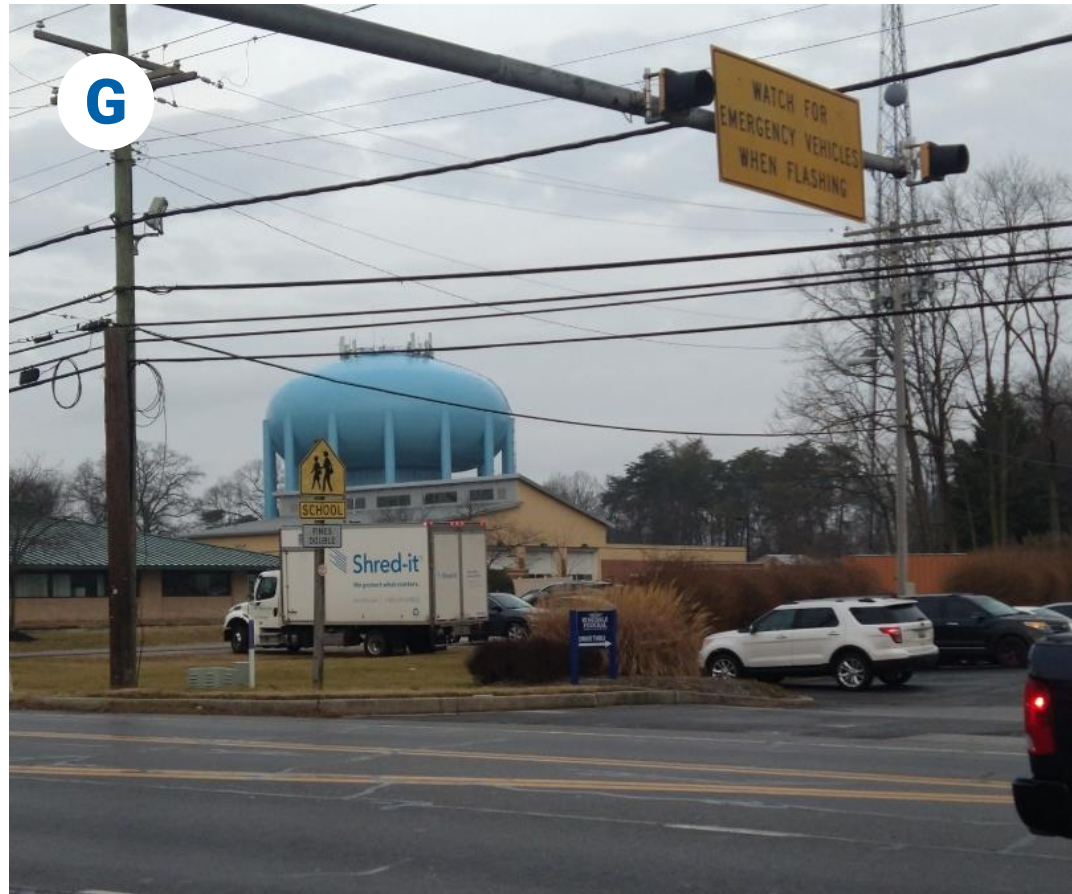
| Map ID | Location | Facility Type | Issue | Recommendation | Potential Cost | Timeframe* |
|---|---|---|---|---|---|---|
| H | Mountain Rd (Midblock between Edwin Raynor Blvd and Hog Neck Rd) (Inside School Zone) | Sidewalk | Missing sidewalk on north side | Install new sidewalk** | | |

Mountain Road across from the school property.

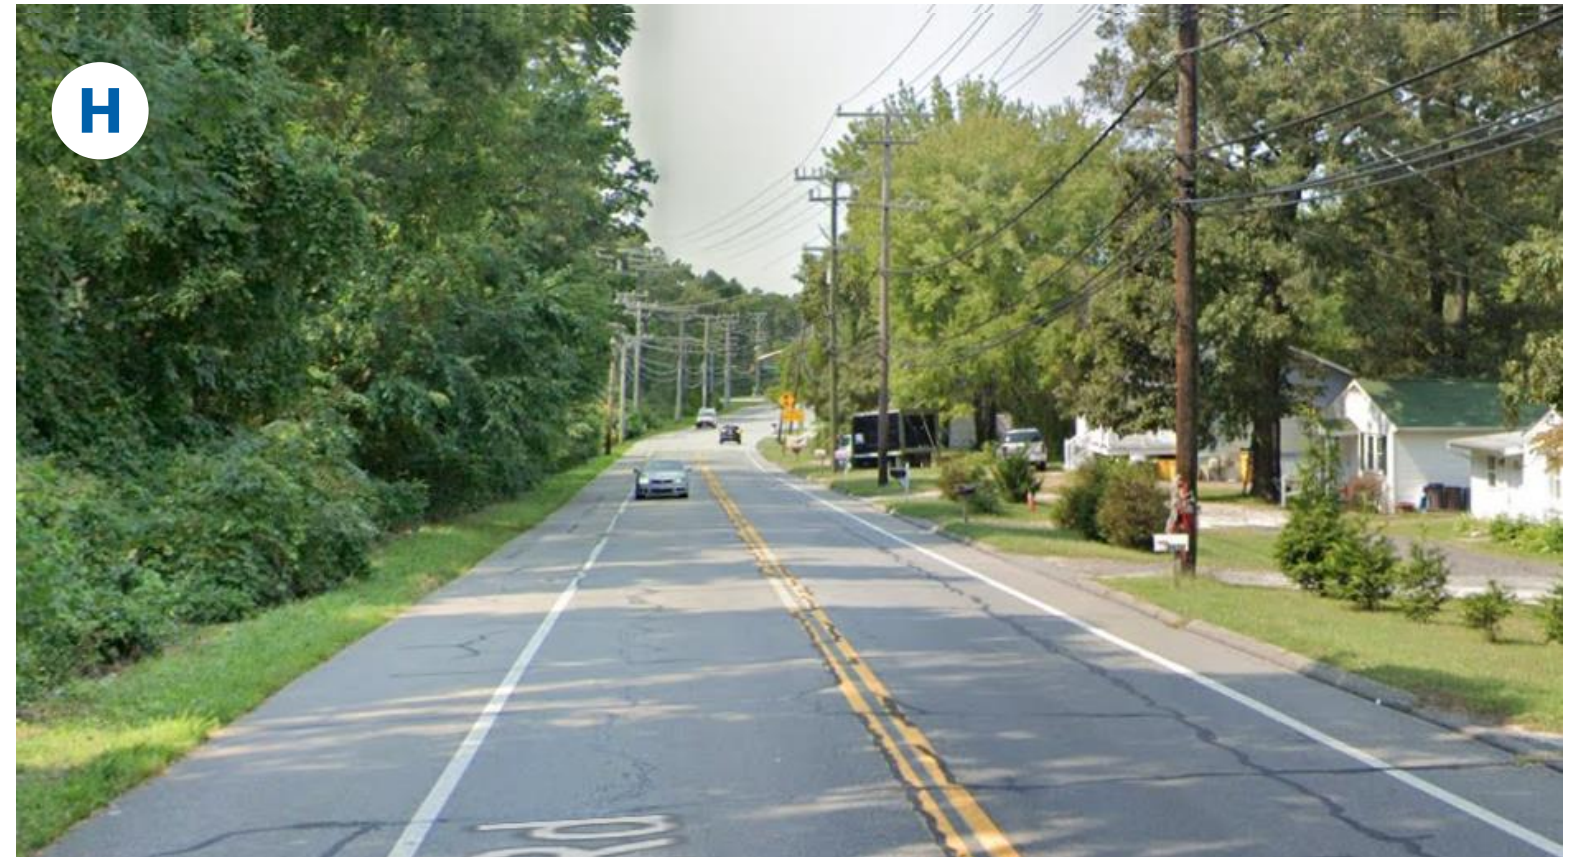
Mountain Road, looking west

| Map ID | Location | Facility Type | Issue | Recommendation | Potential Cost | Timeframe* |
|---|---|---|---|---|---|---|
| G | Mountain Rd (Hog Neck Rd to Edwin Raynor Blvd) (Inside school zone) | School Zone Signs and Pavement Markings | Existing school zone sign deficient | Expand school zone and enhance signage per MdMUTCD part 7: | | Short |
| | | | SCHOOL pavement marking missing | - Repair or replace existing school zone sign (begin/end) | \$1,000 | |
| | | | School zone speed limit sign missing | - Install new SCHOOL pavement marking<br>- Install new school zone speed limit signs | \$1,000<br>\$500 | |
