# Linthicum Elementary School Safe Routes to School Accessibility Study: Existing Conditions and Recommendations

August 17, 2023

# Anne Arundel Safe Routes to School Accessibility Study

# Linthicum Elementary Accessibility Study

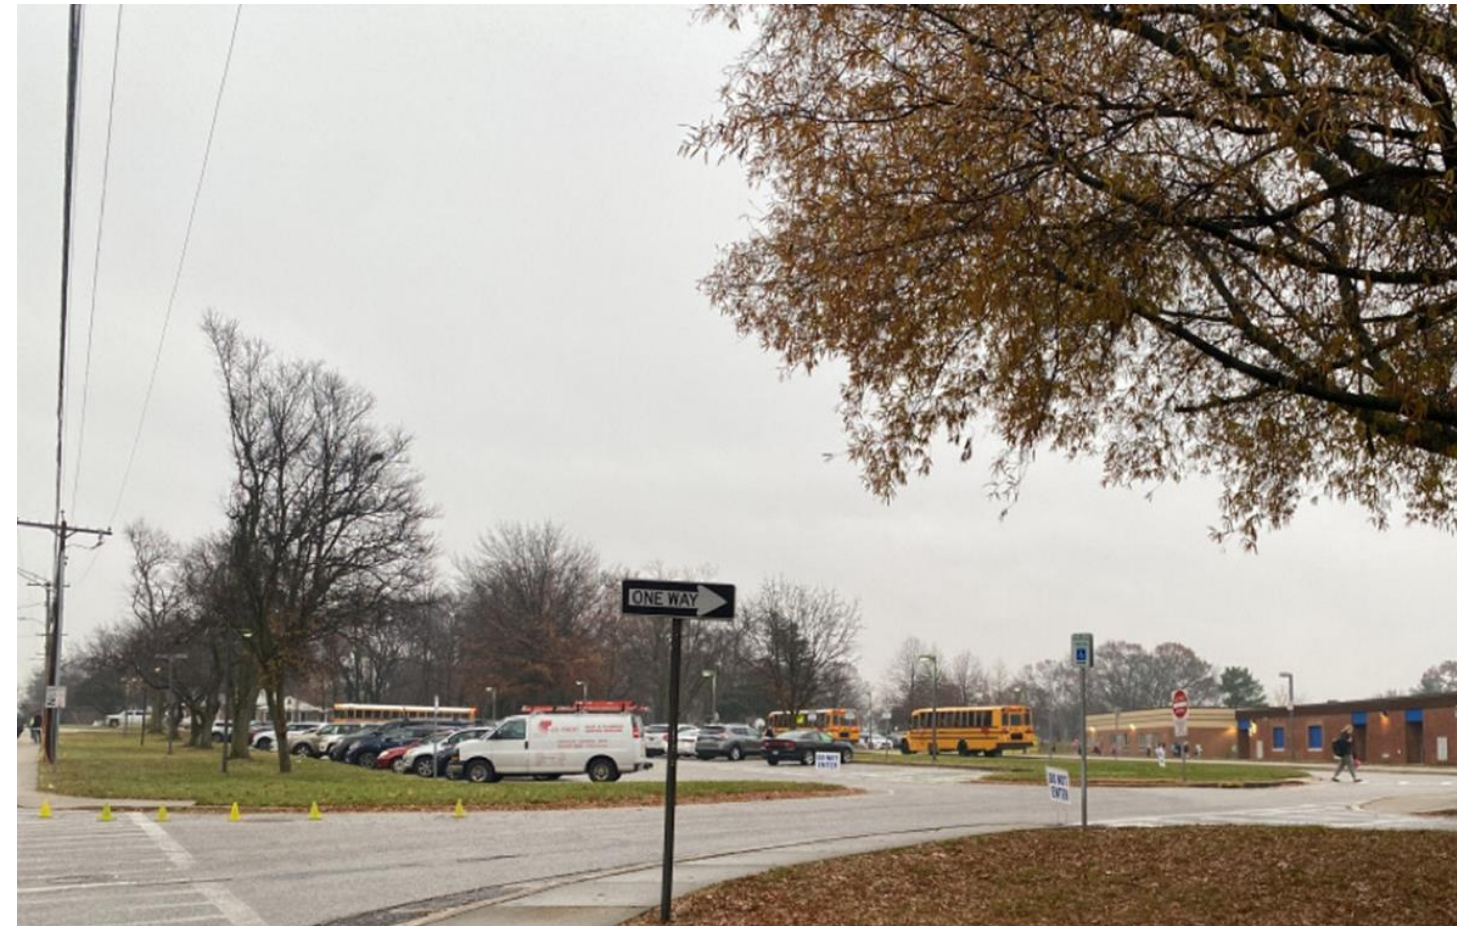
- School starts at 8:00 AM
- Doors open at 7:40 AM; buses hold students until then.
- Walkers gather outside the north entrance until doors open
- Cars line up on Benton Avenue until the gate to the drop-off loop is opened at 7:40 AM.

Buses waiting to drop off students during arrival.

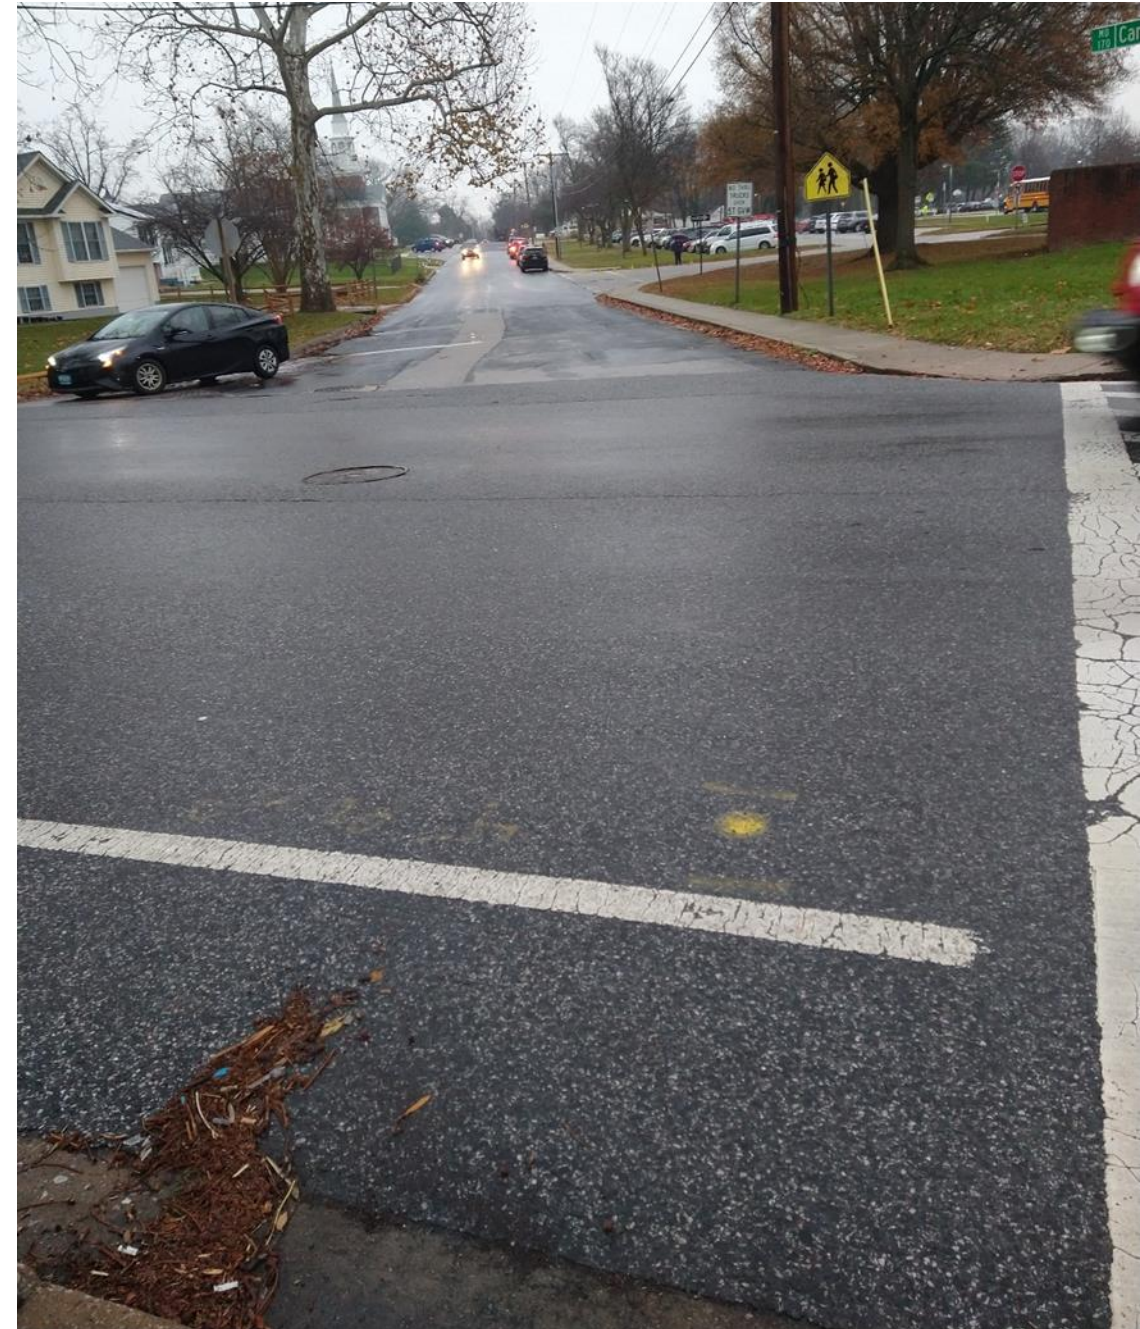
South Camp Meade Road at School Lane

- Approximately four buses were observed at arrival.

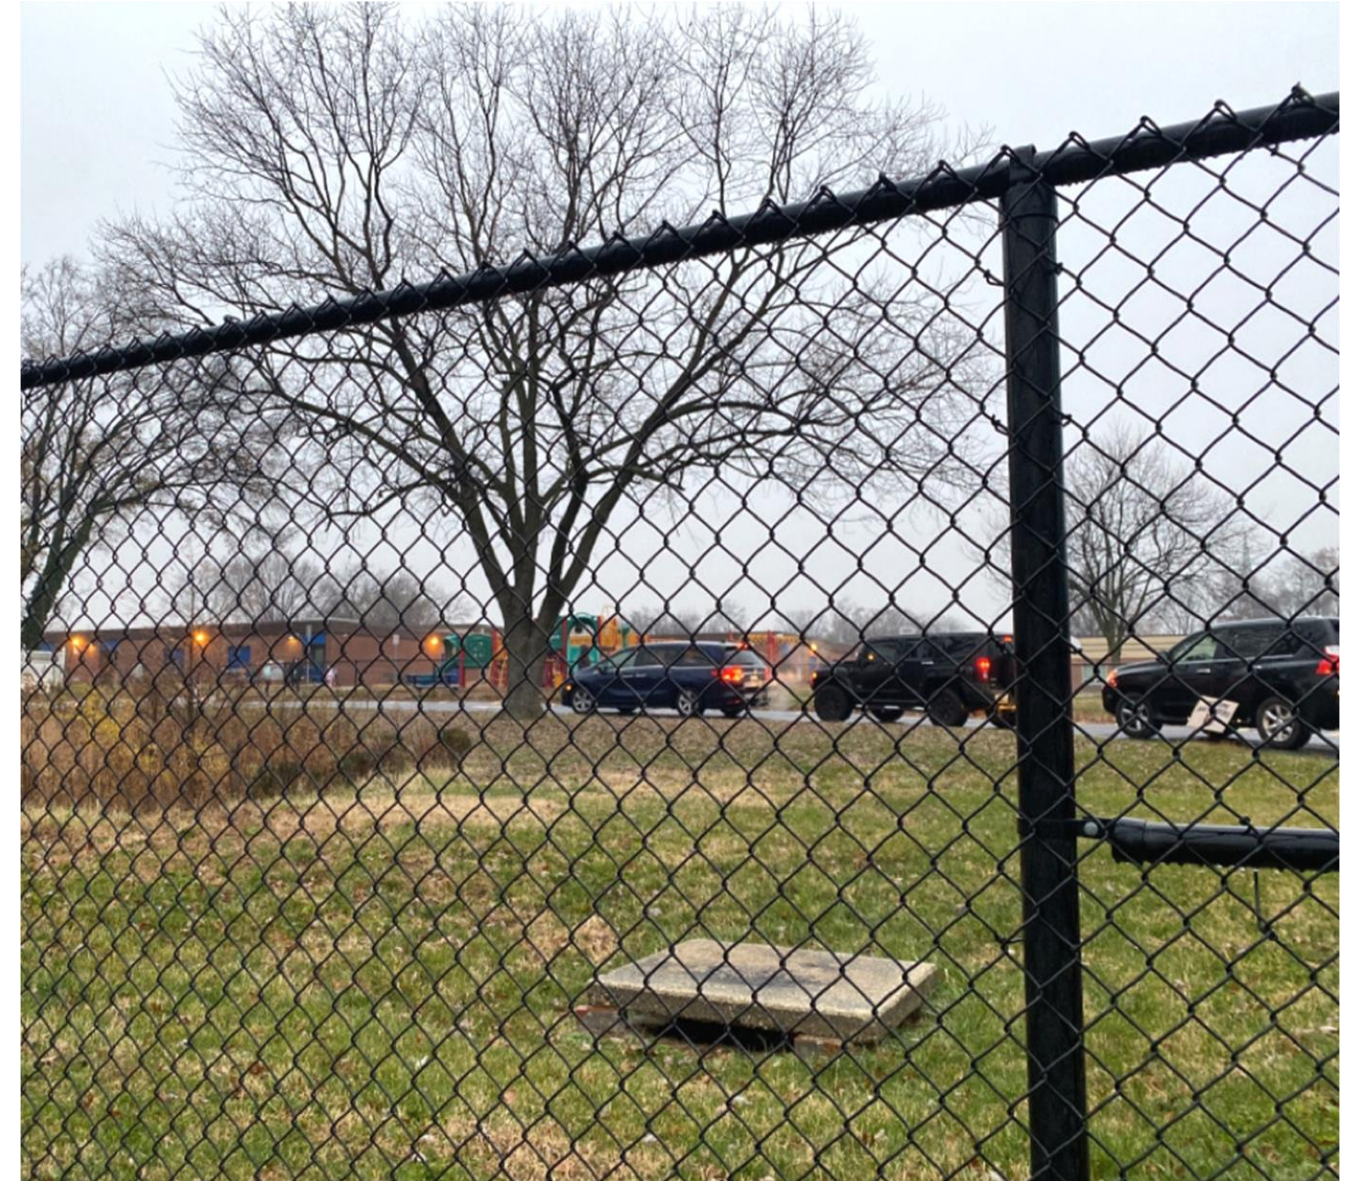
- Drivers were observed transporting students from houses across Benton Avenue.
- Many drivers were observed entering Benton Avenue from South Camp Meade Road, driving past the drop-off driveway, and making a U-turn on Benton Avenue at Golden Oak Drive to return to the driveway.
- Many parents dropped off students on School Lane or parked along the street and walked their kids to the door; double-parking, parking in crosswalks, U-turns, and several near-collisions were observed.

Parent drop-off loop at school arrival.

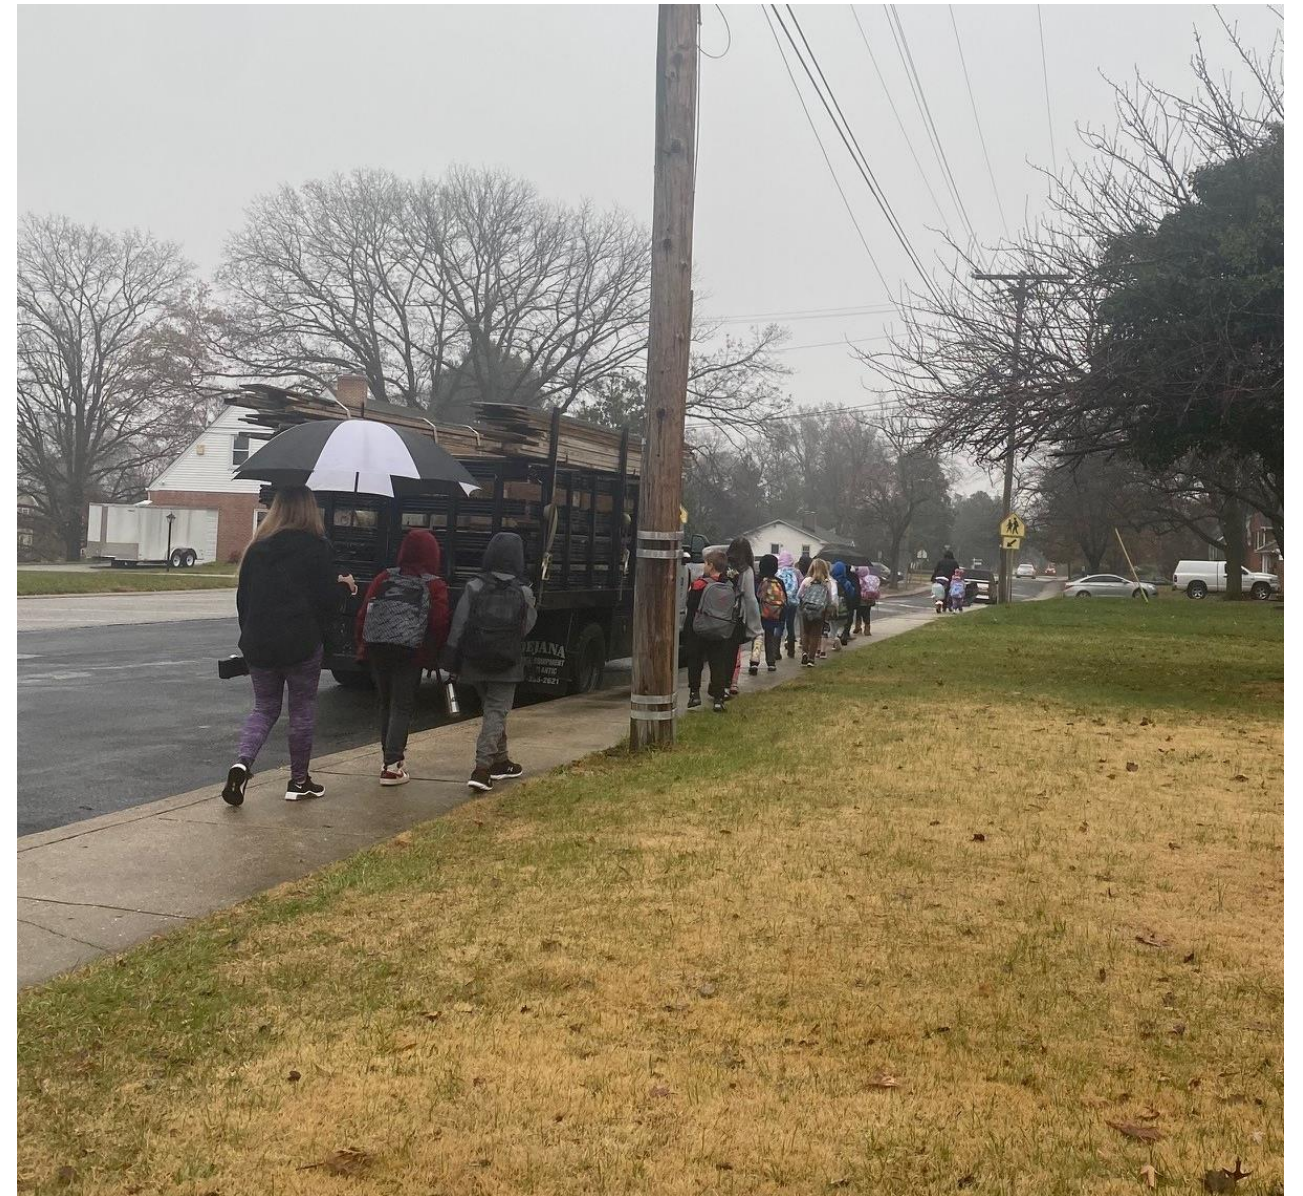
- Approximately 30 students, including a group of about 20 students and 2 parents were observed walking east on School Lane toward Sycamore Street.
- Approximately 5 students with one parent were observed crossing South Camp Meade Road at School Lane and heading south.
- Most students getting dismissed as walkers appeared to be park-and-walk students.

Walkers on School Lane at dismissal.

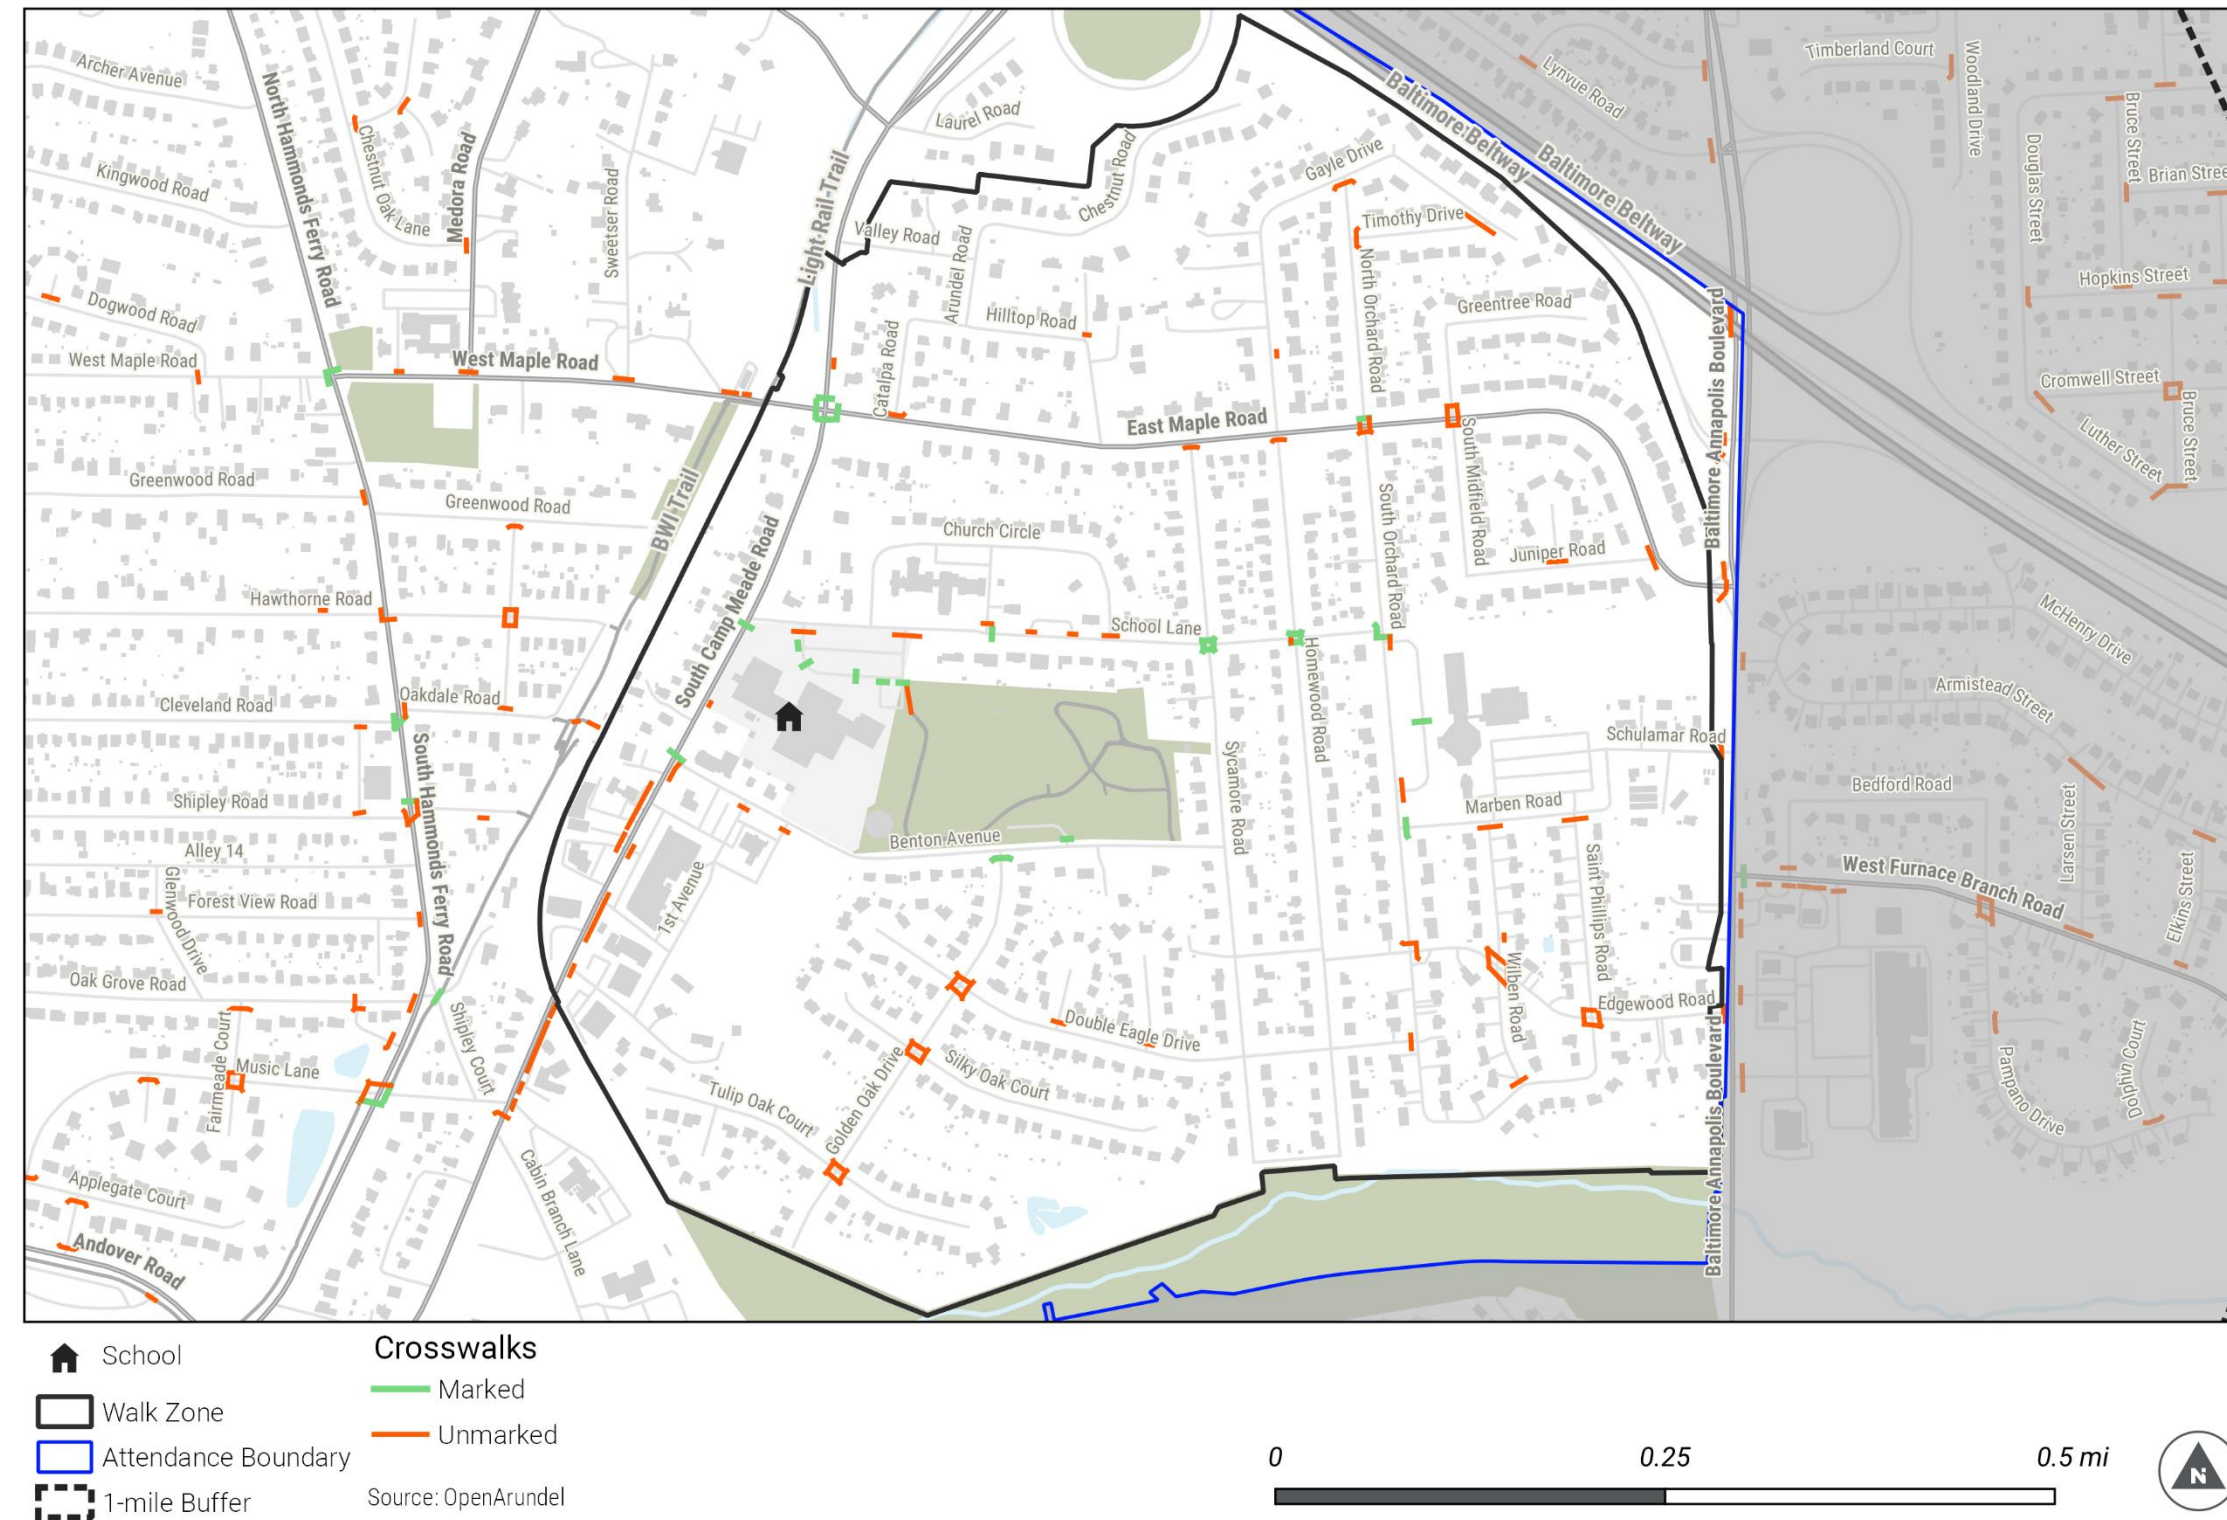
Linthicum Elementary School - Existing Crosswalks

There are marked crosswalks across the school driveways on School Lane, and on the school campus for crossing the north parking lot to the school entrance.

Many crossings at intersections within the walk zone are unmarked.

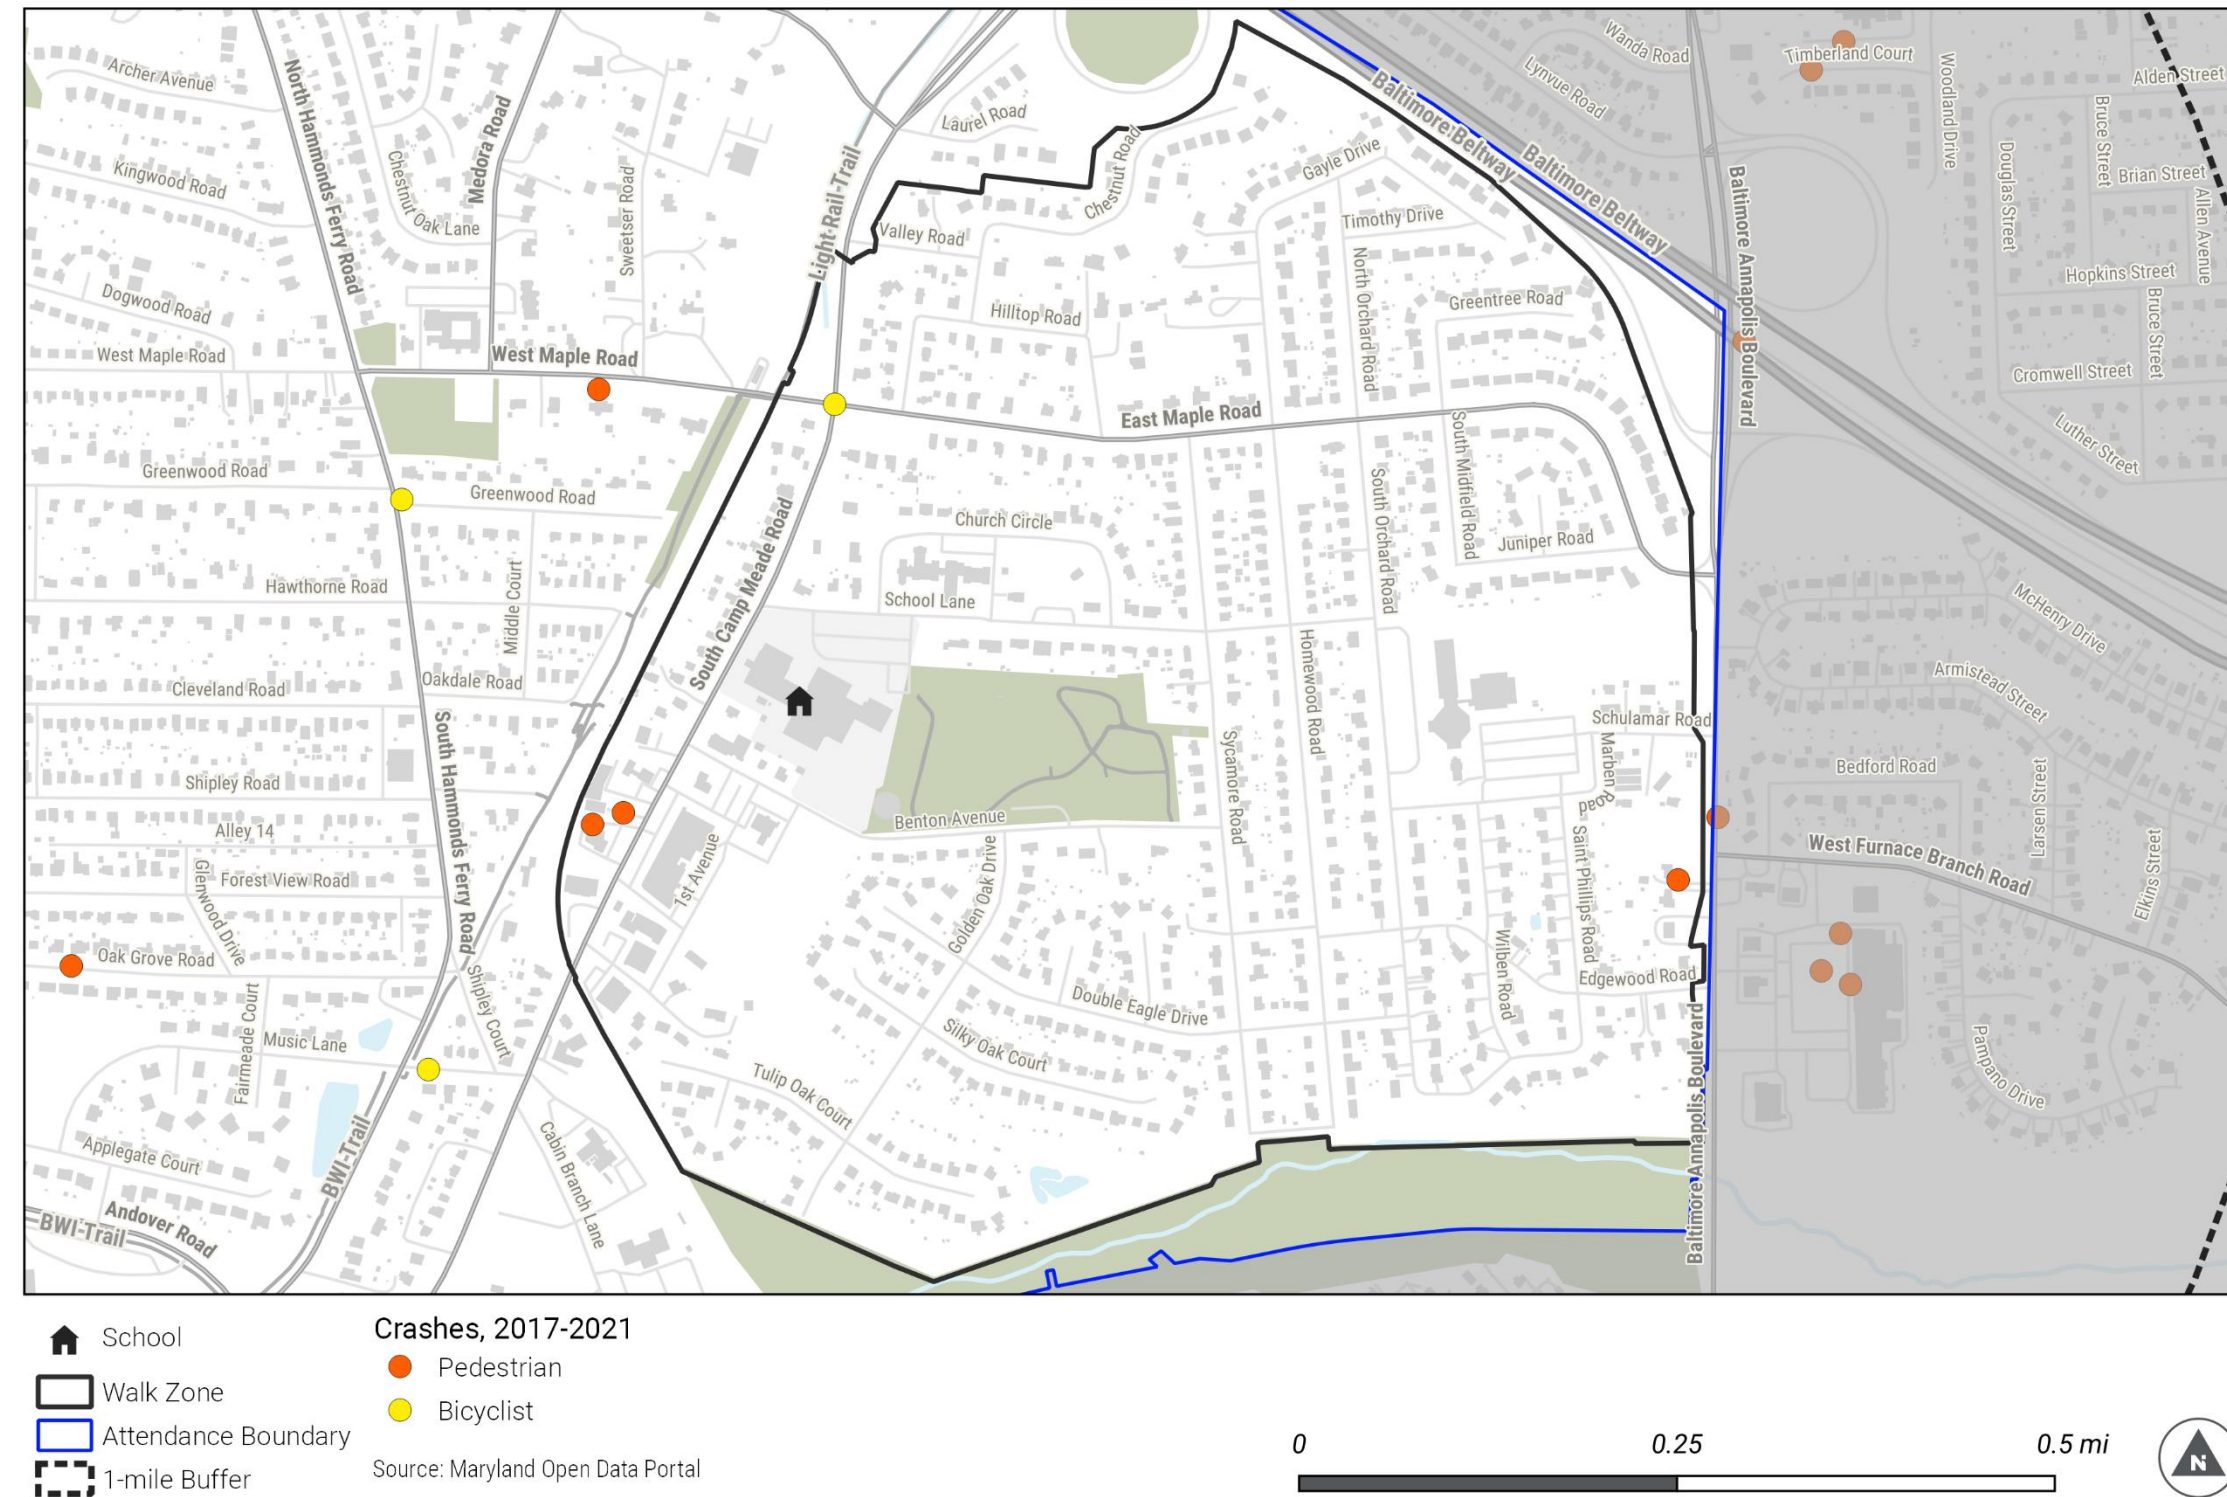
Linthicum Elementary School - Pedestrian and Bicycle Crashes

- 3 pedestrian-involved and 1 bicyclist-involved crashes occurred in the walk zone.

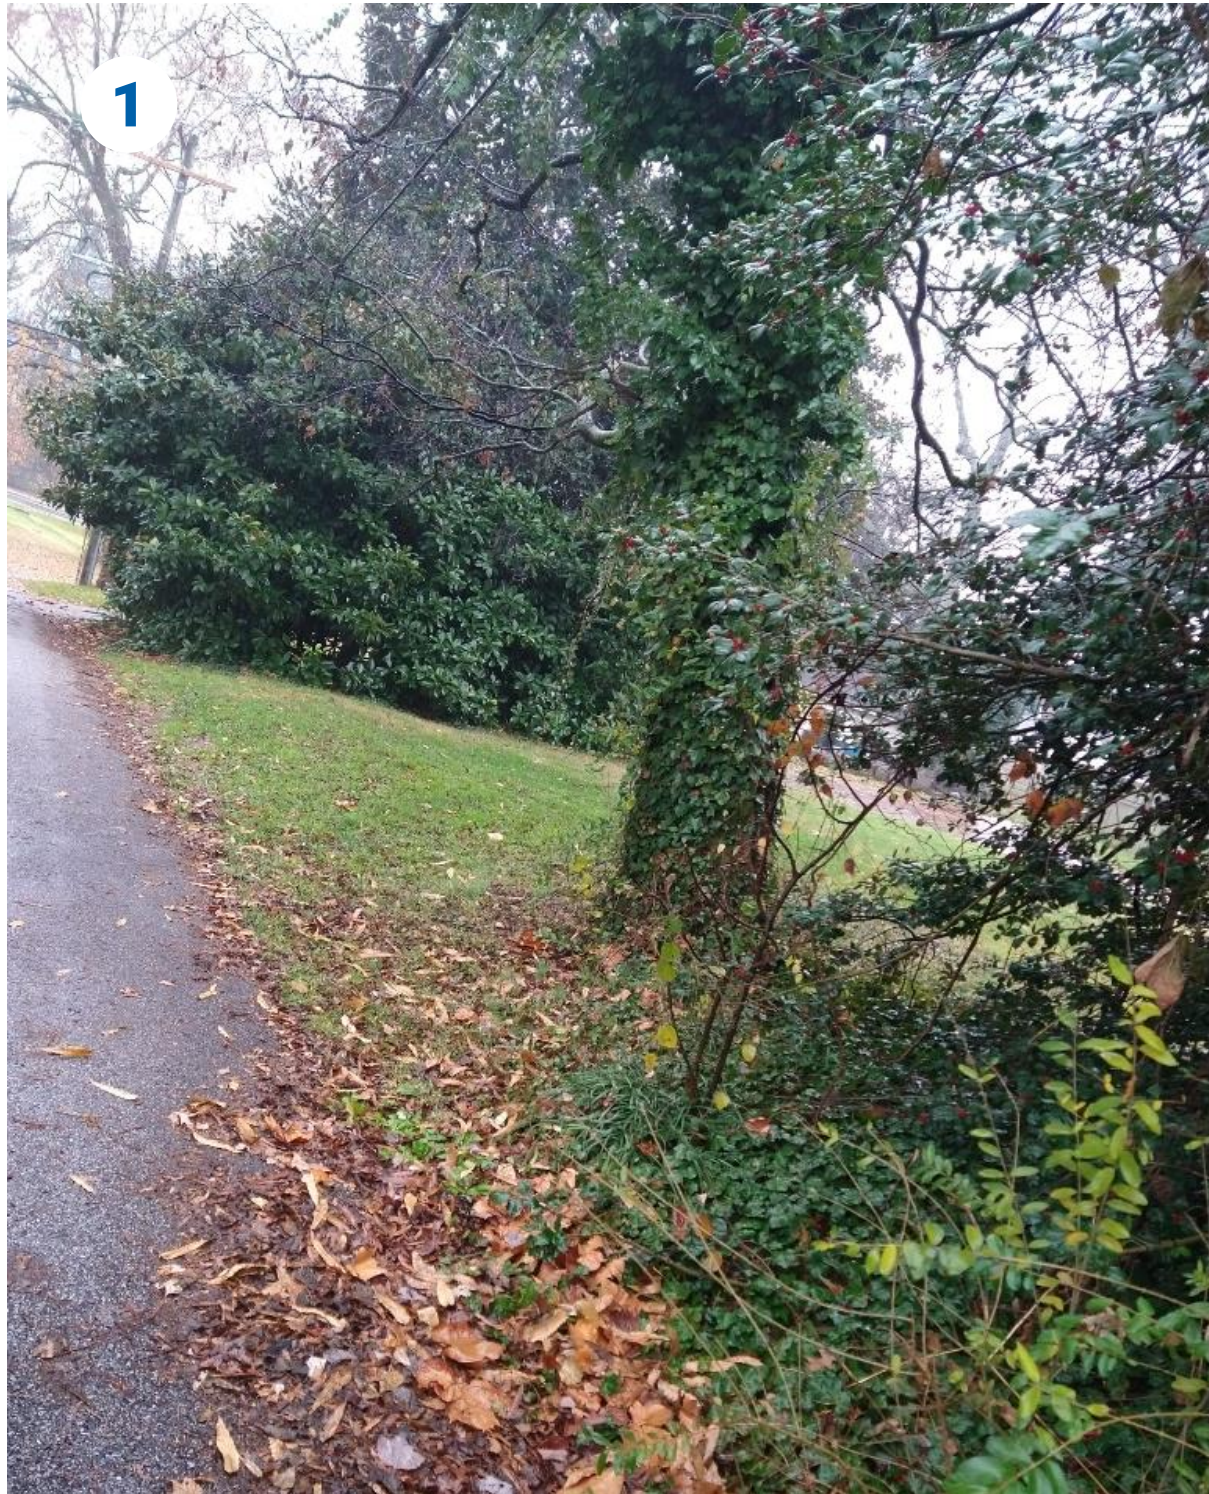
Hilltop Road north of East Maple Road

| Map ID | Location | Facility Type | Issue | Recommendation | Potential Cost | Timeframe* |
|---|---|---|---|---|---|---|
| 1 | Hilltop Rd (Arundel Rd to E Maple Rd) | Sidewalk | Missing sidewalk/gaps in existing sidewalk (both sides) | Install new sidewalk.** | \$61,592 | Long |

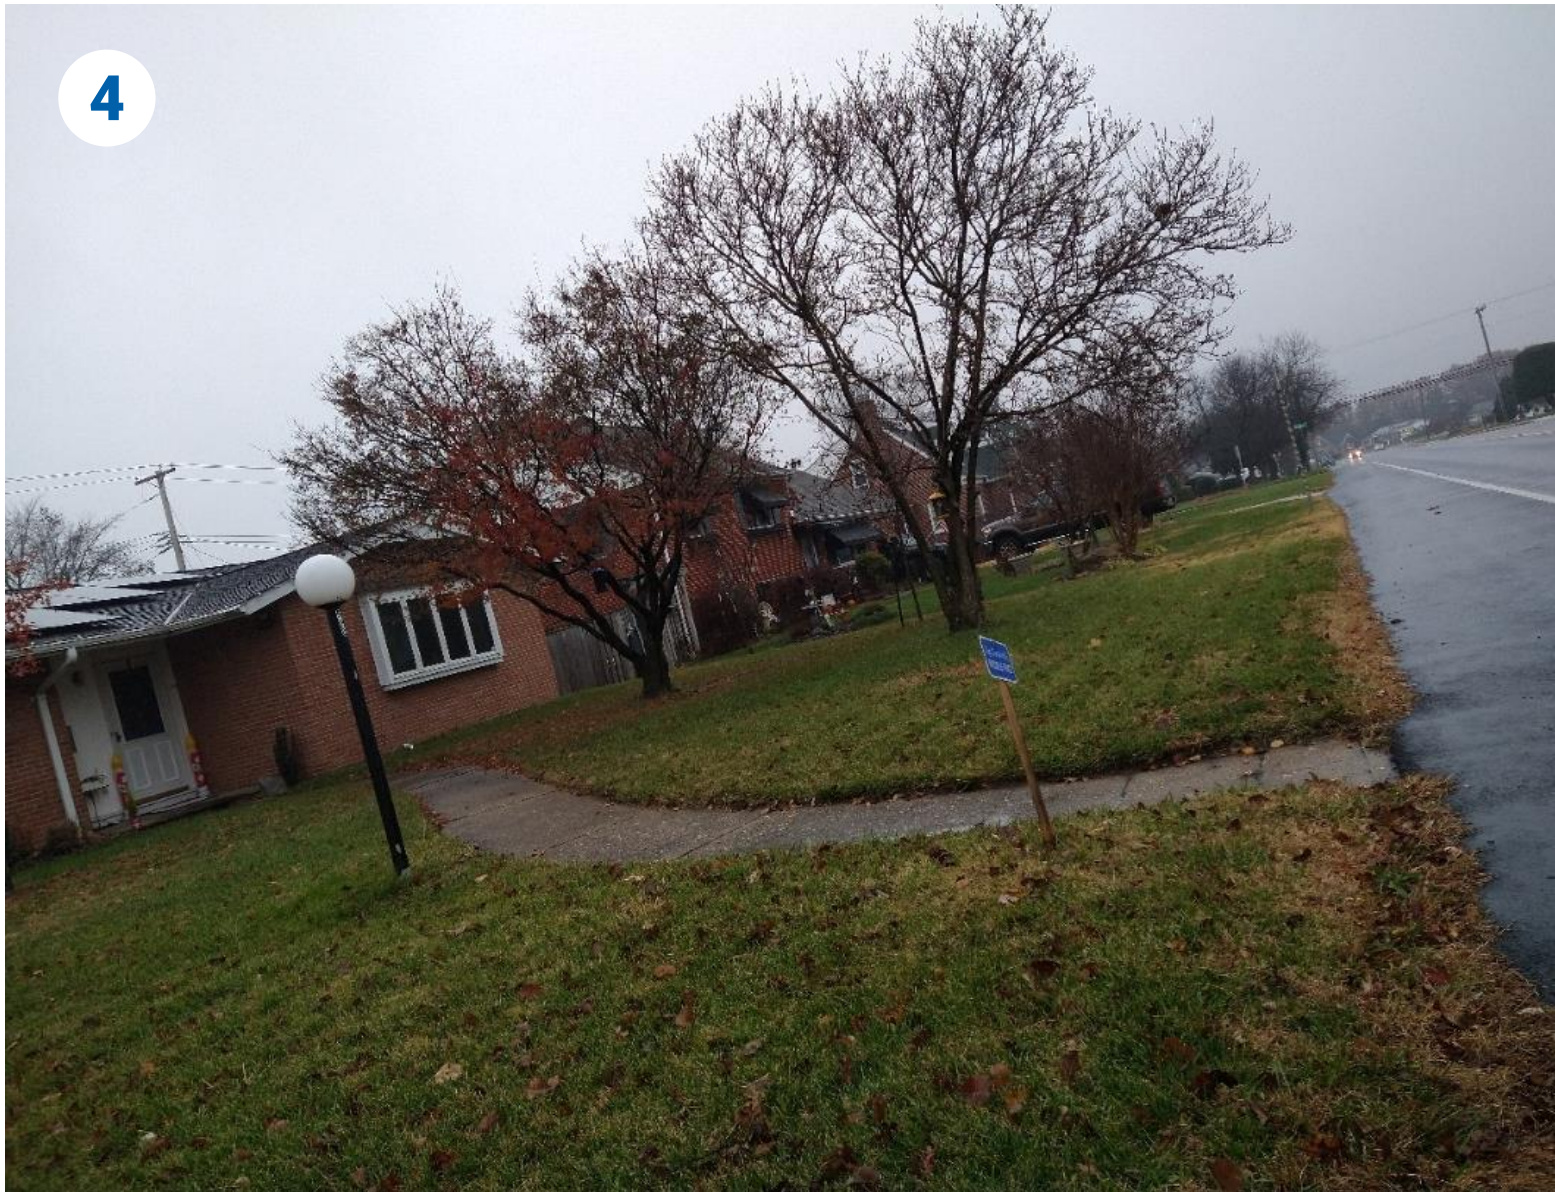
East Maple Road north side between Homewood Road and Orchard Road, looking east

| Map ID | Location | Facility Type | Issue | Recommendation | Potential Cost | Timeframe* |
|---|---|---|---|---|---|---|
| 4 | E Maple Rd (Catalpa Rd to Baltimore-Annapolis Blvd) | Sidewalk | Missing sidewalk on north side | Install new sidewalk** | \$127,911 | Long |

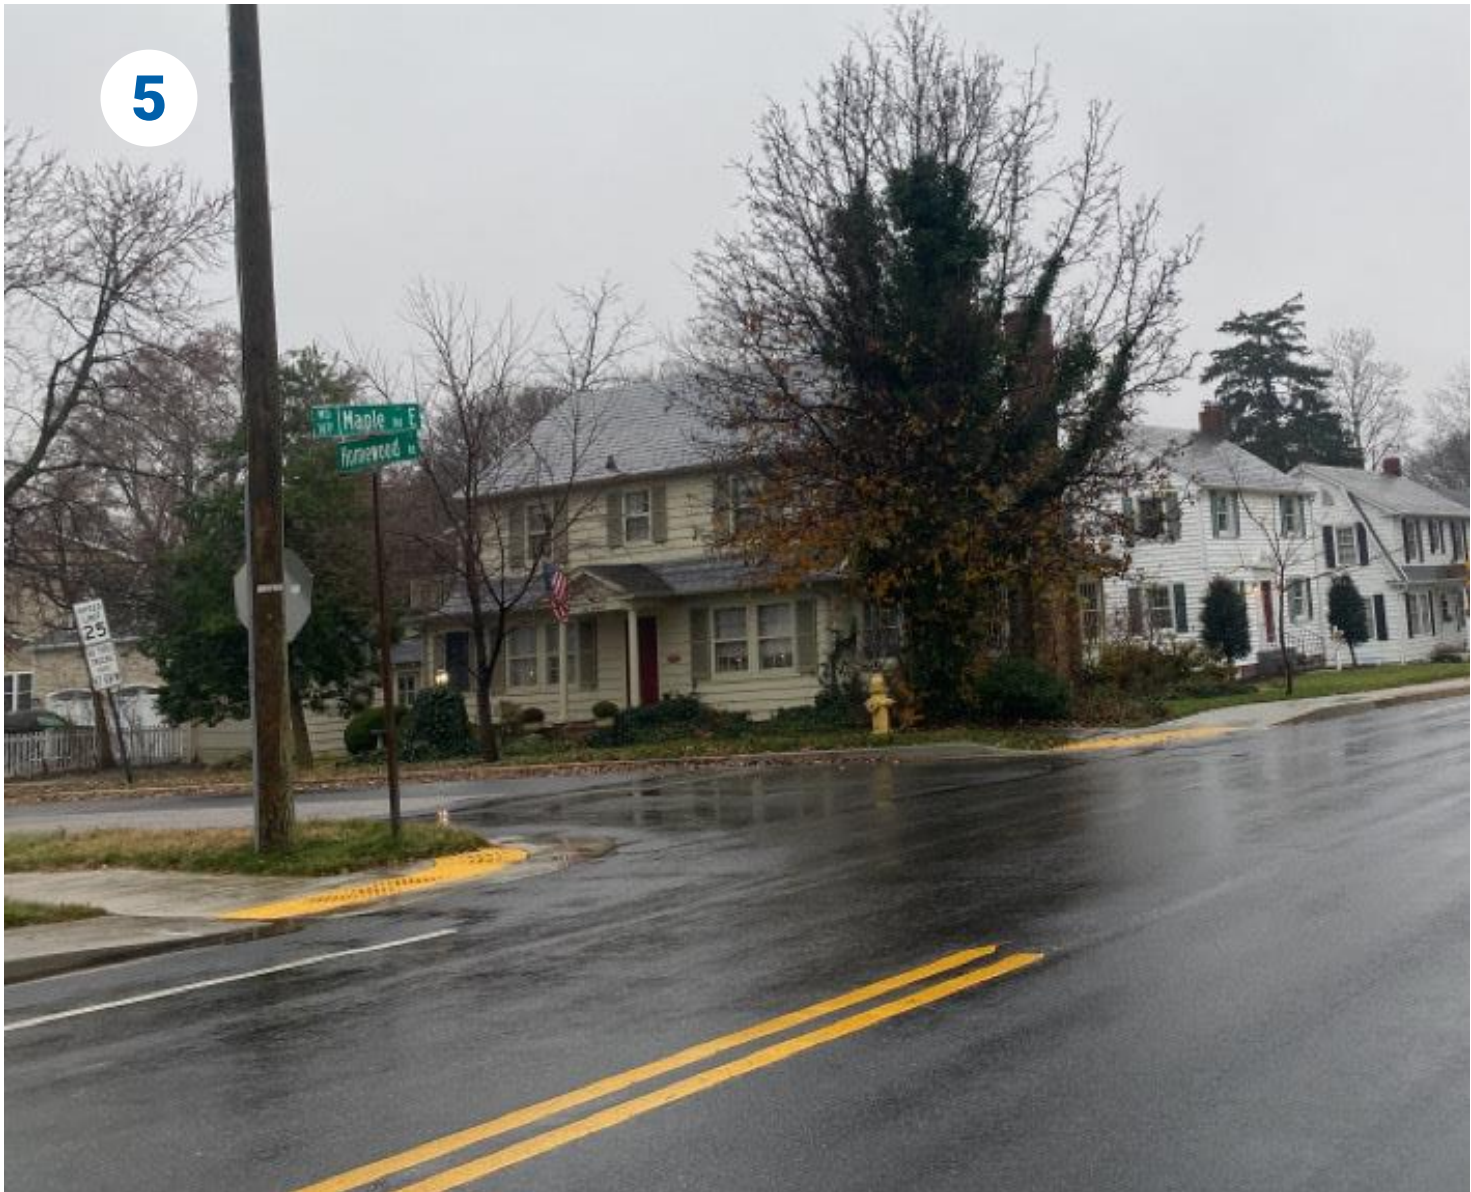
East Maple Road and Homewood Road, south leg

| Map ID | Location | Facility Type | Issue | Recommendation | Potential Cost | Timeframe* |
|---|---|---|---|---|---|---|
| 5 | Homewood Rd & E Maple Rd | 5a. Crosswalk | North, South crossing is unmarked<br>Stop bars missing | Install new standard crosswalks<br>Mark new stop bars | \$1,000 | Short |
| | | 5b. Curb ramps | Northeast, Northwest ramps missing | Install new ramps | \$8,000 | Medium |

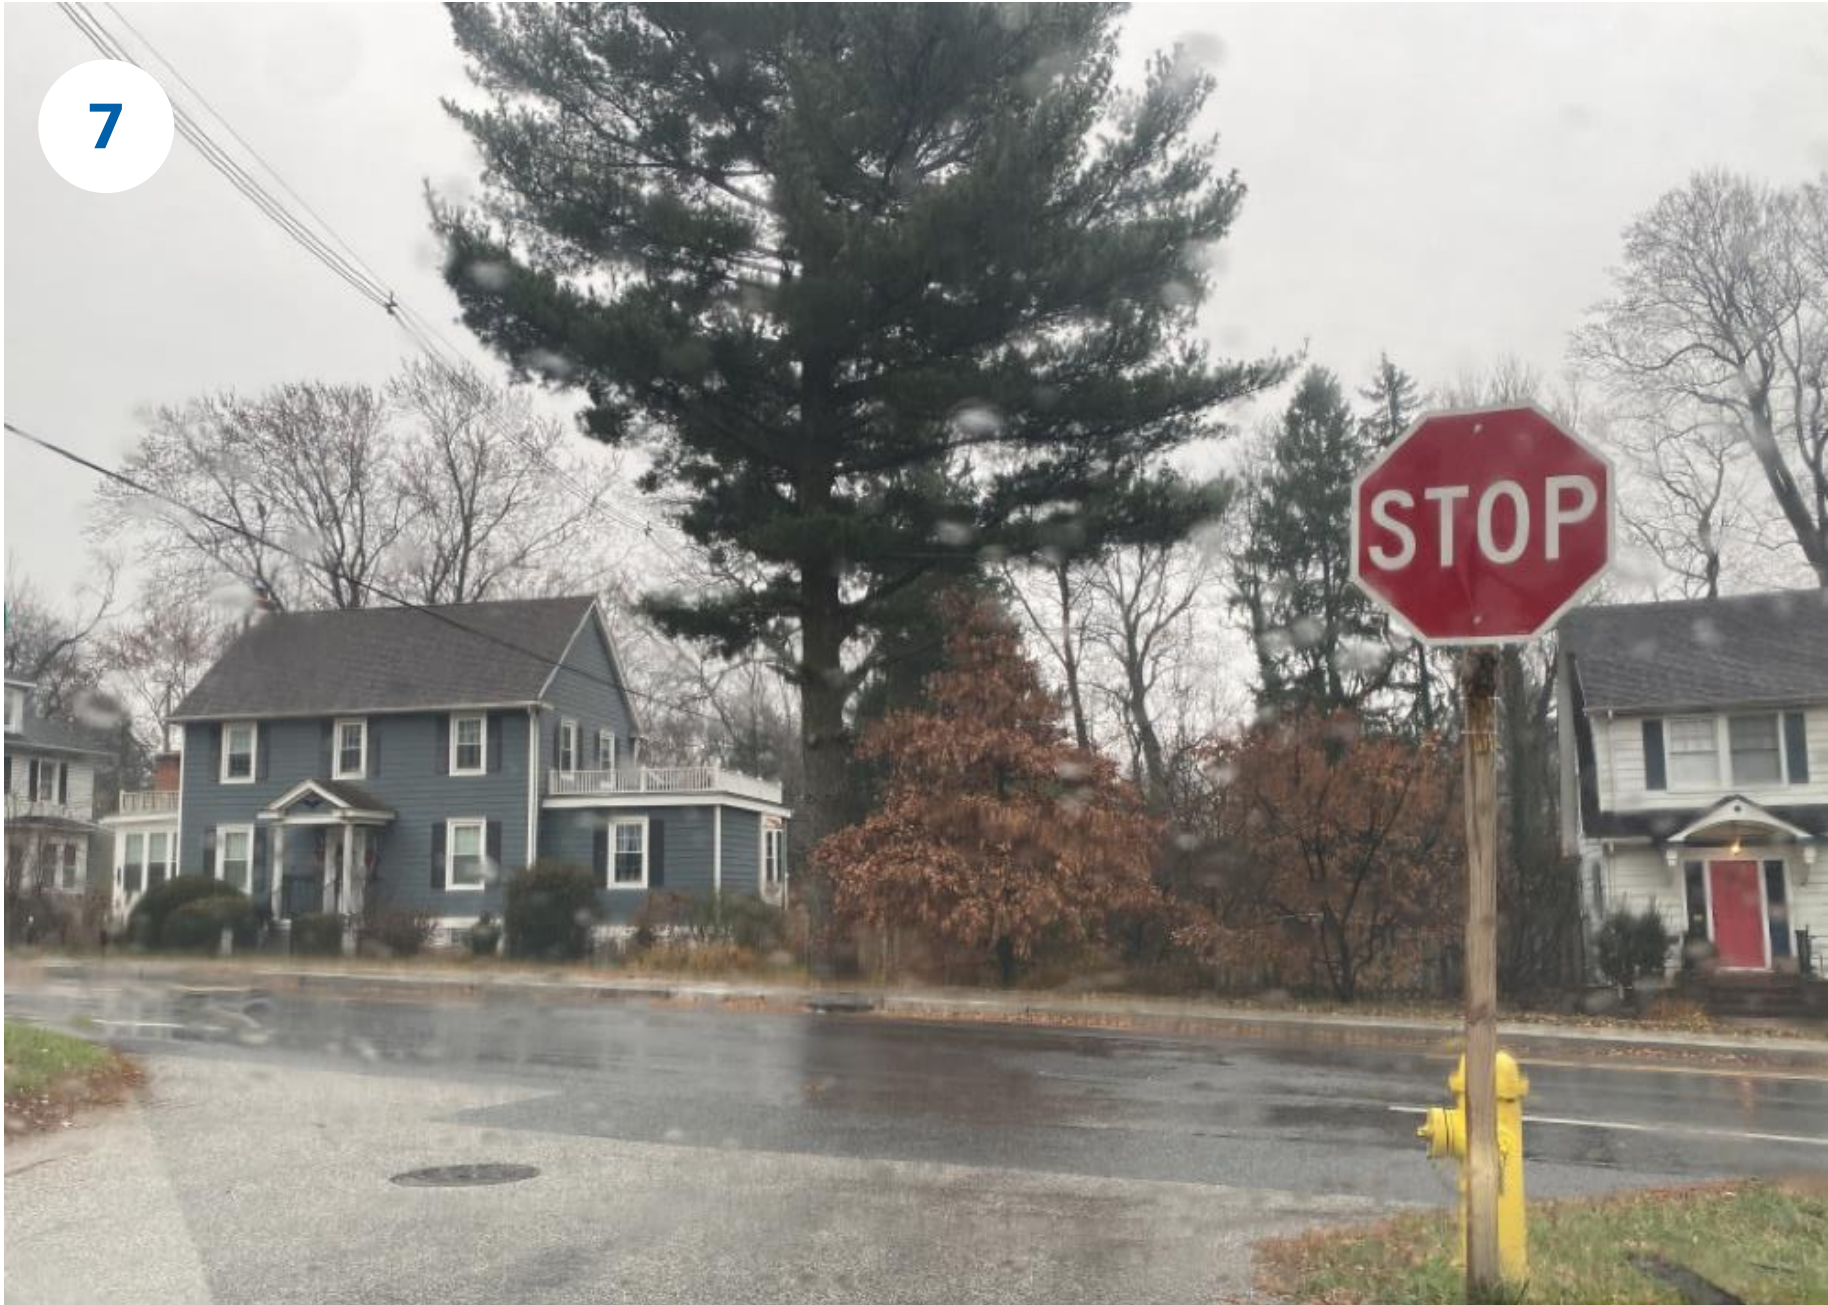
Hilltop Road and East Maple Road

| Map ID | Location | Facility Type | Issue | Recommendation | Potential Cost | Timeframe* |
|---|---|---|---|---|---|---|
| 7 | Hilltop Rd & E Maple Rd | 7a. Crosswalk | North crossing is unmarked<br>Stop bar missing | Install new standard crosswalk,<br>Mark new stop bar | \$500 | Short |
| | | 7b. Curb ramp | North ramps missing | Install new ramps | \$8,000 | Medium |
