# Linthicum Elementary School Safe Routes to School Accessibility Study: Existing Conditions and Recommendations

August 17, 2023

# Anne Arundel Safe Routes to School Accessibility Study

# Linthicum Elementary Accessibility Study

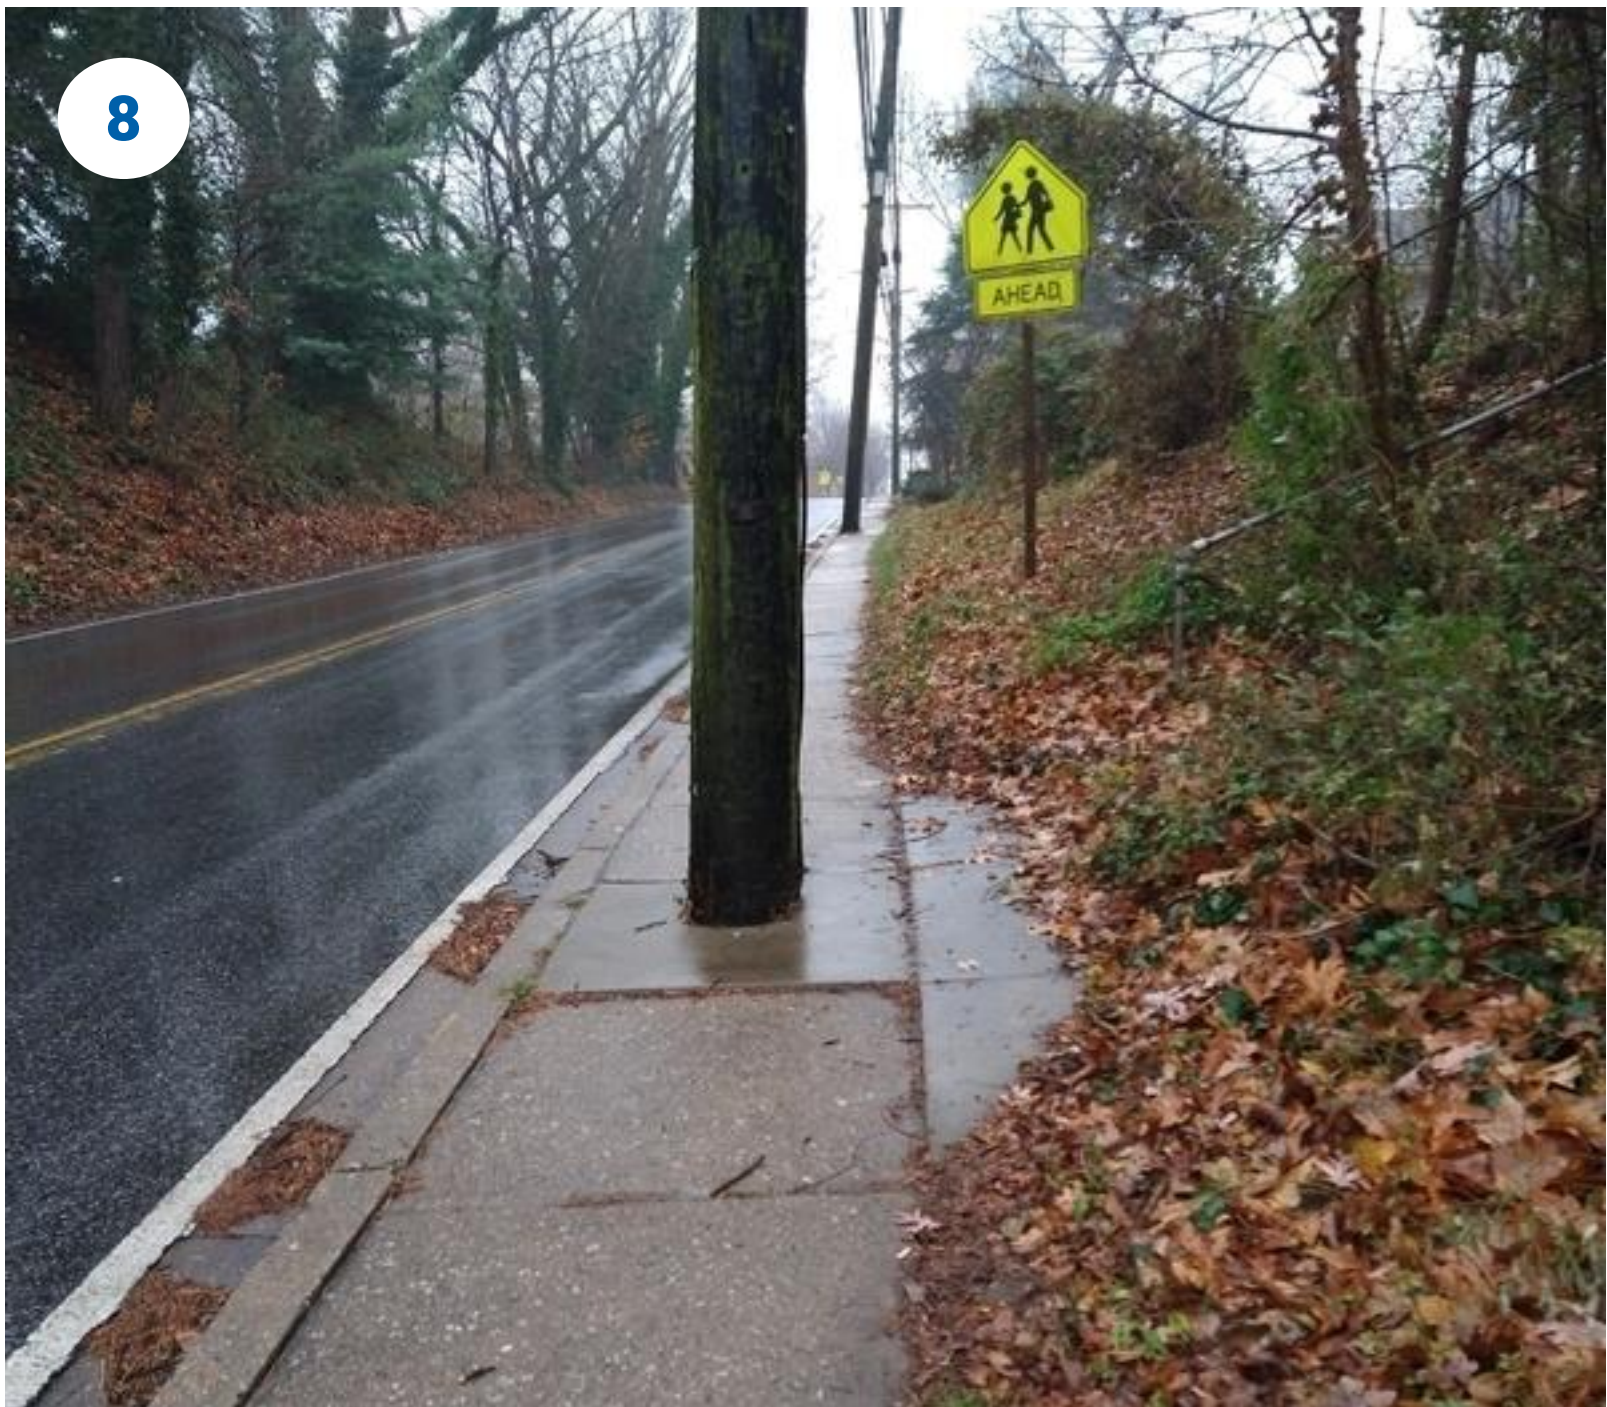
South Camp Meade Road between E/W Maple Road and School Lane

| Map ID | Location | Facility Type | Issue | Recommendation | Potential Cost | Timeframe* |
|---|---|---|---|---|---|---|
| 8 | S Camp Meade Rd (E/W Maple Rd to Benton Ave)<br>(Along key student walking route, Inside school zone) | Sidewalk | East sidewalk is missing. | Install new east sidewalk** | \$51,959 | Long |

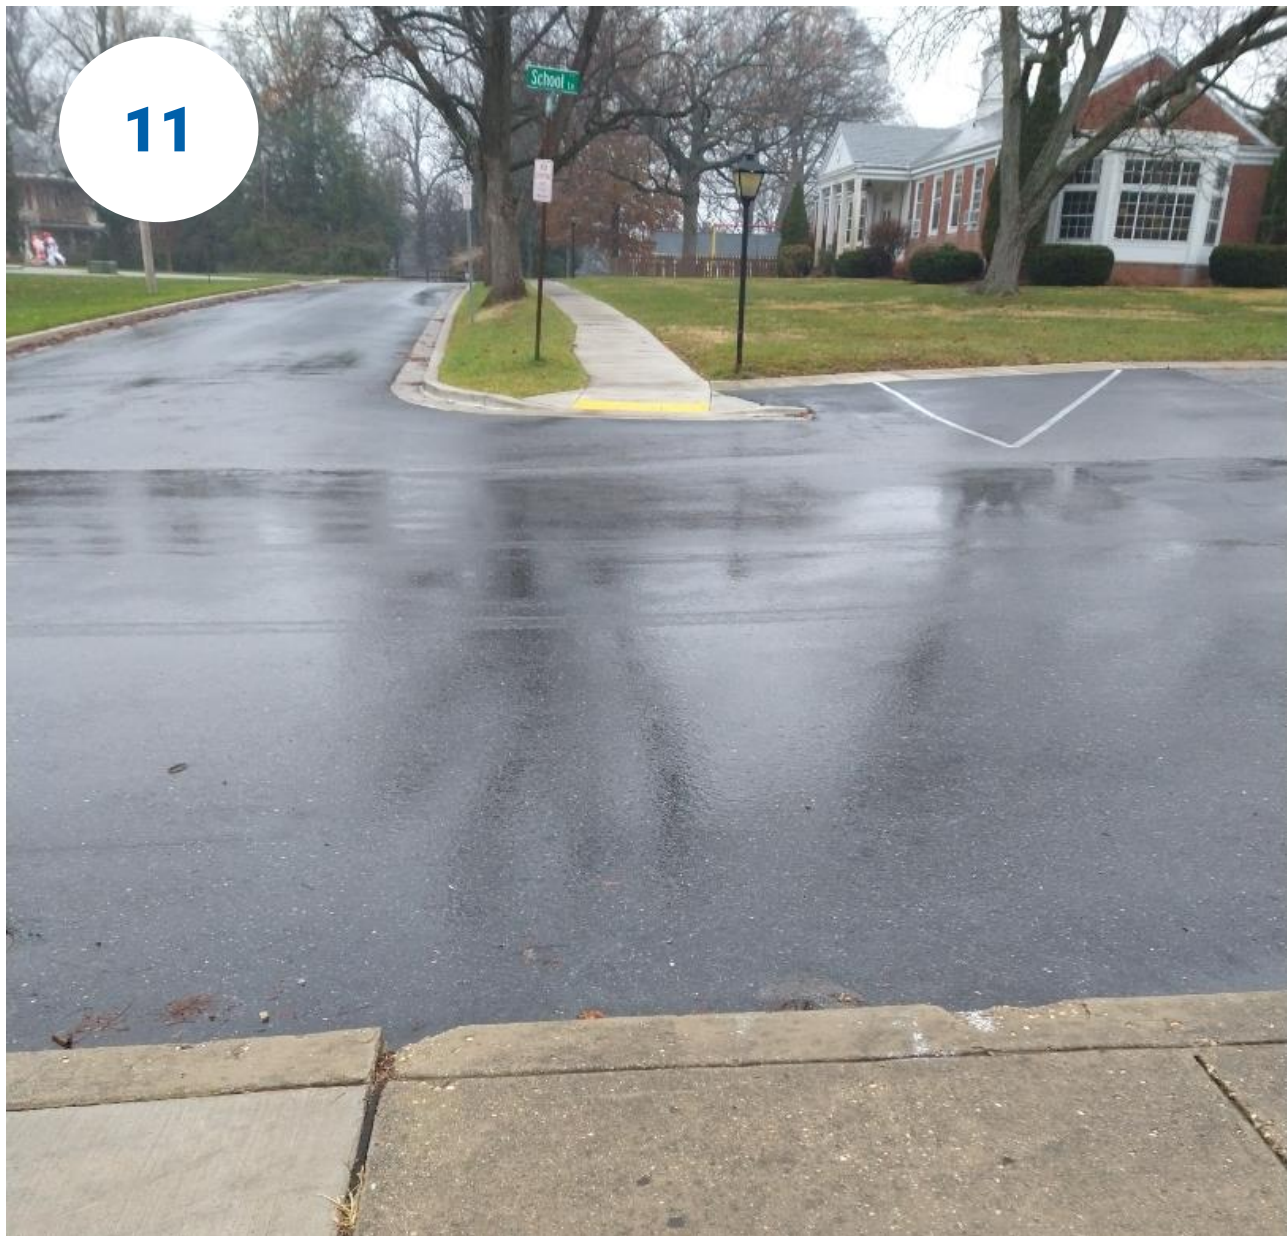
Crossing School Lane at Church Circle (west)

| Map ID | Location | Facility Type | Issue | Recommendation | Potential Cost | Timeframe* |
|---|---|---|---|---|---|---|
| 11 | School Ln & Church Cir (west) (Along key student walking route, Inside school zone) | 11a. Curb ramp | Northeast, Southeast ramps missing | Install new ramps | \$8,000 | Medium |

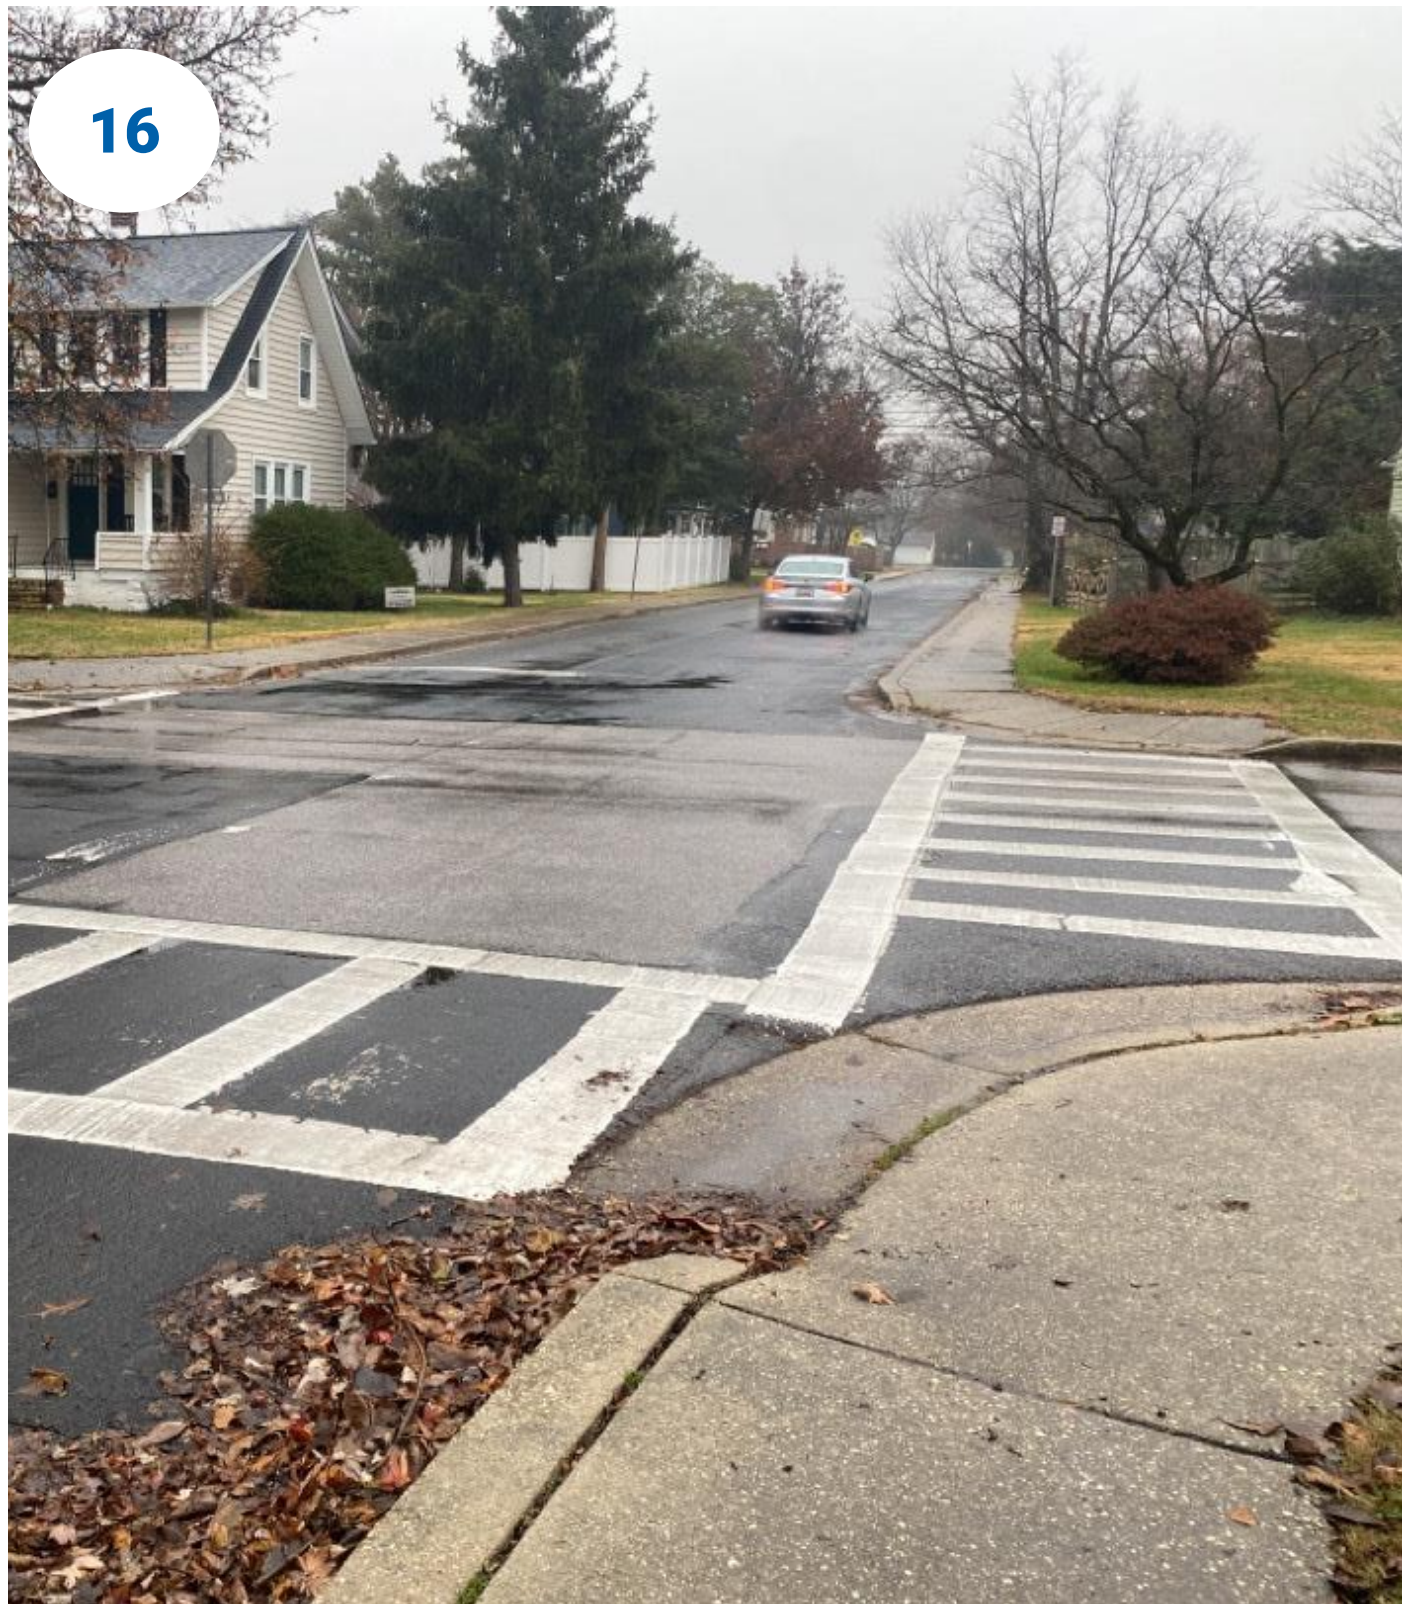
School Lane and Sycamore Road

| Map ID | Location | Facility Type | Issue | Recommendation | Potential Cost | Timeframe* |
|---|---|---|---|---|---|---|
| 16 | School Ln & Sycamore Rd (Along key student walking route) | Curb ramp | All ramps lack detectable warning surface | Reconstruct or repair existing ramps | \$16,000 | Medium |

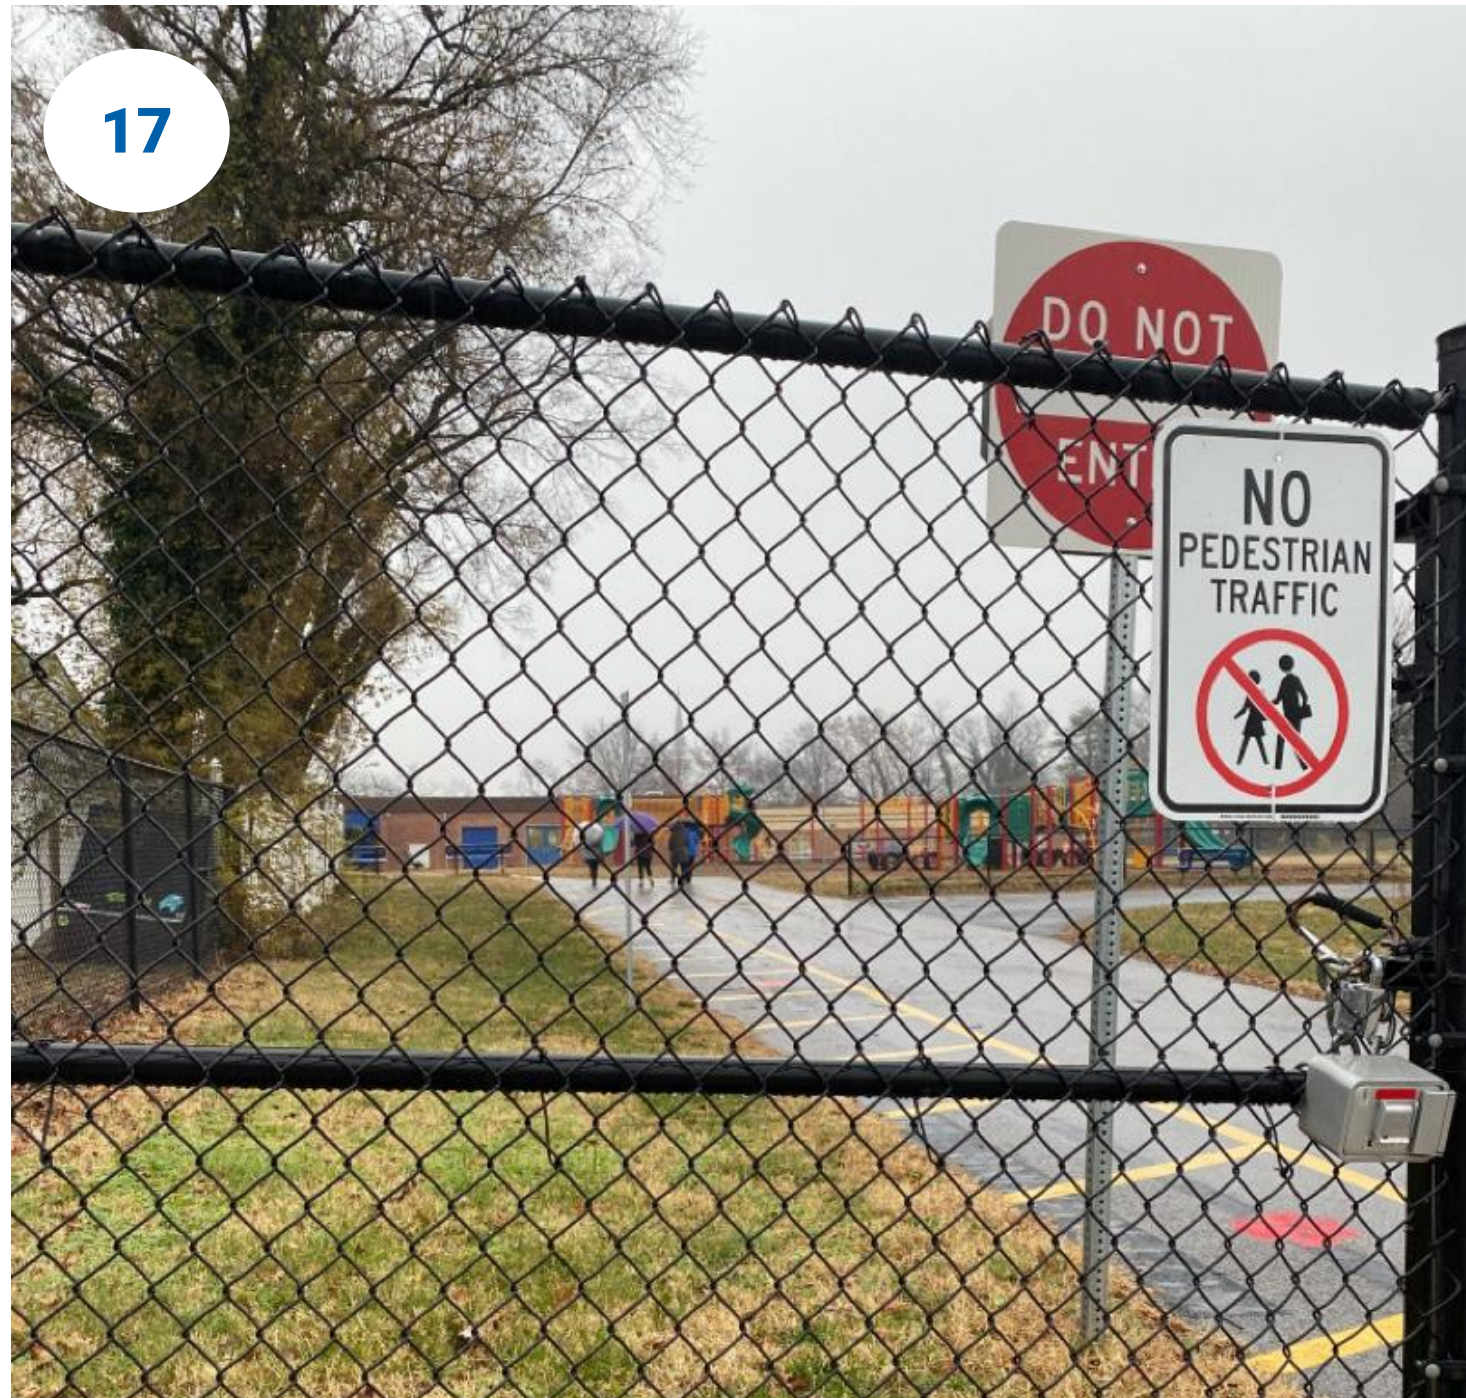
South (car drop off loop) driveway exit

| Map ID | Location | Facility Type | Issue | Recommendation | Potential Cost | Timeframe* |
|---|---|---|---|---|---|---|
| 17 | Benton Ave & south vehicle drop off loop (from Benton Ave to school door) (On school campus) | Sidewalk | Missing sidewalk.<br><br>Car dropoff entrance is provided on the south side of campus, but there are no pedestrian facilities to accommodate the student population in the walk zone to the east and south of the school. | Install new sidewalk on the outer loop of existing school driveway to allow for pedestrian to access school campus from the south** | \$9,363 | Long |

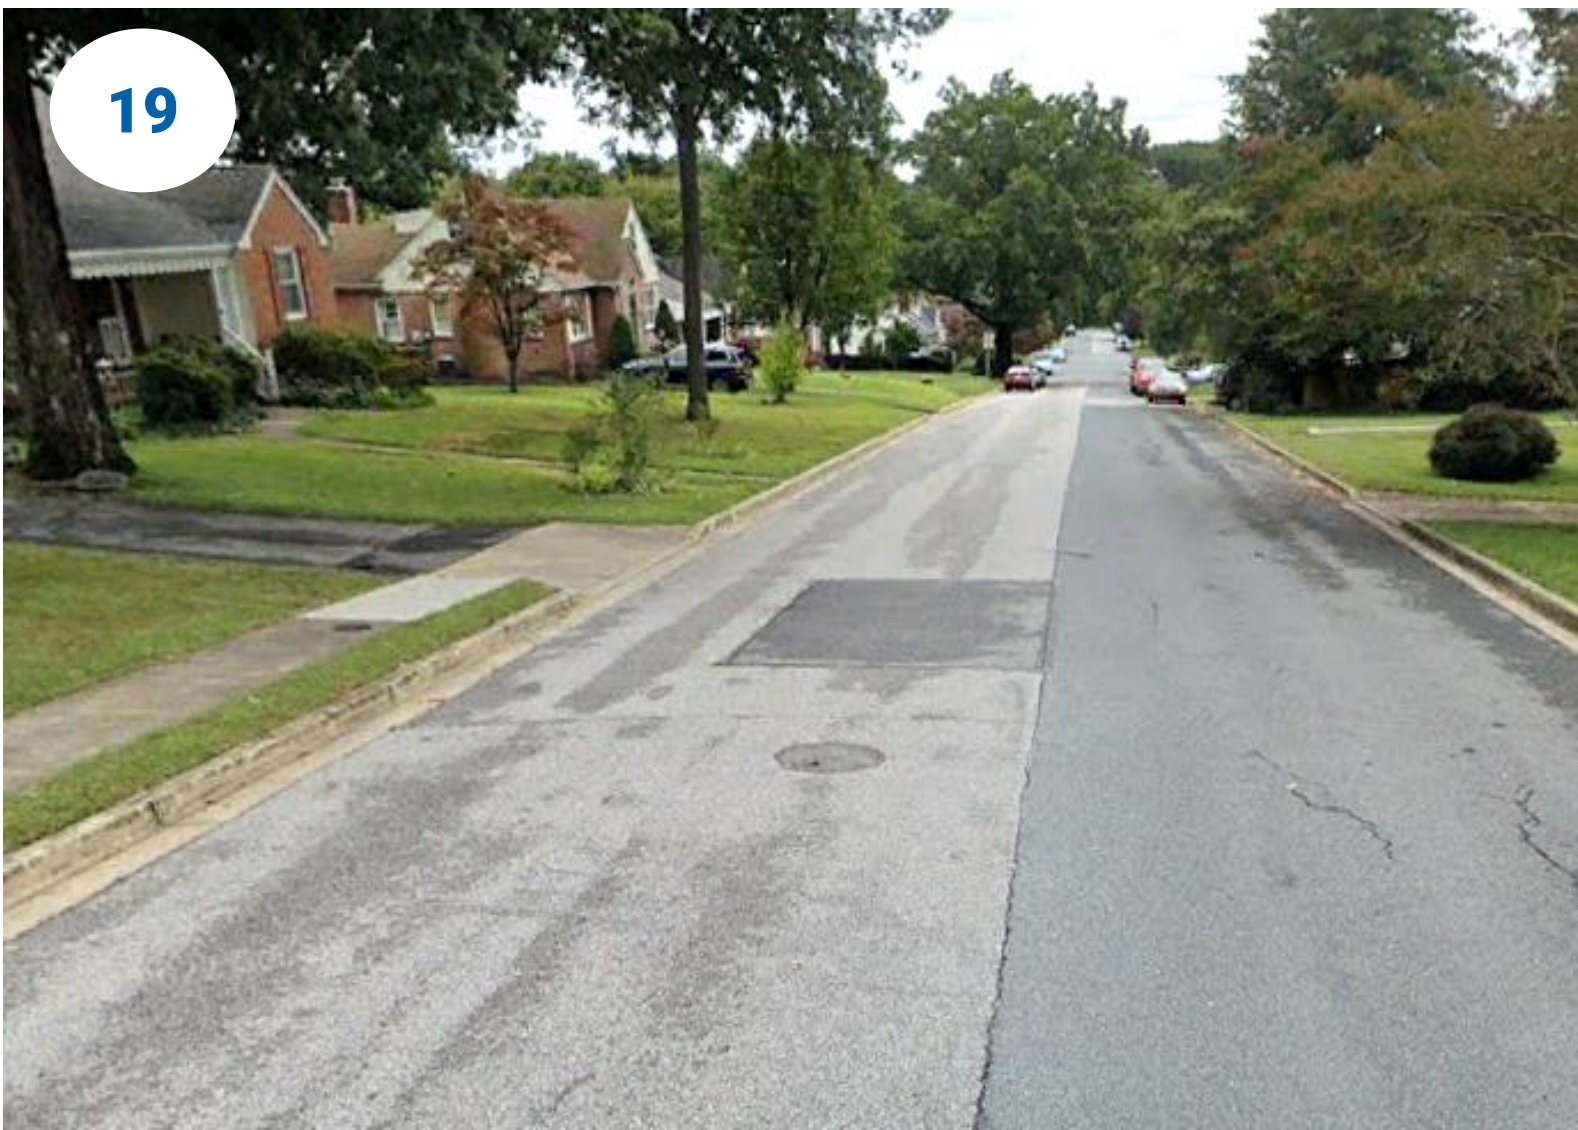
Homewood Road

| Map ID | Location | Facility Type | Issue | Recommendation | Potential Cost | Timeframe* |
|---|---|---|---|---|---|---|
| 19 | Homewood Rd (School Ln to Meadow Rd) | Sidewalk | Missing sidewalk on west and much of east side | Install new sidewalk** | \$100,000 | Long |

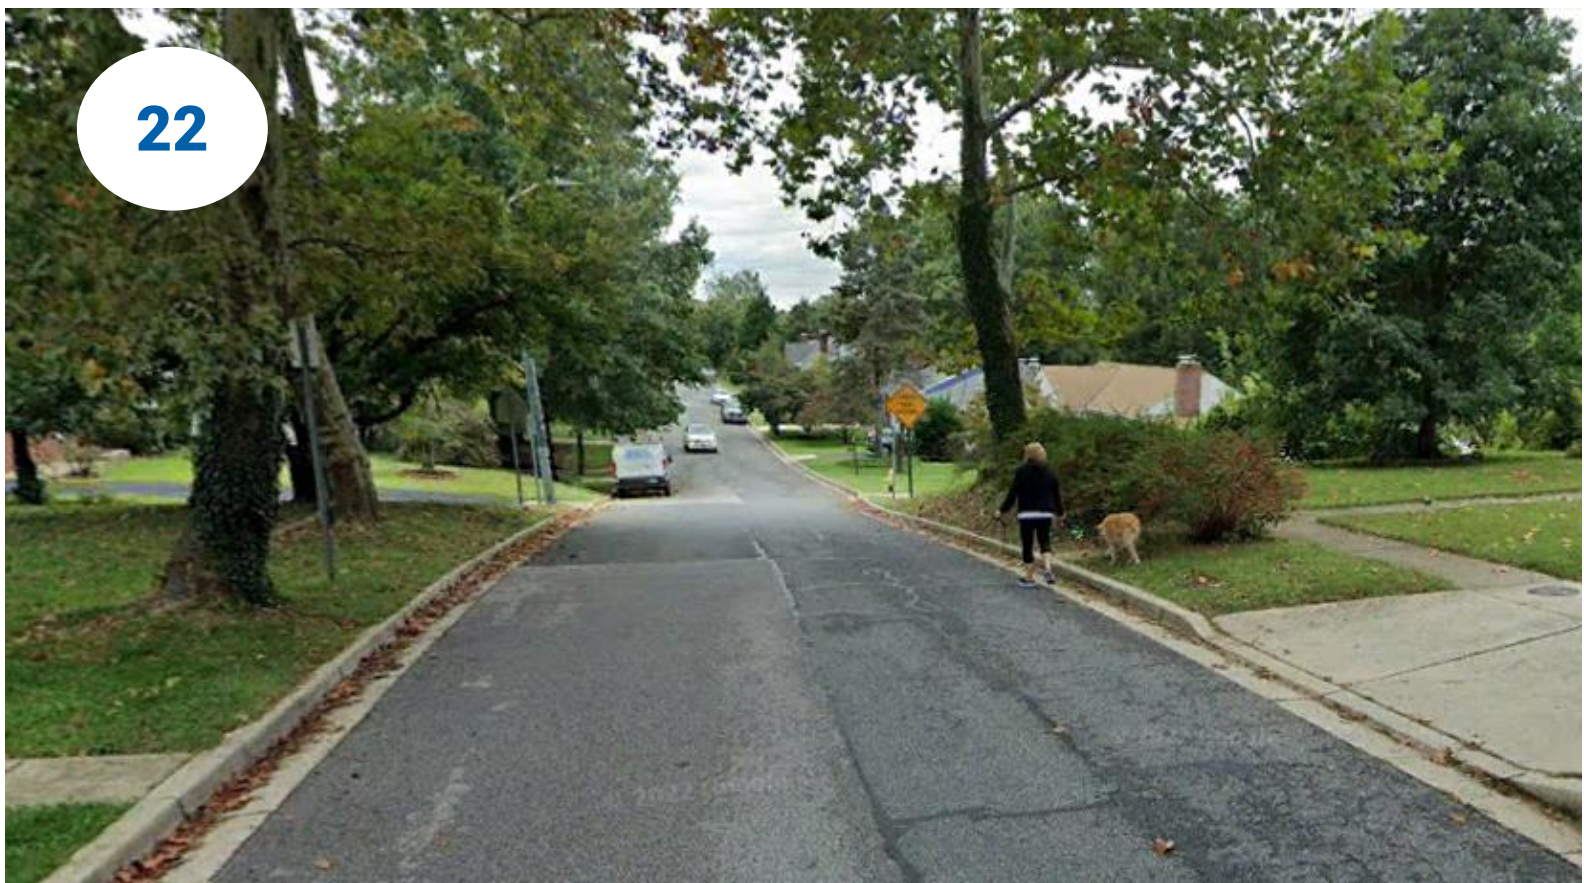
Sycamore Road

| Map ID | Location | Facility Type | Issue | Recommendation | Potential Cost | Timeframe* |
|---|---|---|---|---|---|---|
| 22 | Sycamore Rd (School Ln to Meadow Rd) (Along key student walking route) | Sidewalk | Missing sidewalks<br><br>(Note partial sidewalk on the west side between School Ln & Benton Ave) | Install new sidewalk** | \$120,000 | Long |

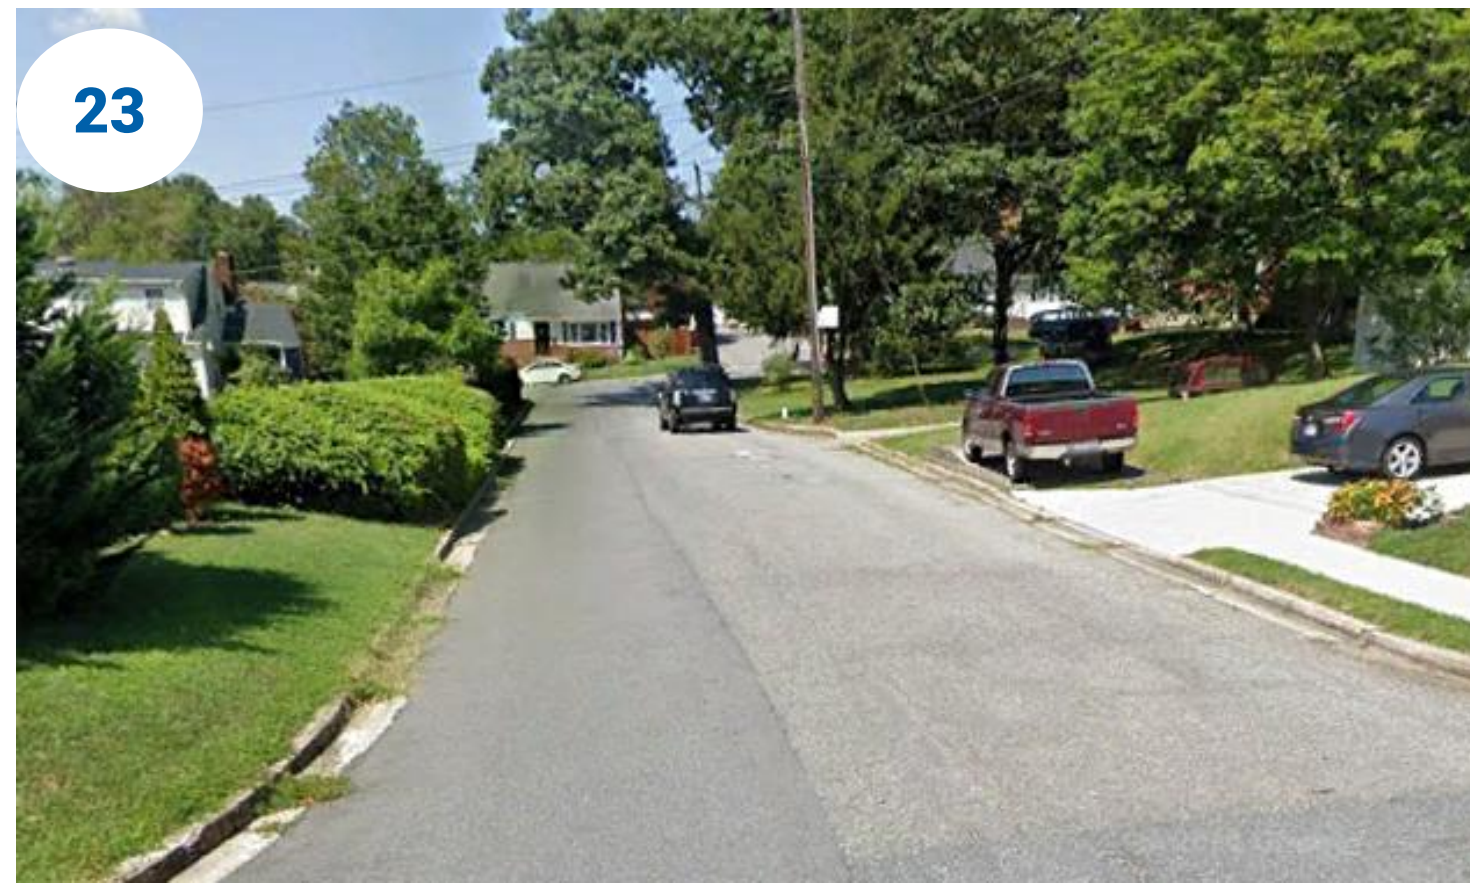
Edgewood Road

| Map ID | Location | Facility Type | Issue | Recommendation | Potential Cost | Timeframe* |
|---|---|---|---|---|---|---|
| 23 | Edgewood Rd (Sycamore Rd to S Orchard Rd) | Sidewalk | Missing sidewalk on both sides | Install new sidewalk** | \$50,000 | Long |

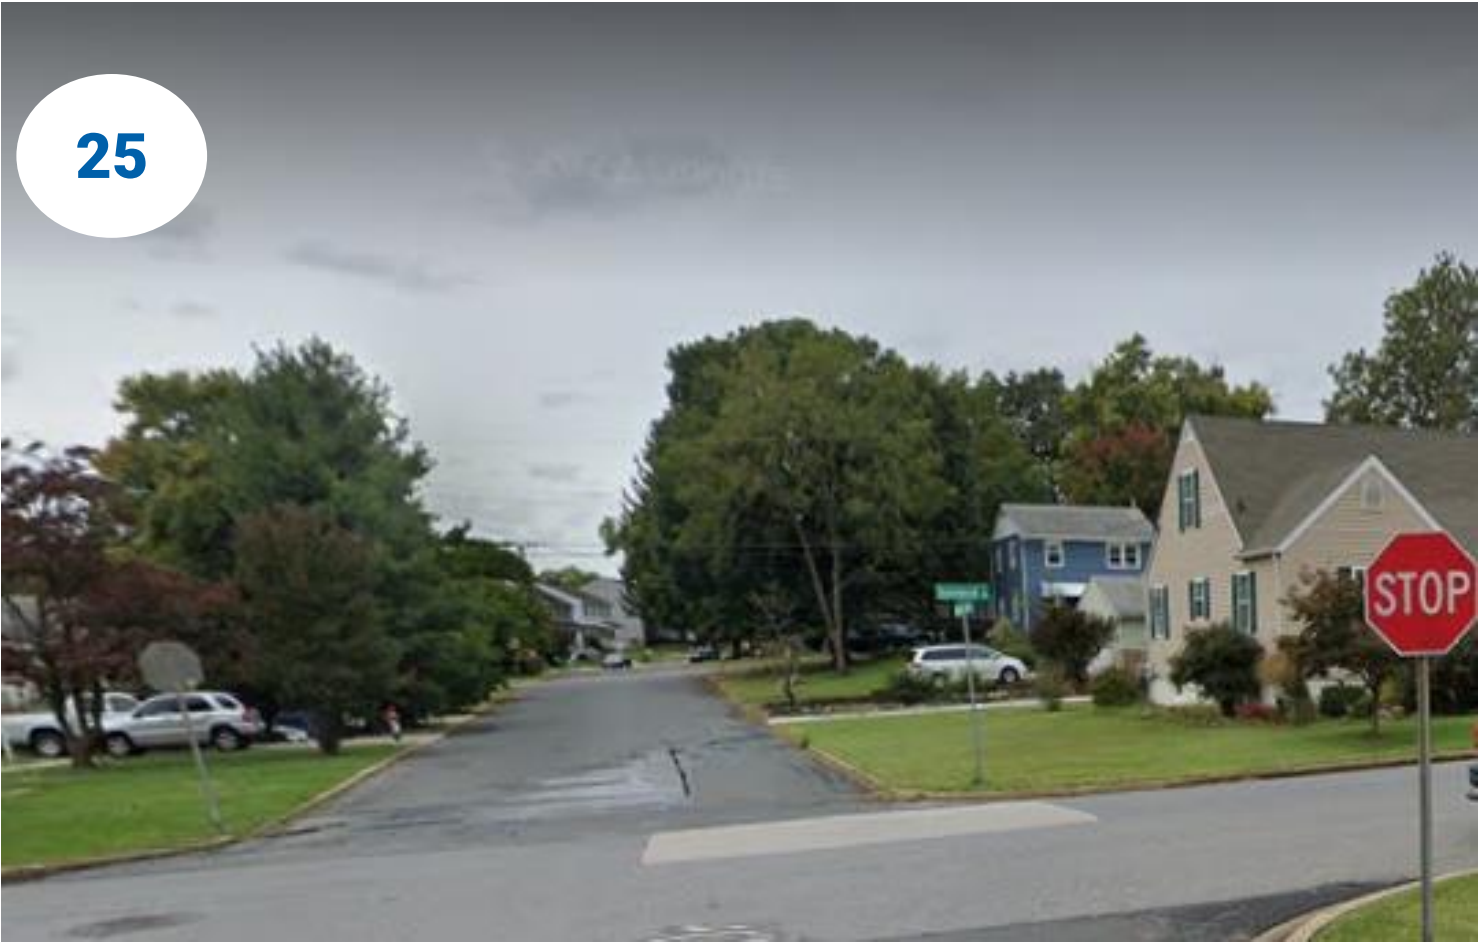
Double Eagle Drive

| Map ID | Location | Facility Type | Issue | Recommendation | Potential Cost | Timeframe* |
|---|---|---|---|---|---|---|
| 25 | Double Eagle Dr (from west of Sycamore Rd to S. Orchard Rd) | Sidewalk | Missing sidewalks on both sides | Install new sidewalk** | \$60,000 | Long |
