**RESILIENCE  
AUTHORITY**  
Annapolis and Anne Arundel County

# Beverly Triton Nature Park Phase II Living Shoreline

## Schematic Design Public Meeting.

OCTOBER 1, 2026

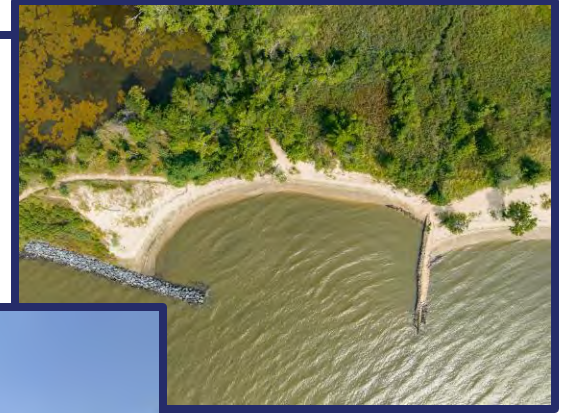
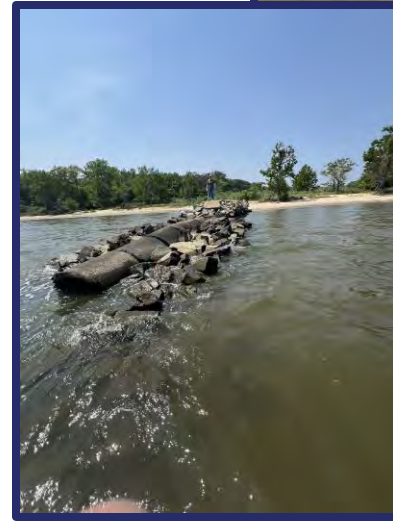
# Existing Conditions – Reach 3

- Reach 3 is approximately 650 feet long with a 25–40-foot-wide beach.
- Existing protection features include a stone groin, low-profile revetment, Phase 1 breakwater, and a dilapidated central groin/outfall structure.
- Outfall 1, a 36-inch RCP from Deep Pond, is deteriorated, with exposed pipe, cracked joints, and failed stone/concrete protection.

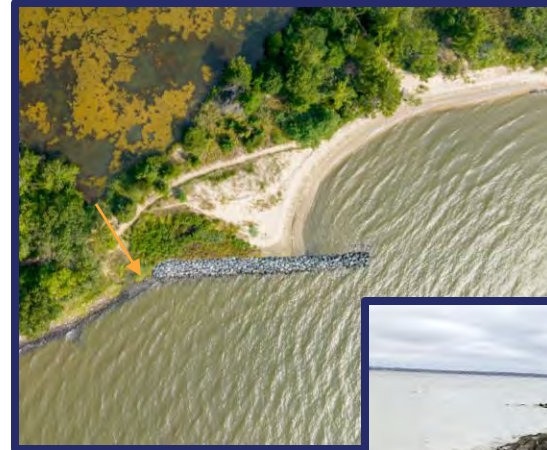
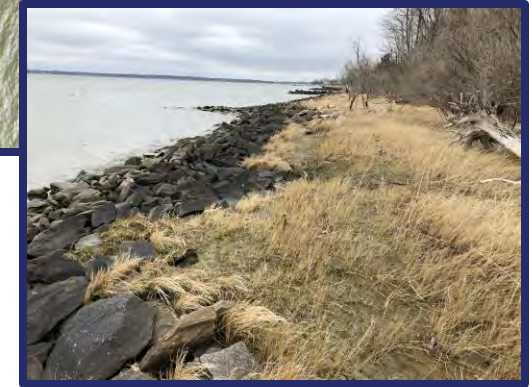
# Existing Conditions – Reach 4

- Approximately 300 linear feet of shoreline
- Existing low-profile stone revetment with adjacent high marsh grasses.
- Relatively flat high marsh transitions to 4-6 ft upland banks along western portion of the reach
- Shallow swale conveys drainage from pond to the north, terminating near the base of the Phase 1 breakwater (orange arrow).

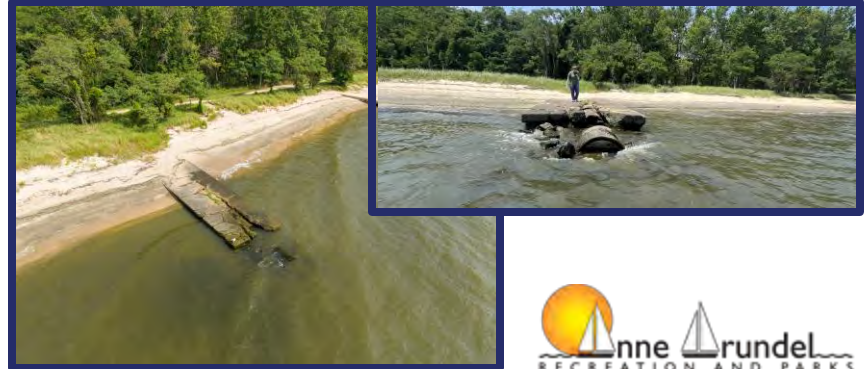
# Existing Conditions – Reach 5

- Approximately 1,100 feet long, with a 30–50-foot-wide beach.
- Shoreline includes high marsh grasses and banks ranging from 1–4 feet high.
- Contains nine deteriorated concrete and stone groins.
- Erosion averages approximately 2.2 ft/year, with localized areas up to 3.4 ft/year.
- Outfall 2 is deteriorated, with damaged pipe sections and failed stone/concrete protection.

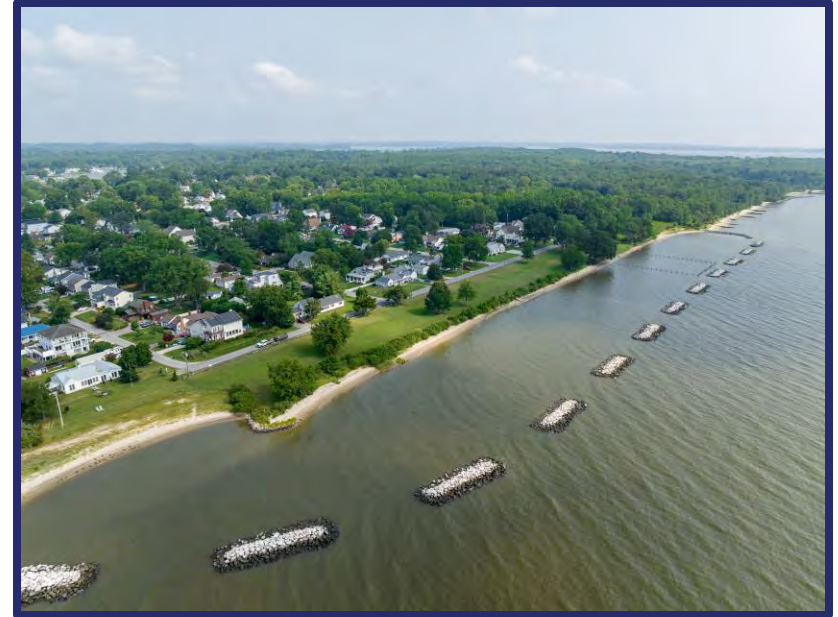
# Existing Conditions – Reach 7

- Existing southern breakwater system includes 12 detached breakwaters.
- Shoreline behind the breakwaters is eroding at approximately 0.8 ft/year.
- Breakwaters average approximately 90 feet long, with 65-foot gaps.
- Beach width averages approximately 15 feet.
- Water depths near the breakwaters are generally -1.5 to -2 feet MLW.
- Two existing 15-inch RCP stormwater outfalls discharge through Reach 7; the exposed ends are broken/deteriorated and require retrofit to maintain stormwater conveyance.

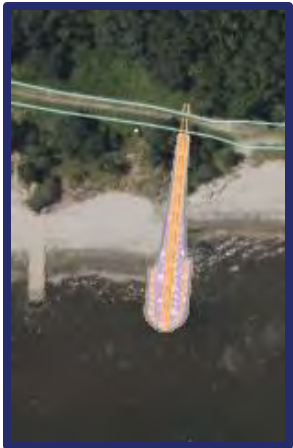
Stone Protection and  
Outfall 2

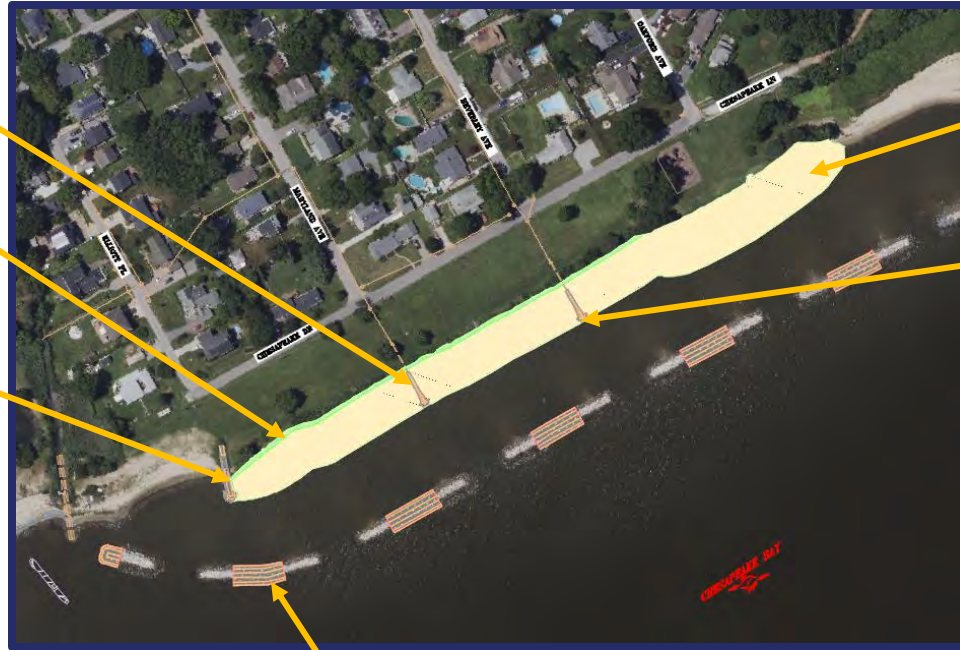
# Proposed Design – Reach 7

Outfall 4 and Stone  
Protection

5'-Wide Beach  
Grass Strip

Groin Repair

Beach Nourishment

Outfall 3 and  
Stone  
Protection

Stone Breakwater Retrofit

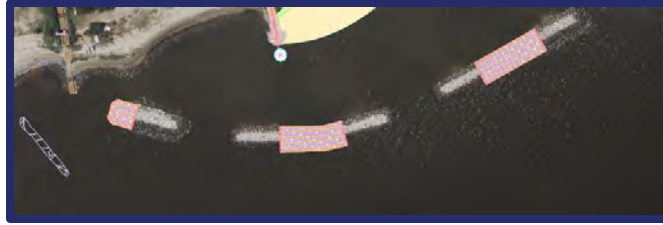
**PR. STONE BREAKWATER RETROFIT PROFILE (TYP)**
