Aquatic Biological Assessment of the Watersheds of Anne Arundel County, Maryland: 2005

Prepared by:

Coastal Resources, Inc.
2988 Solomons Island Road
Edgewater, MD 21037

April 2006

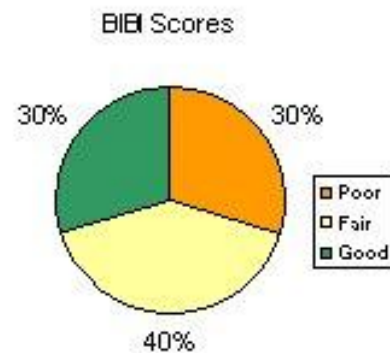
Figure 19 - Stocketts Run BIBI Scores

The MBSS BIBI rated 30 percent of the streams within the Stocketts Run sampling unit as “Good”, 40 percent as “Fair”, and 30 percent as “Poor” (Figure 19). The average BIBI score for Stocketts

Sites located within the Stocketts Run subwatershed ranged from “Poor” to “Good” for the MBSS BIBI. Generally, the sites scoring in the “Good” range (19-09 and 19-10) were located on the mainstem of Stocketts Run, closer to the Patuxent River. The site located farthest downstream, 19-09, was dominated by the sensitive stonefly taxon *Isoperla* sp. This site also had a very high percentage (53.68%) of organisms intolerant to urban stressors. Site 19-10, located farther upstream, had a more even distribution of taxa within the sample. Three taxa, *Ephemerella* sp. (a mayfly), *Paratanytarsus* sp. (a midge), and *Gammarus* sp. (a scud) dominated this sample. Two sites scored in the “Fair” range and were both located on tributary streams to Stocketts Run. One of these sites, 19-06, located closer to the mainstem, was dominated by two blackfly taxa, *Simulium* sp. and *Stegopterna* sp. The other site was located farther up in the sampling unit and was dominated by a midge taxon (*Polypedilum* sp.) and a scud taxon (*Gammarus* sp.). The site scoring in the “Poor” range (19-04) was located in a small headwater tributary in the eastern portion of the sampling unit. This site was dominated by

One site (19-08) was sampled in the Kings Branch subwatershed and scored in the high end of the “Fair” range. This site had a high overall taxa richness and a high EPT taxa richness. No mayfly taxa were found within this site and a relatively high number of aquatic worms and midges were also present in the sample.

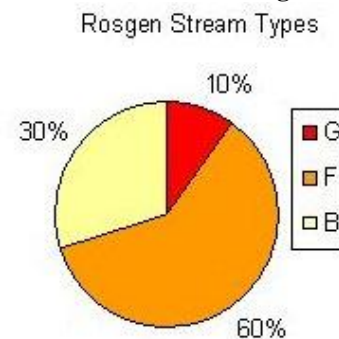
Figure 20 - Stocketts Run Rosgen Stream Types

Six of the Stocketts Run sites are F channels, three are B channels, and one is a G channel (**Figure 20**). The F channels occur throughout all of the Stocketts Run subwatersheds. The B channels occur on headwater tributaries to Davidsonville Branch (19-05) and Stocketts Run (19-06 and 19-07) subwatersheds. The G stream occurs on the mainstem of Davidsonville Branch (19-02). Channel slopes throughout the subwatersheds range from 0.0008 ft/ft to 0.011 ft/ft.

Eight of the streams have sand bed channels, while the remaining two sites have gravel substrates. The gravel bed streams are 19-05 and 19-01, both located in the Davidsonville Branch subwatershed. Five of the sites possess a very hard clay layer in the banks and stream beds. This layer is identified as the IIC3g horizon of the Bibb silt loam soil according to the Anne Arundel County soil survey (USDA 1973), which is characterized as hard, firm, sticky and plastic with some coarse sand and fine gravel. This material appears to provide bed and bank stabilization and grade control, similar to bedrock, in the streams where it is present (noted with the channel substrate modifier /I in the channel classifications assigned to these sites in Appendix B). This clay layer appears at sites 19-02, 19-03, and 19-05 in the

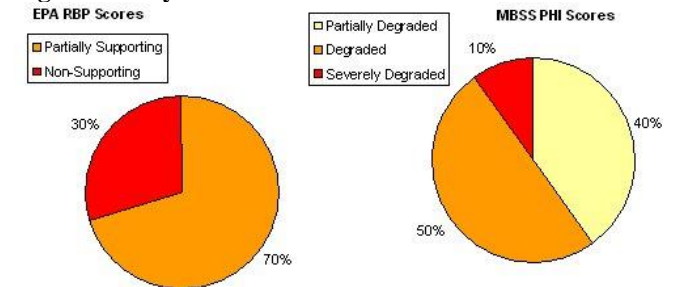
Figure 22 - Lyons Creek Habitat Scores

The MBSS PHI rated 50 percent of the streams within the Lyons Creek sampling unit as “Degraded”, 40 percent of streams were rated as “Partially Degraded”, and the other ten percent as “Severely Degraded” (**Figure 22**). The average PHI score was 62.3 ± 12.1 , which is in the “Degraded” range. Seventy percent of streams were rated as “Partially Supporting” and 30 percent were rated as “Non-Supporting” by the EPA RBP habitat assessment. The average EPA RBP score was resulted in a “Partially Supporting” rating at 103.9 ± 15.1 .

Throughout the sampling unit, instream habitat and epifaunal substrate were in the poor and very poor ranges while shading remained high. Localized areas of high erosion were noted within the sampling unit. A lack of instream woody debris and rootwads was prevalent throughout Lyons Creek. Habitat scores did not appear to vary greatly between larger mainstem sites and smaller tributary streams.

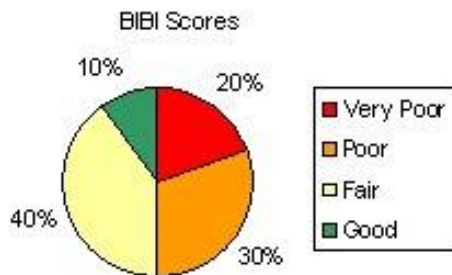
Figure 23 - Lyons Creek BIBI Scores

The MBSS BIBI rated ten percent of the streams within Lyons Creek as “Good”, 40 percent as “Fair”, 30 percent as “Poor”, and 20 percent as “Very Poor” (**Figure 23**). The average BIBI score for Lyons Creek was 2.77 ± 0.78 , which is within the “Poor” range. Sites scoring in the “Good” and “Fair” range were generally located lower in the sampling unit with the exception of one site located on a small tributary stream.

Four sites were located on the mainstem of Lyons Creek. One site (22-09), located on the middle portion of the mainstem scored in the “Fair” range for the MBSS BIBI. This site had low overall tolerance values and a high number of climber taxa. Other sites located on the mainstem of Lyons Creek, farther up in the sampling unit, scored in the “Poor” and “Very Poor” range. The site scoring “Poor” (22-02) was generally dominated by tolerant midge taxa but also had a high number of climber taxa. The sites scoring in the “Very Poor” range (22-03 and 22-06) were dominated by midge taxa, aquatic worms, and amphipods.

The remaining sites were located on tributary streams to Lyons Creek. Scores at these sites ranged from “Poor” to “Good” with sites situated closer to the mainstem of Lyons Creek generally scoring “Fair” or “Good”. The site scoring in the “Good” range (22-01) had high taxa richness, good EPT diversity, and many scraper and climber taxa. Another site (22-11A), located just downstream of this site, scored in the “Fair” range. This site had slightly less diversity overall as well as less diversity of EPT taxa. Sites 22-04 and 22-17A both scored in the “Fair” range and were located on a tributary stream in the western portion of the sampling unit. Mayfly and stonefly taxa were present at these sites but these taxa combined with an abundance of tolerant midge and aquatic worm taxa resulted in the overall “Fair” score. Site 22-05 scored in the “Poor” range and was heavily dominated by the amphipod taxon *Gammarus*.

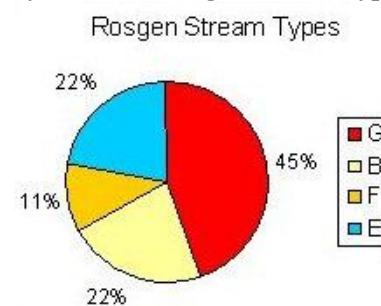
Figure 24 - Lyons Creek Rosgen Stream Types

Four of the Lyons Creek sites are G channels, two are B channels, one is an F channel, and two are E channels (**Figure 24**). Channel slopes range from 0.0004 ft/ft to 0.011 ft/ft. Four of the sites sampled have a sand channel substrate, and four sites have a gravel substrate. One site (22-09) has a silt/clay channel substrate.

One of the B channels identified in the Lyons Creek sampling unit has a width depth ratio more like a G channel (well below 12), but was classified as a B channel because its entrenchment ratio was within the moderately entrenched range. This may indicate that this channel is in transition to an unstable G channel.

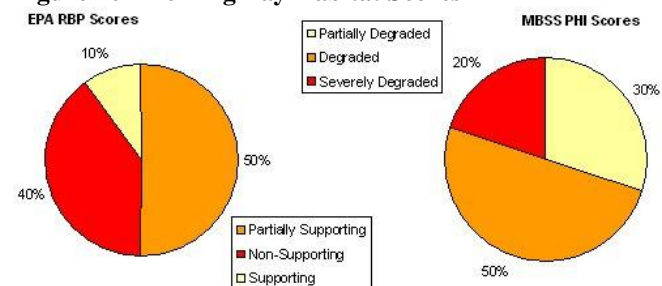
Figure 26 - Herring Bay Habitat Scores

The MBSS PHI rated 50 percent of the streams within the Herring Bay sampling unit as "Degraded", 30 percent of streams were rated as "Partially Degraded", and 20 percent as "Severely Degraded" (**Figure 26**). The average PHI score was 60.2 ± 17.3 , giving this sampling unit an overall habitat condition of "Degraded." Fifty percent of streams were rated as "Partially Supporting", 40 percent were rated as "Non-Supporting", and ten percent were rated as "Supporting" by the EPA RBP habitat assessment. The average EPA RBP score was 105.2 ± 12.9 , giving this sampling unit an overall condition rating of "Partially Supporting". For this sampling unit, habitat conditions were judged approximately equivalent using the two methods.

Generally, the sites were well shaded with a moderate amount of instream woody debris and rootwads and localized severe erosion. Epifaunal substrate was poor while instream habitat was generally marginal. Levels of channel alteration were low throughout the sampling unit while pool substrate characterization was marginal. Other habitat metrics were quite variable throughout the sampling unit.

Aquatic habitat conditions within Tracy's Creek subwatershed were generally "Degraded" with two sampling sites each in the subwatershed scoring in the "Partially Degraded" and "Severely Degraded" ranges. EPA RBP scores showed similar conditions with a combination of "Non-supporting" and "Partially Supporting" aquatic habitat. Most sites scoring lower for the habitat

evaluation were located at a higher position in the subwatershed. Within the Tracy's Creek subwatershed the sites were generally well shaded but contained only moderate amounts of woody debris and localized areas of severe erosion.

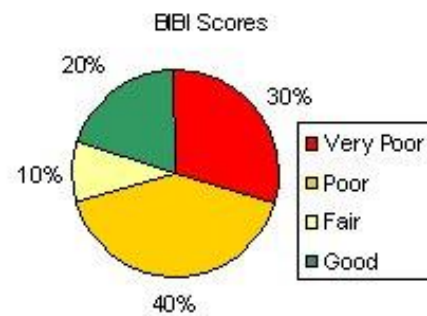
Figure 27 - Herring Bay BIBI Scores

The MBSS BIBI rated 20 percent of the streams within Herring Bay as "Good", ten percent as "Fair", 40 percent as "Poor", and 30 percent as "Very Poor" (**Figure 27**). The average BIBI score for Herring Bay sampling unit was 2.80 ± 1.07 , which is within the "Poor" range. Generally, sites within the Herring Bay sampling unit that scored within the "Good" range were the larger streams that were characterized by good overall taxa richness as well as good EPT taxa richness. Sites scoring in the "Fair" range had similar taxa composition with slightly higher overall tolerance values. Sites scoring in the "Poor" and "Very Poor" ranges contained generally a very tolerant benthic community and were dominated by midges, aquatic worms, and amphipods.

Sites sampled within the Tracy's Creek subwatershed ranged from "Very Poor" to "Good" for the MBSS PHI. The sites scoring in the "Good" range (15-19A and 15-20A) were located in a lower position in the subwatershed and were generally in larger streams than at other sites sampled. These sites, located on the mainstem of Tracy's Creek, had very high EPT taxa richness and a good distribution of taxa abundances. One site (15-12A), located on a tributary stream to Tracy's Creek, scored in the "Fair" range for the MBSS BIBI. This site had good EPT taxa richness, but an overall tolerant community composition. Three sites (15-03, 15-04, and 15-07) scored in the "Poor" range. These sites were generally located higher in the subwatershed on smaller streams and were comprised of a benthic community dominated by midges and amphipods. Two sites (15-05 and 15-11A) scored in the "Very Poor" range. These sites were heavily dominated by midges or amphipod taxa.

One site (15-06) was sampled in the Rockhold Creek subwatershed. This site scored in the "Poor" range. Although this small blackwater stream had a low overall community tolerance value, the sample was mainly dominated by two taxa, an isopod (*Caecidotea* sp.) and aquatic worms.

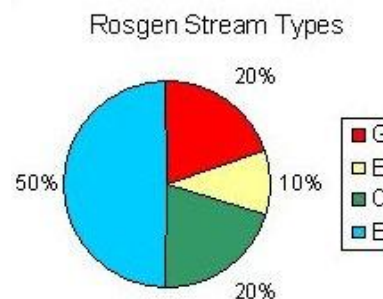
Figure 28 - Herring Bay Rosgen Stream Types

Two of the Herring Bay sites are G channels, one is a B channel, two are C channels, and five are E channels (**Figure 28**). Channel slopes range from 0.001 ft/ft to 0.015 ft/ft. Eight of the sites sampled have a sand channel substrate, and two sites have a silt/clay channel substrate.

The one B channel identified in the Herring Bay sampling unit has a width depth ratio more like a G channel (well below 12), but was classified as a B channel because its entrenchment ratio was within the moderately entrenched range. This may indicate that this channel is in transition to the unstable G channel type.

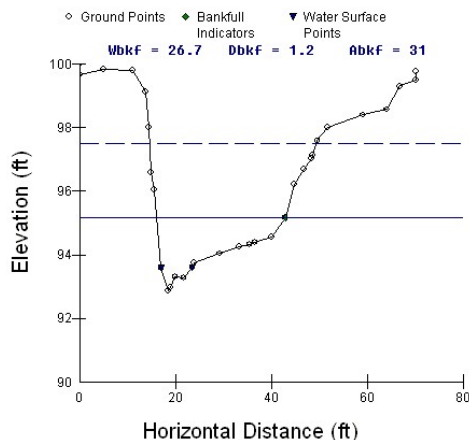
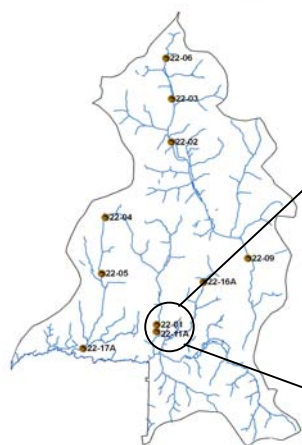
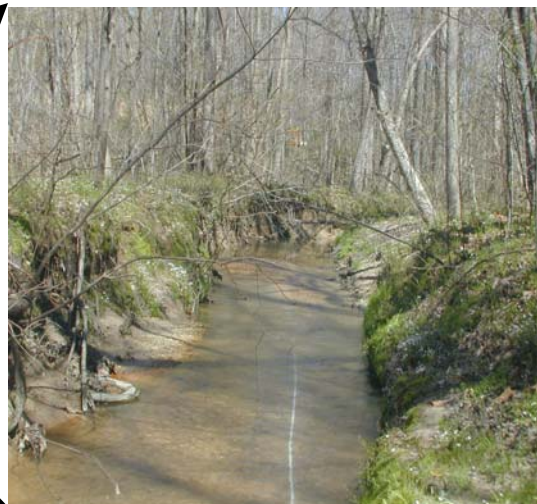
Site 19-10: Riffle STA 80 feet

- Biological condition - “Good”
- Habitat scores in the “Partially Supporting” and “Partially Degraded” ranges
- Good vegetative protection and instream woody debris and rootwads
- Dominant taxa group were several midge taxa with aquatic worms and amphipods
- Stream type was identified as a G4c, the water surface slope was 0.004 ft/ft, and the median channel substrate was very fine gravel
- Typically, G stream types are considered unstable. However, the “Good” biological rating and adequate habitat rating for this reach may imply that the stream is in transition to a more stable form

Recommendations:

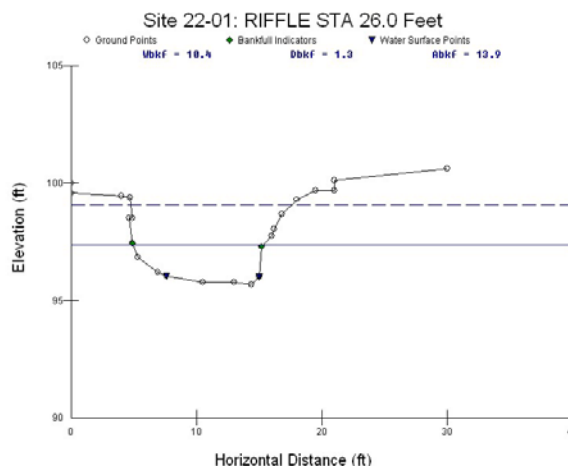
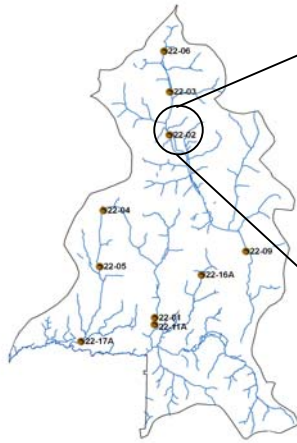
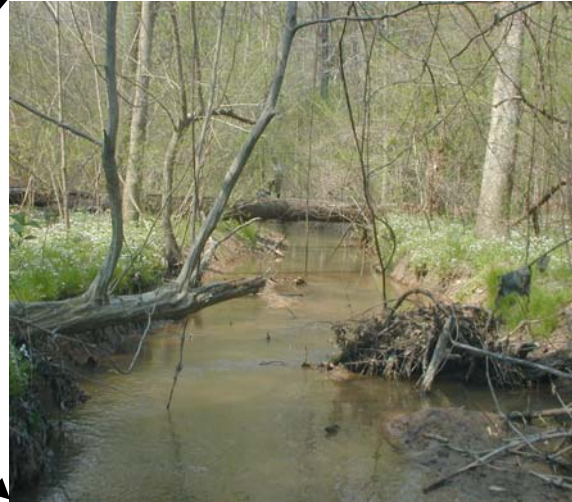
- Biological condition - "Poor"
- Habitat scores in the "Partially Supporting" and "Degraded" ranges
- Optimal channel alteration and riparian vegetative width with marginal instream habitat and poor epifaunal substrate
- Dominant taxa group were several midge taxa with amphipods and aquatic worms
- No geomorphic assessment was completed due to property access denial

Recommendations:

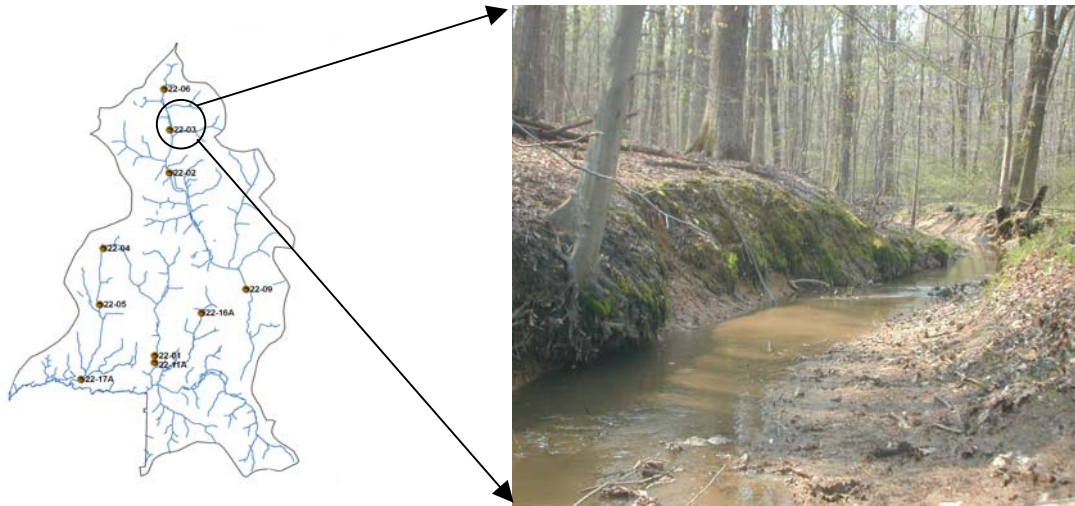
- Biological condition - “Very Poor”
- Habitat scores in the “Non-Supporting” and “Degraded” ranges
- Very poor instream woody debris and rootwads and poor instream habitat and epifaunal substrate
- Dominant taxa group were aquatic worms with several midge taxa
- Stream type was identified as a B5c, the water surface slope was 0.001 ft/ft, and the median channel substrate was very fine sand
- Typically, B channels are stable. However, the “Very Poor” biological ratings and impaired habitat conditions may indicate that this reach is transitioning to an unstable form

Recommendations:

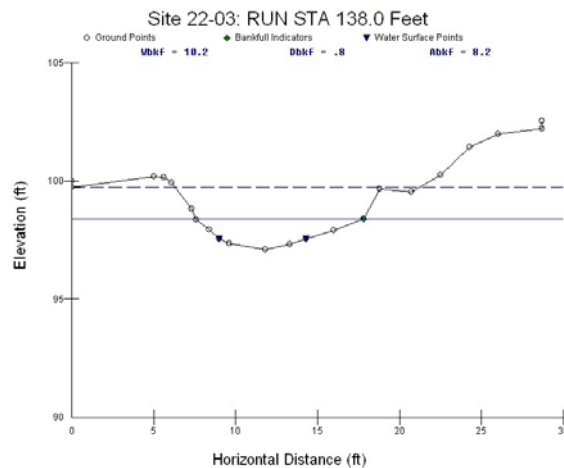
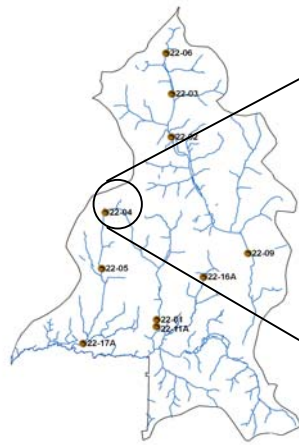
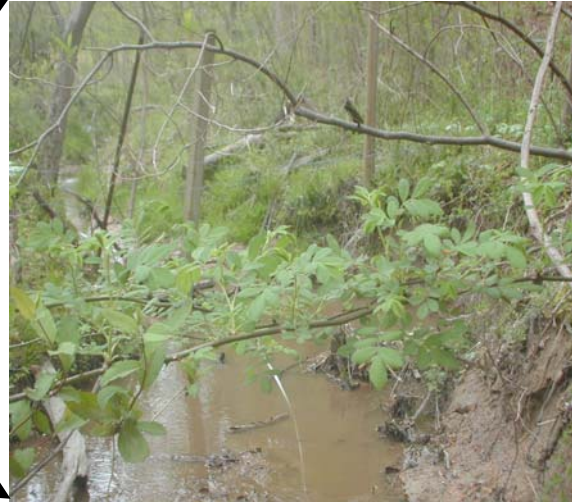
- Biological condition - "Fair"
- Habitat scores in the "Partially Supporting" and "Partially Degraded" ranges
- Optimal channel alteration with good shading and bank erosion
- Dominant taxa group were several midge and amphipod taxa with aquatic worms
- Stream type was identified as a B4c, the water surface slope was 0.012 ft/ft, and the median channel substrate was fine gravel

Recommendations:

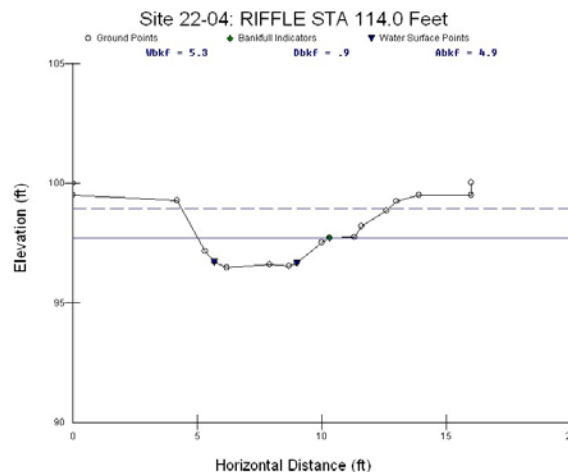
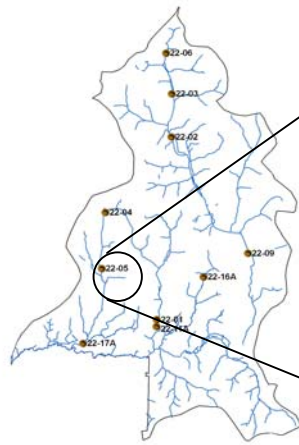
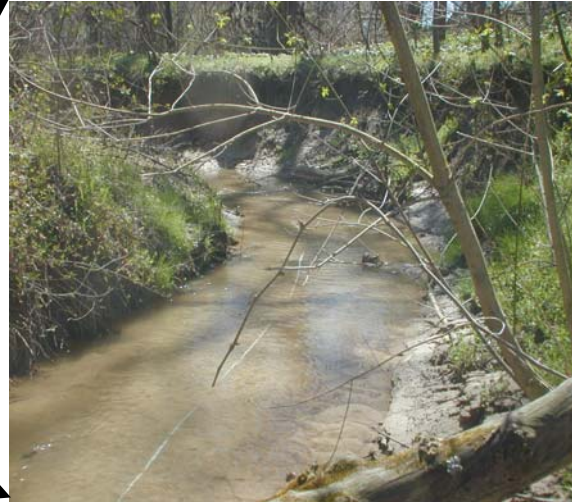
- Biological condition - "Fair"
- Habitat scores in the "Non-Supporting" and "Degraded" ranges
- Optimal channel alteration and shading with poor instream woody debris and epifaunal substrate
- Dominant taxa group were amphipods (*Gammarus* sp.) and several midge taxa
- Stream type was identified as a G4c, the water surface slope was 0.004 ft/ft, and the median channel substrate was very fine gravel
- Impaired benthic communities and stream habitat may be due to the unstable nature of the G stream type

Recommendations:

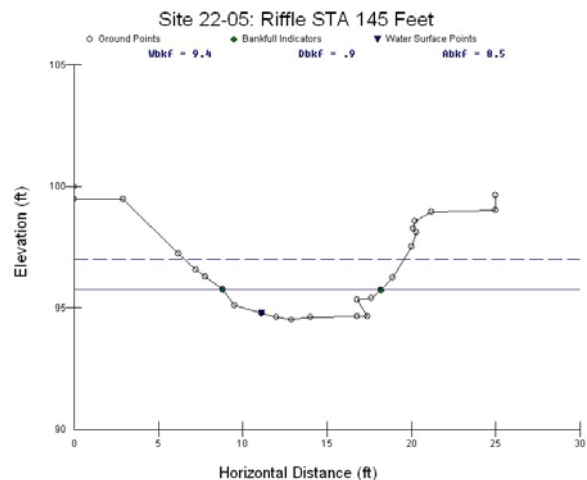
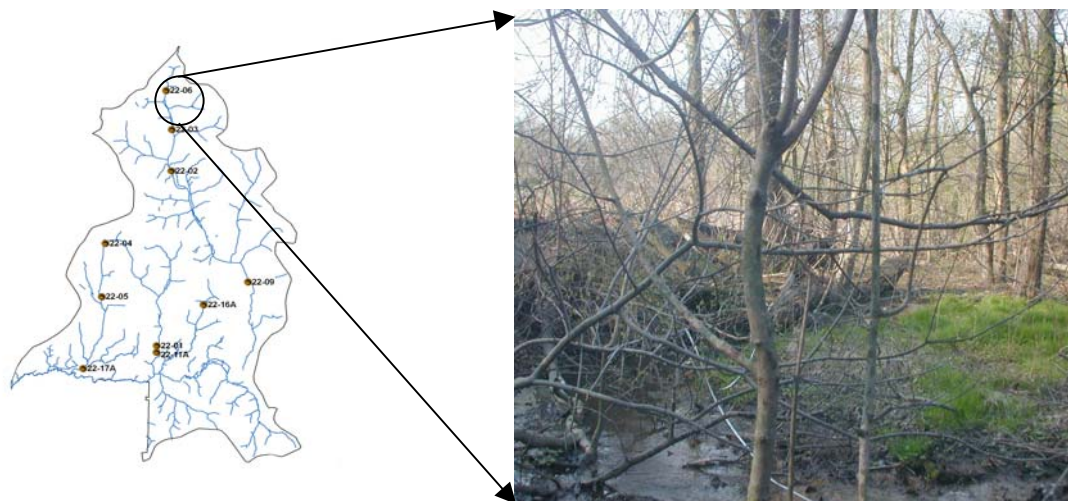
- Biological condition - “Very Poor”
- Habitat scores in the “Partially Supporting” and “Partially Degraded” ranges
- Optimal channel alteration and bank stability with poor epifaunal substrate quality
- Dominant taxa group were amphipods (*Caecidotea* sp.) and aquatic worms
- The stream type was identified as an E5, the water surface slope was 0.011 ft/ft, and the median channel substrate was fine sand
- Biological conditions appear somewhat depressed in comparison to habitat quality observed, so an unknown water quality

Recommendations:

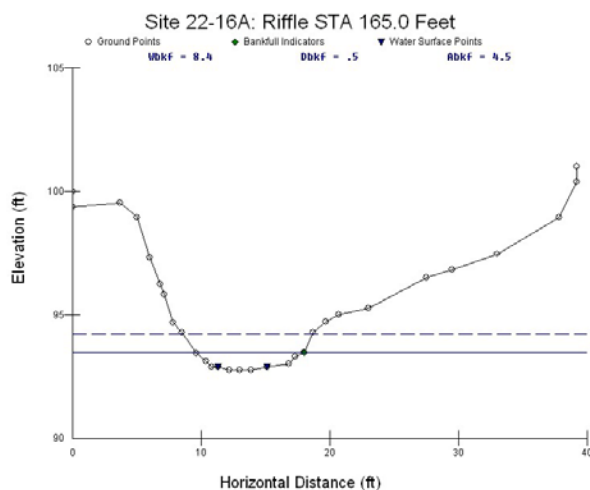
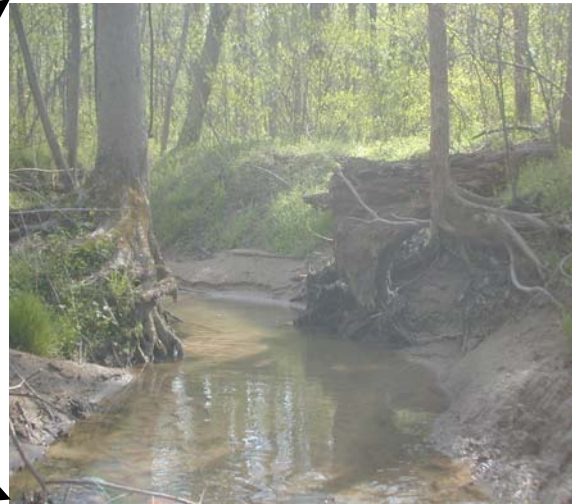
- Biological condition - "Fair"
- Habitat scores in the "Partially Supporting" and "Degraded" ranges
- High bank erosion with poor epifaunal substrate and instream woody debris
- Dominant taxa group were several midge taxa and amphipods (*Gammarus* sp.)
- The stream type was identified as a G4c, the water surface slope was 0.008 ft/ft, and the median channel substrate was very fine gravel
- Impaired benthic communities and stream habitat may be due to the unstable nature of the G stream type

Recommendations:

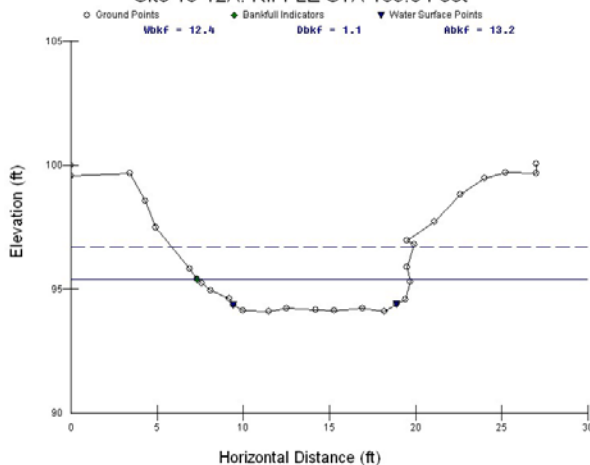
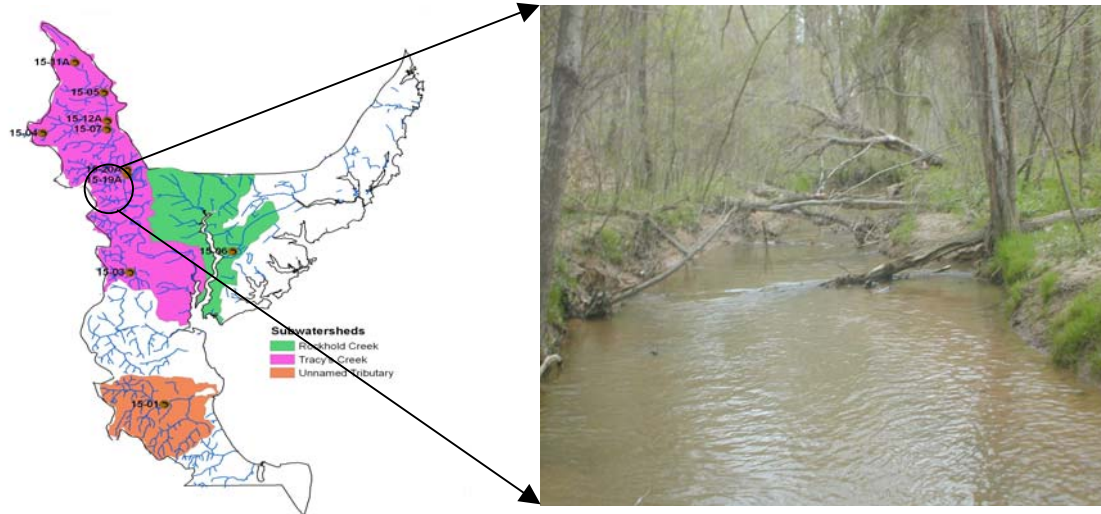
Site 15-12A: RIFFLE STA 189.0 Feet

- Biological condition - "Good"
- Habitat scores in the "Partially Supporting" and "Severely Degraded" ranges
- Channel alteration is considered optimal while epifaunal substrate and erosion was poor
- Dominant taxa group were amphipods (*Gammarus* sp.) and midges (Chironomidae) with several genera of mayfly and stonefly
- Stream type was identified as an E5, the water surface slope was 0.004 ft/ft, and the median channel substrate was medium sand

Recommendations:

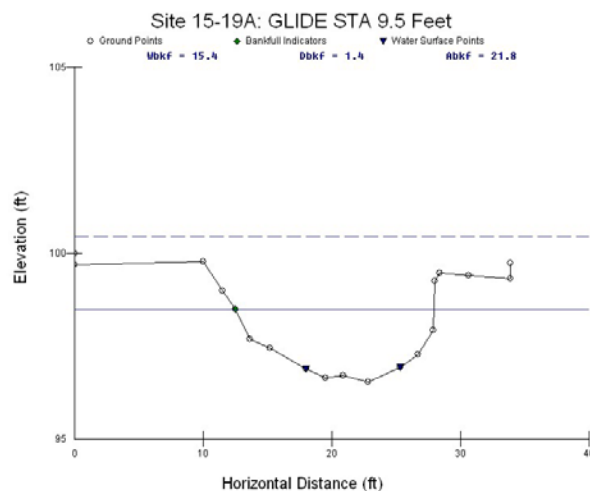
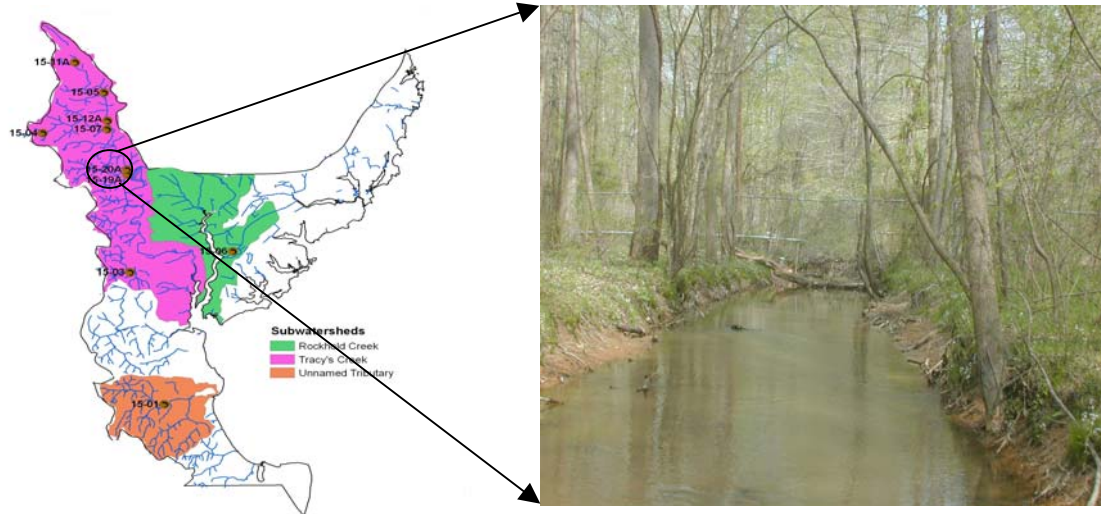
- Biological condition - "Good"
- Habitat scores in the "Non-Supporting" and "Severely Degraded" ranges
- Channel alteration is optimal while instream habitat and epifaunal substrate are poor
- Dominant taxa group were amphipods (*Gammarus* sp.) and mayflies (*Stenonema* sp.)
- Stream type was identified as a C5, the water surface slope was 0.001 ft/ft, and the median channel substrate was medium sand

Recommendations:
