## Aquatic Biological Assessment of the Watersheds of Anne Arundel County, Maryland: 2006

Tetra Tech, Inc.  
400 Red Brook Blvd., Suite 200  
Owings Mills, MD 21117-5159

Anne Arundel County  
Department of Public Works  
Watershed, Ecosystem, and Restoration Services  
2662 Riva Road  
Annapolis, MD 21401

**November 2008**

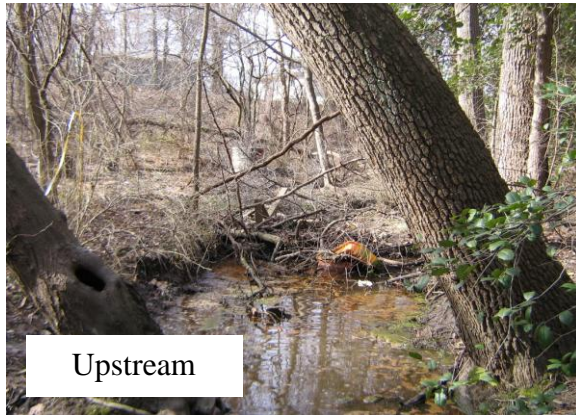
Upstream

**Location/Site Access:** Located approx. 150m US of Margate Road crossing  
**Latitude/Longitude:** 39.17098/-76.60197

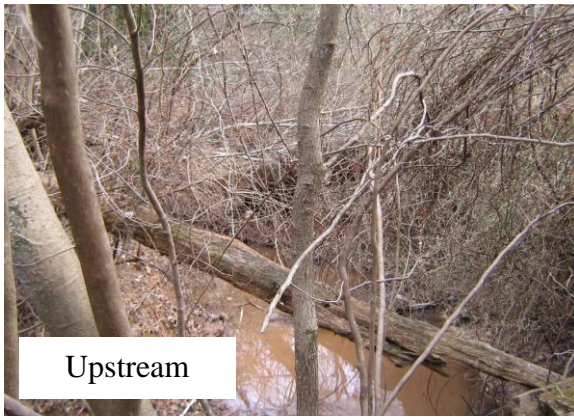
Upstream

**Location/Site Access:** Located approx. 260m SE from Foxwell Road  
**Latitude/Longitude:** 39.12896/-76.60593

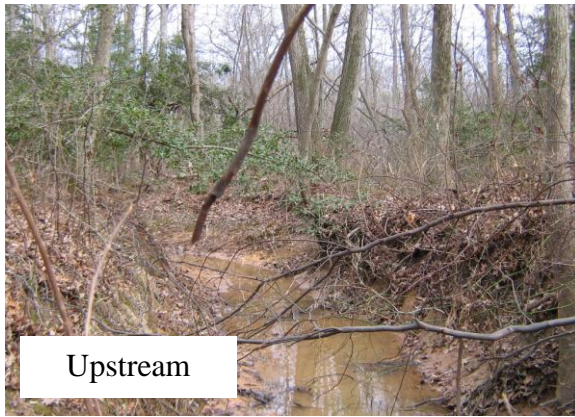
Upstream

**Location/Site Access:** Located approx. 150 DS from Marley Neck Blvd Crossing  
**Latitude/Longitude:** 39.15529/-76.58248

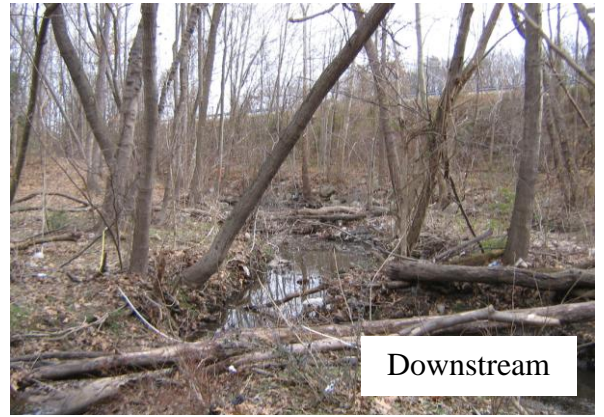
Downstream

- Biological condition – "Poor"
- Habitat scores "Partially Supporting" and "Partially Degraded"
- Most habitat variables scores are marginal
- Impervious percentage in the drainage area is very high (47.3%)
- Sample dominated by a dragonfly (*Argia*) and a midge (*Thienemannimyia*)
- Stream type was identified as an E5, slope was 0.31 percent, and the median channel substrate was fine sand
- Typically, E channels are stable. However, the very high imperviousness is probably affecting hydrologic patterns, which could in turn destabilize channel morphology.
- Habitat assessment results were mixed for this site, but biological community observed is trending toward more than expected impairment based on the observed habitat quality.

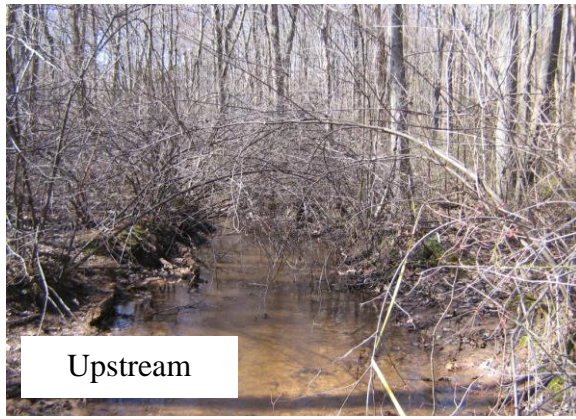
Upstream

- Biological condition – "Poor"
- Habitat scores "Supporting" and "Partially Degraded"
- All habitat variables scored in the sub-optimal to optimal range
- Sample dominated by midges (*Tvetenia* and *Rheotanytarsus*) and lacked mayflies
- Stream type was identified as an E5, slope was 0.985 percent, and the median channel substrate was very fine sand
- Typically, E channels are stable and the high habitat scores indicate potential for continued stability.
- Biological community is in worse condition than would be expected for available habitat quality.

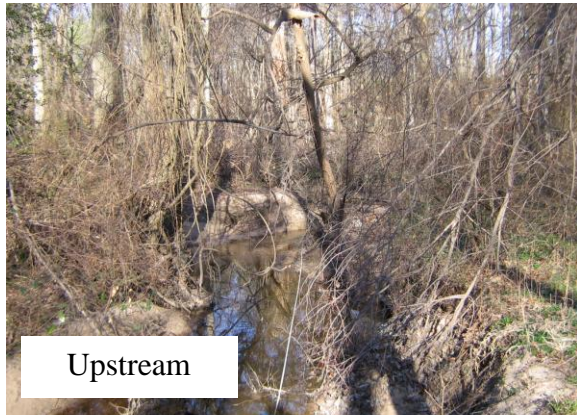
Upstream

- Biological condition – "Poor"
- Habitat scores "Non Supporting" and "Degraded"
- Bank stability and vegetative protection scored low
- Sample dominated by midges (*Polypedilum*, *Orthocladius/Cricotopus*, and *Thienemannimyia*)
- Stream type was identified as an B5c, slope was 0.263 percent, and the median channel substrate was fine sand
- Typically, B channels are stable. However, the low bank stability ratings may indicate that this reach is transitioning to an unstable form.
- Habitat assessment results were mixed for this site, but biological community observed is trending toward less than expected impairment based on the observed habitat quality.

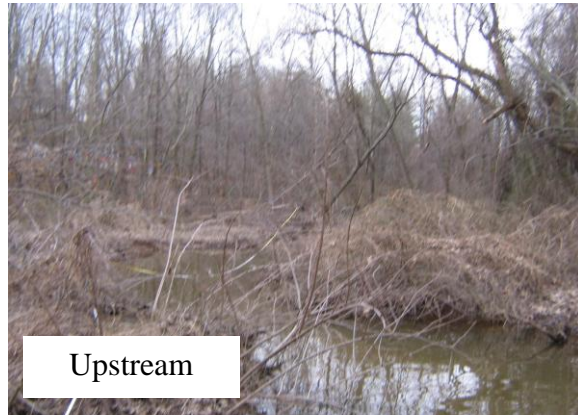
Upstream

- Biological condition – "Fair"
- Habitat scores "Supporting" and "Degraded"
- Riparian zone width scored optimally
- Dominant taxon is *Ancyronyx* (*Elmidae*, riffle beetle)
- Stream type was identified as an E5, slope was 0.029 percent, and the median channel substrate was very fine sand
- Typically, E channels are stable and the EPA habitat and biological scores indicate that continued stability is possible. PHI indicates habitat degradation.
- Habitat assessment results were mixed for this site, but biological community observed is trending toward less than expected impairment based on the observed habitat quality.

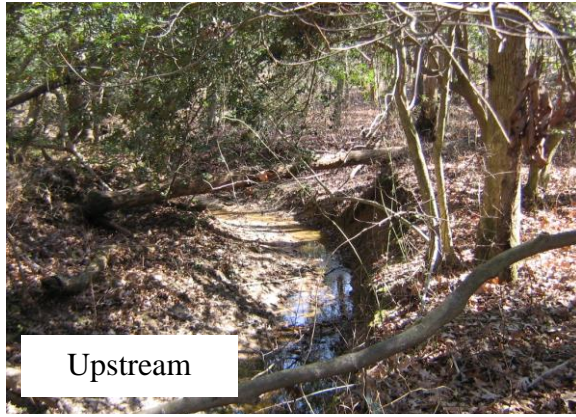
Upstream

- Biological condition – "Poor"
- Habitat scores "Non -supporting" and "Degraded"
- Riparian zone width scored high, though bank stability and vegetative protection scored low.
- Dominant taxa include a clam (*Pisidium*) and a worm (*Aulodrilus*)
- Stream type was identified as an C6, slope was 0.245 percent, and the median channel substrate was silt
- Typically, C channels are stable. Habitat ratings related to bank stability ranked very low, indicating an unstable condition.
- Habitat assessment results were mixed for this site, but biological community observed is trending toward less than expected impairment based on the observed habitat quality.

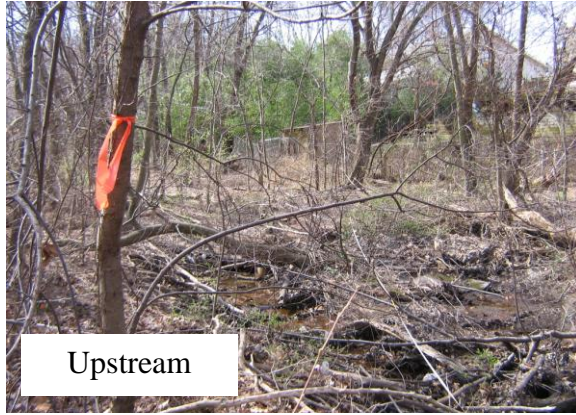
Upstream

- Biological condition – "Poor"
- Habitat scores "Non Supporting" and "Degraded"
- Bank stability scored low and the riparian zone width was marginal
- Dominant taxa are non-insects; a snail (*Physa*), a clam (*Pisidium*), and a worm (*Tubificidae*)
- Stream type was not classified, but was identified as disturbed.
- Habitat assessment results were mixed for this site, but biological community observed is trending toward less than expected impairment based on the observed habitat quality.

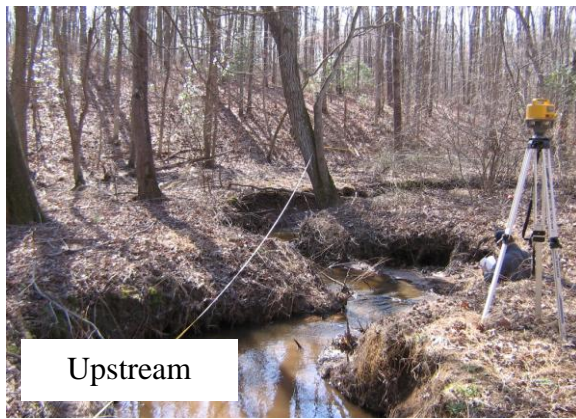
Upstream

- Biological condition – "Fair"
- Habitat scores "Partially Supporting" and "Partially Degraded"
- Riparian zone width scored high, but pool variability, bank stability, and vegetative protection scored low
- Sample dominated by midges (Tvetenia and Parametrioctenus)
- Stream type was identified as an E5, slope was 0.84 percent, and the median channel substrate was fine-medium sand
- Typically, E channels are stable. However, the impaired bank stability may indicate that this reach is transitioning to an unstable form.
- Habitat assessment results were mixed for this site, but biological community observed is trending toward less than expected impairment based on the observed habitat quality.

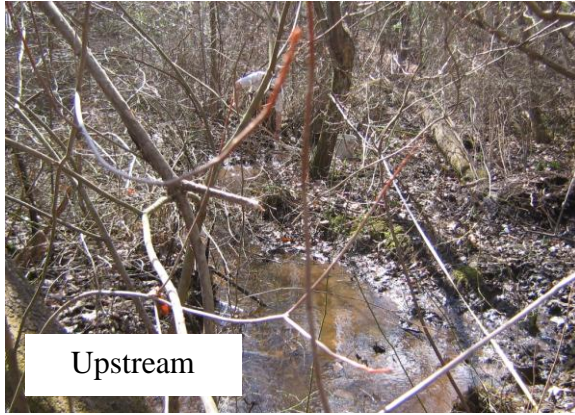
Upstream

- Biological condition – "Poor"
- Habitat scores "Supporting" and "Partially Degraded"
- Riparian vegetation zone width scored high
- Sample dominated by midges: *Rheotanytarsus*, *Parametriocnemus*, and *Thienemannimyia*. No mayflies.
- Stream type was identified as an E5, slope was 0.22 percent, and the median channel substrate was fine sand.
- Typically, E channels are stable and this one has good potential for continued stability.
- Biological community is in worse condition than would be expected for available habitat quality.

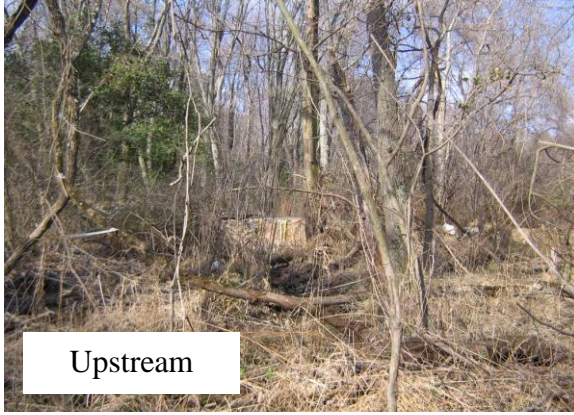
Upstream

- Biological condition – "Very Poor"
- Habitat scores "Non Supporting" and "Degraded"
- Channel flow status and Epifaunal substrate scored very poorly
- Sample had no EPTs and was dominated by clams: *Sphaeriidae* and *Pisidium*
- Stream type was identified as an C6, slope was 0.83 percent, and the median channel substrate was silt
- The "Very Poor" biological ratings may be associated with fine substrates observed in this reach. The banks appear stable (and they should be in a C channel), so excess sediment may be coming from overland flow.
- Habitat assessment results were mixed for this site, but biological community observed is trending toward more than expected impairment based on the observed habitat quality.

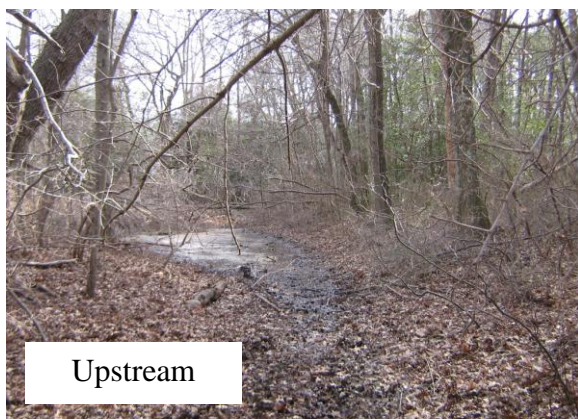
Upstream

- Biological condition – "Poor"
- Habitat scores "Non Supporting" and "Degraded"
- Riparian vegetation zone width and epifaunal substrate scored low
- Sample dominated by biting flies, *Culicoides*
- Stream type was identified as an E6, slope was 0.30 percent, and the median channel substrate was silt
- Dissolved oxygen was very low.
- This channel, like typical E channels, appears stable. However, the very fine substrate indicates that excessive sediment may be a problem.
- Habitat assessment results were mixed for this site, but biological community observed is trending toward less than expected impairment based on the observed habitat quality.

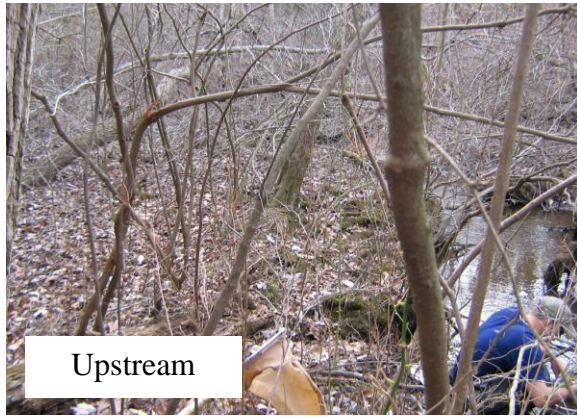
Upstream

- Biological condition – "Fair"
- Habitat scores "Supporting" and "Partially Degraded"
- Most habitat variables were scored in the sub-optimal to optimal range
- Sample lacking mayflies and dominated by *Parametriocnemus*, *Polycentropus*, *Thienemannimyia*, and *Diplectrona*
- Stream type was identified as an E5, slope was 0.29 percent, and the median channel substrate was fine sand
- Habitat and water quality indicators are as expected for an E channel and agree with the "Fair" biological condition.
- Biological community is appropriate for observed habitat quality.

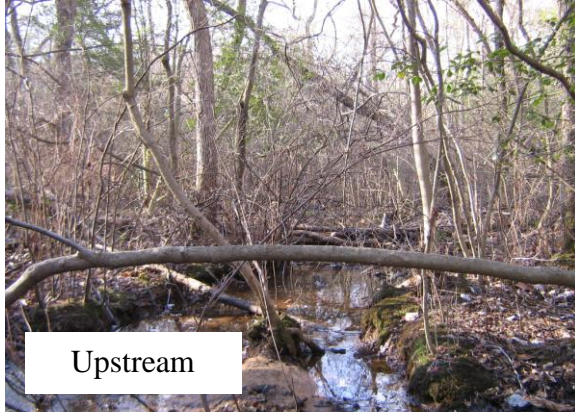
Upstream

- Biological condition – "Fair"
- Habitat scores "Supporting" and "Minimally Degraded"
- All habitat variables scored moderate to optimal
- Sample relatively diverse, but lacking mayflies and dominated by a midge (*Thienemannimyia*)
- Stream type was identified as an E5, slope was 0.19 percent, and the median channel substrate was fine sand
- Habitat and water quality indicators are as expected for an E channel and agree with the "Fair" biological condition. Lack of mayflies may be due to excessive fine sediments.
- Habitat assessment results were mixed for this site, but biological community observed is trending toward more than expected impairment based on the observed habitat quality.

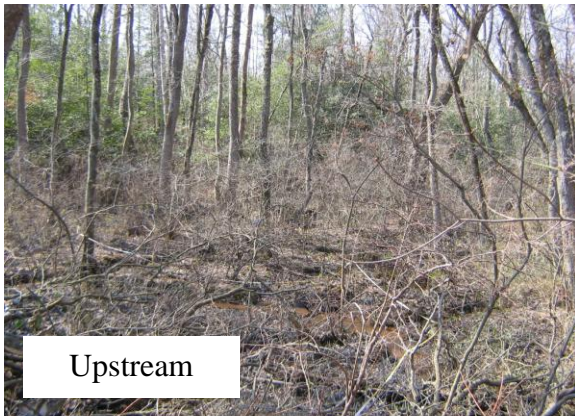
Upstream

- Biological condition – "Very Poor"
- Habitat scores "Comparable" and "Minimally Degraded"
- All scores were near optimal except for epifaunal substrate and pool substrate characterization
- Sample lacking mayflies and dominated by a midge (*Paratendipes*)
- Stream type was identified as an E5, slope was 0.91 percent, and the median channel substrate was fine to medium sand
- This E channel appears stable, habitat and measured water quality indicators are normal, though pH is somewhat low.
- Biological community is in worse condition than would be expected for available habitat quality.

- Because habitat is minimally degraded and biological condition is very poor, look for problems with water quality and correct, if possible.

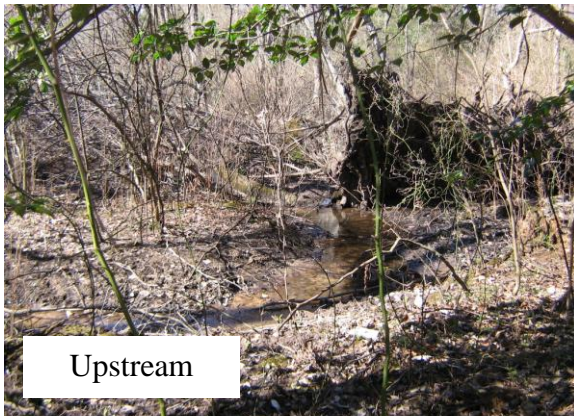
Upstream

- Biological condition – "Poor"
- Habitat scores "Partially Supported" and "Partially Degraded"
- Riparian vegetation zone width scored high
- Sample lacking mayflies and dominated by a midge (*Thienemannimyia*)
- Stream type was identified as an C5, slope was 0.67 percent, and the median channel substrate was fine sand
- Typically, C channels are stable. This channel has sub-optimal bank indicators and marginal substrate indicators.
- Habitat assessment results were mixed for this site, but biological community observed is trending toward more than expected impairment based on the observed habitat quality.

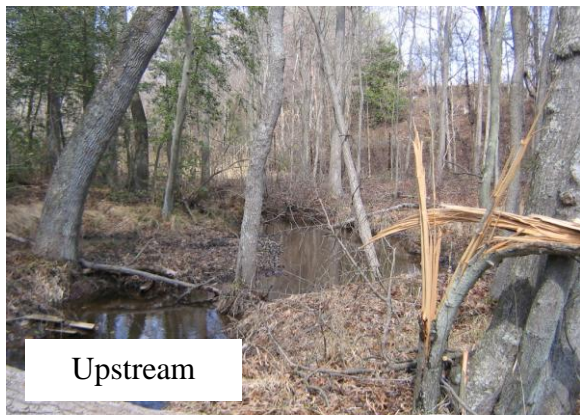
Upstream

- Biological condition – "Very Poor"
- Habitat scores "Partially Supported" and "Partially Degraded"
- Riparian vegetation protection scored relatively low
- Sample lacking mayflies and dominated by midges (*Tribelos* and *Phaenopsectra*)
- Dissolved oxygen recorded value in error: possible corrected value 12.96 mg/L
- Stream type was identified as an C5, slope was 0.37 percent, and the median channel substrate was very fine sand
- Habitat and water quality conditions are better than might be expected for the "Very Poor" biological ratings in this reach.
- Biological community is in worse condition than would be expected for available habitat quality.

- Maintain protection of riparian areas. Investigate possible water quality stressors, likely found in upstream residential and commercial lands.

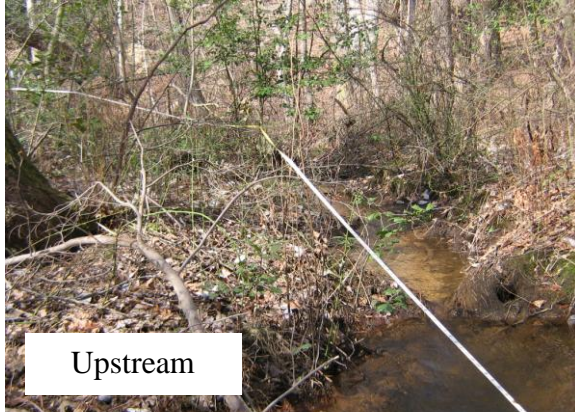
Upstream

- Biological condition – "Poor"
- Habitat scores "Supporting" and "Partially Degraded"
- All EPA habitat variables scored moderate or near optimal
- Sample lacking mayflies and dominated by *Stegopterna* (blackflies)
- Stream type was identified as an E5, slope was 1.1 percent, and the median channel substrate was fine sand
- High dominance of blackflies may have been a temporary biological condition coinciding with the blackfly life cycle. Habitat and water quality indicators suggest that "Fair" or better biological conditions should be possible.
- Biological community is in worse condition than would be expected for available habitat quality.

- Maintain the protection of the riparian area.
- Investigate water quality degradation associated with upstream residential and commercial lands. Correct as necessary and feasible.

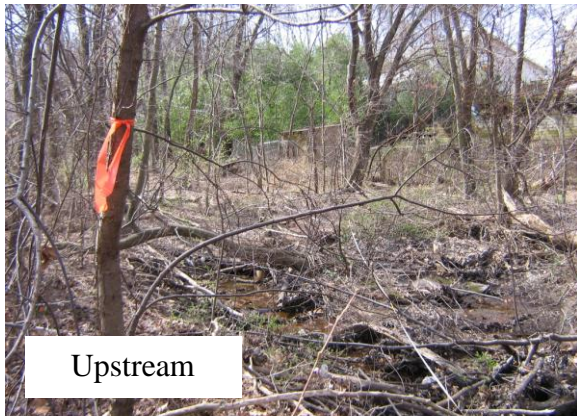
Upstream

- Biological condition – "Poor"
- Habitat scores "Comparable" and incomplete
- All EPA habitat variables scored near optimal
- Sample lacking mayflies and dominated by a midge, *Rheotanytarsus*
- Stream type was identified as an E5, slope was 0.28 percent, and the median channel substrate was fine sand
- This E channel is stable, has good habitat, and normal water quality (though pH is somewhat low).
- Biological community is in worse condition than would be expected for available habitat quality.

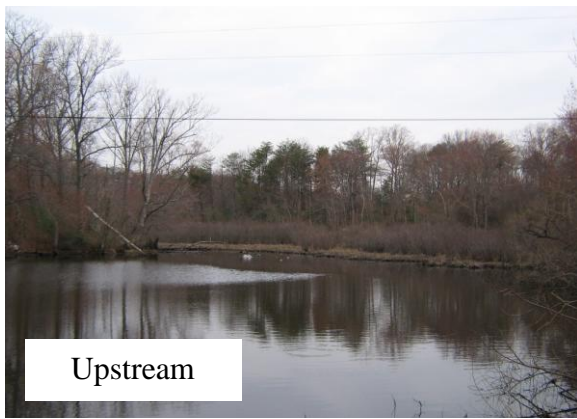
Upstream

- Biological condition – "Fair"
- Habitat scores "Non Supporting" and "Degraded"
- Most EPA habitat variables scored poorly to marginally
- Sample dominated by *Orthocladus*, *Dubiraphia*, *Simulium*, and *Tanytarsus*
- Geomorphic assessment incomplete because pond and culvert comprise approximately half of the assessment reach.
- Association of this reach with the upstream pond affects the hydrology and morphology.
- Biological community is in better condition than expected for measured level of habitat quality.

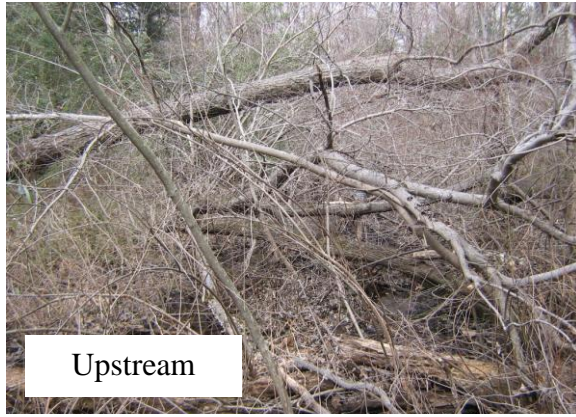
Upstream

- Biological condition – "Fair"
- Habitat scores "Partially Supporting" and "Partially Degraded"
- Bank stability and vegetative protection scored poorly.
- Sample dominated by *Parametriocnemus Diplectrona*
- Stream type was identified as an E5, slope was 1.04 percent, and the median channel substrate was fine sand
- Typically, E channels are stable. However, the marginal bank-related habitat ratings may indicate that this reach is transitioning to an unstable form.
- Habitat assessment results were mixed for this site, but biological community observed is trending toward less than expected impairment based on the observed habitat quality.

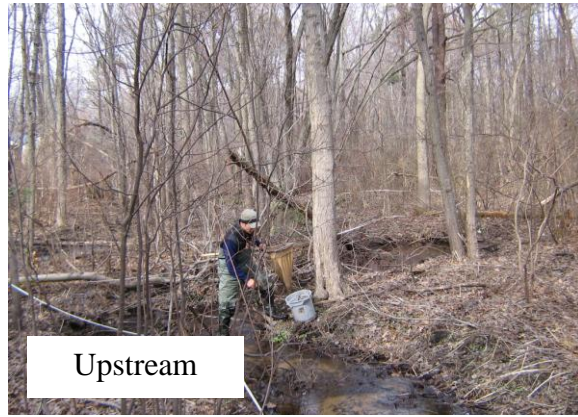
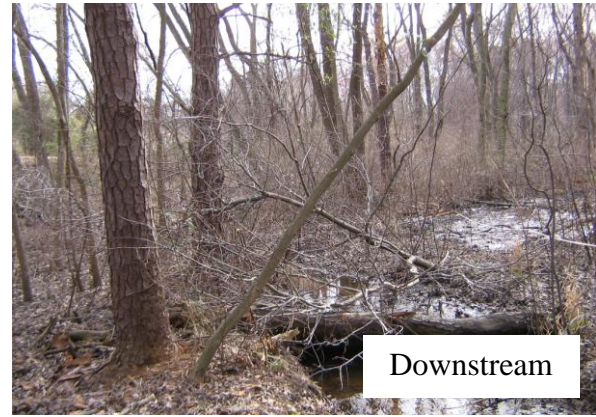
- Biological condition – "Fair"
- Habitat scores "Partially Supporting" and "Partially Degraded"
- Channel alteration and channel flow status scored high
- Sample dominated by *Parametriocnemus* and *Polypedilum*
- Stream type was identified as an E5, slope was 0.54 percent, and the median channel substrate was fine to medium sand
- Typically, E channels are stable. However, the marginal bank and substrate-related habitat ratings may indicate that this reach is transitioning to an unstable form.
- Habitat assessment results were mixed for this site, but biological community observed is trending toward less than expected impairment based on the observed habitat quality.

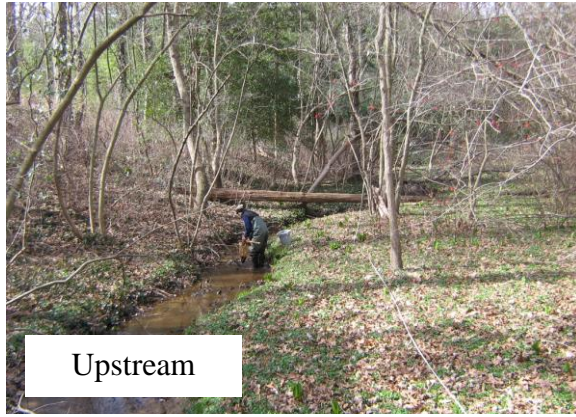
Upstream

- Biological condition – "Poor"
- Habitat scores "Partially Supporting" and "Degraded"
- Bank stability and vegetative protection scored moderately
- Sample lacking mayflies and dominated by midges (*Parametriocnemus* and *Orthocladius/Cricotopus*)
- Stream type was identified as an E5, slope was 0.69 percent, and the median channel substrate was medium sand
- Typically, E channels are stable. However, the "Poor" biological ratings along with sub-optimal and marginal habitat ratings may indicate that this reach is transitioning to an unstable form.
- Biological community is appropriate for observed habitat quality.

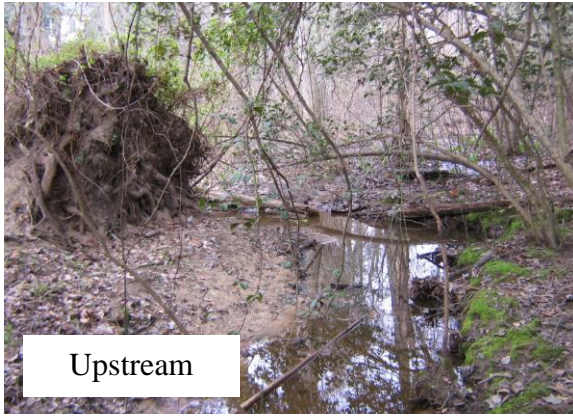
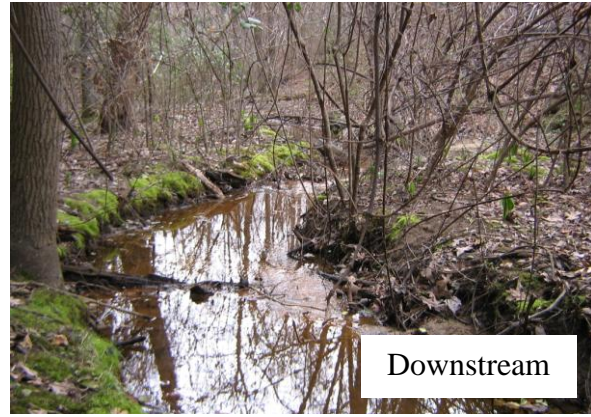
- Biological condition – "Poor"
- Habitat scores "Supporting" and "Partially Degraded"
- Habitat variables related to substrate and pool variability scored lowest of all
- Sample lacking mayflies and dominated by *Stegopterna*, *Rheocricotopus*, and *Orthocladus/Cricotopus*
- Stream type was identified as an E5, slope was 0.7 percent, and the median channel substrate was fine sand
- This E channel may be stable; however, poor substrate conditions may be limiting the biological potential.
- Biological community is in worse condition than would be expected for available habitat quality.

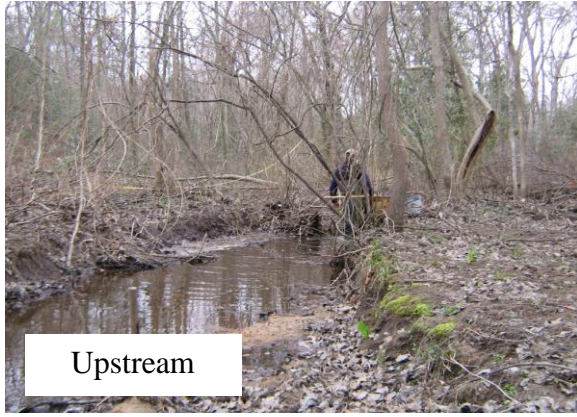
Upstream

- Biological condition – "Fair"
- Habitat score "Non Supporting" and "Degraded"
- Riparian vegetation and physical complexity of habitat scored high
- Sample dominated by *Ancyronyx* and *Parametriocnemus*
- Stream type was identified as an E5, slope was 0.17 percent, and the median channel substrate was very fine sand
- Typically, E channels are stable. However, the marginal bank and substrate habitat ratings may indicate that this reach is transitioning to an unstable form.
- Biological community is in better condition than expected for measured level of habitat quality.

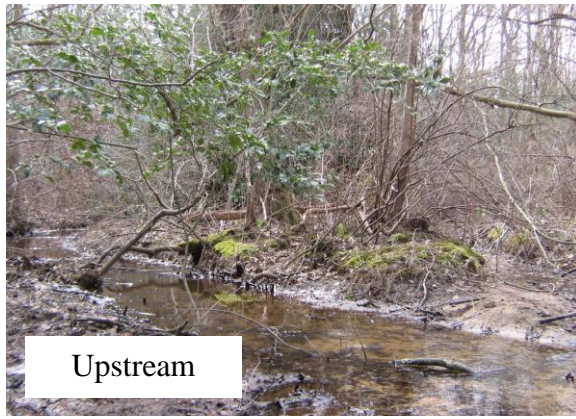
Upstream

- Biological condition – "Fair"
- Habitat scores in "Supporting" and "Partially Degraded" ranges
- All EPA habitat variables scored in the moderate to optimal range
- Sample dominated by *Tanytarsus*, *Parametriocnemus*, and *Polycentropus*
- Stream type was identified as an E5, slope was 0.46 percent, and the median channel substrate was fine sand
- "Fair" biological conditions and "Supporting" habitat assessments are in agreement, though biological potential may be limited by fine substrates.
- Biological community is appropriate for observed habitat quality.

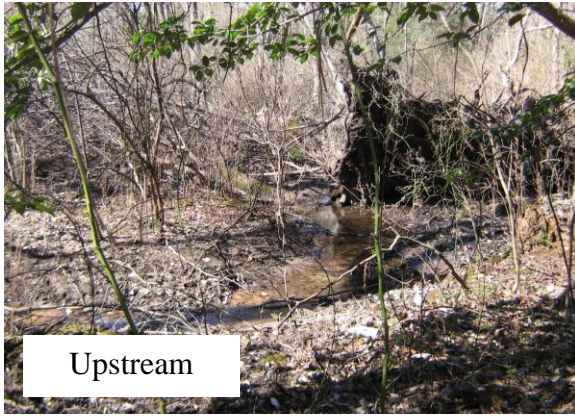
Upstream

- Biological condition – "Fair"
- Habitat scores "Supporting" and "Partially Degraded"
- Channel sinuosity scored poorly
- Sample dominated by non-midge insects (*Simulium*, *Cheumatopsyche*, and *Stenelmis*)
- Stream type was identified as an E5, slope was 0.37 percent, and the median channel substrate was coarse sand
- Typically, E channels are stable. However, the bank-related habitat ratings are suboptimal and may indicate that this reach is transitioning to an unstable form.
- Biological community is appropriate for observed habitat quality.

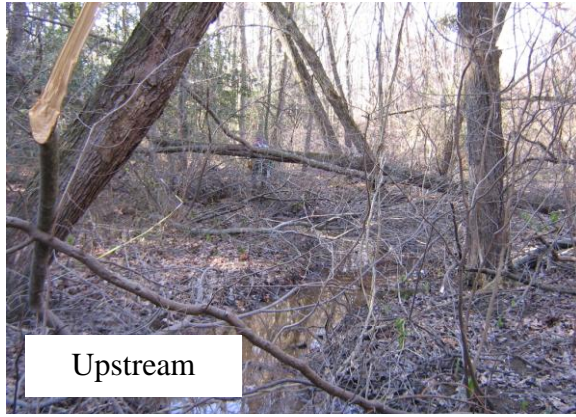
Upstream

- Biological condition – "Poor"
- Habitat scores "Partially Supporting" and "Degraded"
- Substrate and pool variability variables scored poorly
- Sample lacking mayflies and dominated by worms (*Tubificidae*)
- Stream type was identified as an C5, slope was 0.78 percent, and the median channel substrate was fine sand
- Typically, C channels are stable. However, the habitat ratings related to bank stability and substrate indicate that this reach is transitioning to an unstable form
- Biological community is appropriate for observed habitat quality.

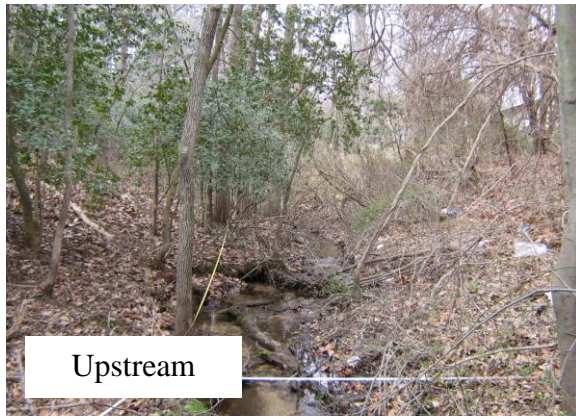
Upstream

- Biological condition – "Very Poor"
- Habitat scores "Partially Supporting" and "Degraded"
- Riparian variables scored marginally
- Sample lacking mayflies and dominated by midges (*Parametriocnemus*)
- Stream type was identified as an E5, slope was 0.77 percent, and the median channel substrate was clay
- Typically, E channels are stable. However, the "Very Poor" biological ratings along with impaired habitat ratings may indicate that this reach is transitioning to an unstable form.
- Biological community is in worse condition than would be expected for available habitat quality.

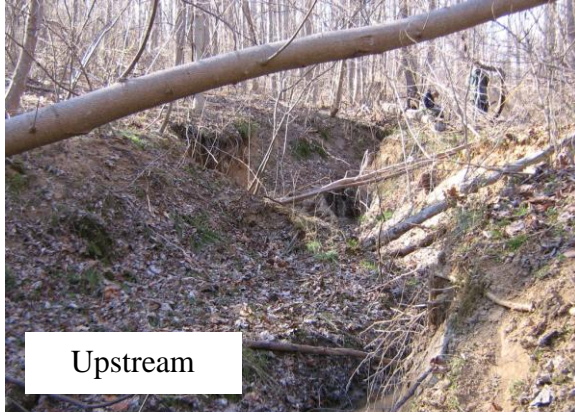
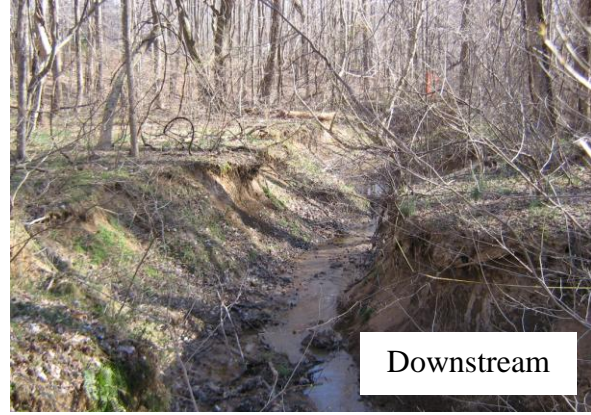
Upstream

- Biological condition – "Poor"
- Habitat scores "Non Supporting" and "Degraded"
- Bank stability and vegetative protection scored very poorly
- Sample lacking mayflies and dominated by *Rheocricotopus*, *Amphinemura*, and *Diplocadius*
- Stream type was identified as an B5, slope was 3.28 percent, and the median channel substrate was fine sand
- Typically, B channels are stable. However, secure headcuts observed downstream with an extremely narrow width to depth ratio. Observation may indicate this reach is downcutting further below its surrounding valley.
- Habitat assessment results were mixed for this site, but biological community observed is trending toward less than expected impairment based on the observed habitat quality.

- Maintain the protection of the riparian area.
- Determine causes of instability observed in this reach and develop appropriate restoration approach.
- Determine necessity, feasibility of retrofitting stormwater BMPs in upstream drainage.

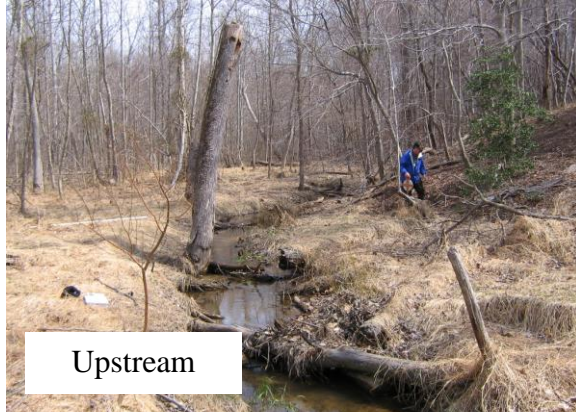
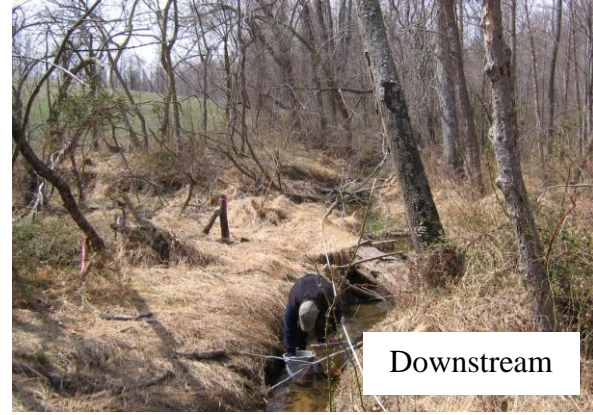
Upstream

- Biological condition – "Very Poor"
- Habitat scores "Partially Supporting" and "Degraded"
- Bank stability and vegetative protection scored moderate
- Sample lacking mayflies and dominated by Midges (*Diplocladius*, *Rheocricotopus*, and *Orthocladius/Cricotopus*)
- Stream type was identified as an C6, slope was 0.927 percent, and the median channel substrate was silt to very fine sand
- Typically, C channels are stable. However, the "Very Poor" biological ratings along with marginal habitat ratings related to bank and substrate variables indicate that this reach is transitioning to an unstable form.
- Biological community is in worse condition than would be expected for available habitat quality.

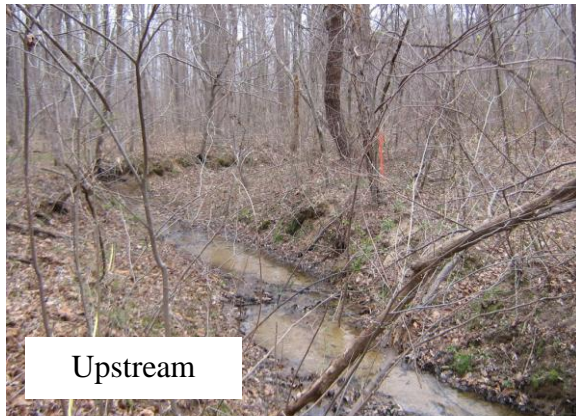
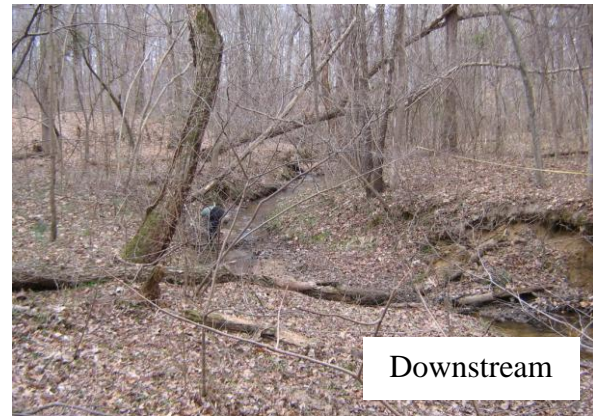
Upstream

- Biological condition – "Fair"
- Habitat scores "Partially Supporting" and "Partially Degraded"
- Pool and bank habitat variables scored marginally
- Sample dominated by midges (*Micropsectra* and *Polypedilum*) and amphipods (*Gammarus*)
- Stream type was identified as an G5c, slope was 0.35 percent, and the median channel substrate was fine sand
- Typically, G channels are not stable. This reach has marginal habitat ratings for variables related to bank stability and substrate, but the biological community is not totally degraded.
- Habitat assessment results were mixed for this site, but biological community observed is trending toward less than expected impairment based on the observed habitat quality.

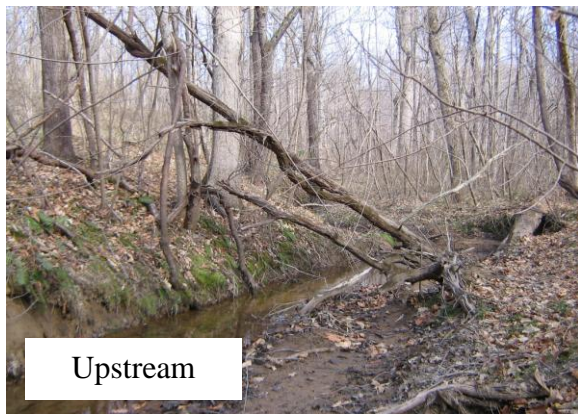
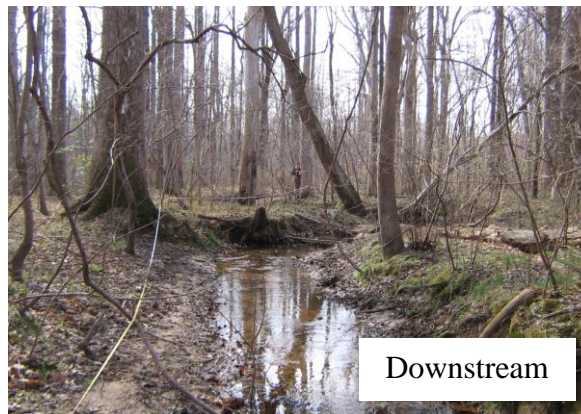
Upstream

- Biological condition – "Poor"
- Habitat scores "Non Supporting" and "Partially Degraded"
- Several habitat variables scored marginally and poorly
- Sample lacking mayflies and dominated by midges (*Diplocladius*) and worms (*Limnodrilus* and unidentified *Tubificidae*)
- Stream type was identified as an C5, slope was 0.23 percent, and the median channel substrate was very fine sand
- Typically, C channels are stable. However, the marginal habitat ratings related to bank and substrate variables indicate that this reach is transitioning to an unstable form.
- Habitat conditions are mixed for this site, with one assessment method indicating impairment and one indicating some kind of enrichment.

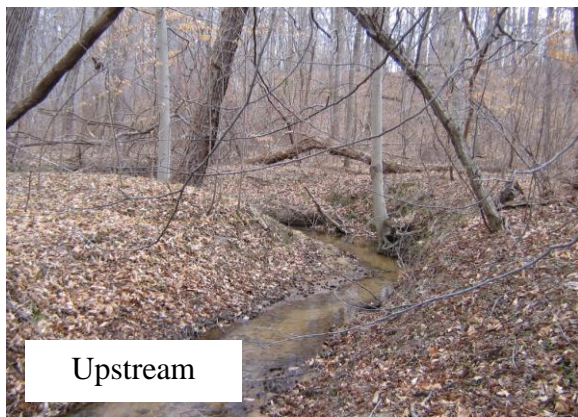
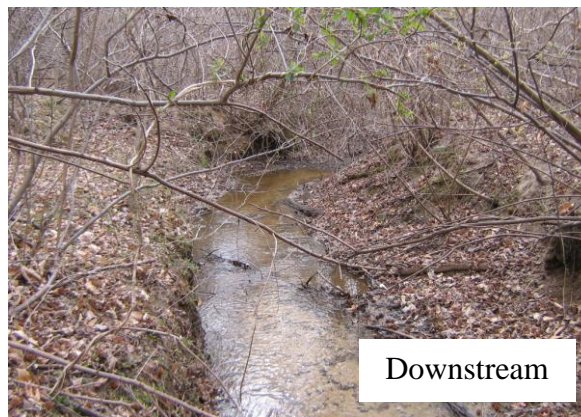
Upstream

- Biological condition – "Fair"
- Habitat scores "Partially Supporting" and "Partially Degraded"
- Bank stability and vegetative protection scored poorly
- Sample dominated by midges (*Polypedilum*, *Micropsectra*, and *Parametriocnemus*)
- Stream type was identified as an B5c, slope was 0.413 percent, and the median channel substrate was fine to medium sand
- Typically, B channels are stable. However, the marginal habitat ratings related to bank conditions indicate that this reach is transitioning to an unstable form.
- Habitat assessment results were mixed for this site, but biological community observed is trending toward less than expected impairment based on the observed habitat quality.

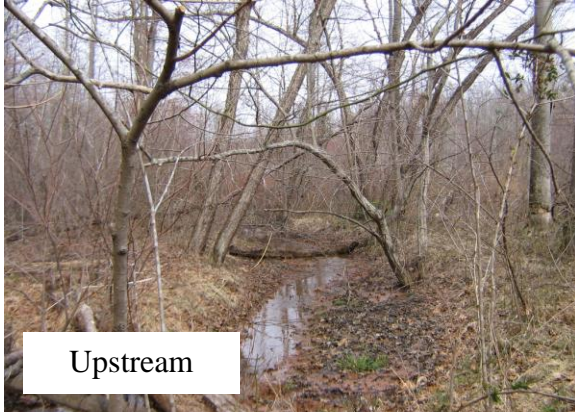
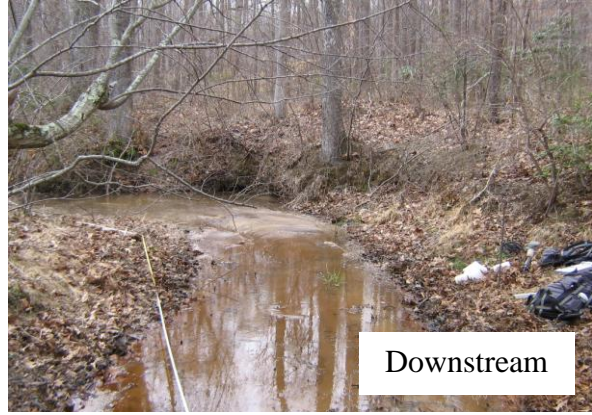
Upstream

- Biological condition – "Poor"
- Habitat scores "Non Supporting" and "Severely Degraded"
- Several habitat variables scored poorly
- Sample lacking mayflies and dominated by worms (unidentified *Tubificidae* and *Ilyodrilus*) and midges (*Orthocladius*)
- Geomorphic assessment was not completed
- Biological community is in better condition than expected for measured level of habitat quality.

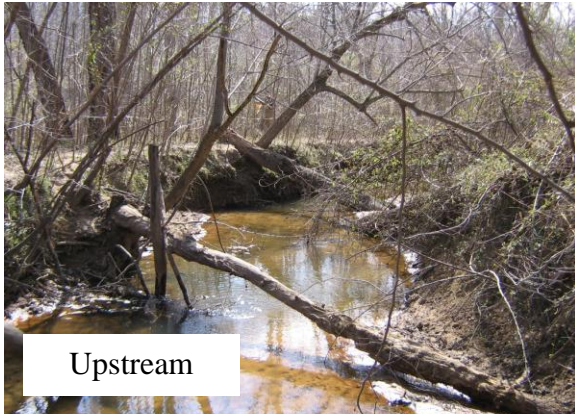
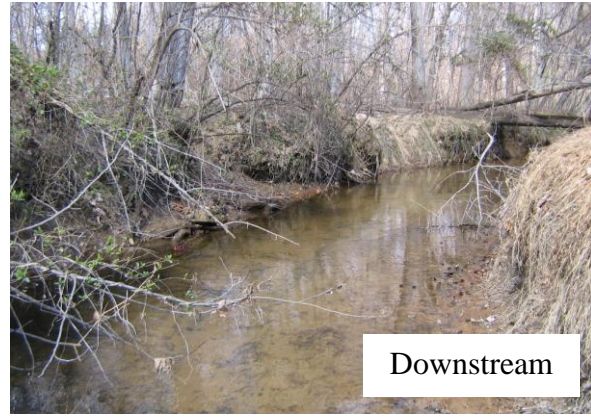
Upstream

- Biological condition – "Fair"
- Habitat scores "Partially Supporting" and "Degraded"
- Riparian zone width scored high but bank variables scored marginally
- Sample dominated by midges (*Tanytarsus* and *Polypedilum*)
- Stream type was identified as an G5c, slope was 0.193 percent, and the median channel substrate was very fine sand
- Typically, G channels are not stable and this reach shows marginal habitat ratings for variables related to banks and substrates.
- Biological community is in better condition than expected for measured level of habitat quality.

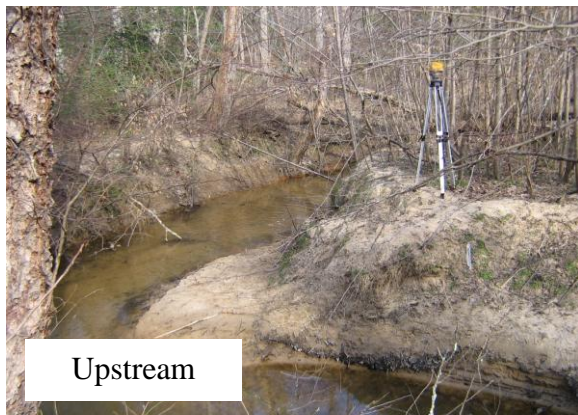
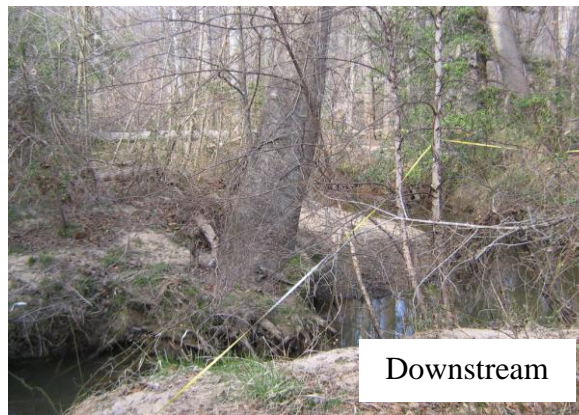
Upstream

- Biological condition – "Fair"
- Habitat scores "Supporting" and "Partially Degraded"
- Bank stability and vegetative protection scored marginally
- Sample dominated by midges (*Tanytarsus*)
- Stream type was identified as an G5c, slope was 0.139 percent, and the median channel substrate was fine sand
- Typically, G channels are not stable and this reach shows marginal habitat ratings for variables related to banks and substrates.
- Biological community is appropriate for observed habitat quality.

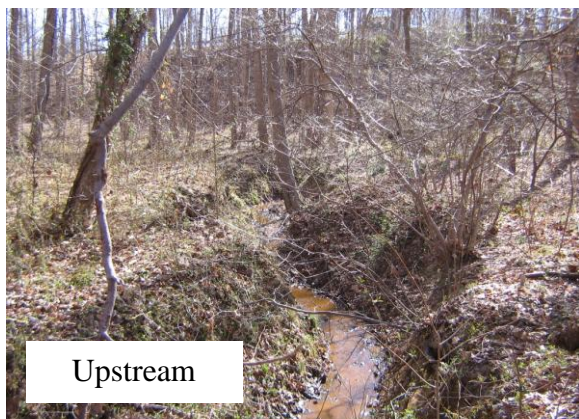
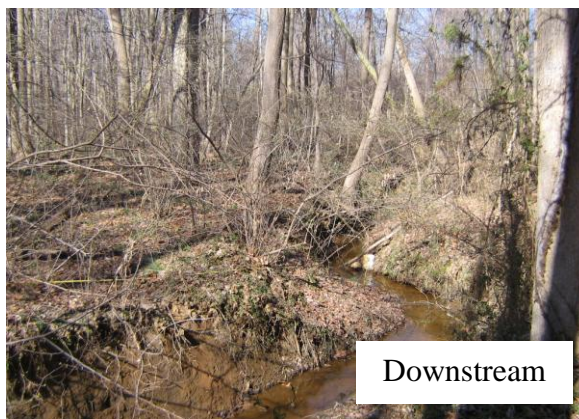
Upstream

- Biological condition – "Poor"
- Habitat score "Non Supporting" and "Partially Degraded."
- Riparian vegetation and physical complexity of habitat scored high
- Sample dominated by amphipods (*Gammarus*) and midges (*Diplocladius*, *Polypedilum*, and *Orthocladius/Cricotopus*)
- Stream type was identified as an G5c, slope was 0.76 percent, and the median channel substrate was very fine sand
- Typically, G channels are not stable and this reach shows marginal habitat ratings for variables related to banks and substrates.
- Habitat conditions are mixed for this site, with one assessment method indicating impairment and one indicating some kind of enrichment.

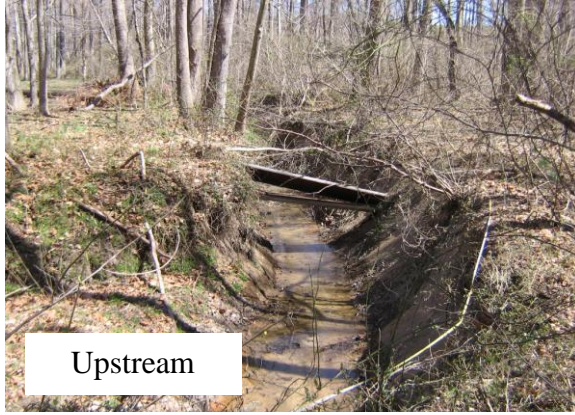
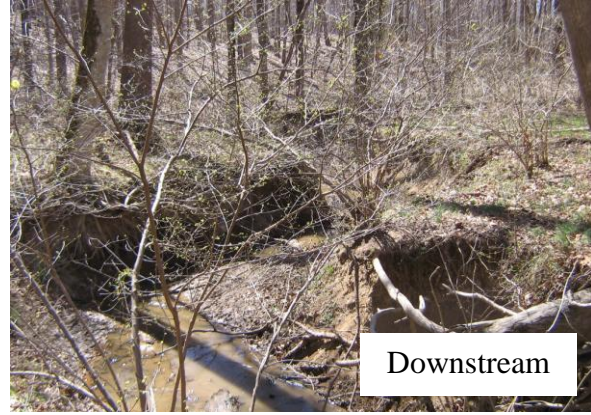
Upstream

- Biological condition – "Very Poor"
- Habitat scores "Non Supporting" and "Degraded"
- Several habitat variables, including bank stability and vegetative protection scored poorly
- Dissolved oxygen concentration very low
- Sample dominated by midges (*Orthocladius/Cricotopus*)
- Stream type was identified as an G5c, slope was 0.347 percent, and the median channel substrate was very fine sand
- Typically, G channels are not stable and this reach shows poor or marginal habitat ratings for variables related to banks and substrates.
- Habitat assessment results were mixed for this site, but biological community observed is trending toward more than expected impairment based on the observed habitat quality.
