Targeted Biological Assessment of Streams in Patapsco Tidal and Bodkin Creek Watersheds, Anne Arundel County, Maryland: 2009

Versar, Inc.
9200 Rumsey Road, Suite 100
Columbia, MD 21045

Anne Arundel County
Department of Public Works
Watershed, Ecosystem, and Restoration Services
2662 Riva Road
Annapolis, MD 21401

October 2009

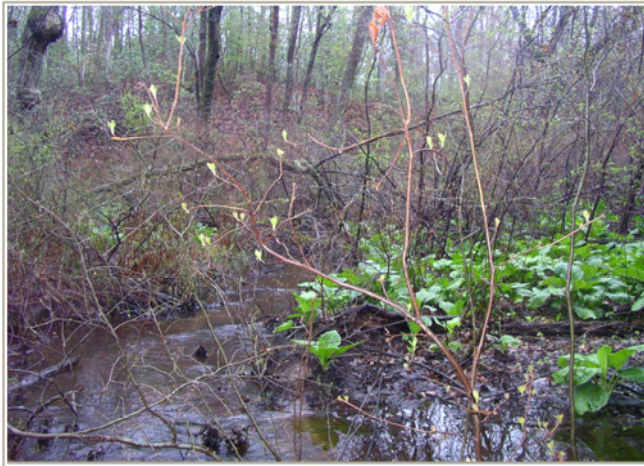
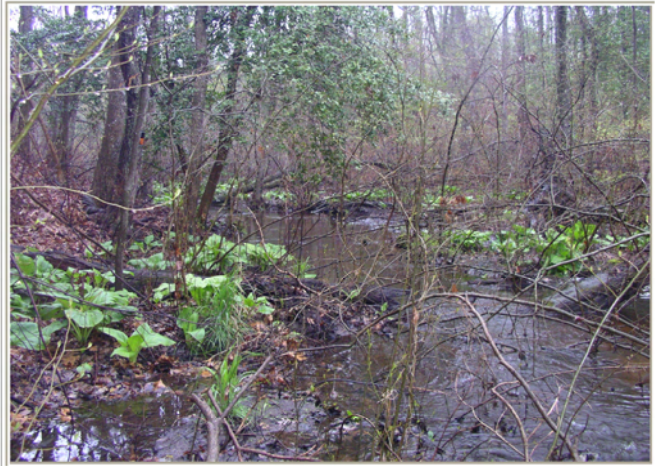
Location = Loreen Drive at Silver Run Drive

This site is located at Loreen Drive at Silver Run Drive in the Bodkin Creek watershed in the Main Creek subwatershed. The area surrounding the stream was very marshy and organic deposits and skunk cabbage were present in large quantities. Streambanks were mainly stable and vegetative protection and riparian widths were good. Fifty-nine percent of the catchment draining to this site has residential landuse, while 33% is wooded. Impervious surfaces make up 17.4% of the catchment acreage. In situ pH was 6.33 at this site, notable since it was slightly below the state water quality standard of 6.5. This site had Partially Degraded habitat conditions according to the PHI and rated Supporting under the RBP. This site tied with two other sites in having the largest number of benthic taxa collected during sampling – 42. Benthic metric scores were high for this large number of taxa as well as for a healthy number of scraper taxa. The biological condition at this site was Fair with a BIBI score of 3.57.

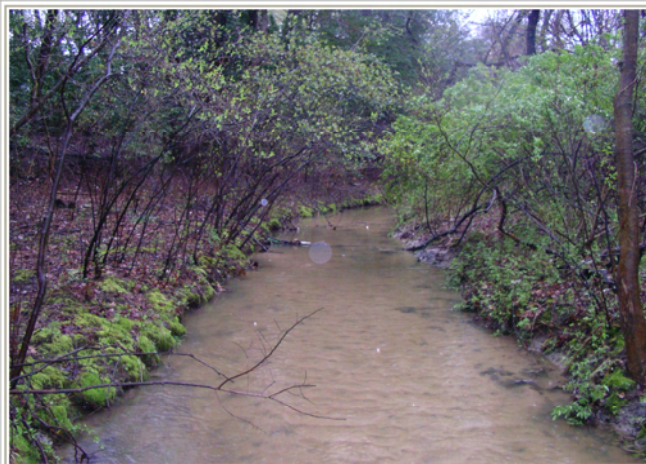
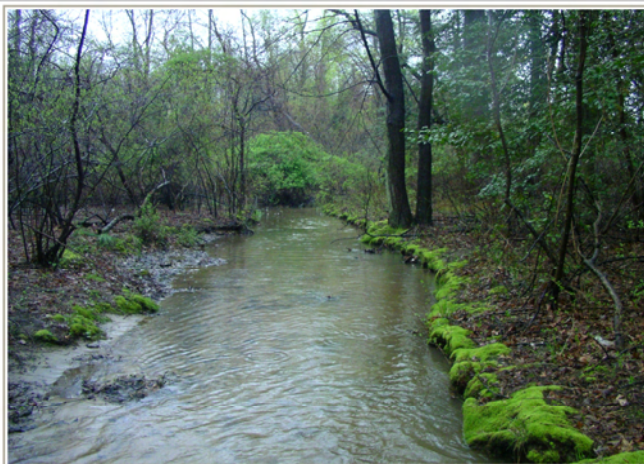
Location = Ventner Drive at Bodkin Elementary School

This site is in Wharf Creek in the Bodkin Creek watershed. The site is located at Bodkin Elementary School at Ventner Drive. Landuse near this site was 41% commercial, 24% wooded, and 23% open space. Impervious surfaces made up 28.3% of the catchment. Moderate levels of trash were present at the time of sampling. Stream substrate was completely sand, and embeddedness was high. Consequently, epifaunal substrate and available cover received a marginal rating. In situ pH was measured as 6.35, slightly below the state water quality standard of 6.5. Habitat rating scores were moderate, resulting in a PHI rating of Partially Degraded and an RBP habitat rating of Supporting. However, the benthic community is Very Poor, with a BIBI score of 1.86. The benthic community consisted of only 1 EPT taxa and only 8% of the macroinvertebrates obtained in the sample are considered intolerant to urban conditions.

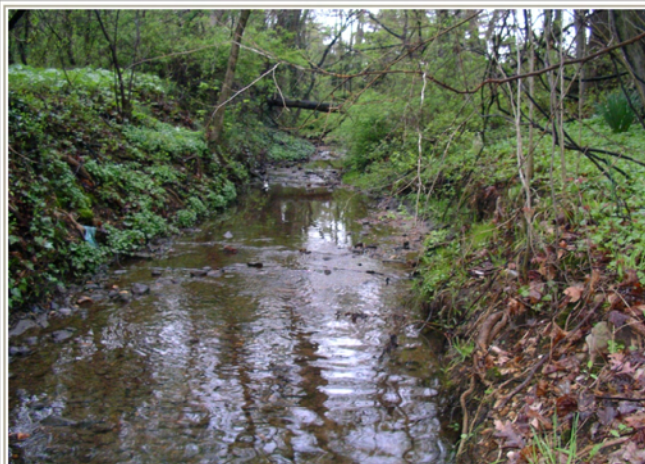
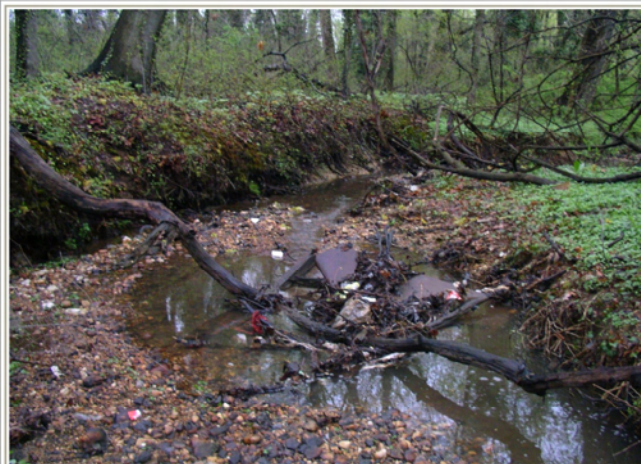
Location = Cedar Hill Cemetery, off of Cedar Hill Lane

This site is located in Cabin Branch Creek 2, in the Patapsco Tidal watershed. The stream site is southeast of the central loop of Cedar Hill Cemetery off of Cedar Hill Lane. Landuse upstream of this site is dominated by residential (57%) and open space (30%), with fairly high levels of impervious surfaces (42% of all surfaces). Embeddedness was low at this site, and epifaunal substrate rated as Suboptimal. The stream was fairly straight, and composed mainly of runs with a few riffles. Its substrate was made up of similar amounts of cobble, gravel, sand, and silt. RBP habitat rated Supporting (73% comparable to reference, total score of 146), while the PHI score was 79.4, or Partially Degraded. Benthos at this site rated Very Poor, with a BIBI score of 1.57. No Ephemeroptera or scraper taxa were present at this site, and none of the macroinvertebrates obtained in the benthic sample were considered intolerant of urban conditions.

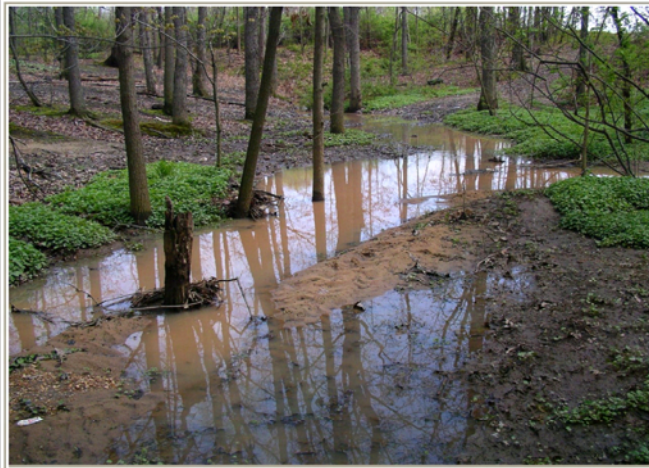
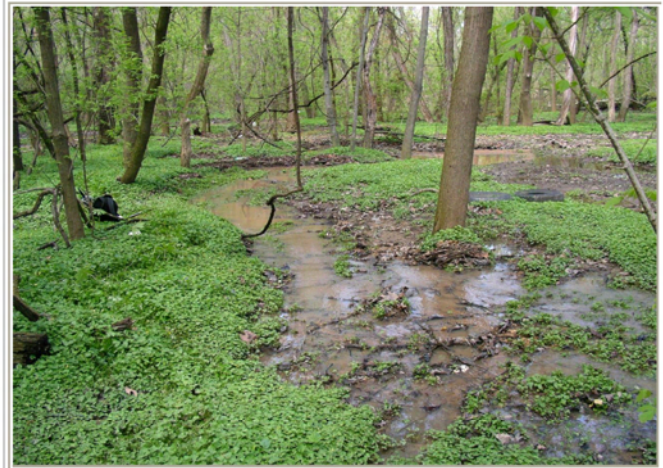
Location = West of undeveloped portion of Arundel Boulevard

This braided stream site is located to the west of the undeveloped portion of Arundel Boulevard. It is in Cabin Branch Creek 2, part of the Patapsco Tidal watershed. Landuse above this site is 52% residential, with some open space (22%) and wooded areas (19%). While bank erosion at this site was very minimal, the stream is highly embedded and substrate for benthos is marginal. The benthic community at this site rated Poor, with a BIBI score of 2.71. Scrapers and climbers were found in healthy numbers at this site, but no EPT taxa were present in the benthic sample, nor were there many macroinvertebrates intolerant of degraded urban condition. ATV tracks near the site indicate activity that may be contributing to less than optimal habitat conditions. The stream rated Partially Degraded under the PHI (total score of 74.7), and Partially Supporting under the RBP habitat with a total score of 121 (60.5% comparable to reference). Channel substrate was dominated by sand with some silt, and in situ water quality parameters were within the normal range.

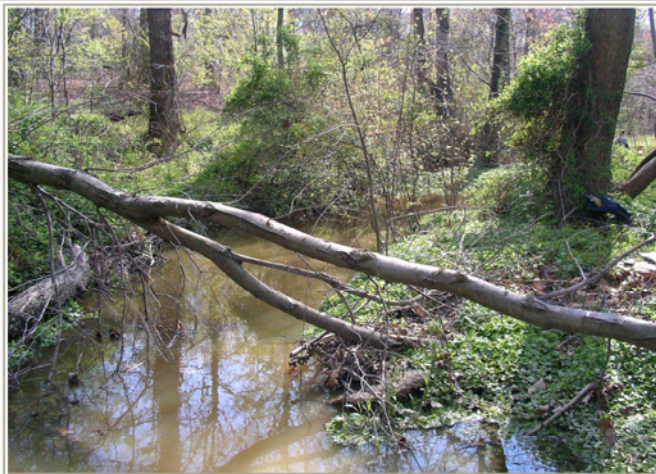
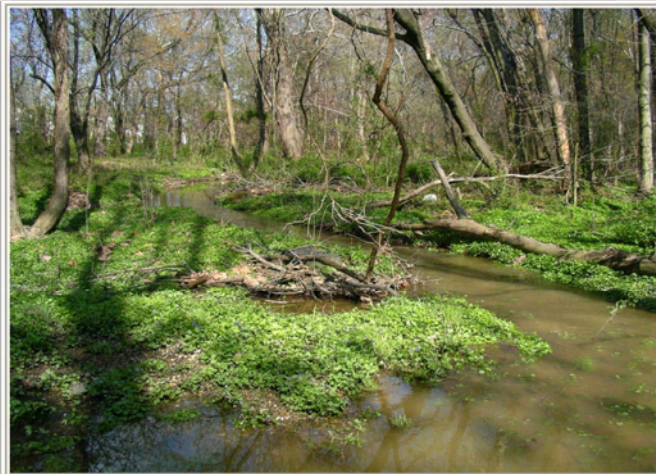
Location = Meadow Road

This Cabin Branch Creek site in the Patapsco Tidal watershed is located at the southeast corner of Meadow Road. A variety of landuses exist in the catchment surrounding this site, but the most prevalent landuse is residential (approximately 41%). Along with the residential landuse, commercial, industrial, transportation, and utility landuses contribute to the 43% impervious surfaces in this catchment. Open space (16.6%) and wooded landuses (11.3%) are also present. In situ pH measured at this site was 6.13, slightly below the state water quality minimum standard of 6.50. Other water quality parameters were within normal ranges. Very little trash was present at the site. Embeddedness was very high, while bank erosion was minimal. Under the PHI, this site received a score of 66.4 (Partially Degraded). Total RBP habitat score was 127 (Supporting). Despite a fairly moderate habitat, as evaluated under both the PHI and RBP assessments, the benthic community at this site is in Very Poor condition according to the BIBI (BIBI score of 1.86). Only 8 kinds of taxa were found at this site, and no EPT nor pollution-intolerant taxa were found.

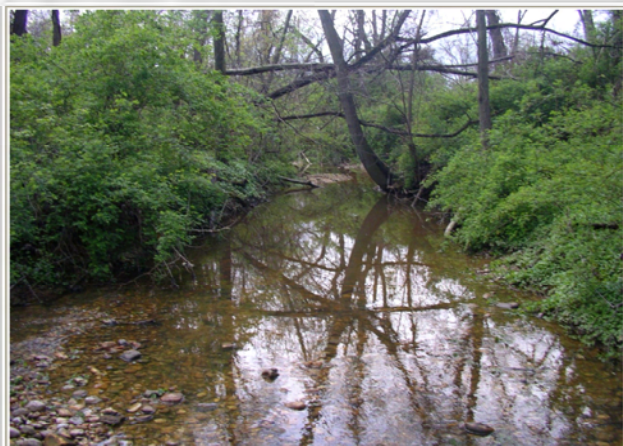
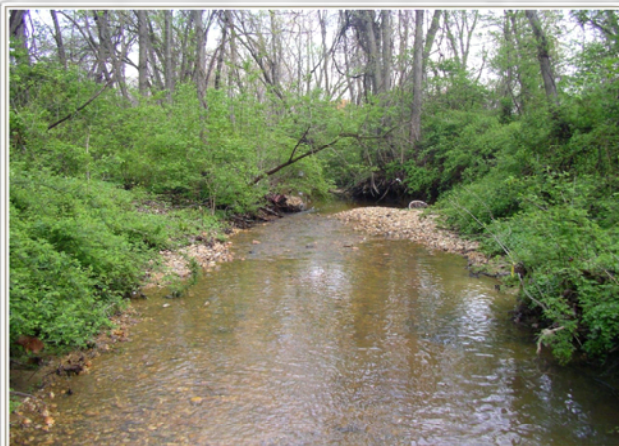
Location = Behind Beltway Crossing Shopping Center

Located in the west corner of the Beltway Crossing Shopping Center, this Cabin Branch Creek site is part of the Patapsco Tidal watershed. There are a wide variety of landuses in the surrounding catchment, including residential (46%), wooded areas (18.5%), and smaller percentages of open space, transportation, commercial, industrial, airport, utility, and water landuses. Thirty-eight percent of the catchment is impervious. All water quality parameters measured at this site fell within normal ranges. Moderate amounts of bank erosion were noted by field staff at this site, with the right bank having the poorest bank stability. A moderate amount of trash was present at the time of sampling. Both epifaunal substrate and pool substrate received optimal ratings. Channel substrate was dominated by gravel (60%) with some cobble and sand (20% of each). The total RBP habitat assessment score at this site was 152. Comparable to Reference, while the PHI rated the site as Partially Degraded, with a score of 71. None of the benthic macroinvertebrates obtained through benthic sampling at this site were considered intolerant to urban conditions, and only 1 EPT taxon was present in the sample. Thus, even with some good substrate for biota, high quality macroinvertebrates are not occupying this site. The overall BIBI score was 2.14, a rating of Poor.

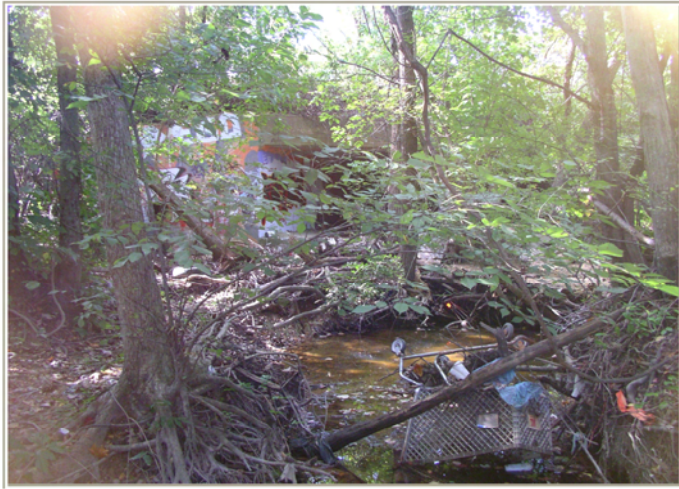
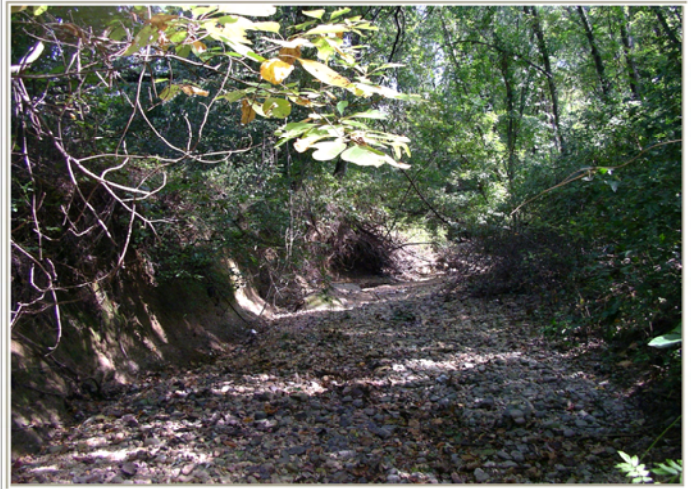
Location = Behind Beltway Crossing Shopping Center

This is a replicate sample for site PT3-947-T-2009. Please note that the photos were taken during a return visit in August 2009. At that time, both the original and duplicate stream reaches were dry. Photos attached do not indicate the condition of stream at the time of benthic sampling.

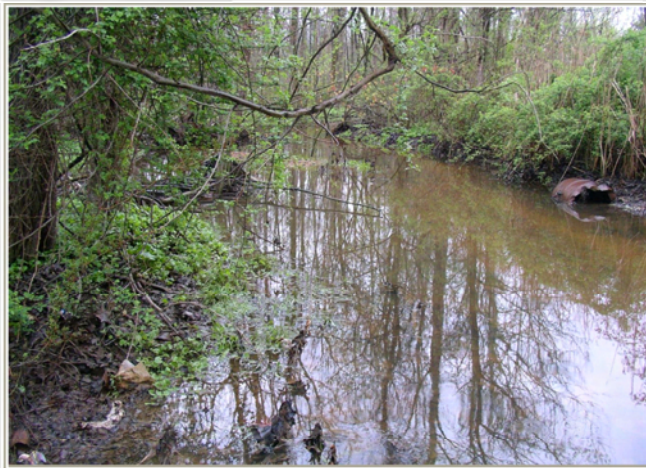
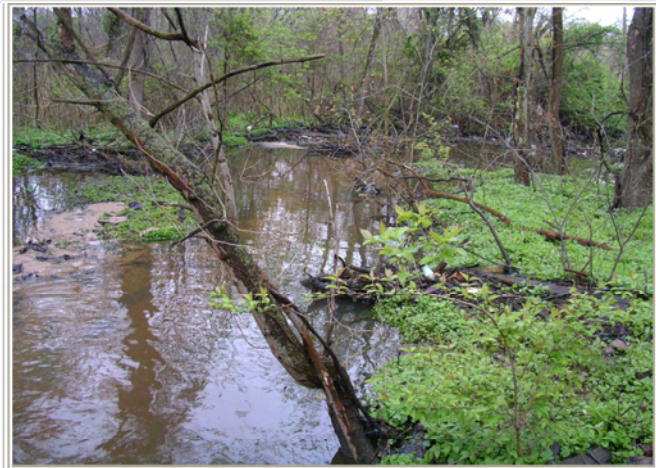
Location = Snow Hill Lane

This braided Cabin Branch Creek site in the Patapsco Tidal watershed can be accessed from the left side of a trail that crosses Snow Hill Lane, and then cutting southeast into the woods. The dominant landuses in the catchment surrounding this site are residential (41%) and wooded (24%), but many other types of landuse are present, including open space, transportation, commercial, industrial, airport, utility, and water landuses. Just over one-third of the catchment area is impervious surface. The field crew noted a large amount of trash present at the time of sampling. Both epifaunal substrate and pool substrate variability received marginal ratings, and sediment deposition was poor. Silt and sand dominated the channel substrate (95% of channel substrate materials when combined). Overall, the total RBP habitat score was 105 (Partially Supporting), one of the lowest scores of all sites in this study. The PHI also rated the stream poorly, with an overall score of 57.1 (Degraded), the second lowest PHI score of all sites in the study. The benthic macroinvertebrate community at the site rated Poor, with a BIBI score of 2.43. Despite a wide variety of taxa obtained through sampling (n=28), no EPT taxa were present, and only six percent of the benthos obtained were considered intolerant to urban conditions.

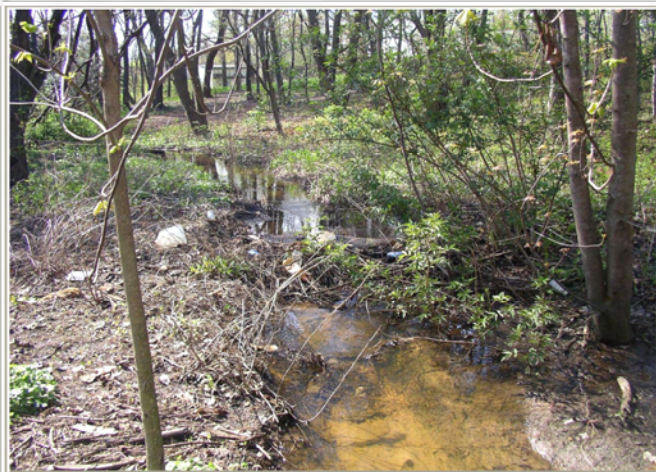
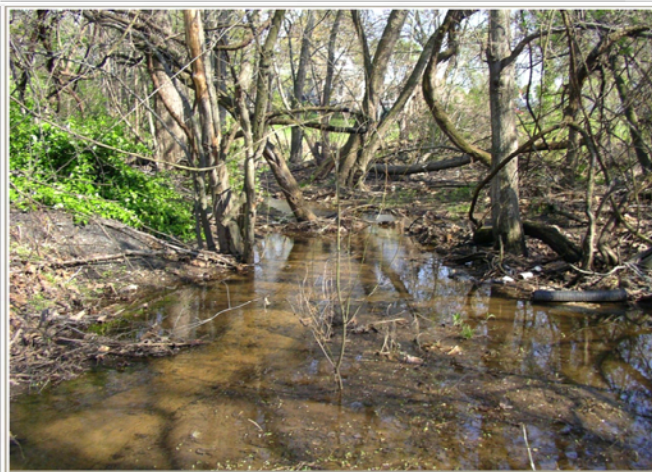
Location = Furnace Branch Road

Just off of Furnace Branch Road, near the north corner of the school parking lot is site PT5-929-T-2009. This is in Furnace Creek in the Patapsco Tidal watershed. The most prevalent landuse in the catchment of this site is residential (63%), with 13% commercial landuse the next most prevalent. These landuses contribute to the 41% imperviousness of the catchment. In situ water quality parameters measured at this site were within acceptable ranges. Significant amounts of trash were noted by the field crew at the time of sampling. The site was approximately 75% embedded, and instream habitat conditions, including epifaunal substrate and pool substrate, were poor to marginal, with very little pool variability and a great amount of sediment deposition. The total RBP score at this site was the lowest of all scores in the study (104, Partially Supporting, 52% Comparable to Reference). The PHI did not rate this site as harshly (PHI = 70.0, Partially Degraded), but did note poor epifaunal substrate, and a lack of instream habitat, including only one piece of instream wood. These poor habitat conditions contribute to the Very Poor benthic community present in this stream (BIBI = 1.57). No EPT taxa were present, and no taxa were considered to be intolerant of urban conditions.

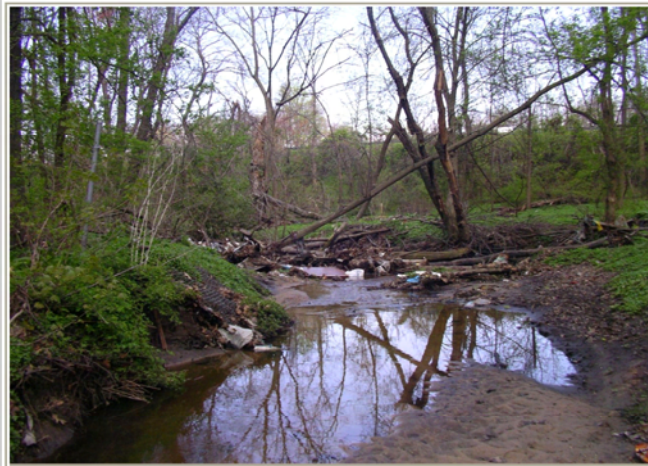
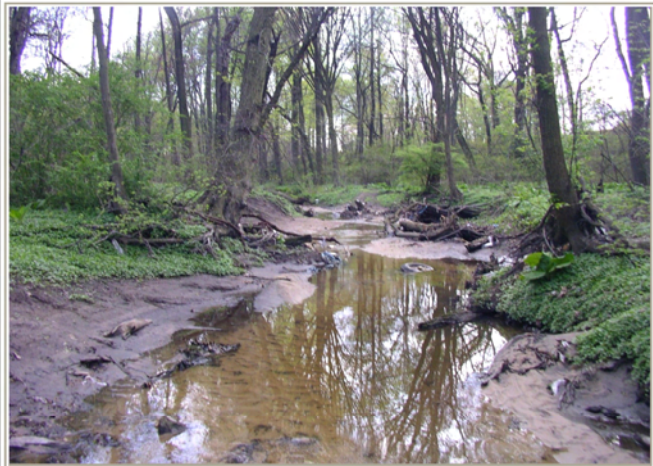
Location = East of Glen Haven Memorial Gardens

This site, located in Furnace Creek in the Patapsco Tidal watershed, has more than 50% impervious catchment area. With 62% residential and 21% commercial landuse, this high percentage of impervious surface is not unusual. This site is just east of the Glen Haven Memorial Gardens. The field crew found in situ water quality parameters to be within acceptable ranges. A minor buffer break (ATV path) was present along the left bank of the stream. Some bank erosion was noted at this site, and approximately 75% of the substrate was embedded. Epifaunal substrate and instream habitat were poor to marginal, and large amounts of trash were found at the site. The PHI rated this site as Degraded, with a score of 60.5, while the RBP habitat assessment was 113, Partially Supporting. A low community diversity was found through benthic sampling (nine taxa), and only one EPT taxon was found. In addition, no benthos considered intolerant to urban conditions were present in the benthic sample. Overall, the BIBI rated this site as Very Poor, with a score of 1.29, the lowest score of all sites sampled in this survey.

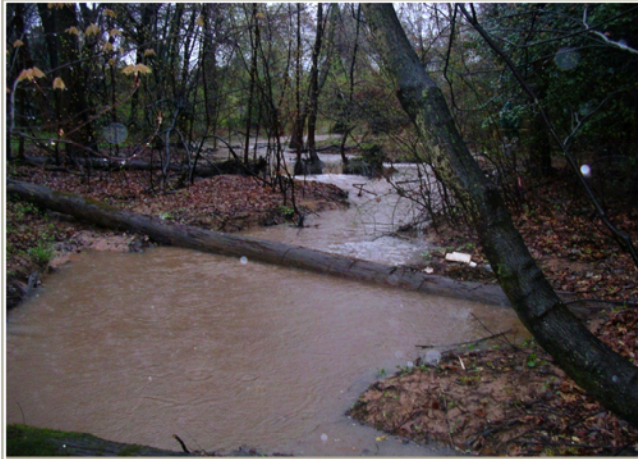
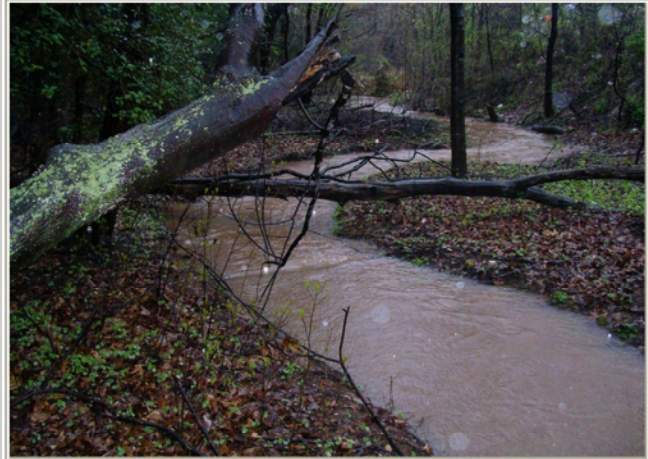
Location = Fort Smallwood Road, behind Jet Blast Companies

This Curtis Creek site is off of Fort Smallwood Road, north of Pillman Road and behind Jet Blast Companies. It is part of the Patapsco Tidal watershed. Wooded areas dominate the landuse of the catchment (57%) with 15% residential and 14% industrial landuses also present. Impervious surfaces account for 23.7% of the catchment area. Sediment fences adjacent to the site were failing at the time of sampling. Channel substrate was composed primarily of sand (80%) with some silt (20%), and most of the sampling reach was long sandy run. Substrate was 100% embedded and the canopy was only 25% shaded. All water quality parameters were within acceptable ranges. The RBP rated this site as Supporting, with a total score of 130. Under the PHI, this site rated Partially Degraded, with a total score of 70.7. No EPT taxa were present in the benthic sample obtained at this site and only 8% of the macroinvertebrates obtained were considered intolerant to urban conditions. Overall, the BIBI rated this site as Poor, with a score of 2.14. Water level was somewhat elevated at time of sampling (it was raining during sampling and had rained within the 24 hours prior to sampling), but site was sampled that day due to limited sampling window.

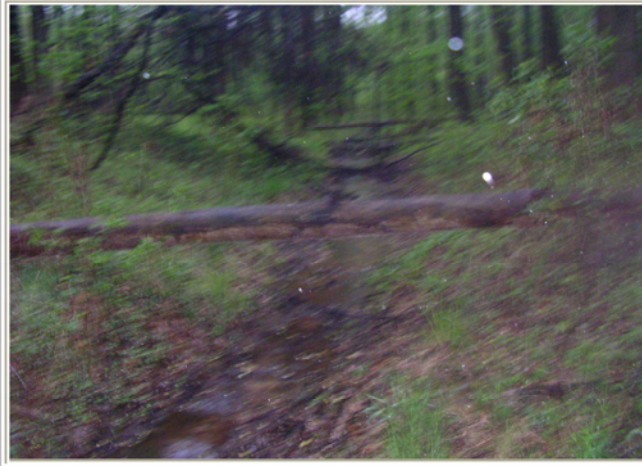
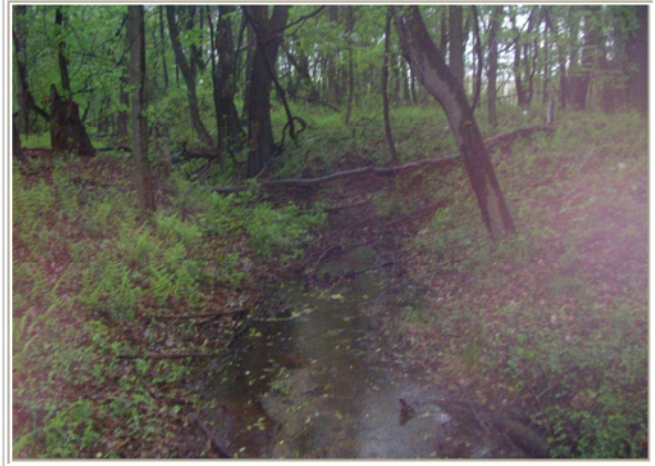
Location = Behind Madison Warehouse property, off of Carbide Road

This Patapsco Tidal site is located in the Curtis Creek subwatershed, in the southwest corner of the Madison Warehouse property, just off of Carbide Road. The dominant landuse near this site is wooded (65%), with some industrial and some transportation landuse. There is no residential landuse in the surrounding catchment. Twenty-two percent of the catchment area is impervious. Channel substrate was 75% sand and 25% silt. Instream habitat, epifaunal substrate, and pool substrate variability rated in the poor to marginal range and sediment deposition levels were also marginal. Channel flow status was also marginal, due to sediment deposition. This site received a Partially Supporting rating under the RBP habitat assessment (score of 117), and a Minimally Degraded rating under the PHI. A large variety of macroinvertebrate taxa were obtained through benthic sampling (n=26), with only two EPT taxa present in the sample. The overall BIBI score was 2.71, Poor.

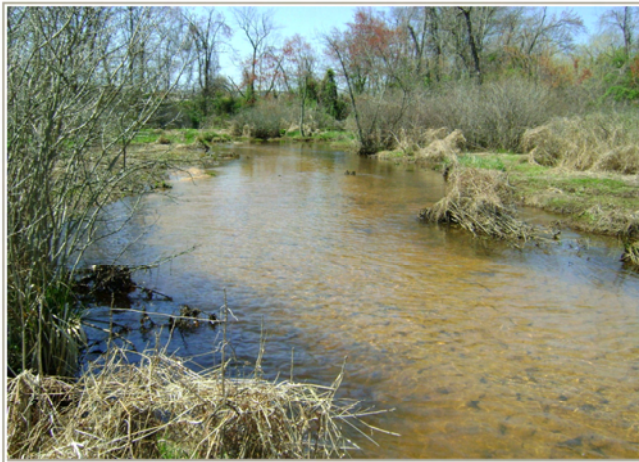
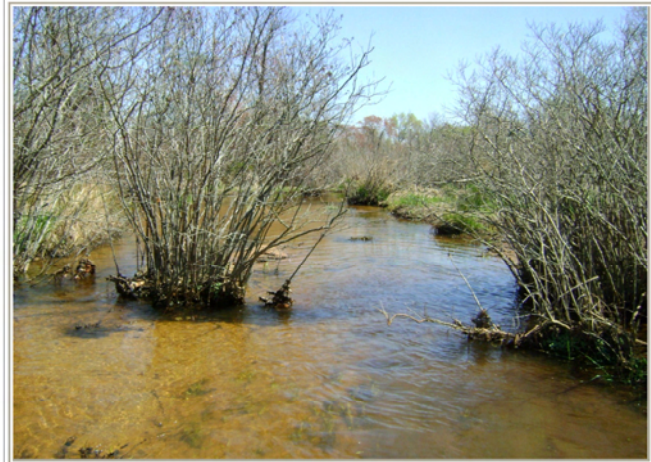
Location = Virginia Avenue and Maple Lane

A wide variety of landuses are present in the catchment surrounding this site, which is located in Sawmill Creek 1 in the Patapsco Tidal watershed. The site can be accessed at the intersection of Virginia Avenue and Maple Lane. No one landuse is particularly dominant, but wooded areas, open space, and residential landuse all contribute between 22 and 27%. Airport land is nearly 10% of the catchment area, and smaller amounts of transportation and industrial lands are present as well. Just under 30% of the catchment is made up of impervious surface. All in situ water quality parameters fell within acceptable limits according to Maryland water quality standards. Streambanks at this site were not eroded, and instream habitat was good. Channel substrate was a mix of sand and silt, and 85% of the reach length was made up of runs, with the remaining 15% riffles. This site received the highest RBP habitat assessment score of all sites included in the study (169, Comparable to Reference). However, under the PHI, this site was rated Degraded with a score of 61.1. One factor negatively affecting the PHI was the paltry 5% canopy shading present at the site. The benthic community at this site was not very diverse (only 9 kinds of taxa were found in the benthic sample), and no EPT nor scraper taxa were included in the sample. In addition none of the benthic macroinvertebrates were considered intolerant of urban conditions. Thus, the BIBI rating for this site was Very Poor, with a score of 1.29.

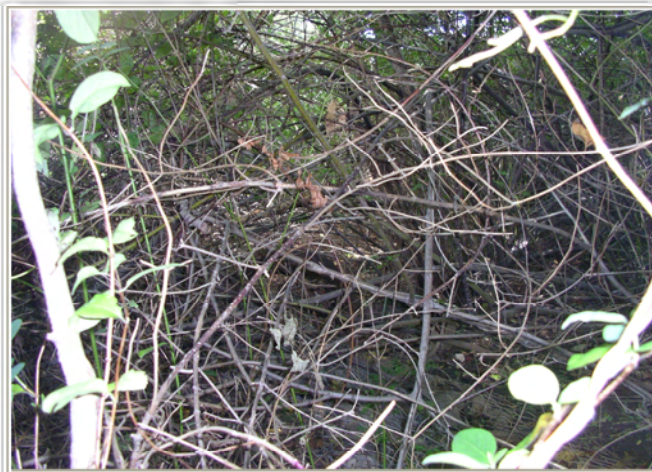
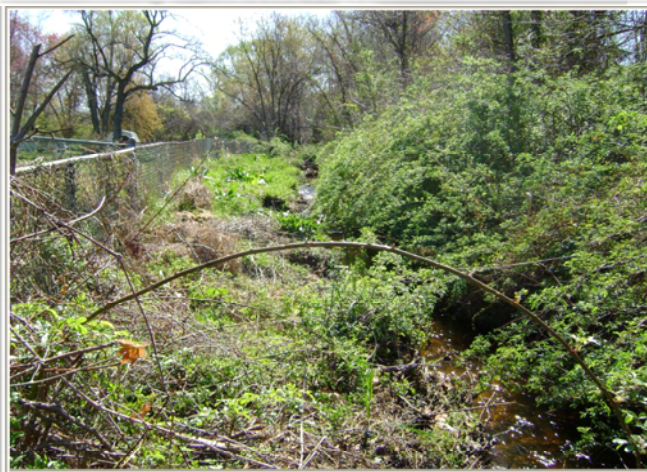
Location = Longwood Avenue, between Hopkins Street
and Idlewood Street

This site is located in Sawmill Creek 1 in the Patapsco Tidal watershed. It is on the south side of Longwood Avenue, between Hopkins and Idlewood Streets. Thirty-two percent of the landuse surrounding this site is related to the BWI airport, and 51% of the catchment acreage is impervious. In situ water quality parameters were all within acceptable ranges. Despite its close proximity to the BWI airport, the benthic macroinvertebrate community at this site scored in the Fair range, with a BIBI of 3.00. Twenty-two different taxa were found, including three EPT taxa and two scrapers. However, only 2% of the sample consisted of macroinvertebrates considered intolerant of urban conditions. According to the landowner, the county had done dredging work there approximately ten years ago and installed chainlink fence and chicken wire throughout the site. An old metal fence is embedded into the streambed along almost the entire length of reach, which made benthic sampling somewhat difficult. Streambanks along both sides of the stream had minimal levels of erosion and only 25% of the canopy was shaded. Epifaunal substrate and pool substrate variability were rated in the lower end of Suboptimal, and sediment deposition was marginal. Along the left bank of the stream, the riparian zone was rated Poor. The total RBP score was 117 (Partially Supporting) while the PHI rating was Degraded (score of 64.9).

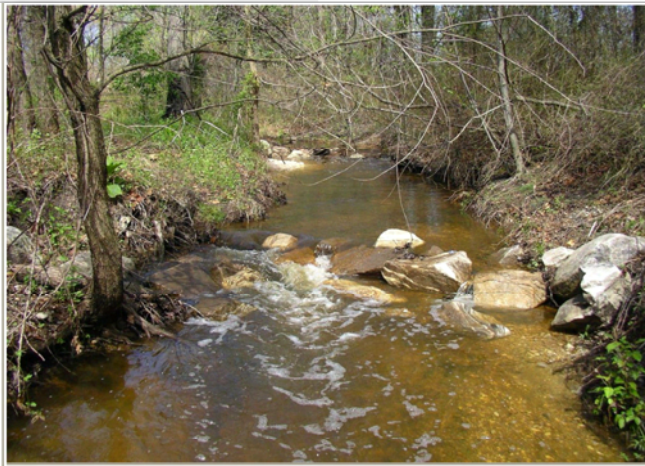
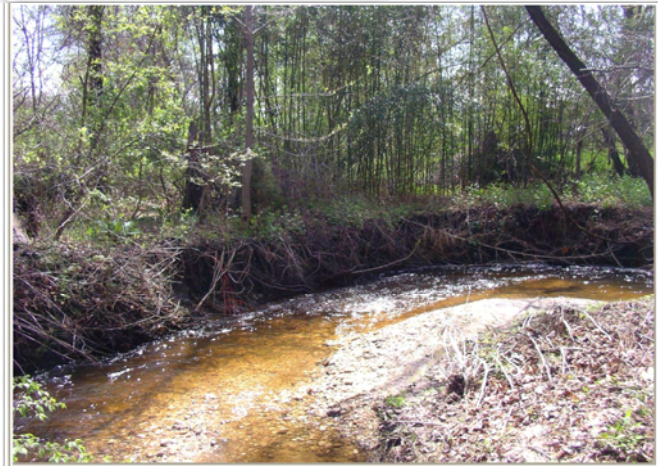
Location = Aviation Boulevard

Near the BWI Airport, this site is located on the east side of Aviation Boulevard where the stream crosses the road. It is in Sawmill Creek 1, in the Patapsco Tidal watershed. Fifty percent of the landuse surrounding this site is related to the BWI airport, and 52% of the catchment acreage is impervious. The close proximity of this site to BWI Airport likely influences the quality of the benthic macroinvertebrate community and the habitat at this site. The benthic community received a BIBI score of 1.86 (Very Poor), as the sample lacked any EPT or scraper taxa and no taxa were considered intolerant to urban conditions. While the water had a distinct reddish/orangish color, all water quality parameters measured by the field crew were within acceptable limits according to state water quality standards. Field crew members noted a moderate amount of trash present at the site. Streambanks had some erosion along both sides of the stream, and bank stability was rated marginal along the left bank. Epifaunal substrate and instream habitat were in the optimal to suboptimal range. Embeddedness was 45% and the canopy was 85% shaded. The total RBP score was 135 (Supporting) while the PHI rating was Partially Degraded (score of 76.7).

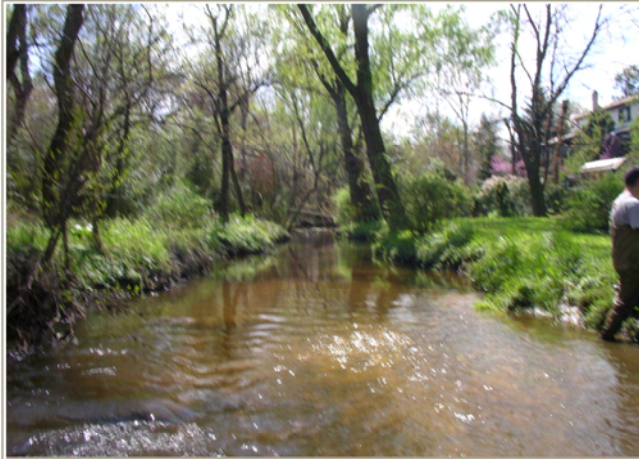
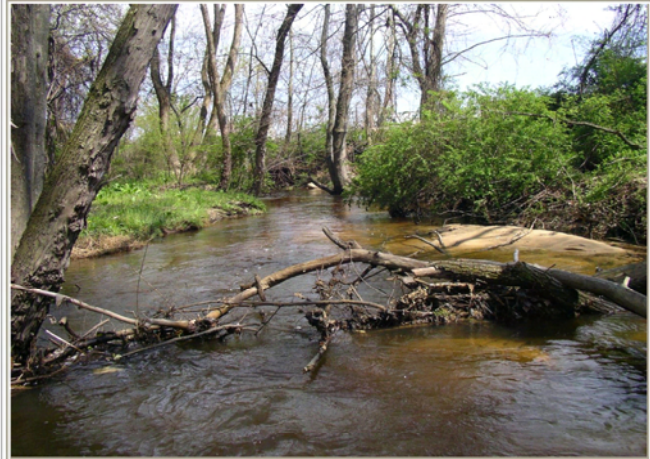
Location = Behind GMC Trucks property on Crain Highway

This site is located behind the GMC Trucks property off of Crain Highway. It is in Sawmill Creek 1 in the Patapsco Tidal watershed. Residential landuse makes up the greatest percentage of landuse in the catchment at 31%, while wooded and open space landuse account for 24 and 19%, respectively. Impervious surface makes up 32.3% of the catchment area. Epifaunal substrate and instream habitat were rated in the suboptimal range at this site, and embeddedness was 50%. The field crew noted a moderate amount of trash nearby, and the left bank lacked adequate vegetative protection along with a narrow riparian vegetative zone. Moderate levels of erosion were noted in the local watershed. Overall, the site received a narrative rating of Partially Degraded under the PHI (score of 70.6) and rated Supporting under the RBP (score of 143, 71.5 % comparable to reference). While a good diversity of taxa were found through benthic macroinvertebrate sampling (n=26), no EPT taxa were present in the sample and only 7.5% of the macroinvertebrates were considered intolerant of urban conditions. A healthy number of scrapers were present, along with some climbers, resulting in a Poor classification by the BIBI (score of 2.43). Some SAV was present.

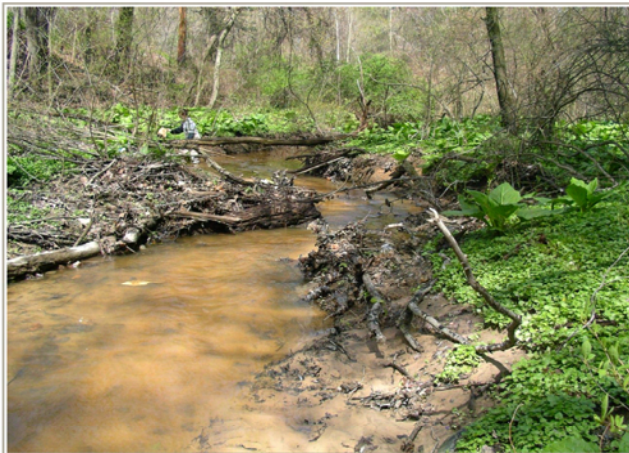
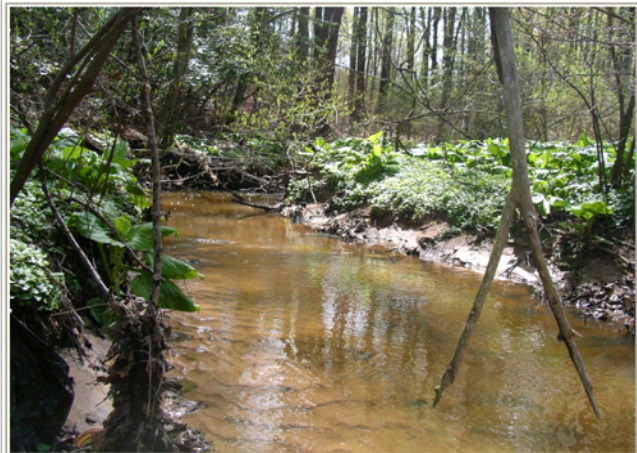
Location = Marley Neck Boulevard, north of Mercr Drive

Residential landuse is the most prevalent landuse in the catchment of site PT8-923-T-2009, accounting for 58% of the catchment area. This site is located in Marley Creek 1, in the Patapsco Tidal watershed. Other landuses present include wooded (24%), commercial (7%), and transportation-related (6%). This site is located on the south side of Marley Neck Boulevard, just north of Mercr Drive. Channel substrate consisted of 80% sand and 20% silt, and the stream was 100% embedded. The field crew noted moderate to heavy amounts of trash and some bank erosion. This site had suboptimal epifaunal substrate, while instream habitat, pool substrate, and pool variability rated marginal. Impervious surfaces account for just under 31% of the catchment area. The total RBP Habitat score was 135 (Supporting), while the PHI score of 78.9 rated the site as Partially Degraded. The benthic community at the site showed signs of degradation, with an overall BIBI score of 1.57 (Very Poor). Benthic macroinvertebrate sampling targeted rootwads and woody debris, which accounted for about half of the benthic habitat present at the site. No sensitive EPT taxa were obtained in the benthic sample, nor were there any scrapers. In addition, less than 5% of the macroinvertebrates present in the benthic sample were considered intolerant of urban conditions.

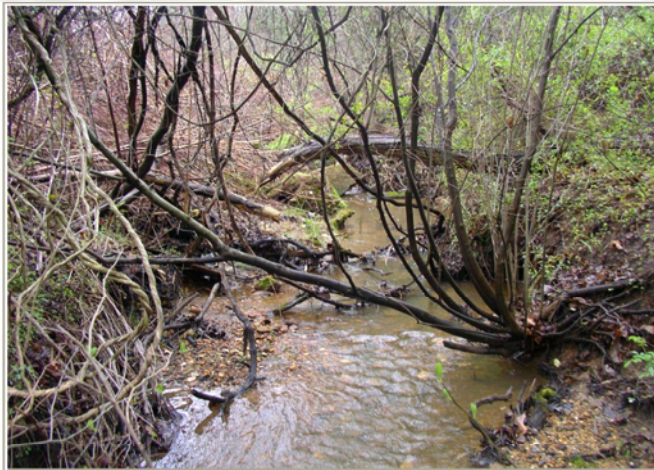
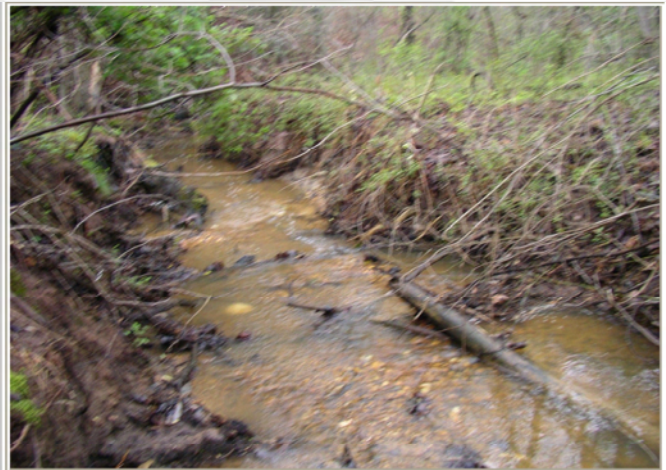
Location = Marley Neck Road

This site in Marley Creek 1 in the Patapsco Tidal watershed had one of the lowest amounts of impervious surface in its catchment of all sites included in this study (4.6%). Much of the landuse surrounding this site is wooded (73%) or open space (16%), and only small amounts of utility (6%), water (2%), and transportation landuses (1.7%) are present. The site is located off of Marley Neck Road, north of a train and automobile junkyard. This junkyard is located just outside the 50-meter riparian area along the right bank of the stream. The proximity of the site just next to the road, along with the nearness of the junkyard resulted in the lowest ratings possible for remoteness and aesthetics (trash). Despite the low amounts of impervious surface, this site is plagued by terrible bank erosion. The field crew rated the entire 75-meter stretch as having extreme bank erosion along the left bank and moderate bank erosion along the right bank. Overall habitat scores were low at this site, with the RBP habitat assessing the site as Partially Supporting (score of 117), and the PHI rating the site as Degraded (score of 55.4, the lowest PHI score in the study). The benthic community also rated as Very Poor, with a BIBI score of 1.86. Community diversity was lacking, as only 7 taxa were present in the benthic sample.

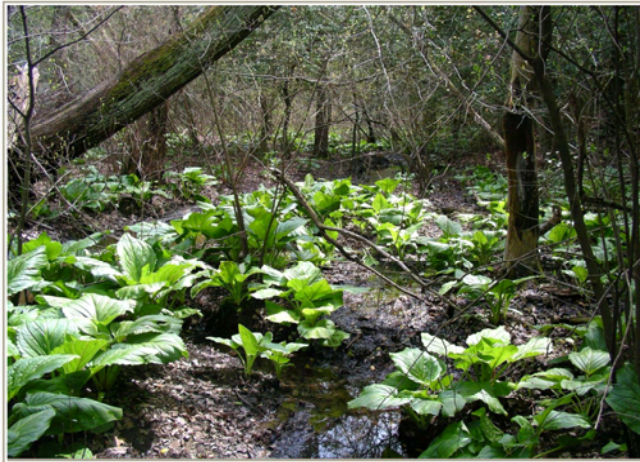
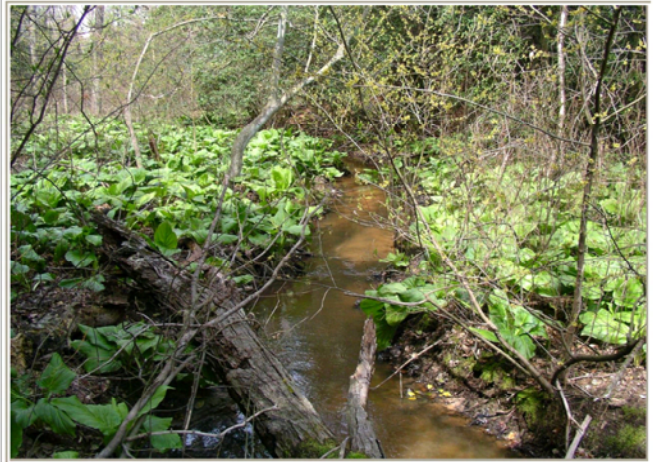
Location = Marley Neck Road at Tanyard Cove Road

This Marley Creek 1 site in the Patapsco Tidal watershed is located on a farm off of Marley Neck Road at Tanyard Cove Road. This stream had stable banks with very little erosion present. No trash was observed at the site by field staff. Much of the length of the stream sampled consisted of long sandy run, with few riffles or pools. Epifaunal substrate and pool substrate were both rated toward the lower end of suboptimal, with most of the channel substrate composed of sand (80%) and some silt (20%). Overall, this site rated as Supporting under the RBP (score of 150, 75% comparable to reference), and as Partially Degraded under the PHI (score of 75.8). The benthic community present at this site received one of the higher BIBI scores of all sites included in this study (BIBI = 3.57, Fair), and had a high amount of diversity (35 taxa present, including 5 EPT taxa). In situ pH levels at this site were 6.33, slightly below the minimum state water quality standard of 6.5.

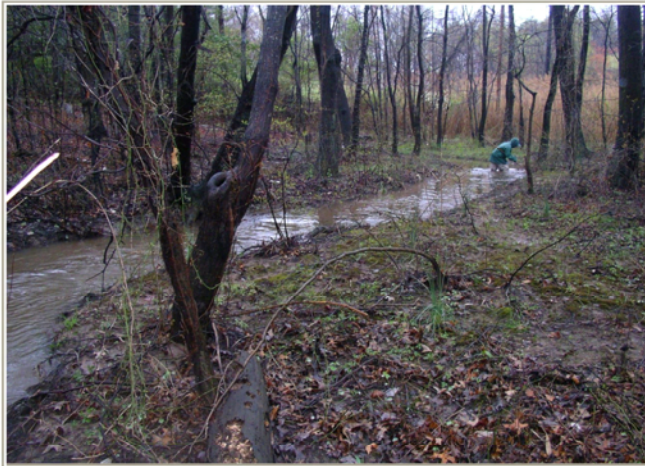
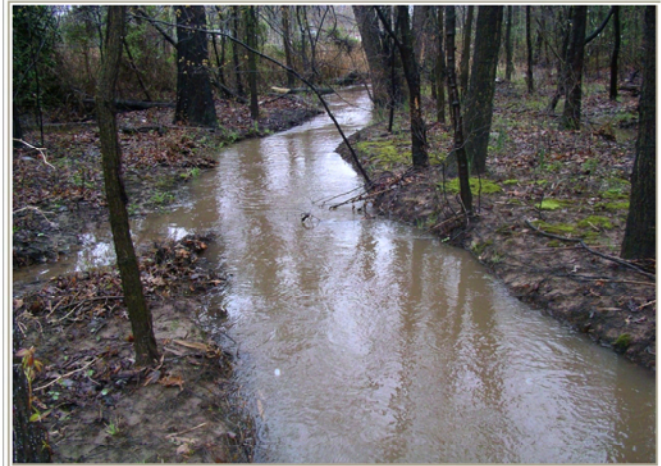
Location = Fort Smallwood Drive, north of Chestnut Cove Drive

Located in the Cox Creek subwatershed of the Patapsco Tidal watershed, this site can be accessed off of Fort Smallwood Drive, north of Chestnut Cove Drive. More than half of the landuse near this site is industrial, with woods (17%) and open space (15%) the next most-prevalent landuses. The surrounding catchment is nearly 47% impervious. The site is located in close proximity to the road, and a moderate amount of trash was present at the time of sampling. A storm drain along the left bank of the stream was present and served as a minor buffer break. Channel substrate was highly embedded and instream habitat, epifaunal substrate, and pool substrate rated in the marginal to suboptimal range. Stream banks were stable with no erosion, while the riparian vegetative width rated at the low end of suboptimal. Under the RBP Habitat Assessment, this site rated Supporting with a total score of 137 (68.5% comparable to reference conditions). Under the PHI, this site received a score of 80.9 (Partially Degraded). A good biological community diversity was present at this site (n=26 taxa), but only one EPT taxa was present and 99% of the benthic sample consisted of macroinvertebrates tolerant of urban conditions. A healthy amount of scraper taxa and climbers were present in the benthic sample, resulting in an overall BIBI score of 2.71, a rating of Poor. Sampling was conducted when water level was slightly elevated (rainy conditions) because of limited sampling window.

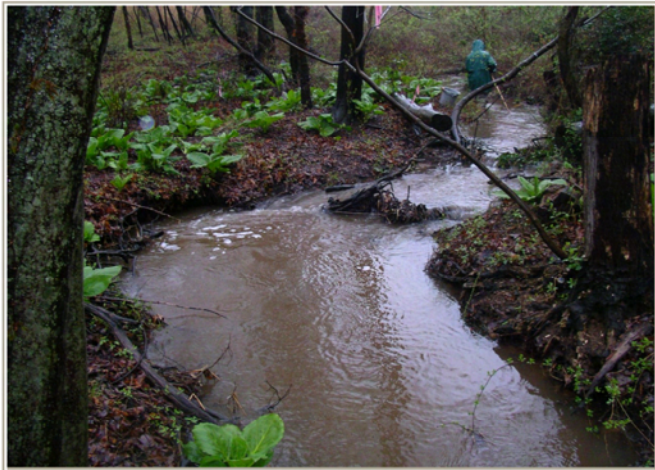
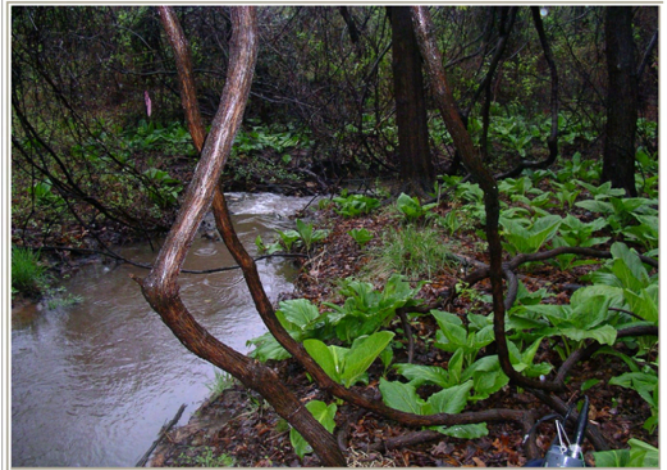
Location = Wagner Station Road, southwest side
treatment plant.

Wooded and industrial landuses each account for approximately one-third of the landuse surrounding site PT9-935-T-2009. No residential landuse is present, and 29% of the catchment of this Cox Creek subwatershed site is impervious. This site is located along the southwestern side of the Cox Creek wastewater treatment plant, just off of Wagner Station Road in the Patapsco Tidal watershed. Some trash was present at the site, as well as an odor of sewage likely resulting from the nearby treatment plant. Benthic community diversity was good, with 36 different taxa present in the benthic sample obtained here. A healthy number of climbers were present, but only two EPT taxa and one scraper taxa were present, resulting in a BIBI score of 2.71, Poor. Habitat conditions assessed under the RBP mainly rated in the suboptimal range, with stable banks with little to no erosion noted. The total RBP habitat score was 152, Comparable to Reference. The PHI also rated habitat conditions well, with a total score of 87, Minimally Degraded.

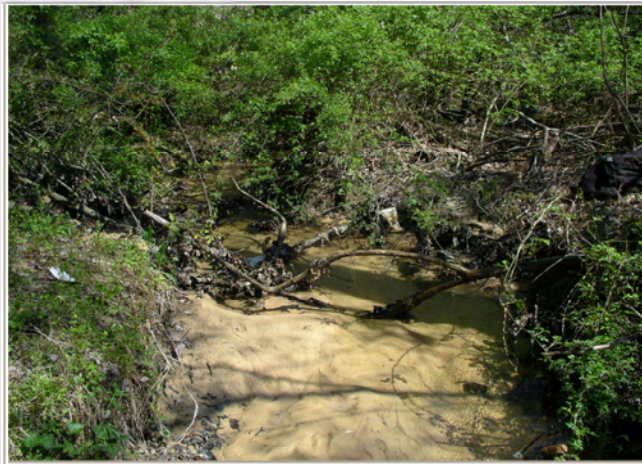
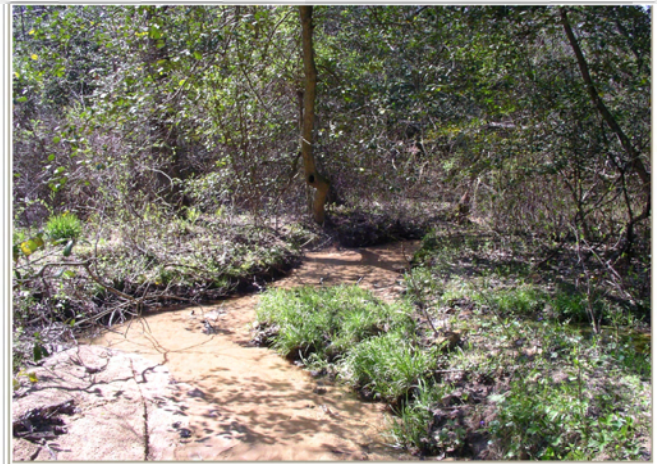
Location = Tower Bridge Drive and Robin Air Court

This site in the Rock Creek subwatershed of the Patapsco Tidal watershed is surrounded by residential landuse in 64% of its catchment. Wooded landuse accounts for 20% of the catchment, and some commercial (8%) and some transportation-related landuse (4%) is also present. Approximately 30% of the catchment draining to this site is impervious surface. This site is located near the intersection of Tower Bridge Drive and Robin Air Court. A sewage line runs along the stream on the right bank and serves as a severe break in the buffer. Sewage odors were strong and field staff thought that sewage could possibly be draining into the stream. In situ pH was 6.24, slightly below the minimum state water quality standard of 6.5. The biological community at this site rated Poor under the BIBI, with a total score of 2.14. Only one pollution-sensitive EPT taxa was present in the benthic sample, and only one scraper taxa. Seventy-five percent of the benthic macroinvertebrates found at this site were considered tolerant of urban conditions. Severe bank erosion was present along some stretches of both streambanks. Epifaunal substrate rated Marginal, and channel substrate consisted mainly of sand (90%) with some silt, and was almost completely embedded. Deposition was severe with sand 30 to 50 cm deep in some places. These less than ideal habitat conditions resulted in a Partially Degraded rating under the PHI and a Partially Supporting rating under the RBP.

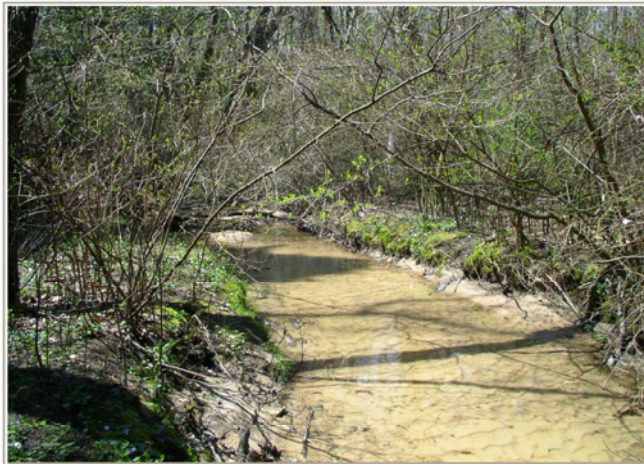
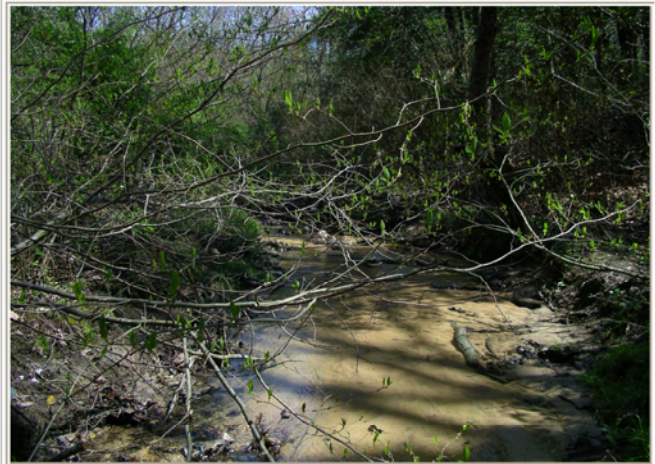
Location = Edwin Raynor Boulevard, north of Countryside Drive

This site is located along the east side of Edwin Raynor Boulevard, north of Countryside Drive. It is in the Rock Creek subwatershed of the Patapsco Tidal watershed. Eighty-three percent of the landuse surrounding this site is residential with some open space present (9.8%). Impervious surface accounts for just under 40% of the catchment area. From the benthic macroinvertebrate sample obtained here, biological community diversity was high, with 24 different taxa present, including three EPT taxa. No scrapers were present, however, and the overall BIBI score was 2.43, Poor. Severe bank erosion affected some stretches of both streambanks, and large amounts of litter were noted by field staff. A large amount of sand was present at this site, both in the form of channel substrate and deposition that affected channel flow status and filled pools. In general, habitat conditions were somewhat degraded, as reflected by a PHI rating of Partially Degraded (score of 77.3) and a RBP rating of Partially Supporting (score of 121). A slightly low pH level was detected at this site, with in situ pH at 6.31, just below the state's minimum water quality standard of 6.5.
