Targeted Biological Assessment of Streams in Patapsco Tidal and Bodkin Creek Watersheds, Anne Arundel County, Maryland: 2009

Versar, Inc.
9200 Rumsey Road, Suite 100
Columbia, MD 21045

Anne Arundel County
Department of Public Works
Watershed, Ecosystem, and Restoration Services
2662 Riva Road
Annapolis, MD 21401

October 2009

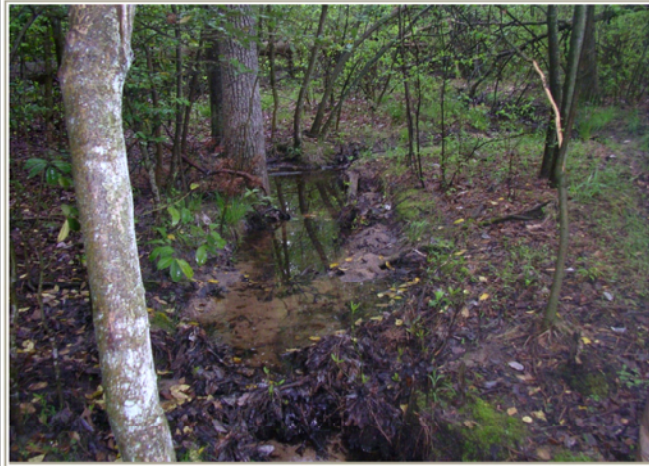
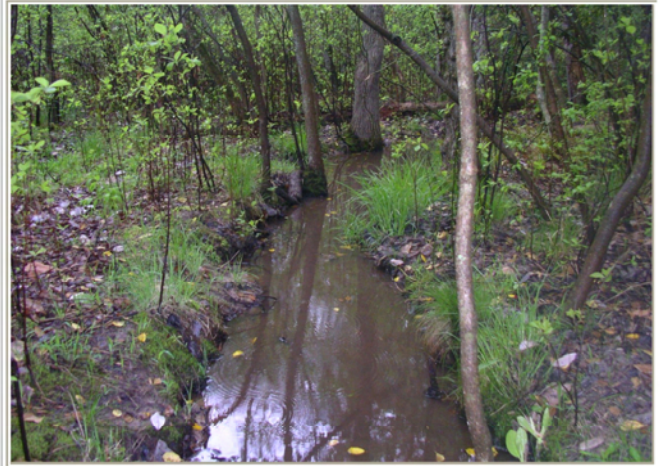
Location = Tar Cove Park, north of golf course

Wooded landuse is dominant around site PTB-918-T-2009, contributing to 60% of the catchment area. Some residential (23%) and some open space (12%) landuses are also present, and overall imperviousness levels are only about 9%. This site is located in Tar Cove Park, north of Compass Point Golf Course. This is part of the Rock Creek subwatershed of the Patapsco Tidal watershed. Overall, the benthic macroinvertebrate community at this site indicates a stream in Poor condition, with a BIBI score of 2.14. The site scored well for the percent of the benthic sample considered intolerant of urban conditions (67%), but moderate community diversity and few EPT and no scraper taxa, as well as few climbers contributed to the Poor rating. Habitat at this site rated Minimally Degraded under the PHI with the highest total PHI score of all sites included in this study (90.6). Bank stability was good with no erosion present and a healthy riparian buffer width. Only small amounts of trash were noted. Epifaunal substrate and pool substrate were in the suboptimal to marginal ranges, and the overall RBP habitat score was 133, Supporting.

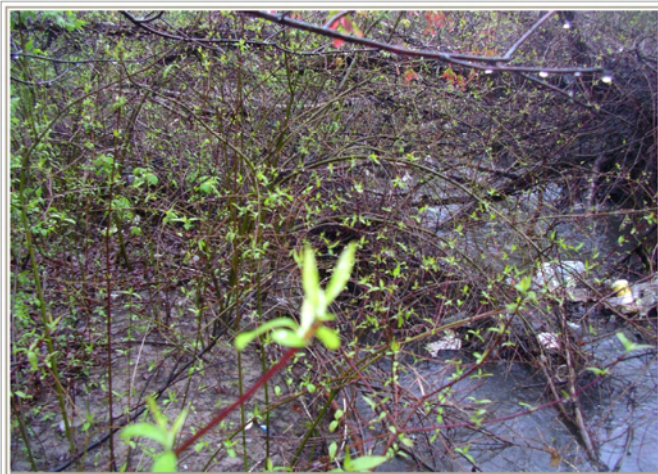
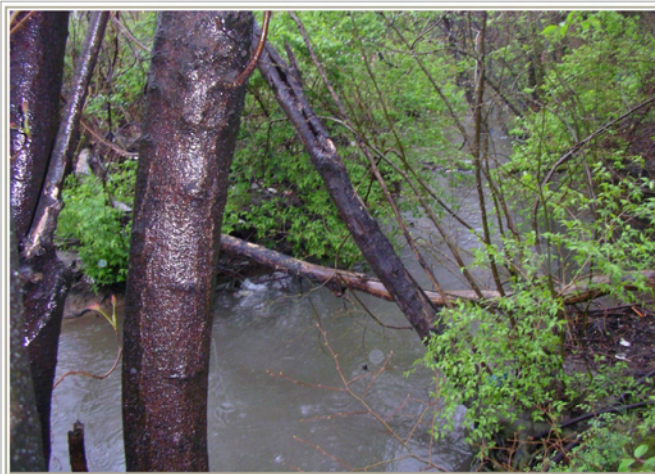
Location = Chesapeake Center Drive at Glen Burnie Mall

The catchment surrounding this site had the greatest percentage of impervious surface (65%) of any site in this study. More than half of the landuse here is commercial, with another 32% residential, and 6.7% transportation-related. Only 6.8% of the surrounding landuse is wooded. This site is part of the Back Creek subwatershed in the Patapsco Tidal watershed. It is located off of Chesapeake Center Drive at the Centre at Glen Burnie shopping center, and it was littered with large amounts of trash when the field crew visited. In addition, in situ pH values at this site were 8.68, a bit above the state's maximum water quality standard of 8.5. The benthic community at this site scored among the lowest of all sites included in this survey (BIBI score of 1.57, Very Poor), which was not surprising, given the prevalence of impervious cover and the site's proximity to a large retail area. There were very few macroinvertebrates living in this stream, and only 4 taxa were present in the benthic sample, none of which were EPT taxa nor any taxa considered intolerant of urban conditions. Some bank erosion affected portions of both banks, and the riparian buffer zone width rated at the low end of suboptimal. Instream habitat, epifaunal substrate, and pool substrate showed signs of degradation, and the site rated as Partially Degraded under the PHI with a score of 68.1. Under the RBP, this site rated Supporting with a total score of 126.

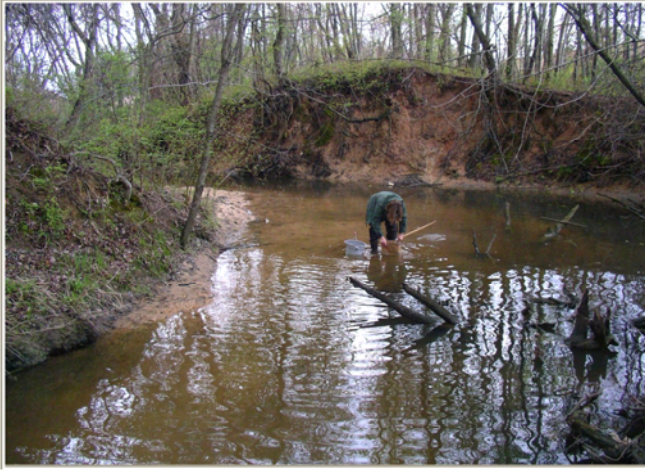
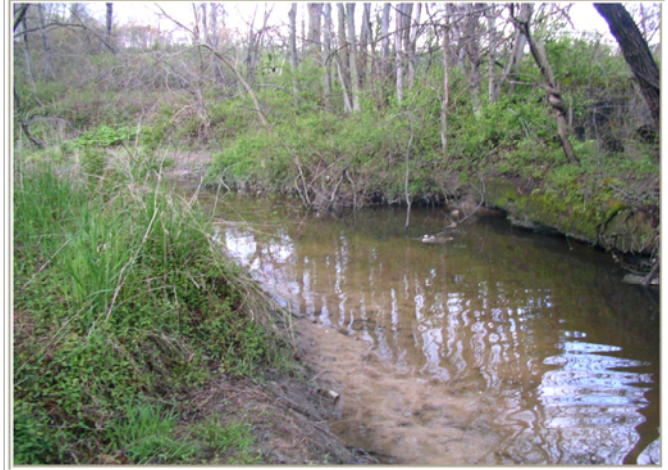
Location = McLean Way, at the Bay Meadow Industrial Park

This Patapsco Tidal watershed site is located in the Back Creek subwatershed off McLean Way, at the Bay Meadow Industrial Park. Commercial landuse is the most prevalent in the surrounding catchment (36%), but a mixture of other landuses also contribute, including residential (21%), wooded (15%), and open space, industrial, and transportation (each approximately 9% of catchment area). This results in a fairly high amount of impervious surface (52% of the surrounding catchment). Likely a result of degradation associated with this urbanized area, the benthic community at this site received an overall rating of Very Poor, with a BIBI score of 1.86. Benthos exhibited a moderate community diversity, with EPT and scraper taxa lacking, and only one macroinvertebrate considered intolerant of urban conditions. The sampled reach contained no riffles, and very little instream wood, thus benthic habitat was lacking. Bank erosion affected both streambanks, and sand dominated the substrate material. Some SAV was present at the site. Under the PHI, habitat rated Degraded with a score of 61.4. Under the RBP, habitat rated Partially Supporting (score of 116).

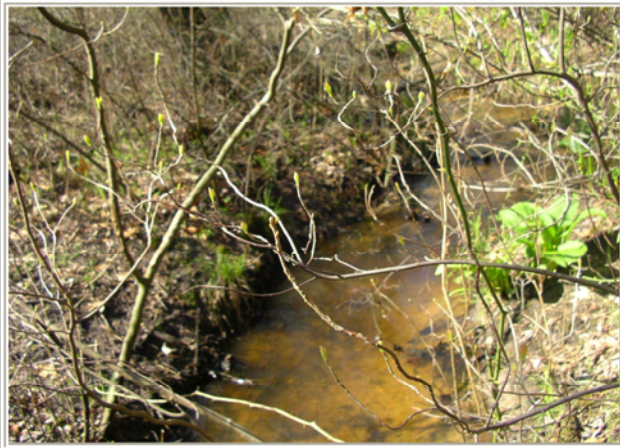
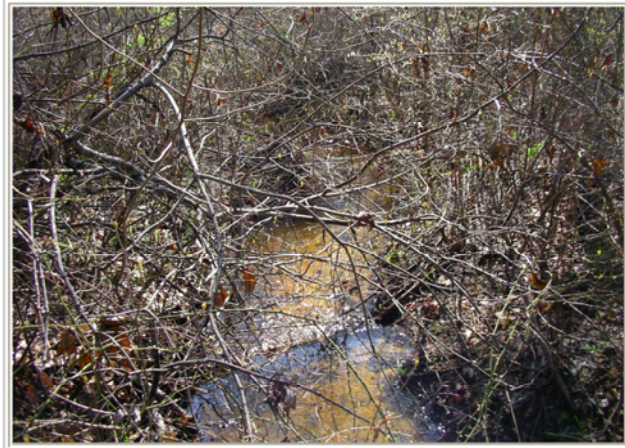
Location = Queenstown Park

This site is located at Queenstown Park, and is part of the Sawmill Creek 2 subwatershed leading to the Patapsco Tidal watershed. The most prevalent landuses surrounding this site are residential and wooded, each accounting for approximately 37% of the surrounding catchment area, and approximately 17% of the catchment is impervious. The benthic community at this site scored the highest out of all sites in this study, with a total BIBI score of 4.14. A healthy, diverse community, with healthy numbers of EPT and scraper taxa, and a good proportion of climbers contributed to this Good rating. A minimal amount of bank erosion was present along both banks, and very little trash was noted by the field crew. However, deep pools were missing and sediment deposition and pool substrate each rated Marginal. Overall, the habitat at this site rated Partially Degraded according to the PHI (score of 79.3) and Supporting according to the RBP (score of 131).

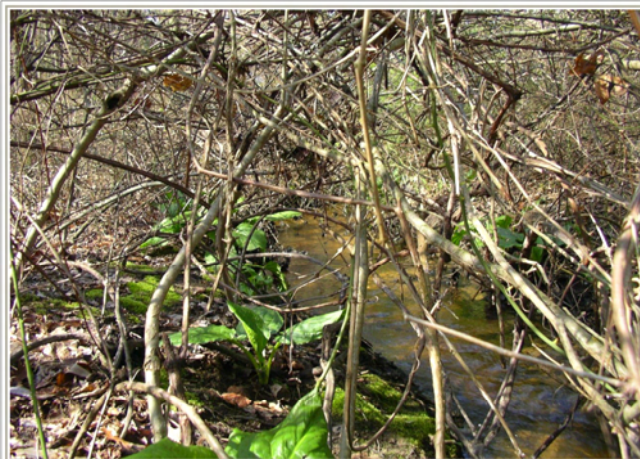
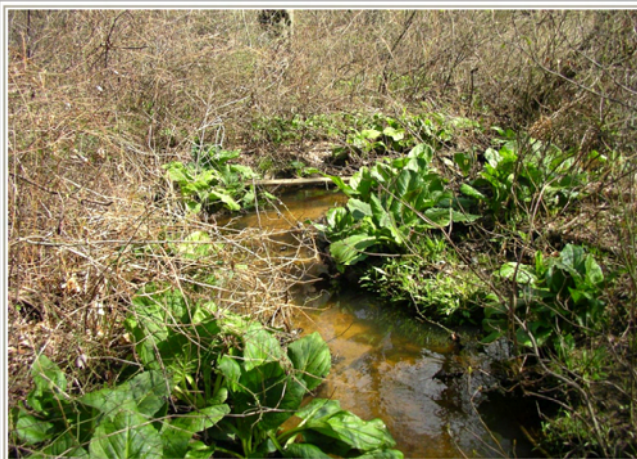
Location = Friendship Park

This Friendship Park site is part of the Sawmill Creek 2 subwatershed in the Patapsco Tidal watershed. Industrial landuse contributes to 31% of the catchment area, followed by wooded and open space, which each account for approximately 25%. The overall catchment impervious percentage is 38%. Benthic macroinvertebrates sampled at this site indicate a fairly healthy stream, with an overall BIBI score of 3.57 (Fair). There was good community diversity, with moderate amounts of EPT taxa present, but overall very few macroinvertebrates considered intolerant of urban conditions. A minimal amount of bank erosion was present along both streambanks, while moderate amounts of sediment deposition affected substrate. Instream wood was completely absent and only one piece of dewatered wood was present in the reach. Habitat was rated Partially Degraded (76.3) under the PHI and Supporting (129) under the RBP.

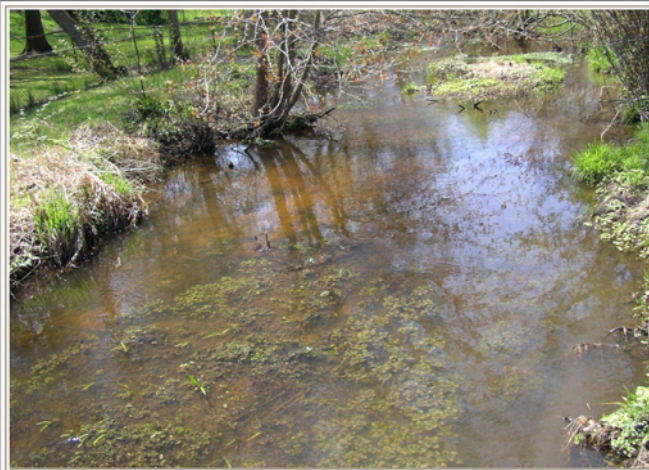
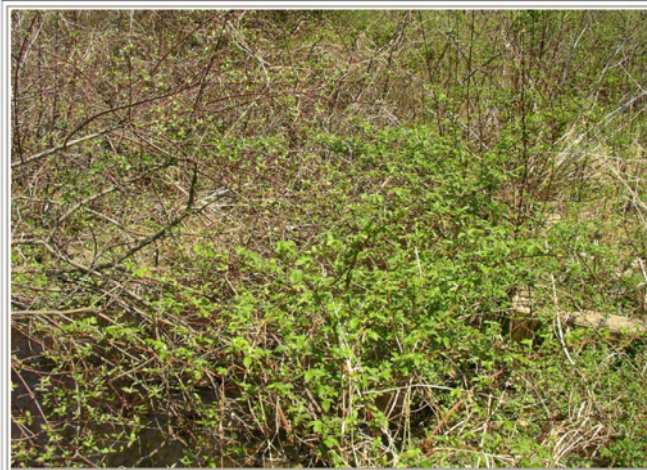
Location = Between Sawmill Creek Park and Glenview Avenue

Landuse around this site is mainly a mixture of wooded (35%), residential (24%), and open space (22%), but a variety of other landuses are present in small amounts, resulting in 21% impervious surface in the catchment. This site is between Sawmill Creek Park and Glenview Avenue, in the Sawmill Creek 2 subwatershed of the Patapsco Tidal drainage. Beaver activity was obvious at this site, and a landowner expressed concern to the field crew about possible damage caused by beavers. Mowed lawn adjacent to the stream resulted in a partially open canopy (only 45% shading) and a poor riparian vegetative zone width, particularly along the right bank. Embeddedness was low and some SAV was present. Habitat rated Degraded under the PHI with a score of 58.3 and Partially Supporting under the RBP with a score of 117 (58.5% comparable to reference). The benthic community at this site was diverse, with 26 different taxa found in the benthic sample. Some EPT taxa were present, but no scrapers, and only a few macroinvertebrates intolerant of urban conditions. Overall, the BIBI score was 2.43 (Poor).

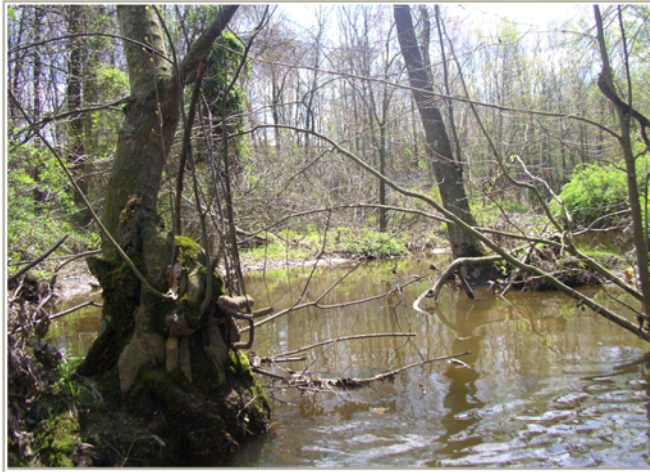
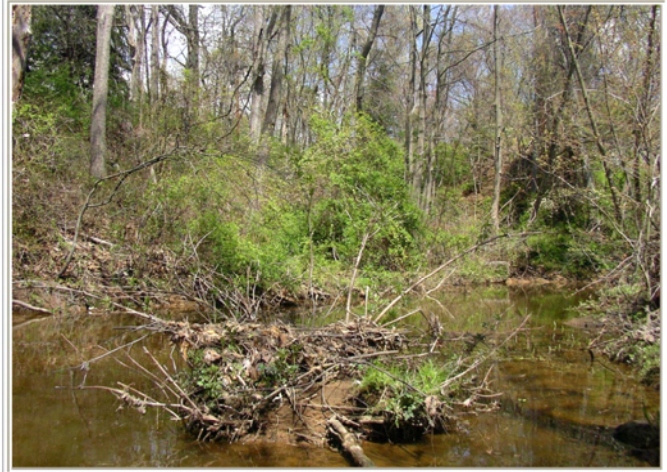
Location = Marley Station Mall

This site can be accessed from the Marley Station Mall, in the northwest corner of the parking lot. It is part of the Marley Creek 3 subwatershed in the Patapsco Tidal watershed. Most of the landuse in the surrounding area is residential (55%) and wooded (18%), and the shopping center and other commercial areas contribute to about 11% of the catchment area. This results in 36% impervious surface in the surrounding catchment. Benthic community diversity was somewhat diminished at this site, and no macroinvertebrates considered intolerant to urban conditions and no scraper taxa were obtained through benthic sampling. The site received a BIBI score of 2.14 (Poor). Field crew members noted large amounts of trash present at the time of sampling. Channel substrate was dominated by silt (60%) with some sand and gravel, and sediment deposition rated Marginal. Thus epifaunal substrate, pool substrate, and instream habitat conditions were all less than ideal. Habitat overall was rated Degraded under the PHI (57.7) and Supporting under the RBP habitat assessment procedure (score of 139).

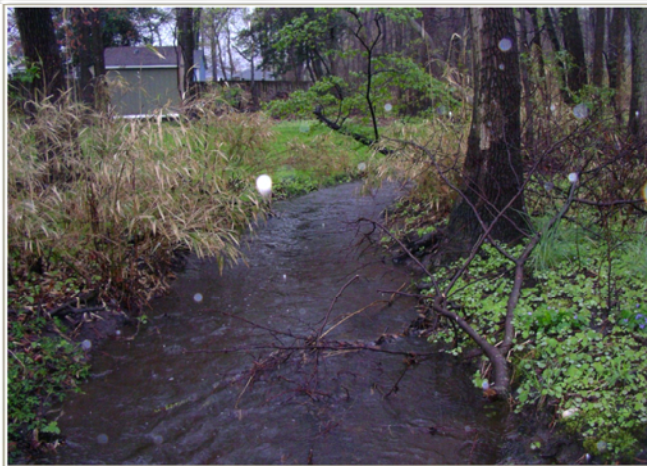
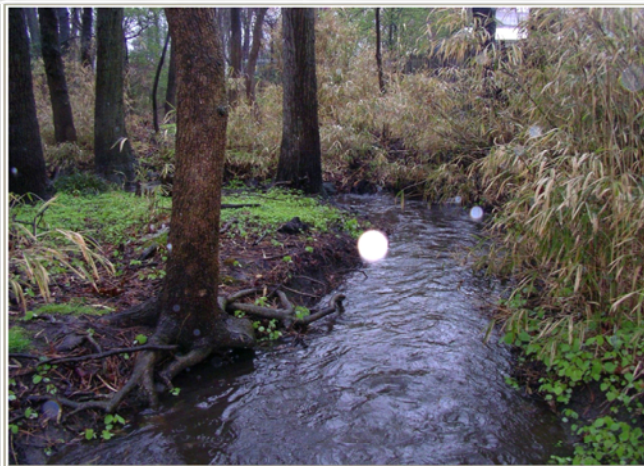
Location = Williamstowne Drive, between Mali Court and Williamstowne Court

This Marley Creek 4 site is located in the Patapsco Tidal watershed, off of Williamstowne Drive, between Mali Court and Williamstowne Court. At this site, residential landuse dominates the surrounding catchment, contributing to 87% of the catchment area. Twenty-nine percent of the catchment consists of impervious surfaces. Riparian buffer was lacking on the right side of the stream, likely resulting in unstable, erosive banks. In fact, a landowner near this site expressed concern that the erosion is so great that the stream might erode into his property. Moderate amounts of trash were present, along with some SAV. With some cobble in the channel substrate and a good proportion of riffles throughout the reach, epifaunal substrate rated Suboptimal, as did pool substrate. Overall, the RBP rated habitat at this site as Supporting, with a score of 126, while the PHI rated it as Partially Degraded with a score of 75.2. With an overall BIBI score of 3.86, this site rated Fair according to the benthic macroinvertebrate community obtained here. There were 7 different EPT taxa in the benthic sample, the most EPT taxa found at any site in this study. Community diversity was good, and approximately 25% of the macroinvertebrates in the sample were considered intolerant of urban conditions.

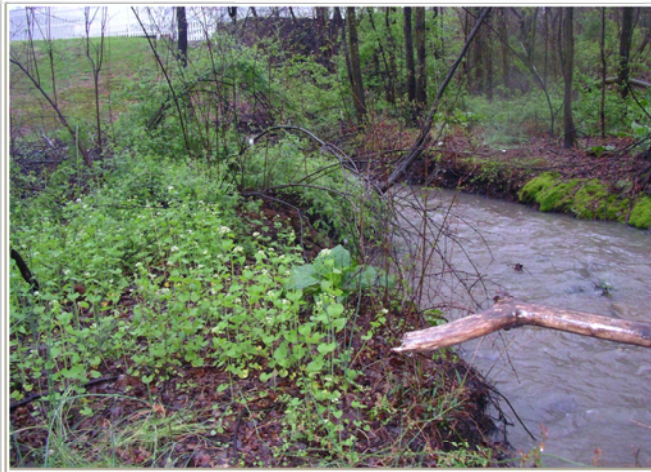
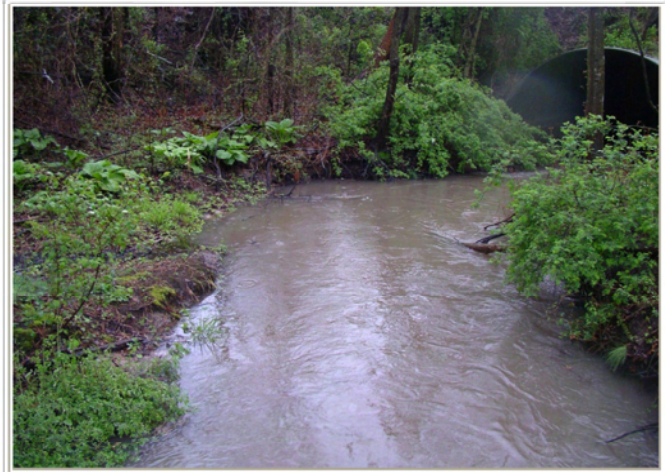
Location = Between Nolberry Drive and Phirne Drive

A variety of landuses contribute to the catchment area here, including residential (29%), commercial (23%), and wooded (18%). In addition, row crop landuse is present in the surrounding catchment, contributing 9.5% of total area – the largest proportion of row crop landuse of sites included in this survey. Impervious surfaces occupy 39% of the surrounding catchment. This site is located in open space between Nolberry Drive and Phirne Drive, and is part of the Marley Creek 4 subwatershed of the Patapsco Tidal watershed. The stream is located very close to the road and the field crew noted large amounts of trash present. The benthic community at this site revealed less than ideal conditions, as only one EPT taxa and only one scraper taxa were present in the benthic sample, and no climbers were found. In addition, less than 2% of the macroinvertebrates sampled were considered intolerant of urban conditions. Overall, the BIBI rated this site as Very Poor, with a score of 1.57. Some erosion was present along both banks, and the stream exhibited some channelization in the vicinity of a 5-meter wide and 18-meter long culvert. Under the PHI, habitat at this site scored 76.4 (Partially Degraded), and under the RBP, it scored 143 (Supporting).

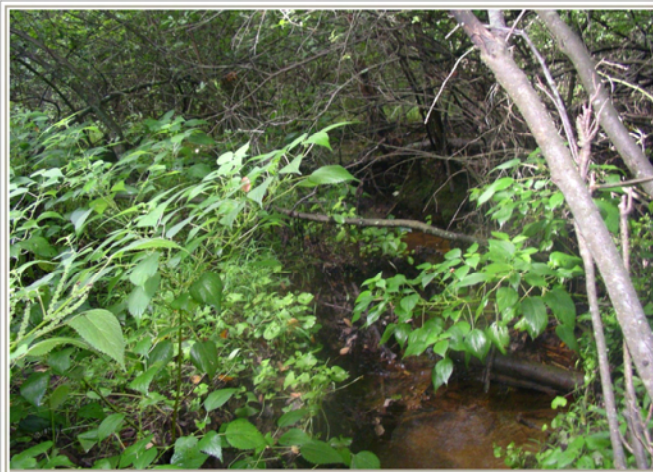
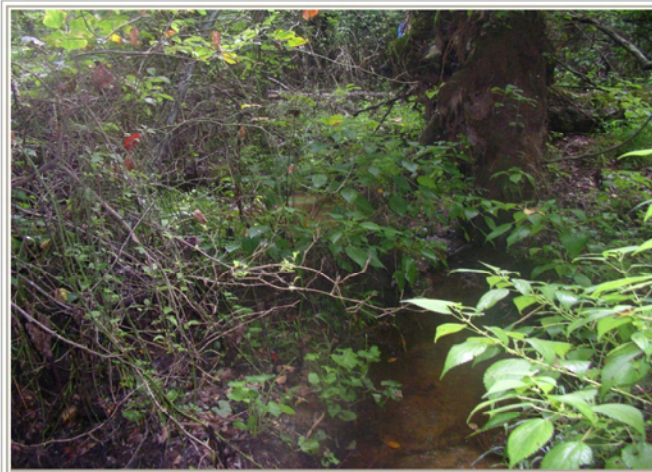
Location = Elvaton Road

This site is part of the Marley Creek 4 subwatershed in the Patapsco Tidal watershed. Residential landuse is the most prevalent here, contributing 55% of catchment area. Wooded and commercial landuse contribute 15% and 12%, respectively, and the overall imperviousness is 37%. This site had the greatest benthic community diversity of all sites in the study, with 42 different taxa present. Only 8% of the macroinvertebrates were considered intolerant of urban conditions, and the site rated Fair overall (BIBI score of 3.57). Some erosion was present along both banks, and lots of deposition was present throughout the channel. Channel substrate and deposition both consisted of large amounts of sand. The site was located very close to road, and field staff noted moderate amounts of trash present, along with some algae. Overall the PHI rated habitat at this site as Degraded (score of 64.3), and the RBP rated habitat as Supporting (score of 137).

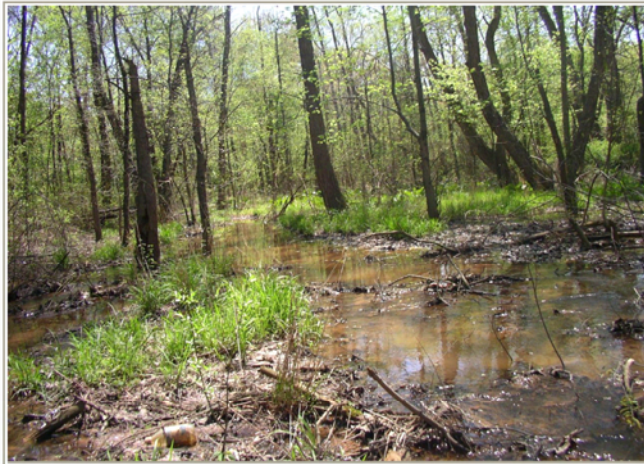
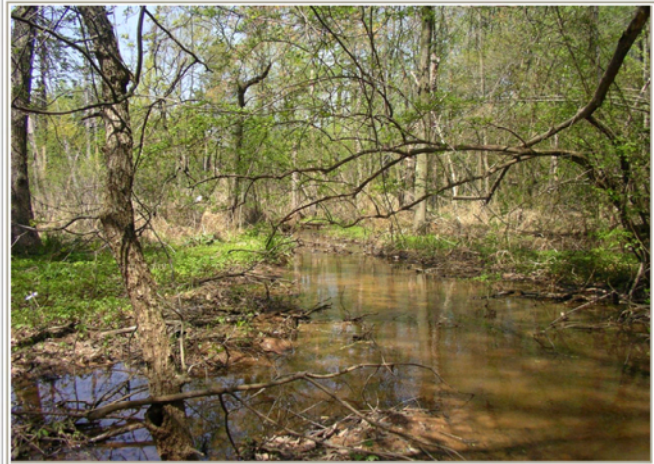
Location = Cross Creek Drive

More than half of the catchment surrounding site PTG-939-T-2009 consists of residential landuse, with 36% wooded landuse. This results in 19.6% imperviousness in this catchment. The site can be accessed through a wooded lot on the right side of Cross Creek Drive. It is part of the Marley Creek 4 subwatershed in the Patapsco Tidal watershed. The benthic community at this site received a Fair rating with a BIBI score of 3.00. A diverse benthic community was present, with healthy numbers of scrapers, but less than 1% of the macroinvertebrates were considered intolerant of urban conditions. Both epifaunal and pool substrate were less than ideal, as the channel substrate consisted of 60% silt and 40% sand, with large amounts of deposition. Moderate amounts of trash were present at the site, and deep pools were lacking. Habitat rated Partially Degraded under the PHI and Partially Supporting under the RBP (scores of 70 and 118, respectively).

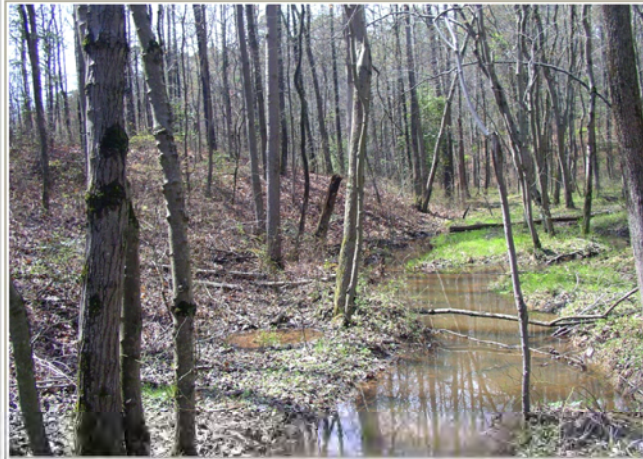
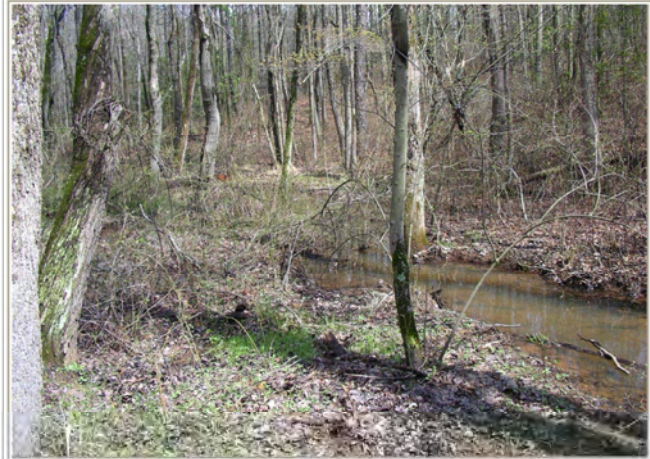
Location = Nabbs Creek Road, north of Locust Grove Road

This mainly wooded site (80% of total catchment area) has a resulting low level of overall imperviousness in its surrounding catchment (less than 5% impervious). It is located off of Nabbs Creek Road, north of Locust Grove Road, and is part of the Nabbs Creek subwatershed in the Patapsco Tidal watershed. Habitat conditions were good at this site, as it rated Minimally Degraded under the PHI (score of 81.9), and Supporting under the RBP (score of 142, 71% comparable to reference conditions). Riffle substrate was minimal, but large amounts of rootwads/woody debris and overhanging grasses provided substrate for benthos, as did some emergent aquatic vegetation. A dirt road served as a severe buffer break along both sides of the stream, and moderate amounts of trash were present. Despite over 70% of the macroinvertebrates sampled at this site being considered intolerant of degraded urban conditions, a moderate community diversity and a lack of climbers and scrapers resulted in an overall benthic assessment of Poor (BIBI score of 2.14).

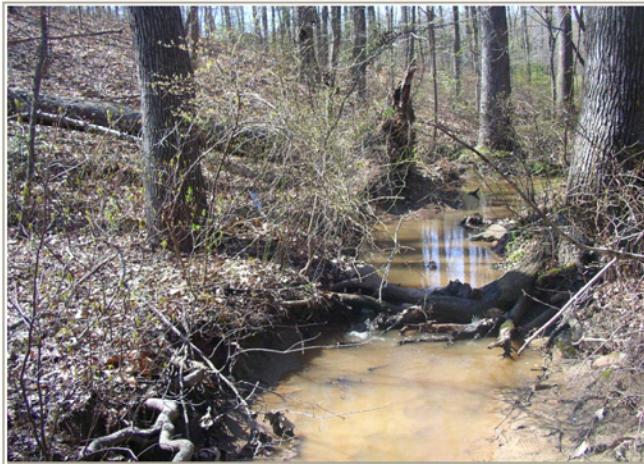
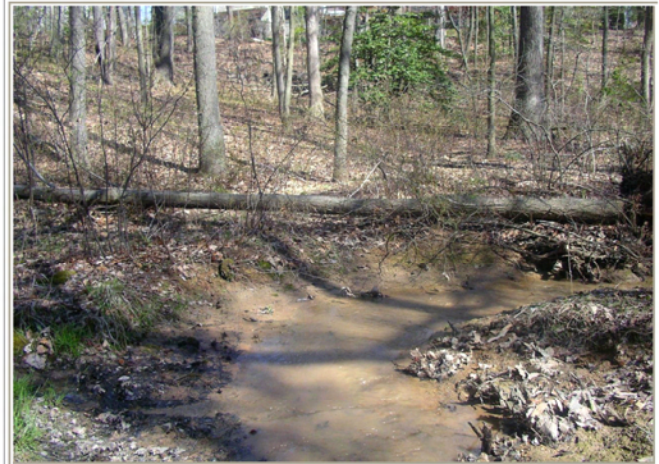
Location = Arbor Wood Place

At this site, wooded and open space landuses are most prevalent in the surrounding catchment (37% and 30%, respectively), followed by 25% industrial landuse. Resultant imperviousness is 18%. Part of the Nabbs Creek subwatershed of the Patapsco Tidal watershed, this site is located near the southwest corner of Arbor Wood Place. The benthic community sampled at this site had a poor community diversity ($n=10$ taxa), and low numbers of EPT and scraper taxa, with few climbers. Thus, it rated Very Poor according to the BIBI (score of 1.57). The PHI rated the habitat as Degraded (score of 57.2), while the RBP rated the habitat as Partially Supporting (score of 112). Moderate amounts of bank erosion were affecting the stability of both banks, and significant levels of deposition were present throughout the stream, resulting in poor substrate conditions. Emergent grasses, some SAV, and some algae were present in the stream, and only 30% of the canopy was shaded.

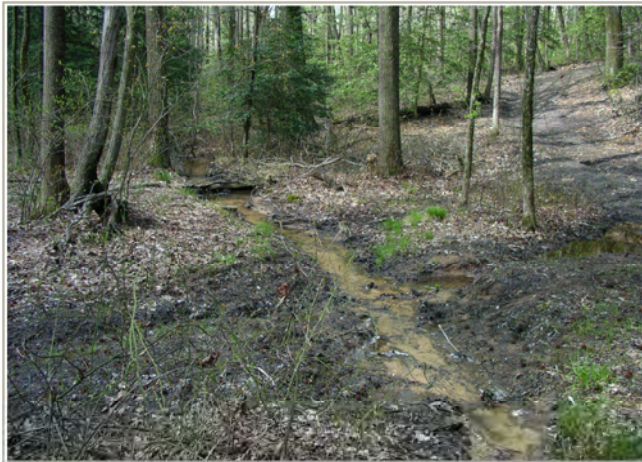
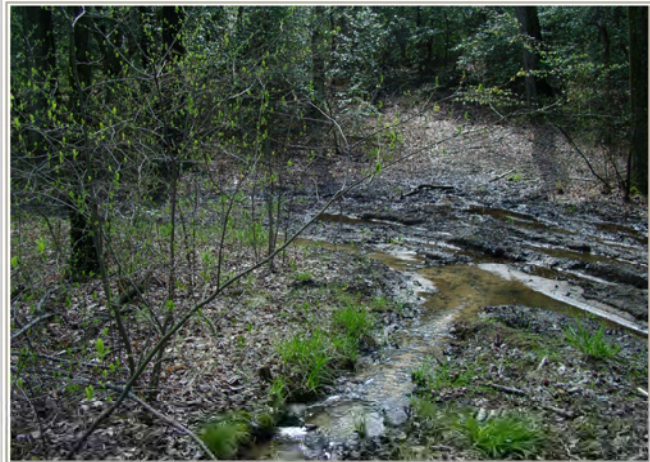
Location = Fox Hollow Run

The catchment surrounding this site is made up of residential and wooded landuse (70% and 30% respectively). Approximately 12% of the catchment area is impervious. It is part of the Hines Bog Pond subwatershed in the Patapsco Tidal watershed, and is located off of Fox Hollow Run. During spring sampling, large numbers of juvenile spring peepers were present at this site. The macroinvertebrates in the benthic sample revealed a Very Poor stream, with low community diversity, only 1 EPT taxa, and no scraper taxa (BIBI score of 1.57). Habitat assessments were not quite as harsh, with the RBP rating the stream as Partially Supporting, and the PHI rating the stream as Partially Degraded. Severe bank erosion affected portions of both banks, and the riparian buffer zone along both banks was very narrow. A dirt road served as a severe buffer break along both sides of the stream. Field staff noted moderate amounts of trash present, and deep pools were lacking.

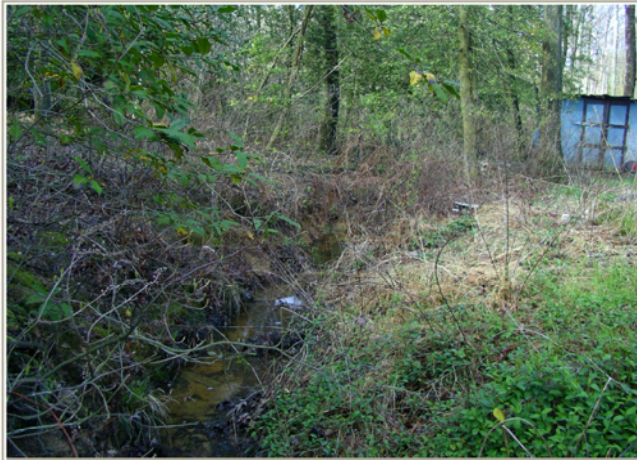
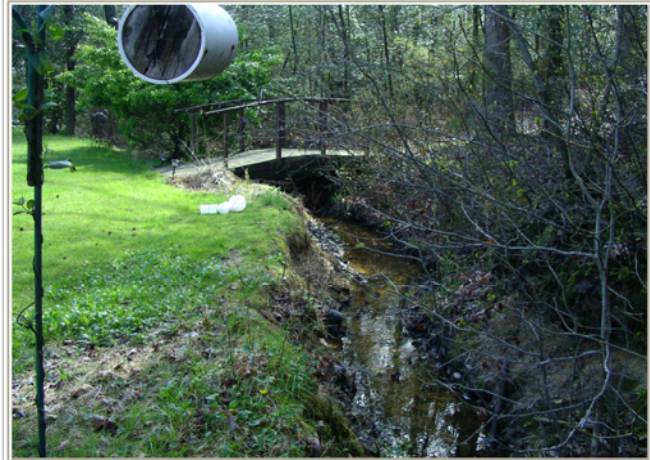
Location = Venetian Drive

Residential landuse is the most prevalent at site PTM-921-T-2009, contributing to 67% of the landuse in the surrounding catchment. The rest of the catchment is wooded with a small amount of transportation-related landuse. Overall, impervious surface accounts for 12.3% of the catchment area. The site is located off of Venetian Drive, near a property with a lot of heavy equipment. It is part of the Hines Bog Pond subwatershed in the Patapsco Tidal watershed. Moderate amounts of bank erosion were present along some portions of both streambanks at this site, and a storm drain served as a minor buffer break along the right side of the stream. In addition, the riparian buffer was narrow, particularly along the left side of the stream. Pool variability was poor, and no deep pools were present. However, embeddedness was very low, and very little trash was present at the site. Thus, habitat ratings were somewhat moderate, with an overall RBP score of 118 (Partially Supporting), and an overall PHI score of 76.8 (Partially Degraded). The benthic community at this site was diverse, and 45% of the macroinvertebrates were considered intolerant to urban conditions. However, a moderate number of EPT taxa and climbers, and a lack of scrapers resulted in an overall assessment of Poor, with a BIBI of 2.71.

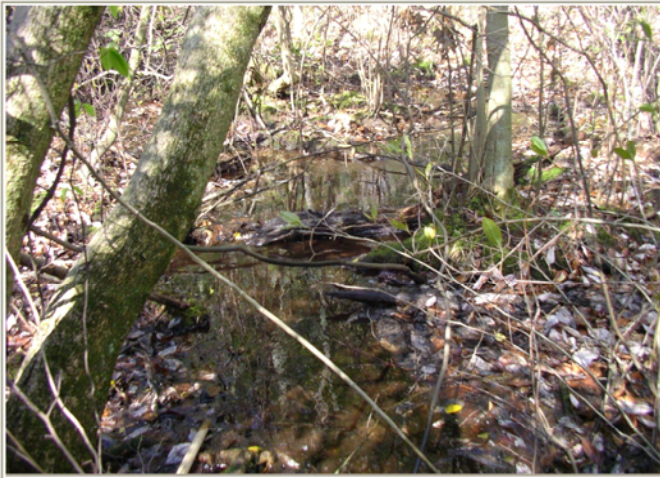
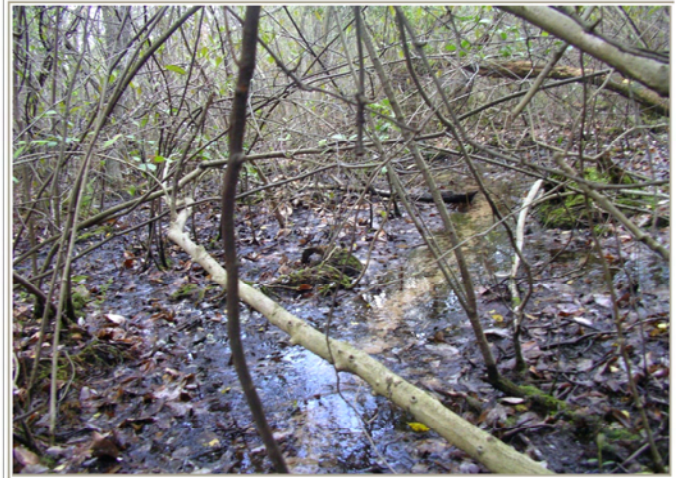
Location = Choptank Avenue, south of Hines Pond

Located off of the Choptank Avenue cul-de-sac, south of Hines Pond, this site is part of the Hines Bog subwatershed in the Patapsco Tidal watershed. Less than 6% of the catchment is impervious, as surrounding landuses are wooded (62%) and residential (38%). This site had healthy benthic community diversity, a healthy number of climbers, and more than 50% of the macroinvertebrates sampled were considered intolerant to urban conditions. However, only 2 EPT taxa were present in the sample and no scrapers, so the site rated Fair with a BIBI score of 3.00. Streambanks at this site were stable with no erosion, and a shaded canopy was present, along with only a small amount of trash. However, epifaunal substrate and pool substrate received low ratings, and pool variability was poor with no deep pools present. Channel substrate was composed of 90% sand with some silt, and sediment deposition was extensive. Overall, the RBP rated the habitat here as Partially Supporting (58.5% comparable to reference, with a total score of 117). The PHI rated habitat Minimally Degraded, with an overall score of 85.3.
