# Herring Bay, Middle Patuxent, and Lower Patuxent Watershed Assessment

## Comprehensive Summary Report

June 2018 | Final Report

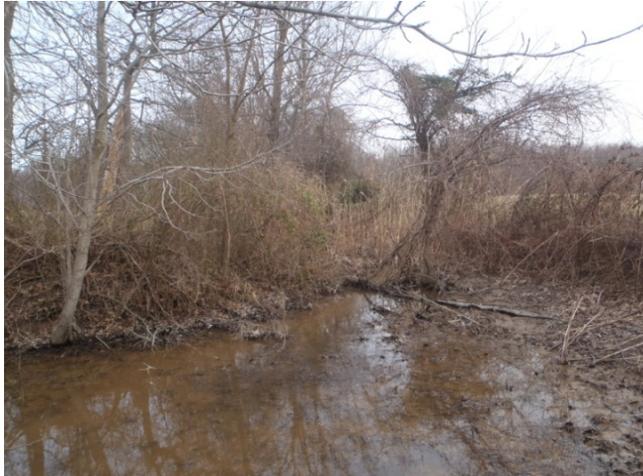
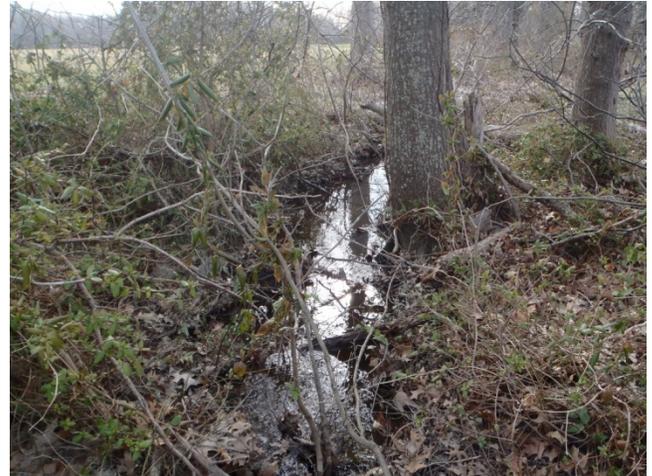
Site HB-01-2013 is located south of Muddy Creek Road within the Rockhold Creek subwatershed. Primary land uses within this site’s drainage area include forest and agriculture and imperviousness is approximately 3%. At the time of the benthic macroinvertebrate assessment, the stream flow at this site was very low and the lower end of the reach was backwatered, potentially due to a farm pond located downstream of the site. The stream in this area is very straight, probably from historic channelization for agriculture. Aquatic habitat is dominated by shallow runs and glides, and defined riffles and overall complex habitat for stream biota are lacking. This is likely an intermittent stream that functions more as a wetland swale during the growing season. The benthic macroinvertebrate community at this site was rated as Very Poor and was dominated by aquatic worms. No intolerant individuals and very few specialized feeding groups or habits were collected at this site. Low flow conditions, an intermittent water regime, and poor habitat complexity are likely affecting the biological community at this site.

- Benthic macroinvertebrate community – “Very Poor”
- Habitat scores “Partially Supporting” and “Partially Degraded”
- Aquatic worms (Tubificidae) heavily dominated the community.
- *In-situ* water quality values met COMAR standards.
- This is an intermittent stream primarily consisting of shallow runs and glides, with no well defined riffles. Benthic and instream habitats are poor due to shallow and homogenous flow conditions.

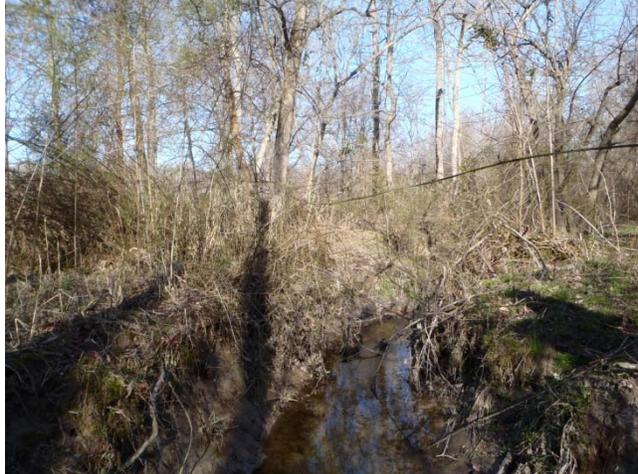
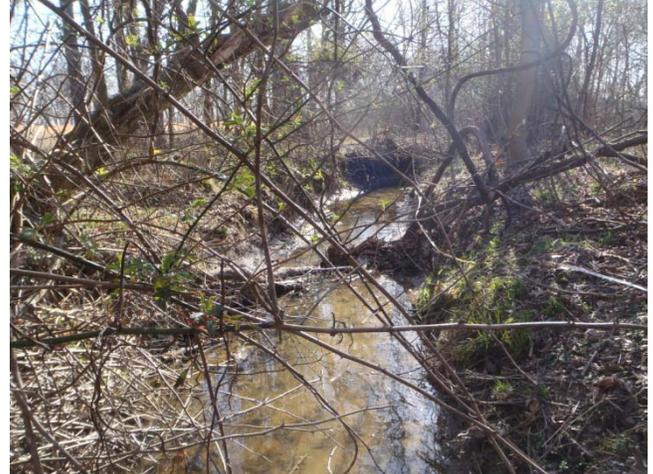
Site HB-02-2013 is located west of a newly planted reforestation area within the Rockhold Creek subwatershed. Forest and agriculture are the primary land uses comprising the site’s drainage area and imperviousness is less than 1%. At the time of sampling, the stream channel was relatively shallow but had a moderate diversity of velocities including some fast flowing areas. A few shallow pools and riffles are present, but the segment consists mainly of long run/glide complexes. The benthic macroinvertebrate community at this site was rated Very Poor and dominated by black fly larvae (*Stegopterna*). Although 92% of the individuals were intolerant to urban stressors, a lack of Ephemeroptera taxa and poor taxa diversity resulted in a low biological score. Low amounts of favorable and stable substrates for benthic macroinvertebrates are likely affecting the biological community at this site.

- Benthic macroinvertebrate community – “Very Poor”
- Habitat scores “Partially Supporting” and “Partially Degraded”
- Black flies (*Stegopterna*) heavily dominated the community.
- *In-situ* water quality values met COMAR standards.
- This channel is shallow and incised with a few small pools and marginal velocity depth diversity. Rootwads and woody debris are present, but in small amounts. The banks are raw and eroded, but have optimal riparian width.

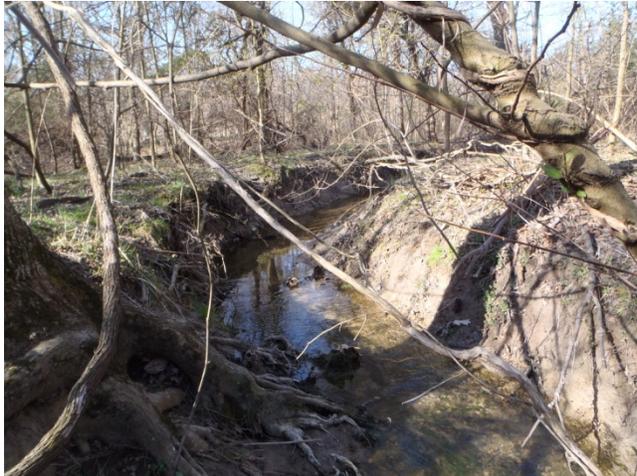
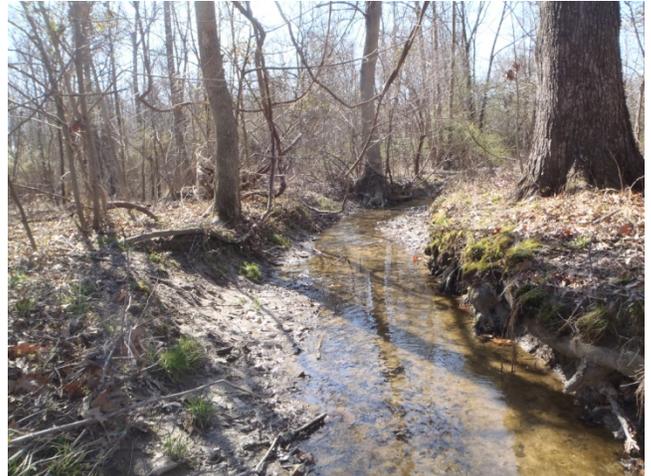
Site HB-02-Dup-2013 is located immediately upstream of site HB-02-2013 within the Rockhold Creek subwatershed. Instream features consist mostly of long run/glide complexes, but a few shallow pools and riffles are present. The majority of stable benthic macroinvertebrate habitat consists of instream rootwads and woody debris as well as a few riffles covered in filamentous algae. Both banks are moderately unstable with long patches of erosion. The benthic macroinvertebrate community at this site was rated Very Poor and was dominated by black fly larvae (*Stegopterna*). Although 93% of the individuals were intolerant to urban stressors, specialized feeding groups and Ephemeroptera taxa were absent which contributed to the low biological score. Forest and agriculture are the primary land uses comprising the site’s drainage area and imperviousness is less than 1%.

- Benthic macroinvertebrate community – “Very Poor”
- Habitat scores “Partially Supporting” and “Partially Degraded”
- Black flies (*Stegopterna*) heavily dominated the community.
- *In-situ* water quality values met COMAR standards.
- This site has a shallow incised channel with moderate flow and optimal riparian vegetative width. Instream rootwads and woody debris are present in moderate amounts providing the majority of stable habitat for the benthic macroinvertebrate community. Both banks are moderately unstable.

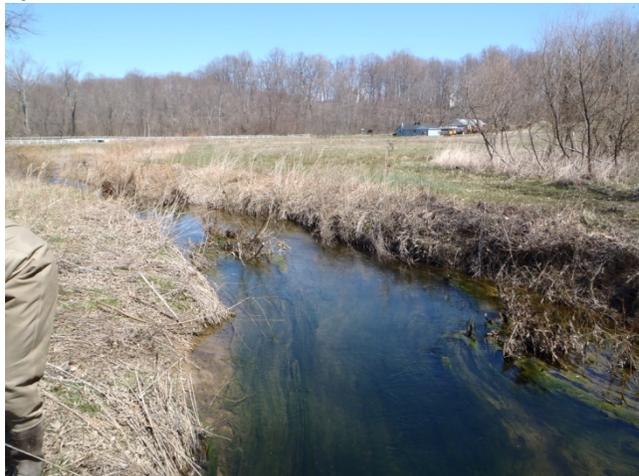
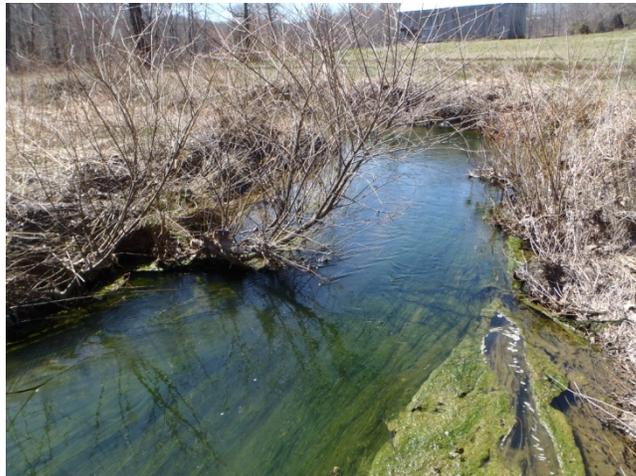
# HB-03-2013

Site HB-03-2013 is located downstream (south) of Nutwell Road on Tracy’s Creek within the Tracy’s Creek I subwatershed. A large beaver pond is located directly upstream of Nutwell Road approximately 300 meters from this site. Of the 2,632 acre drainage area, more than 50% is forested land and almost 25% is developed. This is the second largest drainage area sampled within the Herring Bay Watershed and only 3% consists of impervious surfaces. The entirety of this site runs within a pasture, and a forested riparian buffer is completely lacking. Instream features at this site are dominated by runs and glides. Riffles, pools, and instream rootwads and woody debris are uncommon. The stream substrate is comprised of silt and clay and at the time of sampling, filamentous algae covered the channel. About 20% of the individuals collected at this site were intolerant to urban stressors, but an absence of scrapers, climbers, and Ephemeroptera taxa resulted in a Very Poor score for the biological community.

- Benthic macroinvertebrate community – “Very Poor”
- Habitat scores “Partially Supporting” and “Severely Degraded”
- Black flies (*Simulium*) and midges (*Orthocladius*) heavily dominated the community.
- *In-situ* water quality values met COMAR standards.
- Stream runs through pasture with minimal riparian width. Velocity depth diversity is optimal with fast flowing areas present, but overall habitat is lacking. High amounts of filamentous algae are present covering the entire channel.

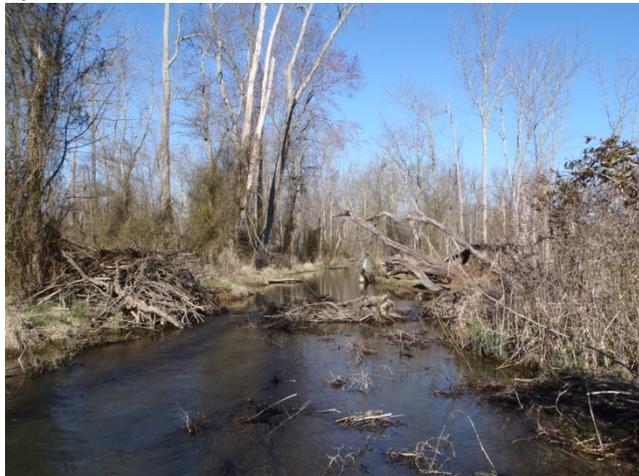
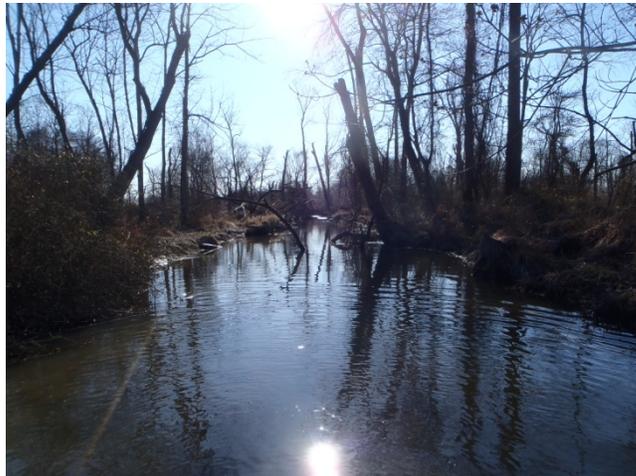
# HB-04-2013

Site HB-04-2013 is located upstream of Franklin Gibson Road on Tracy’s Creek within the Tracy’s Creek I subwatershed. Beaver activity is present in the floodplain and is affecting the stream within the vicinity of the site. The area was once completely flooded, resulting in numerous dead trees on both banks. The site is close to the upper reaches of tidal influence. Of the 3,549 acre drainage area, 50% is forested land and almost 25% is developed. This is the largest drainage area sampled within the Herring Bay Watershed and only 3% of the drainage consists of impervious surfaces. A few deep pools with moderate cover are present, but aquatic habitat consists primarily of instream woody debris. Run/glide complexes are the dominant instream features and the substrate is predominately comprised of silt and clay. Although the habitat is Comparable to Reference/Partially Degraded, moderately low taxa diversity with no Ephemeroptera or scraper taxa, and a low percentage of individuals intolerant to urban stressors resulted in a Very Poor biological community.

- Benthic macroinvertebrate community – “Very Poor”
- Habitat scores “Comparable to Reference” and “Partially Degraded”
- Midges (*Orthocladius*) dominated the community.
- *In-situ* water quality values met COMAR standards.
- This is a wide fast flowing channel with optimal riparian width. Banks are stable with very little evidence of erosion. There is an abundance of submerged woody debris along with optimal velocity depth diversity and pool/glide/eddy quality.

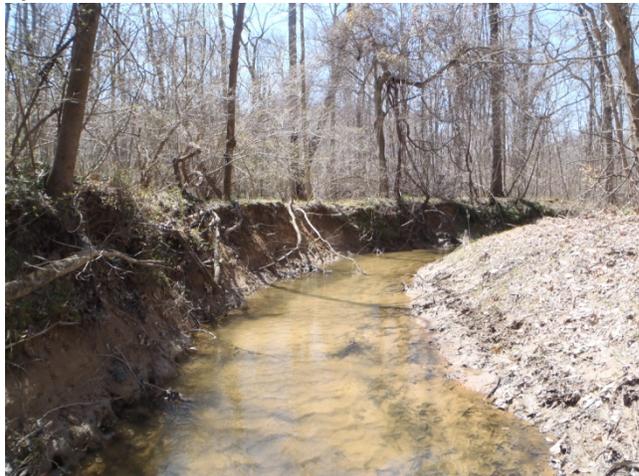
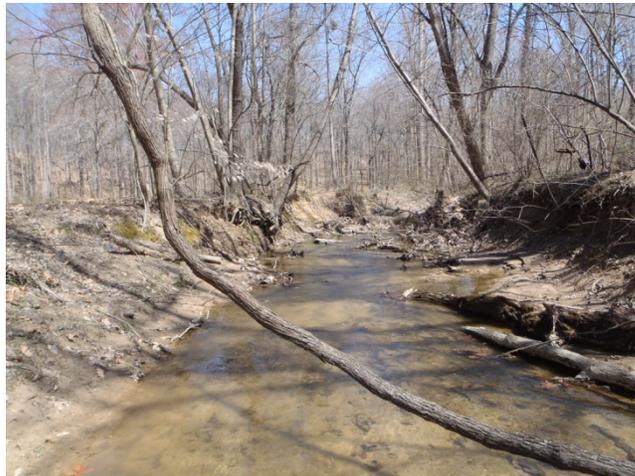
Site HB-05-2013 is located west of Sudley Road, on Tracy’s Creek in a large stream valley, within the Tracy’s Creek II subwatershed. Forest and development are the primary land uses comprising this site’s drainage area and imperviousness is just over 3%. The reach is comprised mainly of shallow runs and glides, but a few shallow pools and sandy riffles are present. A large woody debris jam is located in a deep pool in the middle of the reach, creating suboptimal habitat. The benthic macroinvertebrate community at this site was rated as Fair and was dominated by stoneflies (*Isoptera*). Over 50% of the total individuals collected were considered intolerant to urban stressors. The benthic community also had relatively high taxa and EPT diversity. This could be attributed to the diverse stable habitat substrates and diversity of flows.

- Benthic macroinvertebrate community – “Fair”
- Habitat scores “Supporting” and “Partially Degraded”
- Stoneflies (*Isoptera*) dominated the community.
- *In-situ* water quality values met COMAR standards.
- Instream rootwads and woody debris provide the majority of stable substrates. The bottom of the channel is sandy and comprised of a few sandy/gravel riffles. The right bank is unstable but has a good riparian width.

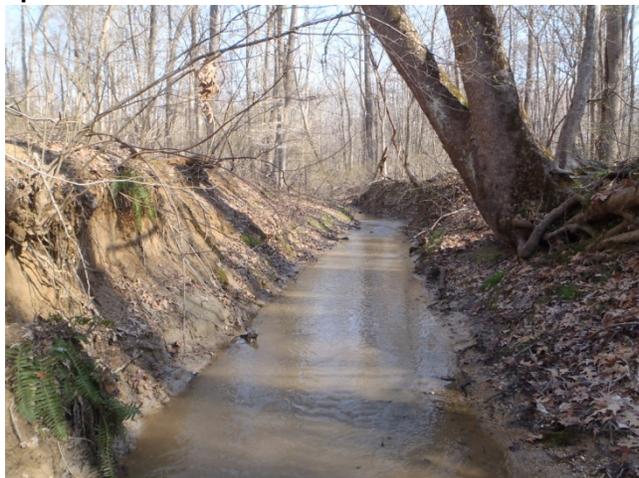
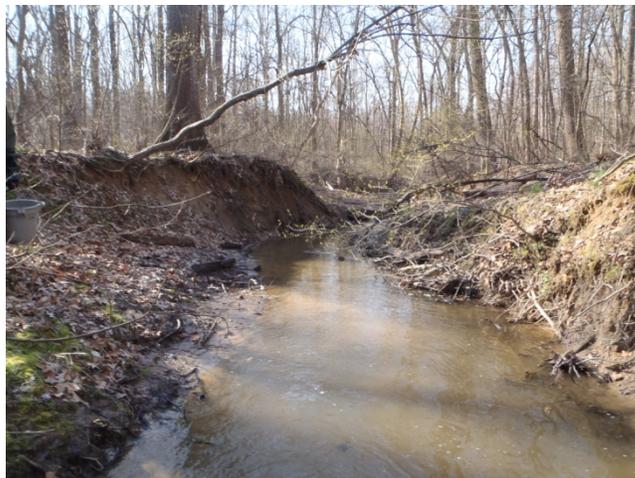
# HB-06-2013

Site HB-06-2013 is located west of Sudley Road within the Tracy’s Creek II subwatershed. Of the 693 acre drainage area, 42% is forested land and 35% is developed land, with impervious surfaces accounting for almost 7%. The stream is relatively straight and deeply incised due to past land use, but some eroded areas are healing over. Erosion is severe in some areas, but there is a well developed riparian buffer. The stream bottom consists mostly of clay and sand with some gravel. Instream features are primarily riffle run complexes with small shallow pools. The biological community had moderate taxa diversity and a high percentage of individuals intolerant to urban stressors. However, the benthic macroinvertebrate community lacked Ephemeroptera taxa and climbers, which contributed to the Poor score. The pH reading was out of compliance with COMAR standards at 8.72, exceeding the one time standard of 8.5.

- Benthic macroinvertebrate community – “Poor”
- Habitat scores “Partially Supporting” and “Partially Degraded”
- Midges (*Ortholadius*) and black flies (*Stegopterna*) dominated the community.
- Was out of compliance with COMAR standards for pH.
- The channel at this site is relatively straight and deeply incised. Some areas are highly eroded but there is optimal vegetative protection and riparian width. A good mix of aquatic habitats and velocities are present at this site.

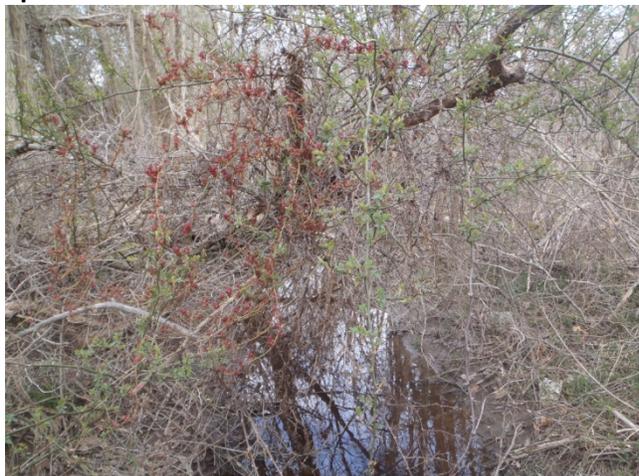
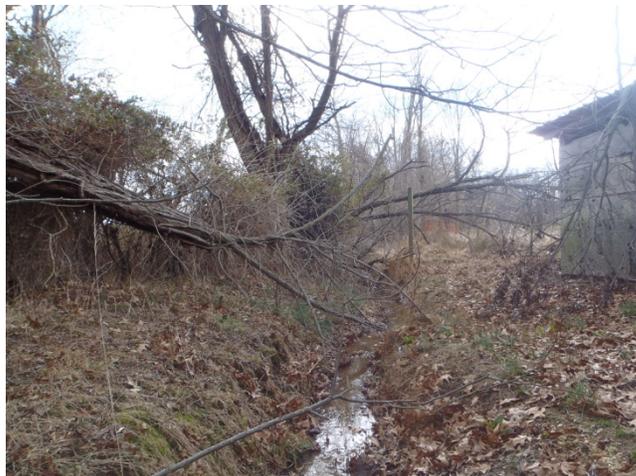
Site HB-07-2013 is located on farm property east of Kay Road on Jack Creek, within the Jack Creek subwatershed. The channel has been straightened and is comprised mainly of shallow run/glide complexes. Submerged vegetation and leaf packs provide the primary habitat for benthic macroinvertebrates. Instream rootwads, woody debris, and pools are almost completely absent. Bank stability is optimal but farm structures and equipment are very close to the stream, greatly impacting the riparian zone on the right bank. The benthic macroinvertebrate community at this site was rated as Very Poor and was dominated by aquatic worms (Tubificidae). Taxa diversity was the lowest out of any site sampled. Seven taxa were collected, which included no EPT taxa. The Very Poor rating can be attributed to these factors and are likely due to low flow conditions and a lack of stable habitat. Of the 31 acre drainage area, 49% is developed, 27% is forested, and the remaining 24% is open land. Impervious surfaces make up approximately 11% of this sites drainage area.

- Benthic macroinvertebrate community – “Very Poor”
- Habitat scores “Non Supporting” and “Partially Degraded”
- Aquatic worms (Tubificidae) heavily dominated the community.
- *In-situ* water quality values met COMAR standards.
- This is a small ditched channel that runs through an inactive pasture. The channel has very low flows. Habitat complexity is poor, consisting mainly of shallow run/glide complexes. Refuse is present in moderate amounts, and the riparian zone is moderately impacted on one bank.

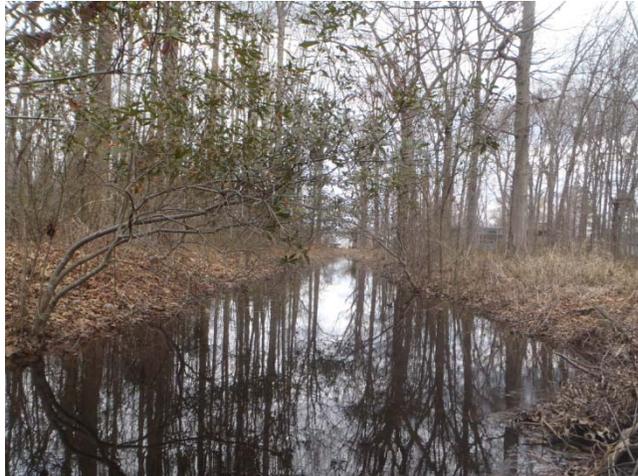
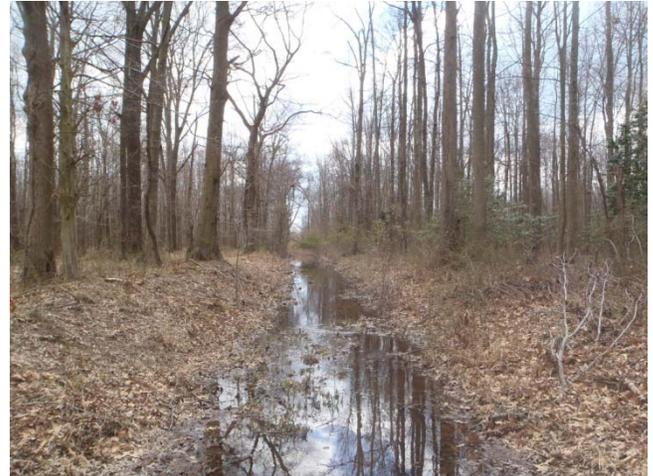
Site HB-09-2013 is located south of Cedar Avenue within the Cedarhurst subwatershed. Habitat complexity is poor at this site, dominated by shallow run/glide complexes with primarily a single current velocity. Instream rootwads and woody debris are completely absent, but submerged vegetation is present, providing some habitat. Banks are stable with no evidence of erosion. This site contained specialized feeding groups and over one-third of the benthic community was comprised of individuals intolerant to urban stressors. However, Ephemeroptera and EPT taxa were completely absent resulting in a Poor benthic macroinvertebrate rating. Of this site's 60 acre drainage area, 54% is forested and 41% is development. Impervious surfaces make up approximately 9% of this site's drainage area.

- Benthic macroinvertebrate community – "Poor"
- Habitat scores "Supporting" and "Degraded"
- Isopods (Asellidae) heavily dominated the community.
- *In-situ* water quality values met COMAR standards.
- Site is characterized by a straight channel with low flow and poor velocity depth diversity. The habitat consists mainly of leaf packs and submerged vegetation. Erosion is absent on both banks.

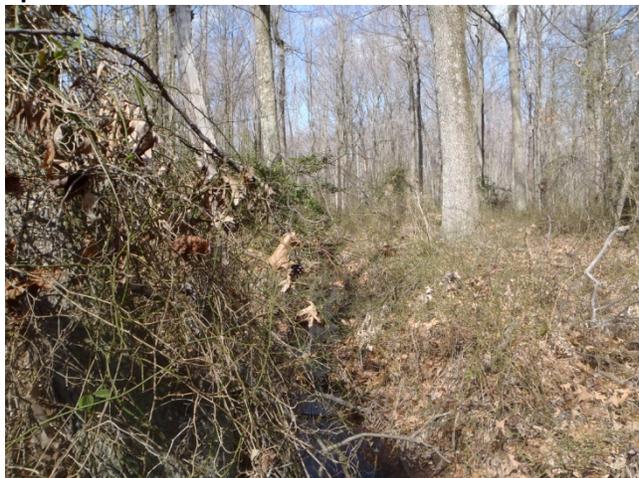
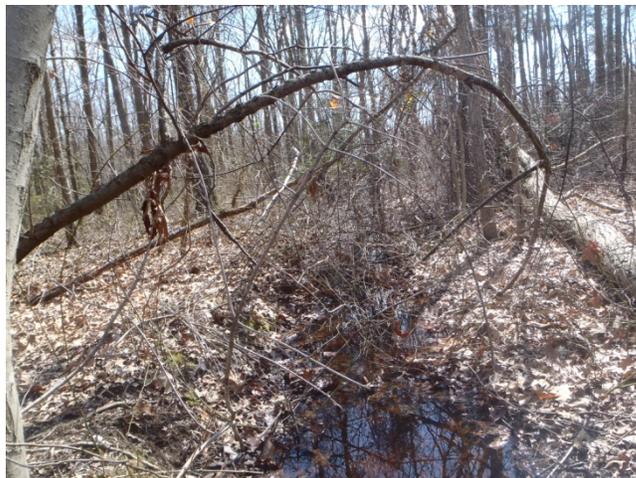
Site HB-10-2013 is located south of Kellam Road within the Cedarhurst subwatershed. Of the 35 acre drainage area, 44% is forested land and 51% is developed land, with impervious surfaces accounting for almost 7%. It is likely that this channel has been straightened in the past. It has very low habitat complexity, consisting primarily of shallow runs and glides. Leaf packs make up the majority of benthic habitat along with a few pieces of instream woody debris. Both banks are stable with optimal vegetative protection and riparian width. The benthic macroinvertebrate community at this site was rated as Very Poor and dominated by midges (*Pseudorthocladius*) and isopods (*Asellidae*). Specialized feeding groups and EPT taxa were completely absent at this site. A lack of complex and stable habitats is likely affecting the biological community at this site.

- Benthic macroinvertebrate community – “Very Poor”
- Habitat scores “Supporting” and “Partially Degraded”
- Midges (*Pseudorthocladius*) and Isopods (*Asellidae*) dominated the community.
- *In-situ* water quality values met COMAR standards.
- This site consists of a shallow channel with runs and glides. Habitat complexity is poor. Pools are absent and woody debris is only present in very small amounts. Banks are stable with optimal vegetative protection and riparian width.

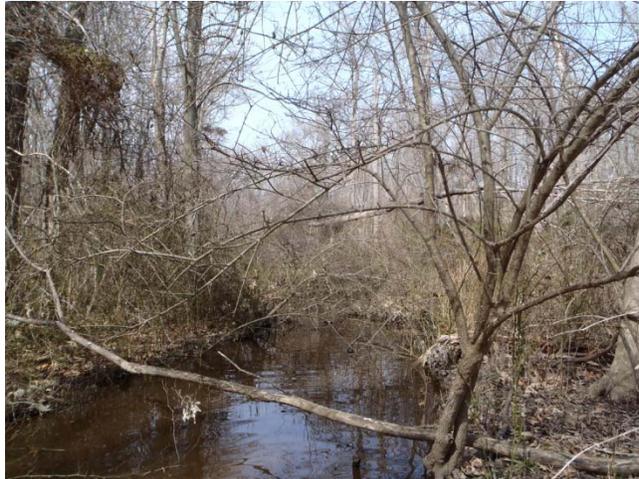
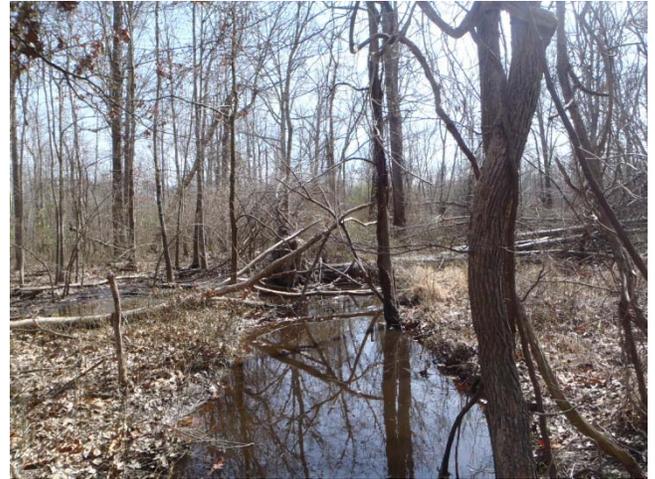
Site HB-12-2013 is located west of Shady Side Road within the Deep Cove Creek subwatershed. The channel is relatively straight and backwatered due to a debris jam and wetlands located downstream. Benthic macroinvertebrate habitat consists primarily of submerged woody debris, instream rootwads, and leaf packs. The reach substrate is dominated by mud and sand. Banks are stable with optimal vegetative protection and riparian width. Although one-third of the benthic community consisted of individuals intolerant to urban stressors, overall taxa diversity was poor, and lacked Ephemeroptera, scrapers, and climbers. Forest and development are the primary land uses, comprising this site’s 192 acre drainage area and imperviousness is approximately 6%.

- Benthic macroinvertebrate community – “Very Poor”
- Habitat scores “Supporting” and “Partially Degraded”
- Isopods (*Caecidotea*) dominated the community.
- *In-situ* water quality values met COMAR standards.
- This straightened channel is heavily stained with tannins. It has poor habitat complexity with only a few rootwads and submerged woody debris. Banks are stable with optimal vegetative protection and riparian width.

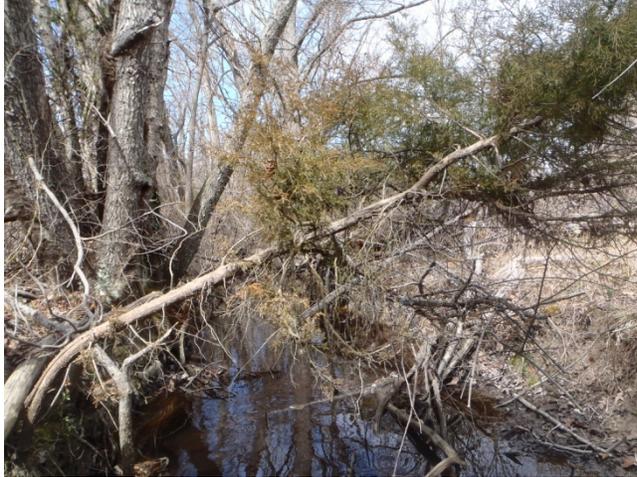
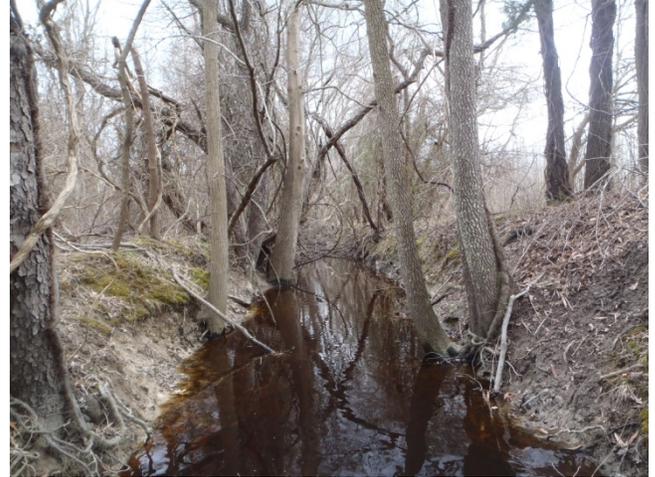
Site HB-13-2013 is located northeast of Dent Road on Deep Creek within the Deep Creek subwatershed. The channel appears to have been straightened in the past. The stream is also tannic due to heavy leaf litter and low flow. Instream rootwads and woody debris are abundant, providing the majority of stable habitat for benthic macroinvertebrates. Both banks are moderately stable, with suboptimal vegetative protection and riparian width. Forest is the primary land use, comprising 71% of this site’s drainage area and imperviousness is approximately 5%. Although approximately one-third of the benthic sample consisted of individuals intolerant to urban stressors, an absence of Ephemeroptera, scraper, and climber taxa contributed to a Poor biological community rating.

- Benthic macroinvertebrate community – “Poor”
- Habitat scores “Partially Supporting” and “Partially Degraded”
- Amphipods (Gammaridae) and Isopods (Asellidae) dominated the community.
- *In-situ* water quality values met COMAR standards.
- This site is very straight and only has slow flowing water. The water is stained heavily with tannins from leaf litter. Woody debris and rootwads provide a majority of the stable habitat present. Both banks are moderately stable.

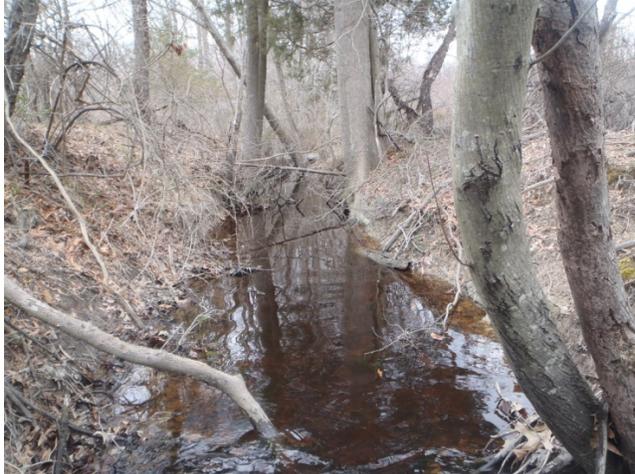
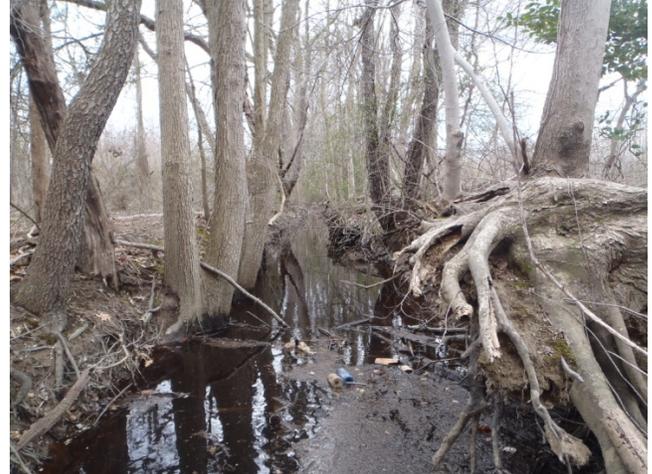
Site HB-13-Dup-2013 is located directly upstream of site HB-13-2013 on Deep Creek within the Deep Creek subwatershed. The channel appears to have been straightened in the past. The stream is also tannic due to heavy leaf litter and low flow. Instream rootwads and woody debris are abundant and a large debris jam is present on the upstream end of the site creating stable habitat for the benthic macroinvertebrate community. Both banks are moderately stable, with suboptimal vegetative protection and riparian width. The benthic macroinvertebrate community at this site was rated as Very Poor and dominated by isopods. No specialized feeding groups or habitats were present as well as no Ephemeroptera taxa. Low flow conditions and poor habitat complexity are likely affecting the biological community at this site. Forest is the primary land use, comprising 73% of this site’s drainage area and imperviousness is approximately 5%.

- Benthic macroinvertebrate community – “Very Poor”
- Habitat scores “Partially Supporting” and “Partially Degraded”
- Isopods (Asellidae) dominated the community.
- *In-situ* water quality values met COMAR standards.
- This site is very straight and only has slow flowing water. The water is stained heavily with tannins from leaf litter. Woody debris and rootwads provide a majority of the stable habitat present. Both banks are moderately stable.

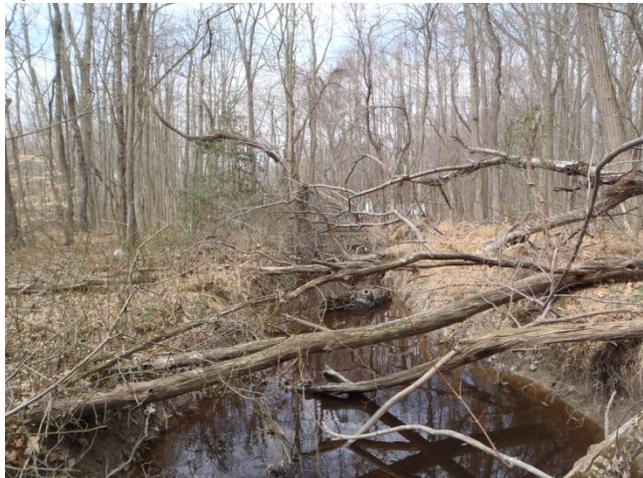
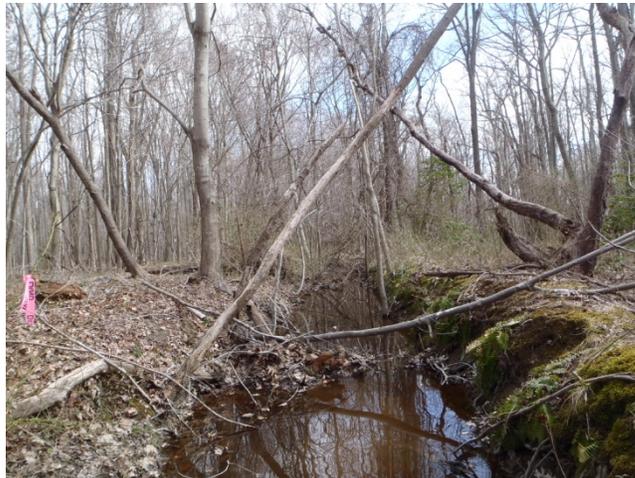
Site HB-14-2013 is located east of Deale Churchton Road on Deep Cove Creek within the Deep Cove Creek subwatershed. The channel has been straightened in the past and has very poor habitat complexity. Mud and sand are the dominate substrates and the water has been heavily stained with tannins from sitting leaf litter. Leaf packs and instream rootwads and woody debris make up the majority of stable benthic macroinvertebrate habitat. Banks are moderately unstable but have well developed riparian buffers. Aquatic worms dominated the community at this site. About 20% of the benthic macroinvertebrate community consisted of individuals intolerant to urban stressors. However, taxa diversity was low and Ephemeroptera taxa were absent, resulting in a Very Poor rating. The 367 acre drainage area is dominated by forested land (70%) and only 3% of the total area is comprised of impervious surfaces.

- Benthic macroinvertebrate community – “Very Poor”
- Habitat scores “Partially Supporting” and “Partially Degraded”
- Aquatic worms (Tubificidae) dominated the community.
- *In-situ* water quality values met COMAR standards.
- Very straight channel dominated by mud and sand substrates. Stream heavily stained with tannins due to standing leaf litter. Rootwads, woody debris, and leaf packs represent the primary benthic macroinvertebrate habitat. Human refuse is abundant and unsightly at this site.

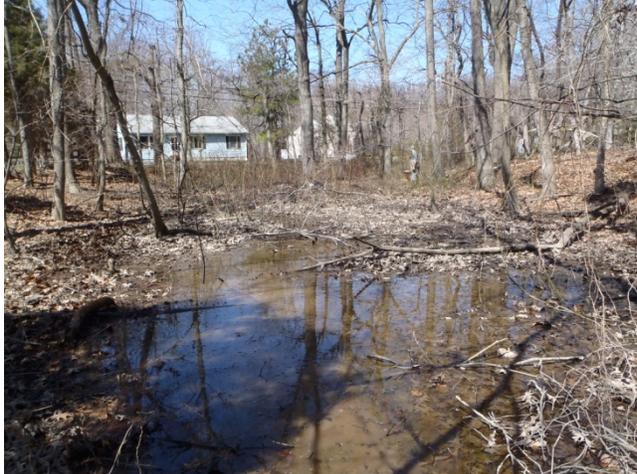
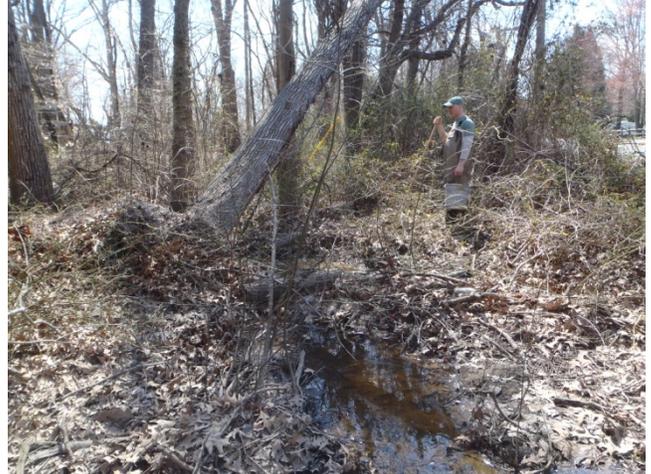
Site HB-19-2013 is located approximately 15 meters east of Tyler Road within the Parker Creek subwatershed. The channel lies between two wetlands and may function more as a wetland during the growing season. Velocity depth diversity and instream habitat are both poor with the primary stable habitat consisting of instream rootwads and woody debris. Bank stability and vegetative protection are optimal but riparian width is suboptimal on the right bank due to its close proximity to Tyler Road. The benthic macroinvertebrate community at this site was rated as Very Poor due to low taxa diversity and an absence of EPT taxa. Lack of habitat complexity, low flow conditions, and an intermittent water regime are likely affecting the biological community at this site. Of the 34 acre drainage area, 50% is developed land, 47% is forested land, and the remaining 3% is open land. Thirty-one percent of the drainage area is comprised of impervious surfaces, which is the highest of all Herring Bay sites sampled.

- Benthic macroinvertebrate community – “Very Poor”
- Habitat scores “Supporting” and “Partially Degraded”
- Aquatic worms (Tubificidae) and Isopods (Asellidae) dominated the community.
- *In-situ* water quality values met COMAR standards, but conductivity was elevated.
- This site is located in a shallow channel between two wetlands. Instream rootwads/woody debris and leaf packs are the dominate habitat. Banks are stable and vegetative protection is optimal.

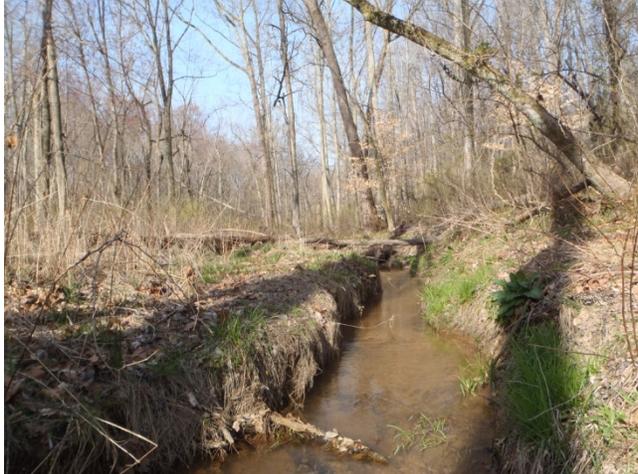
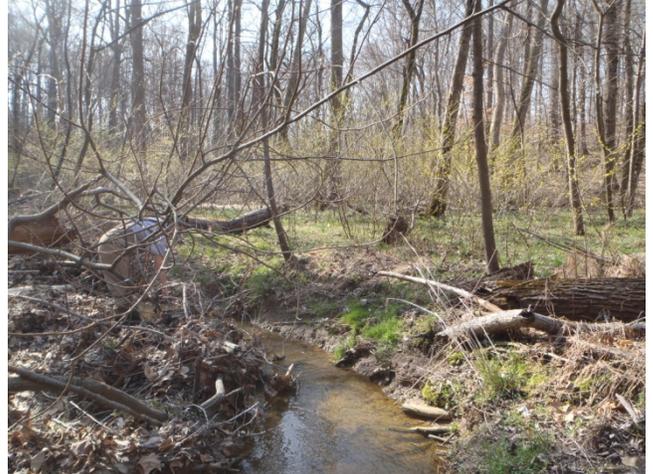
Site HB-20-2013 is located south of Tracys Lane in a stream valley behind a large farm within the Trotts Branch subwatershed. The dominant land cover of the 428 acre drainage area is forest (63%) and impervious surfaces account for less than 2% of the total area. The stream is relatively straight but has good habitat complexity, consisting of a few sandy riffles, deep pools with cover, and moderate amounts of submerged woody debris and aquatic vegetation. The stream has a well developed riparian buffer and banks are moderately stable with minor erosion and good vegetative bank protection. The benthic macroinvertebrate community at this site was rated as Poor and dominated by both mayflies and midges. Although this site supported the most diverse benthic macroinvertebrate community of all Herring Bay sites sampled and had a relatively high number of EPT taxa, the absence of Ephemeroptera taxa and lack of scrapers and climbers resulted in a Poor score.

- Benthic macroinvertebrate community – “Poor”
- Habitat scores “Supporting” and “Partially Degraded”
- Mayflies (*Amphinemura*) and midges (*Diplocladius*) dominated the community.
- *In-situ* water quality values met COMAR standards.
- This site has a small incised channel with moderate flow and good habitat complexity. The sampled reach consists of riffle/run complexes and a few deep pools with good cover. Submerged woody debris and vegetation and leaf packs provide the majority of the preferred benthic macroinvertebrate substrate.

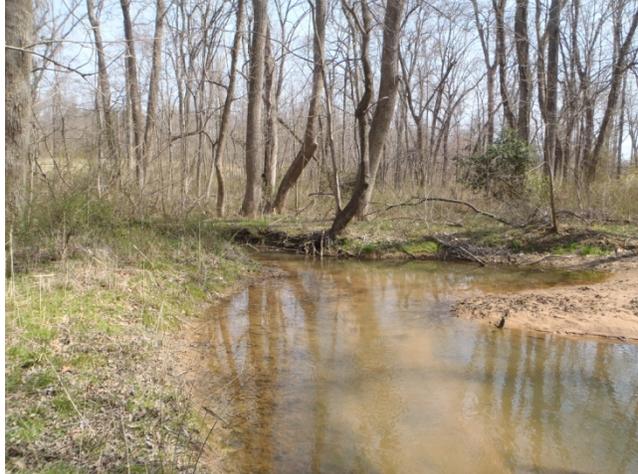
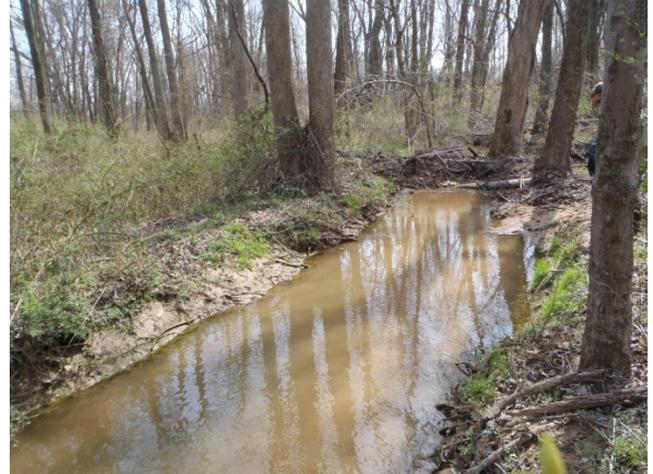
Site HB-21-2013 is located downstream of Franklin Gibson Road within the Trotts Branch subwatershed. A beaver dam is present downstream of the site and the zero meter portion of the reach has been excavated and appears to be used as a fishing pool. Almost two-thirds of the 1,135 acre drainage area is forested and 23% is developed land. Imperviousness accounts for a little over 2% of the drainage area. The stream is well connected to the floodplain with vernal pools and wetlands on both banks. Habitat complexity is moderate, consisting mostly of riffle/run complexes with some pools and high amounts of instream rootwads and woody debris. Banks are moderately stable with good vegetative protection and a well developed riparian buffer. The benthic macroinvertebrate community at this site supported a relatively high number of taxa and was one of the only sites sampled in the Herring Bay Watershed to contain an Ephemeroptera taxon. Although the taxa diversity was high, it consisted mainly of midge genera, which are tolerant to urban stressors. The pH reading was out of compliance with COMAR standards at 8.71, exceeding the one time standard of 8.50, which may be due to large amounts of algae observed during the fieldwork.

- Benthic macroinvertebrate community – “Poor”
- Habitat scores “Supporting” and “Minimally Degraded”
- Midges (*Diplocladius* & *Orthocladius*) dominated the community.
- Was out of compliance with COMAR standards for pH.
- The channel at this site is wide and shallow with a diversity of flows and little erosion. The stream bottom consists of mostly sand and clay, with some gravel riffles. High amounts of instream rootwads and woody debris account for the majority of benthic macroinvertebrate habitat.

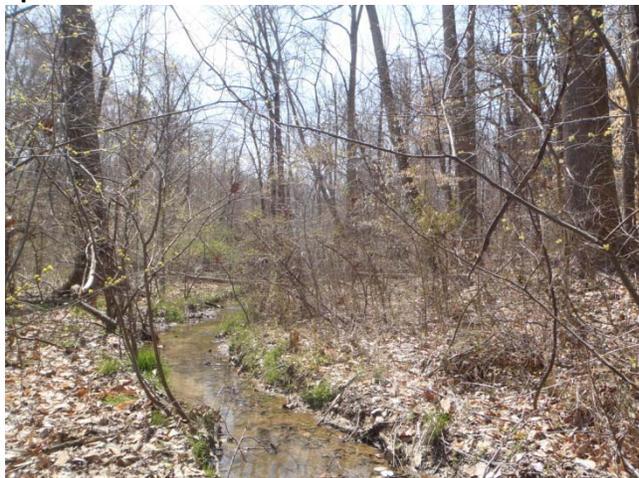
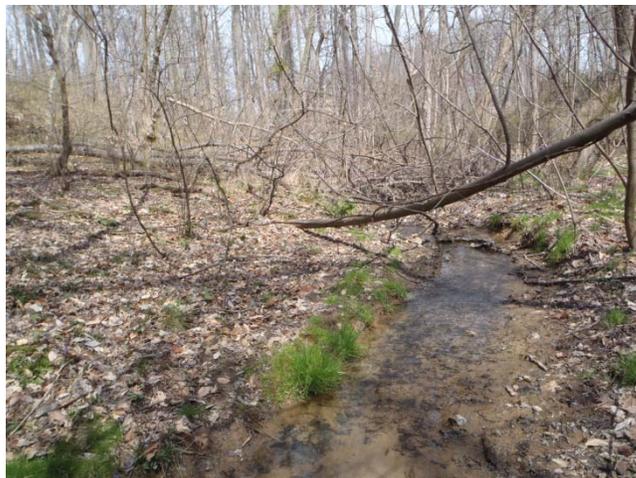
Site HB-23-2013 is located upstream of Town Point Road within the Unnamed Tributary subwatershed. The channel is very shallow, but the site appears to be relatively unimpaired. The stream bottom consists of mud, sand, and clay, and extensive wetlands are present on the right bank. Instream features consist of run/glide complexes with small areas of shallow pools. Leaf packs and instream rootwads and woody debris are the primary habitats for benthic macroinvertebrates at this site. Banks are stable with no evidence of erosion and the riparian buffer is well developed. The benthic macroinvertebrate community at this site had moderately low taxa diversity. However, 35% of the community was intolerant to urban stressors and specialized feeding groups and habits were present, resulting in a Fair rating. Forest is the primary land use in this site’s drainage area and imperviousness is approximately 4%.

- Benthic macroinvertebrate community – “Fair”
- Habitat scores “Supporting” and “Minimally Degraded”
- Amphipods (Crangonyctidae) dominated the community.
- *In-situ* water quality values met COMAR standards.
- The stream channel is shallow and has extensive wetlands in its floodplain. The stream bottom consists of mud, sand, and clay. Moderate amounts of instream rootwads/woody debris are present and there is no evidence of erosion at this site.

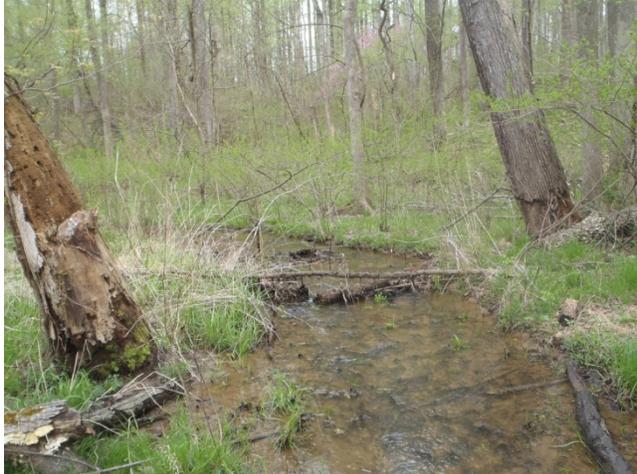
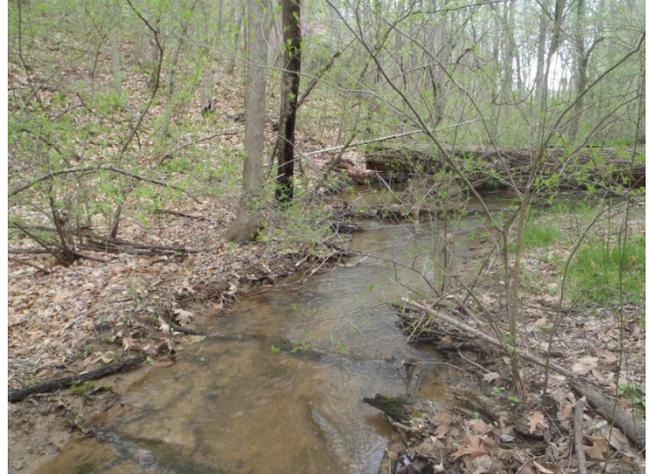
Site HB-25-2013 is located downstream of Highland Road in the Unnamed Tributary II subwatershed. The stream is braided due to historic beaver activity and has extensive wetlands in its floodplain. Instream features consist mostly of run/glide complexes with a few shallow riffles. Instream woody debris and submerged vegetation account for the majority of the benthic macroinvertebrate habitat. This site has a well developed riparian buffer and stable stream banks. Taxa diversity was relatively high and the percentage of individuals intolerant to urban stressors was over 40%. However, Ephemeroptera taxa and climbers were absent, resulting in a Poor rating. Of the 456 acre drainage area, over 85% is forest and just over 1% consists of impervious surfaces.

- Benthic macroinvertebrate community – “Poor”
- Habitat scores “Comparable to Reference” and “Minimally Degraded”
- Stoneflies (*Amphinemura*), Amphipods (*Crangonyctidae*), and Isopods (*Caecidotea*) dominated the community.
- *In-situ* water quality values met COMAR standards.
- This shallow stream is in excellent condition. The bottom consists of clay, mud, and sand with little gravel. The banks at this site are very stable and the riparian buffer is unimpaired. Epifaunal habitat is suboptimal.

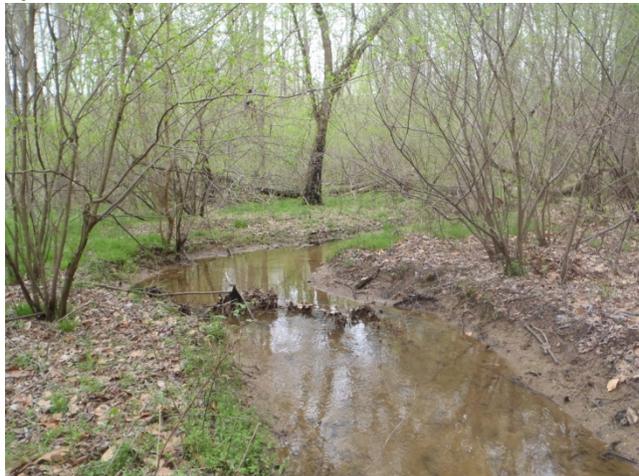
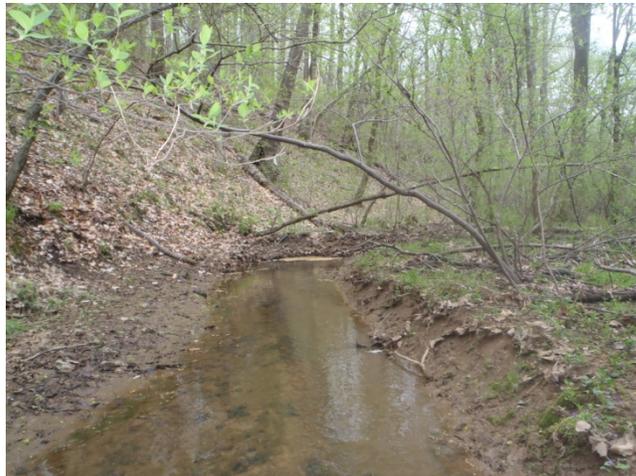
Site HB-25-Dup-2013 is located immediately upstream of the sampling site HB-25-2013 in the Unnamed Tributary II subwatershed. Extensive wetlands are present in the floodplain due to historic beaver activity. Instream features consist mostly of run/glide complexes with shallow riffles. The stream substrate is dominated by mud, sand, and clay, with little gravel present. Leaf packs and instream woody debris and rootwads account for the majority of the benthic macroinvertebrate habitat. The stream has a well developed riparian buffer and banks are stable with minor erosion and optimal vegetative protection. Despite having a benthic macroinvertebrate community with a high percentage of individuals intolerant to urban stressors and moderate taxa diversity, the community was rated as Poor because Ephemeroptera taxa and climbers were absent. Of the 455 acre drainage area, over 85% is forest and just over 1% consists of impervious surfaces.

- Benthic macroinvertebrate community – “Poor”
- Habitat scores “Supporting” and “Minimally Degraded”
- Stoneflies (*Amphinemura*), Amphipods (*Crangonyctidae*), and Isopods (*Caecidotea*) dominated the community.
- *In-situ* water quality values met COMAR standards.
- The stream channel is shallow and has extensive wetlands in the floodplain. Moderate amounts of instream rootwads/woody debris are present at there is very minor erosion on both banks. Leafpacks provide the majority of instream habitat for benthic macroinvertebrates.

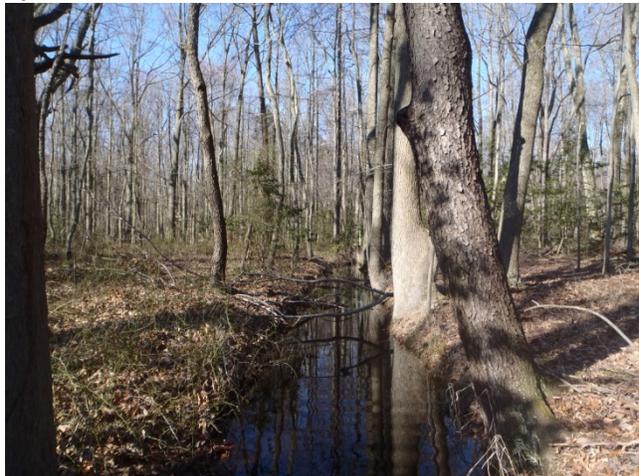
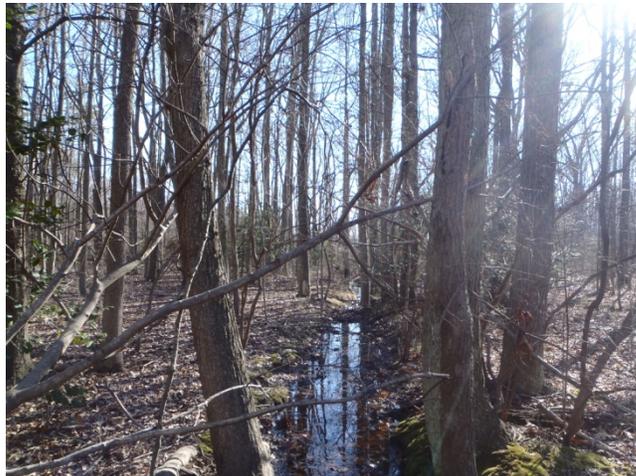
# HB-31-2013

Site HB-31-2013 is located southeast of Kellman Road within the Cedarhurst subwatershed. Forested and developed lands encompass the entire 67 acre drainage area, covering 70 and 30 percent, respectively. Approximately 3% of the drainage area is comprised of impervious surfaces. The stream channel at this site consists mainly of long runs and glides with a few shallow pools. A moderate amount of instream rootwads are present, but other stable substrates for benthic macroinvertebrates are lacking and the stream did not have a diversity of flows. The benthic macroinvertebrate community at this site was rated as Very Poor. Taxa diversity and the percentage of individuals intolerant to urban stressors were low. Low flow conditions and poor habitat complexity are likely affecting the biological community at this site.

- Benthic macroinvertebrate community – “Very Poor”
- Habitat scores “Supporting” and “Minimally Degraded”
- Midges (*Pseudorthocladus*) heavily dominated the community.
- *In-situ* water quality values met COMAR standards.
- This is a highly straightened slow flowing stream with tannic water from standing leaves. Instream rootwads make up the majority of habitat, but overall Epifaunal substrate is poor.

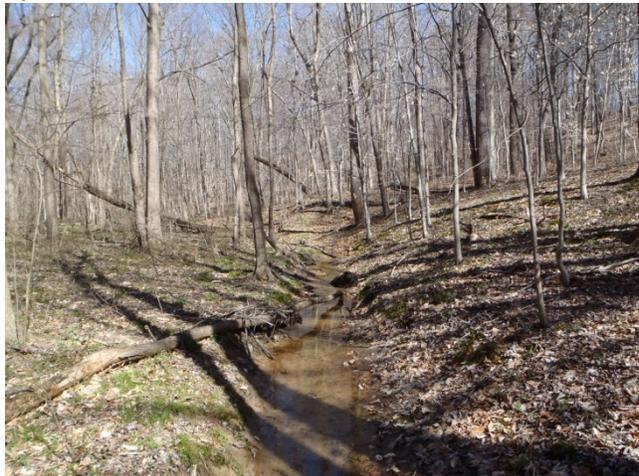
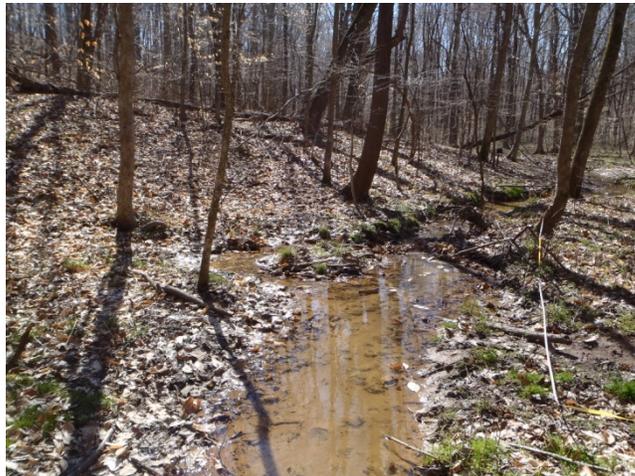
# HB-36-2013

Site HB-36-2013 is located in a forested valley downstream of Bayfront Road within the Tracy’s Creek I subwatershed. Although the stream is in good condition with minimal disturbance, it appears have an intermittent flow regime. Instream reach features consist primarily of run/glide complexes and a few shallow riffles. Small sections of erosion are present on both banks, but they are generally stable. Despite having a benthic macroinvertebrate community with a high percentage of individuals intolerant to urban stressors and moderate taxa diversity, the community was still rated as Poor because Ephemeroptera taxa were absent. The Poor community rating may be attributed to an intermittent water regime and low habitat complexity. The majority of the 126 acre drainage area is forested with only 3% impervious surfaces.

- Benthic macroinvertebrate community – “Poor”
- Habitat scores “Supporting” and “Partially Degraded”
- Midges (*Rheocricotopus* & *Orthocladius*) and black flies (*Stegopterna*) dominated the community.
- *In-situ* water quality values met COMAR standards.
- This shallow intermittent channel has a silty/clay bottom and no pool habitat. Instream rootwads and woody debris make up the majority of stable benthic macroinvertebrate habitat. Stream banks are relatively stable with optimal vegetative protection and riparian width.
