# Herring Bay, Middle Patuxent, and Lower Patuxent Watershed Assessment

## Comprehensive Summary Report

June 2018 | Final Report

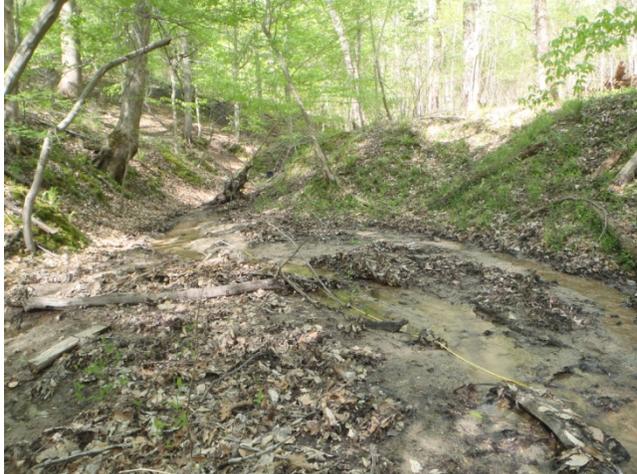
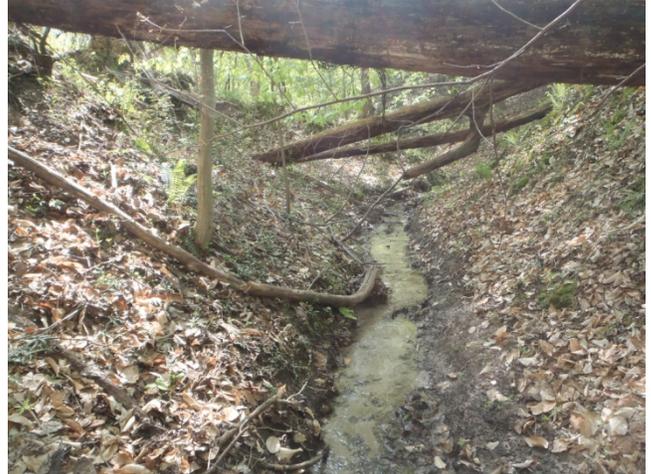
Site HB-41-2013 is located in a deep forested valley with steep side slopes, northwest of Fairhaven Road, within the Unnamed Tributary III subwatershed. This headwater channel is intermittent with very low water level and poor habitat complexity. The reach consists mainly of run/glide complexes with very little pool and riffle habitat. The channel substrate is primarily comprised of sand, which is the dominate habitat. The benthic macroinvertebrate community at this site was rated as Very Poor and consisted mainly of midges (*Parametrioctenus*) and isopods (*Caecidotea*). About 33% of the community was comprised of individuals intolerant to urban stressors, but an absence of Ephemeroptera, scrapers, and climbers resulted in a Very Poor score. Of the 13 acre drainage area, over 99% is forested land and about 4% is impervious surfaces. *In-situ* water quality parameters measured within COMAR standards, but conductivity was elevated, with a reading of 321 $\mu$ S/cm.

- Benthic macroinvertebrate community – “Very Poor”
- Habitat scores “Supporting” and “Minimally Degraded”
- Midges (*Parametrioctenus*) and Isopods (*Caecidotea*) dominated the community.
- *In-situ* water quality values met COMAR standards, but conductivity was elevated.
- This very small/shallow headwater channel located in a deep valley had good sinuosity, stable stream banks, and a well developed riparian buffer.

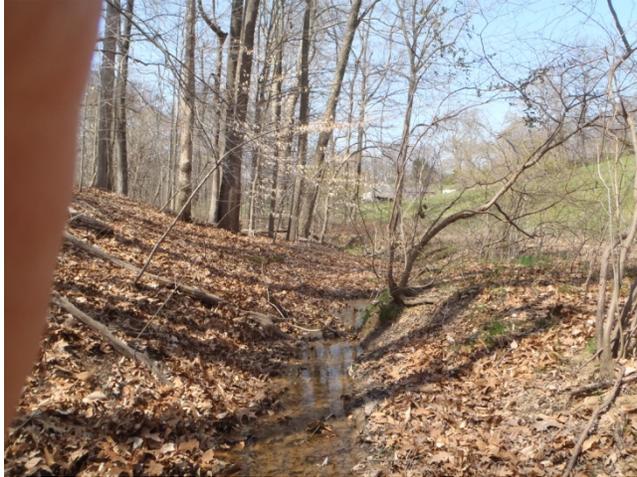
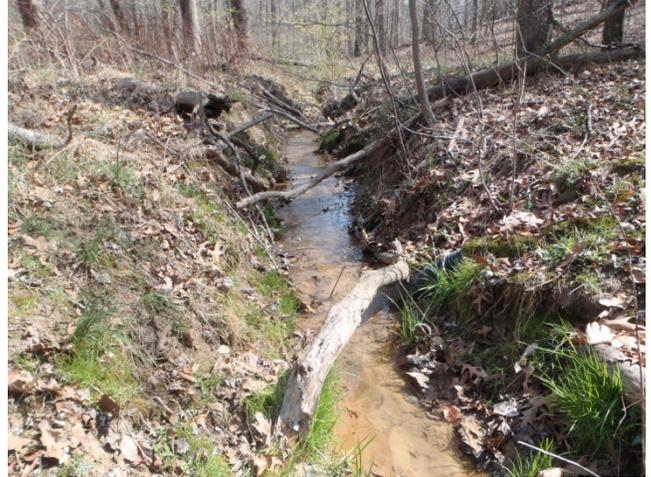
**(Latitude: 38.758725, Longitude: -76.576628)**

Site HB-47-2013 begins just downstream of a farm field, east of Franklin Gibson Road, within the Unnamed Tributary subwatershed. The stream in this area is incised and banks are moderately unstable. Human activity has moderately impacted the riparian zone on both banks. The benthic macroinvertebrate community was rated as Very Poor due to low taxa diversity, low percentage of individuals intolerant to urban stressors, and an absence of Ephemeroptera taxa. This may be attributed to an overall lack of habitat and stable substrate. *In-situ* water quality values were within COMAR standards, but conductivity was elevated, with a reading of 359µS/cm. Land use in the drainage area to this site is diverse with 28% developed land, 42% forested land, and 28% agricultural land. Impervious surfaces account for about 5% of the drainage area.

- Benthic macroinvertebrate community – “Very Poor”
- Habitat scores “Partially Supporting” and “Partially Degraded”
- Midges (*Diplocladius*) dominated the community.
- *In-situ* water quality values met COMAR standards, but conductivity was elevated.
- This small incised channel has low flow and very little benthic macroinvertebrate habitat. The reach consists mainly of long run/glide complexes with a moderate amount of instream woody debris present.

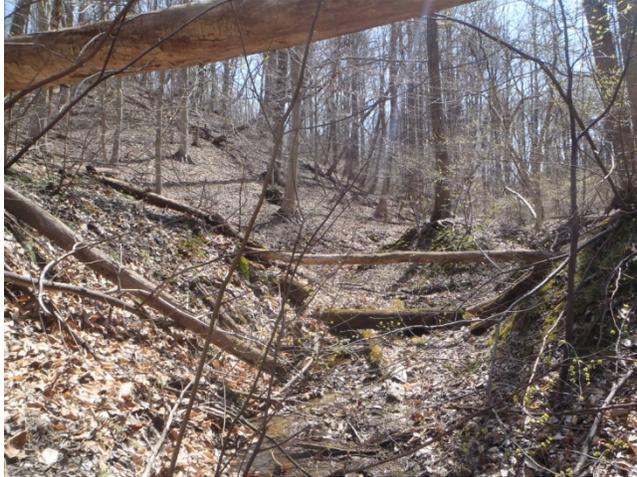
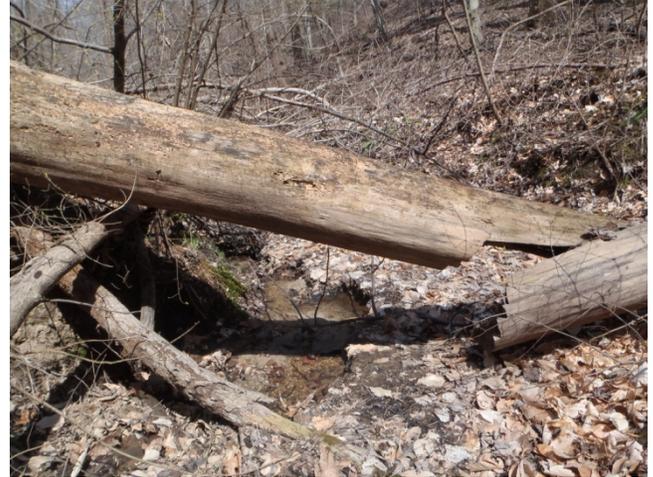
(Latitude: 38.731533, Longitude: -76.568654)

Site HB-48-2013 is located in a valley north of Fairhaven Road within the Unnamed Tributary II subwatershed. Of the 9.6 acre drainage area, approximately 77% is forested, 23% is developed, and 3% consists of impervious surfaces. This is the smallest drainage area sampled within the Herring Bay Watershed. This headwater stream likely has intermittent flow indicated by very low water level. A few pieces of instream woody debris are present, but the majority of the macroinvertebrate habitat consists of leaf packs and shallow silty/clay riffles. The left bank of the stream is moderately unstable with some areas of severe erosion, but the riparian width is optimal on both banks. The benthic macroinvertebrate community at this site had low taxa diversity and a low percentage of individuals that were intolerant to urban stressors, which resulted in a Very Poor rating. This may be attributed to a lack of complex and stable habitat, and an intermittent water regime. *In-situ* water quality values were within COMAR standards, but conductivity was elevated with a reading of 527.3µS/cm.

- Benthic macroinvertebrate community – “Very Poor”
- Habitat scores “Partially Supporting” and “Partially Degraded”
- Amphipods (Gammaridae) and midges (*Diplocladius* & *Parametriocnemus*) dominated the community.
- *In-situ* water quality values met COMAR standards, but conductivity was elevated.
- This is a shallow, intermittent channel with lots of instream leaf litter. A few pools are present throughout, but the site consists primarily of long stretches of shallow riffles, resulting in poor habitat complexity.

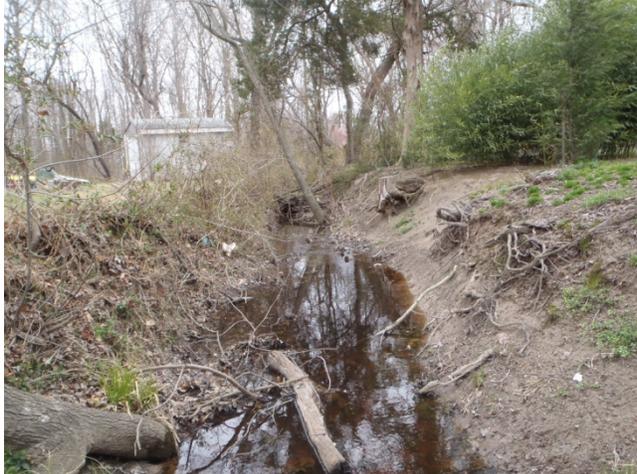
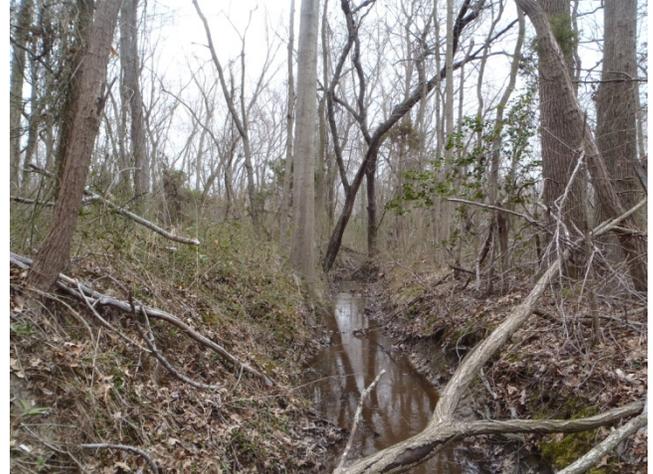
**(Latitude: 38.798462, Longitude: -76.536159)**

Site HB-49-2013 is located behind a residential area at the end of Lee Way Court, within the Broadwater Creek subwatershed. The stream appears to have been straightened and the vegetation is mowed up to the edge on both banks. The stream has extensive amounts of trash due to its close proximity to homes. One neighbor indicated the stream has been treated with insecticides to control mosquito populations. Channel substrate consists mainly of silt and clay with little sand. Riffles are almost entirely absent and run/glides are the most dominant instream feature. Leaf packs are the primary habitat for benthic macroinvertebrates. The benthic macroinvertebrate community at this site was rated as Poor and dominated by aquatic worms. No Ephemeroptera taxa and very few specialized feeding groups or habits were collected at this site. Of the 157 acre drainage area, 52% is comprised of developed land. Impervious surfaces account for almost 12% of the drainage area, which is the second highest percentage of all Herring Bay sites. *In-situ* water quality values were within COMAR standards, but conductivity was slightly elevated with a reading of 260.3µS/cm.

- Benthic macroinvertebrate community – “Poor”
- Habitat scores “Non Supporting” and “Degraded”
- Aquatic worms (*Tubificidae*, *Naididae* & *Lumbriculidae*) dominated the community.
- *In-situ* water quality values met COMAR standards, but conductivity was elevated.
- This straightened stream had abundant human refuse. Banks are moderately unstable with marginal vegetative protection. This site has poor habitat complexity for aquatic biota.

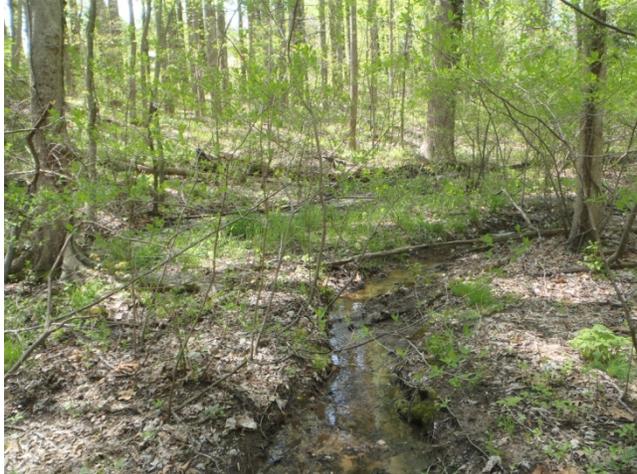
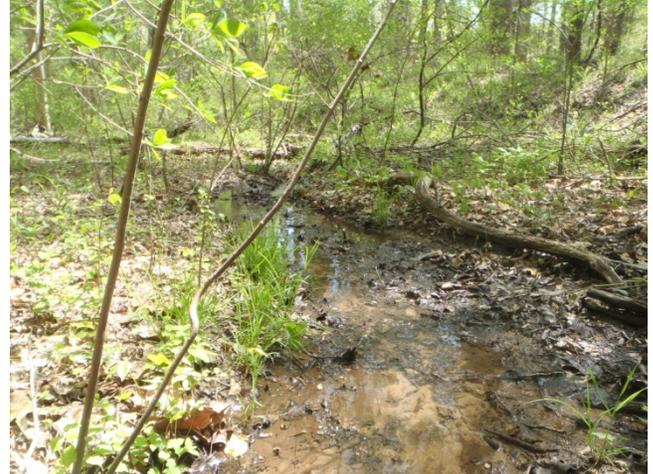
(Latitude: 38.724922, Longitude: -76.561613)

Site HB-50-2013 is located north of Friendship Road, behind a residential area, within the Unnamed Tributary III subwatershed. A dirt trail leads up to the stream and there is a small culvert directly in the middle of the reach. The stream is very shallow and dissipates into wetland swales both at the upstream and downstream end. Long run/glide complexes make up the majority of the reach. A few shallow sandy riffles are present, but pools are essentially absent. Instream rootwads and woody debris are present, but in small amounts. The benthic macroinvertebrate community at this site had a high percentage of individuals intolerant to urban stressors and moderate taxa richness, but Ephemeroptera taxa and climbers were absent, resulting in the Poor score. Developed and forested land made up more than 96% of this 10.6 acre drainage area, with about 6% of the total area consisting of impervious surfaces. *In-situ* water quality measurements were within COMAR standards. However, conductivity was elevated with a reading of 289.5µS/cm and the water level was too low to record an accurate turbidity measurement.

- Benthic macroinvertebrate community – “Poor”
- Habitat scores “Supporting” and “Minimally Degraded”
- Isopods (*Caecidotea*) and Amphipods (*Crangonyctidae*) dominated the community.
- *In-situ* water quality values met COMAR standards, but conductivity was elevated.
- This is likely an intermittent or ephemeral stream which dissipates into wetlands both at the upstream and downstream ends. Marginal instream habitat consists mainly of leaf packs and shallow riffles. This site has good bank stability with minimal erosion.
