MAYO BEACH PARK

4150 Honeysuckle Drive
Edgewater, Maryland 21037

Condition Assessment for Anne Arundel County DEPARTMENT OF RECREATION & PARKS

Contract Number: P582101
Project Number: P582100

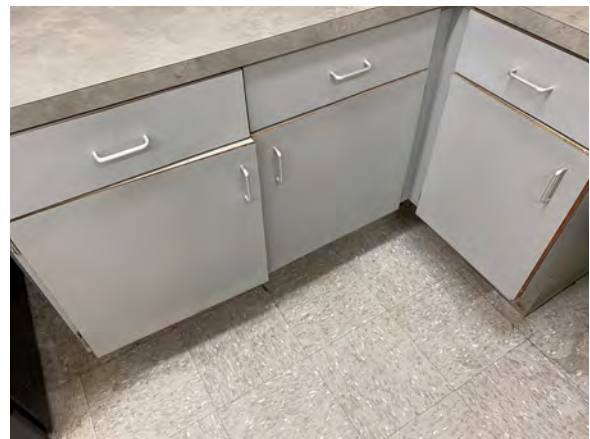
Building 1 - Glass Pavilion appears to be in good working condition and generally functions as anticipated. Later renovations (dates unknown) replaced the sliding doors, windows, bathroom fixtures, and flooring. The kitchen cabinets and countertop are in very poor condition with delaminating surfaces occurring in several locations.

Kitchen cabinets

Recommendations - Interior Finishes			
Item	Description	Condition	Action Required
1.4.1	Vestibule 1 & 2	WORK	Repaint walls, ceiling, and base trim
1.4.2	Glass Pavilion	WORK	Repaint walls, ceiling, and wood base trim. Replace flooring and vinyl base.
1.4.3	Men's	WORK	Repaint walls and ceiling. Replace flooring and vinyl base. Additional soap dispenser needed.
1.4.4	Women's	WORK	Repaint walls and ceiling. Replace flooring and vinyl base. Install a mirror.
1.4.5	Kitchen	POOR	Repaint walls and ceiling. Replace flooring and vinyl base with a more durable and slip resistant product. Replace base & wall cabinets and countertops. For additional action refer to kitchen assessment on page 37 of this report.

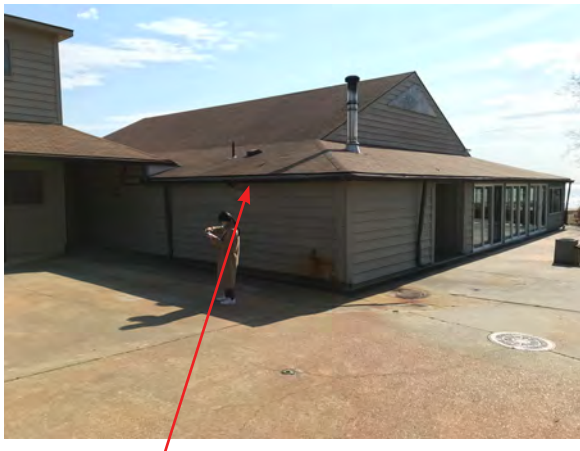
Damaged gutter and downspout

Recommendations - Exterior Envelope			
Item	Description	Condition	Action Required
1.1.1	Roofing	WORK	Further inspections of the asphalt roofing shingles to determine age of roof. Repair/replace sections of gutter and downspouts that are damaged.
1.1.2	Siding	WORK	Repair/replace deteriorated sections of siding and wood corner boards where deterioration/rot is evident.
1.1.3	Siding - Sealant at Windows and Doors	POOR	Sealant at windows and doors are deteriorated in some areas and need to be replaced.

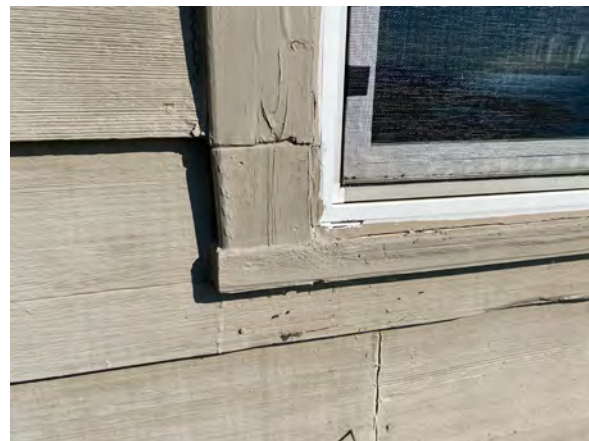
The siding is wood lap siding with 2x wood corner boards. It has received many coats of paint over the years. It is in fair condition with some areas around sliding doors, windows, fascia board, and near ground contact that show rotted or deteriorated conditions.

Damaged siding

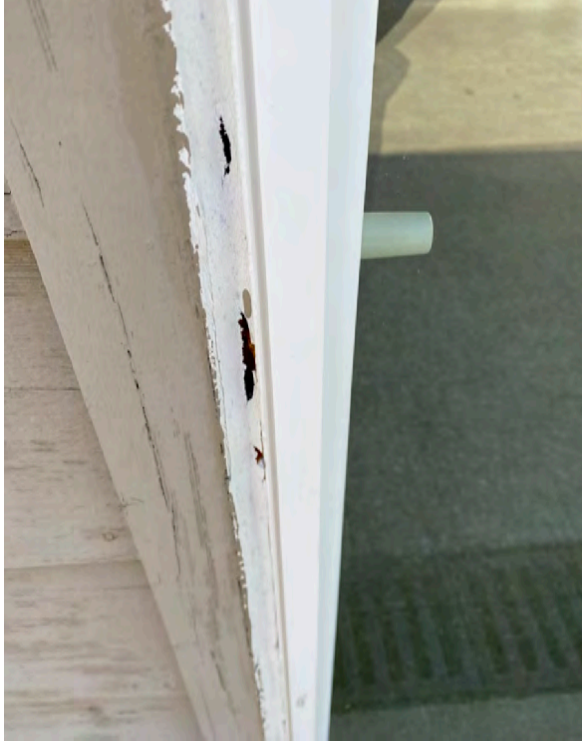
Deteriorated sealant

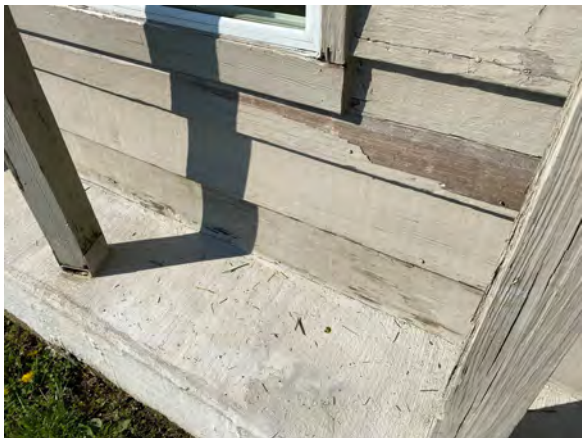
Deteriorated siding

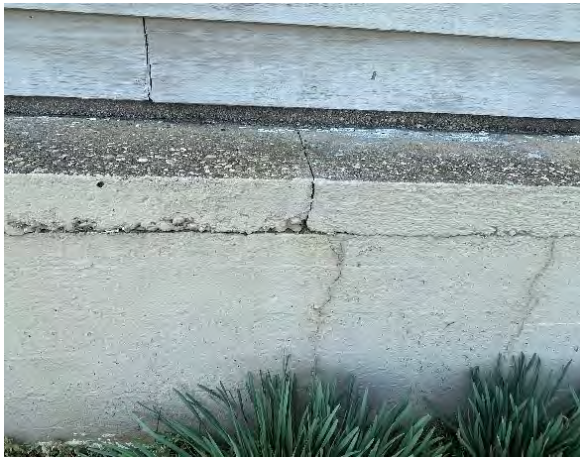
The exterior perimeter foundation walls are concrete. We noted the top surface of the walls where the slab projects beyond the exterior wall to be weathered with minor cracking distress at the slab joints.

Exterior Foundation wall where slab projects

Recommendations - Glass Pavilion Structure			
Item	Description	Condition	Action Required
1.5.1	Foundation Wall Slab Joints	POOR	Clean and fill with backer rod and sealant.
1.5.2	Shallow Stepped Footings	WORK	Monitor for any distress, consider adding fill to protect from frost.
1.5.3	Bathroom Column Corrosion	WORK	Clean and paint to minimize deterioration.
1.5.4	Exterior Slab Cracking	WORK	Rout and fill with sealant to prevent water Infiltration and deterioration.

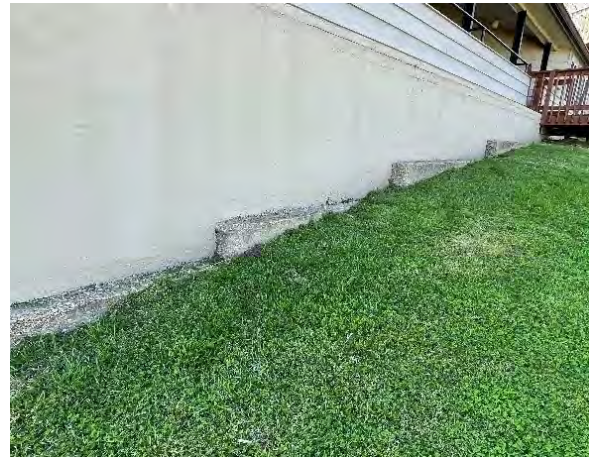
The exterior grade slopes downward toward the water. Along the water elevations the footings appear to have been stepped and the tops of the footings are visible and be flush with grade. We suspect the footings are not deep enough to be below the frost line, although we did not observe any distress or movement that would be an immediate structural concern.

Stepped footing exposed, suspect not below frost line

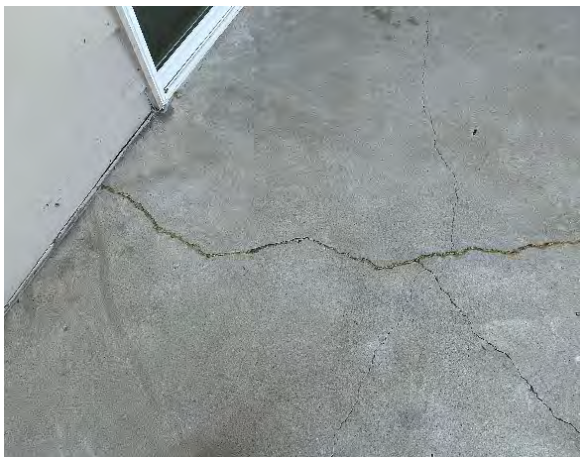
The floor is slab on grade. On the water side elevation there is an exterior concrete deck. We observed minor hairline shrinkage cracking in the concrete surface, however nothing of a structural concern.

Exterior slab shrinkage cracking

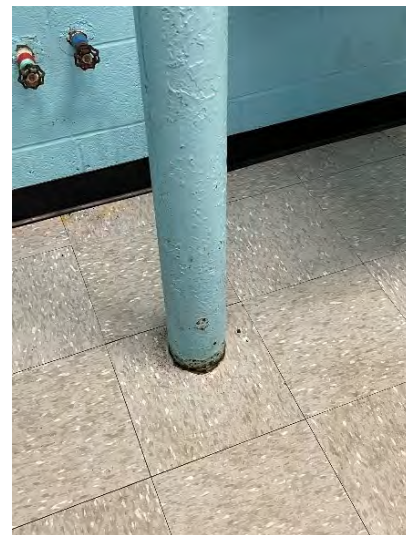
The bathroom walls are partitioned with concrete masonry walls. We observed steel pipe columns with minor corrosion noted at the base interface with the slab.

View of column base in bathroom

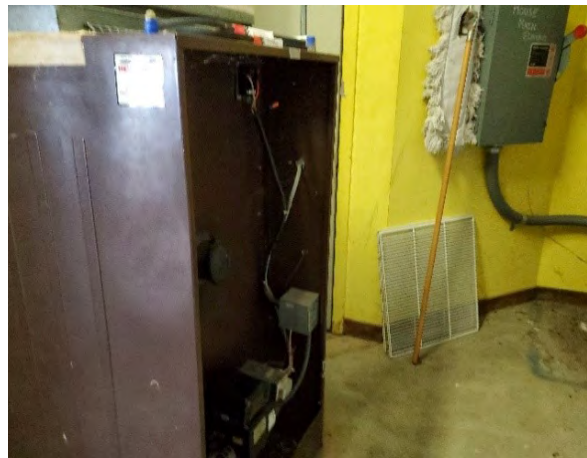
Ducted Oil Fired furnace

The ducted oil fired furnace unit, and space electric unit heaters shall be replaced with a 16 ton split system heat pump unit with electric backup heat to provide heating and cooling to the building. The unit shall be located in the space of the old ducted oil fired furnace. An exterior location shall be picked for the location of the condensing unit. The unit shall be provided with ventilation air. The existing ductwork shall remain in place and branch ducts shall be added to the kitchen and corridor. All the existing ductwork shall be insulated.

Recommendations - Mechanical Systems			
Item	Description	Condition	Action Required
1.6.1	Ducted Oil Fired Furnace	WORK	No space cooling. Shall be replaced with cooling unit.
1.6.2	Bathroom Exhaust Fan	WORK	No Action Required
1.6.3	Mechanical Room Unit Heater	WORK	The unit heater shall remain in place.
1.6.4	Kitchen Unit Heater	WORK	The unit heater can be removed with the installation of branch ductwork from the split system heat pump.
1.6.5	Corridor Unit Heater	WORK	The unit heater can be removed with the installation of branch ductwork from the split system heat pump.
1.6.6	Men's Unit Heater	WORK	No Action Required
1.6.7	Mechanical Room Exhaust Fan	WORK	No Action Required
1.6.8	Janitor Closet Exhaust Fan	WORK	No Action Required

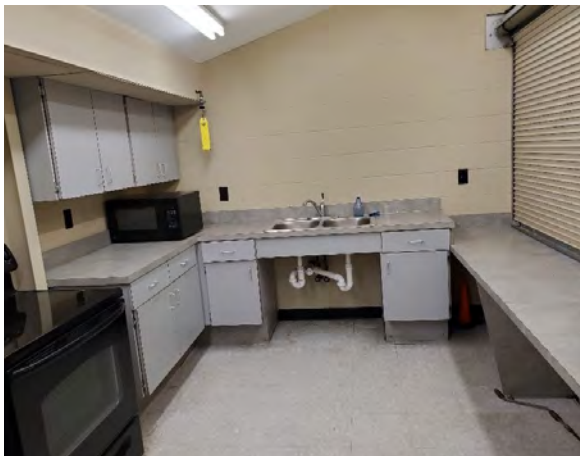
The Kitchen contains a residential style double sink with faucet that looks like it is in good condition without any crack or damages. There is also a cold water connection that is rusted and should be replaced.

Kitchen Sink

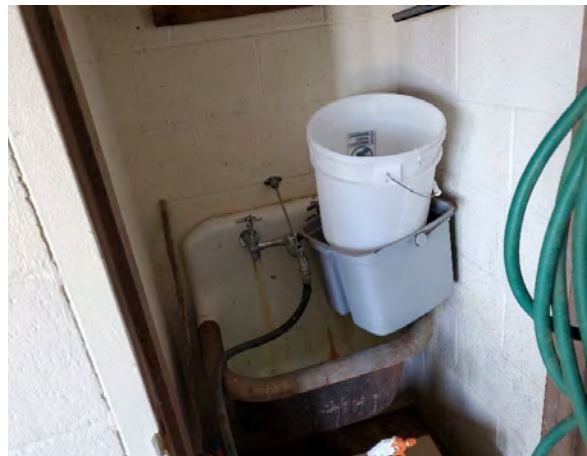
The janitor closet is located next to the bathroom and contains a janitor sink that looks like it is in good condition without any crack or damages.

Janitor Closet Sink

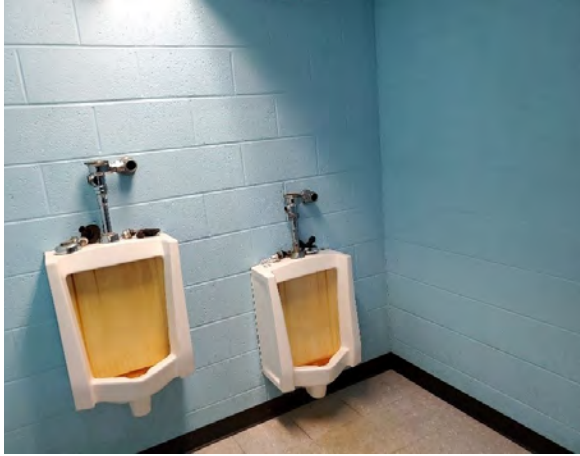
The Men's and Women's Bathroom contain metered lavatory, and flush valve water closets and the Men's Bathroom also contain flush valve urinals. The plumbing fixtures look like they are in good condition without any crack or damages. The water closets and urinal are stained from water hardness.

Men's Bathroom Urinal

Recommendations - Plumbing Systems			
Item	Description	Condition	Action Required
1.7.1	Water Closet	WORK	Should be replaced after campus water hardness is resolved
1.7.2	Urinal	WORK	Should be replaced after campus water hardness is resolved
1.7.3	Lavatory	WORK	No action required.
1.7.4	Janitor Sink	WORK	No action required.
1.7.5	Kitchen Sink	WORK	No action required.

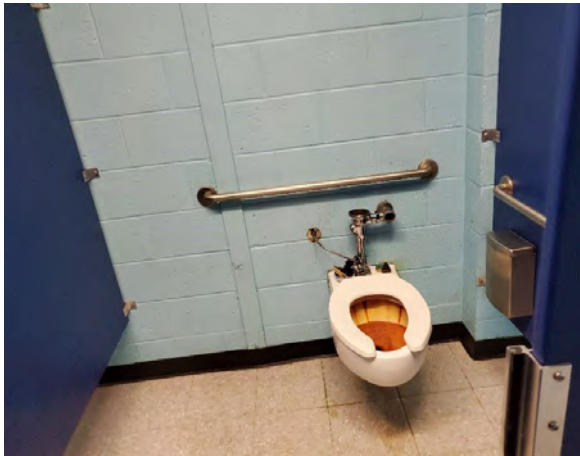
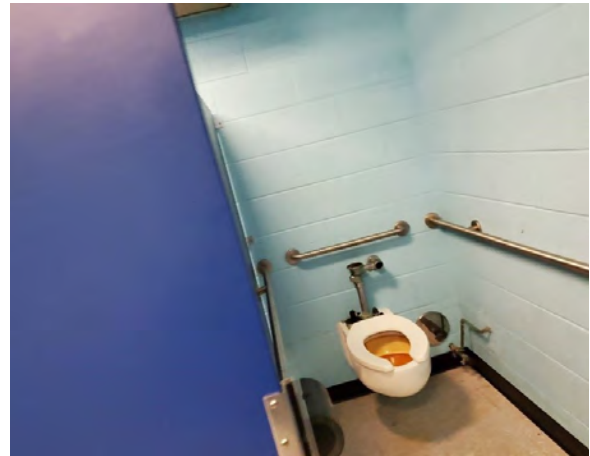
Women's Bathroom Water Closet

Men's Bathroom Water Closet

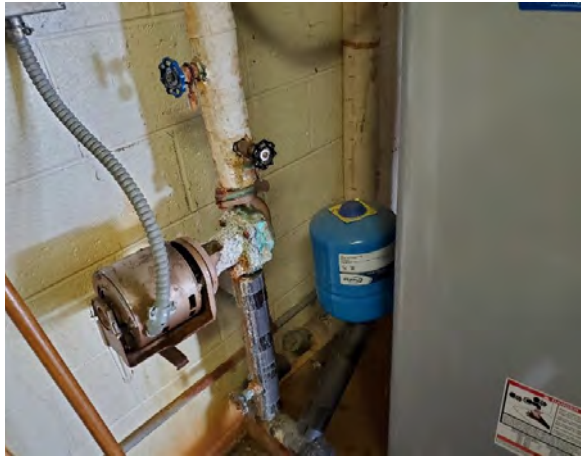
The building is served by a 50 gallon 12 KW domestic water heater. The water heater is manufactured by State and looks to be in good condition. The hot water system also has an expansion tank in good condition and a recirculating pump that is corroded. Water heaters of this capacity are available in both residential and commercial grades. Replacement unit should be a commercial grade unit.

Expansion Tank and Recirculating Pump

Recommendations - Plumbing Systems			
Item	Description	Condition	Action Required
1.7.6	Domestic Water Heater	GWC	No action required.
1.7.7	Expansion tank	GWC	No action required.
1.7.8	Recirculating pump	POOR	The recirculating pump shall be replaced in kind.

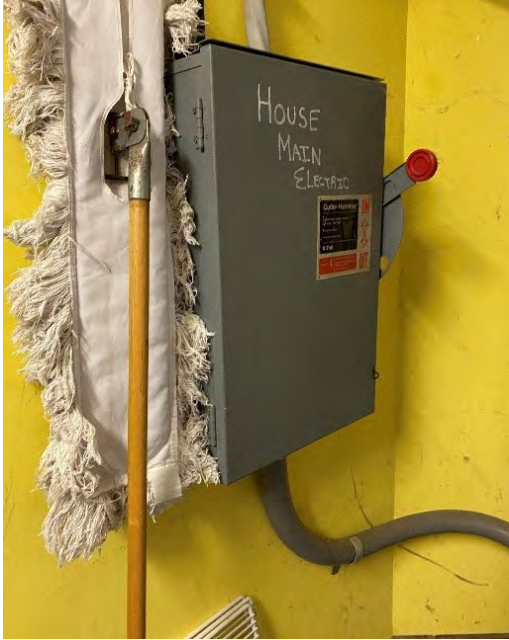
Recommendations - Distribution System			
Item	Description	Condition	Action Required
1.8.1	Main Panelboard	POOR	Over 40 years old. Replace with service entrance rated main breaker panelboard.
1.8.2	Service Disconnect	POOR	Over 40 years old. Remove disconnect when new service entrance rated panelboard is provided.
1.8.3	Building Grounding System	POOR	Replace building grounding system with distribution replacement in next 1-3 years.

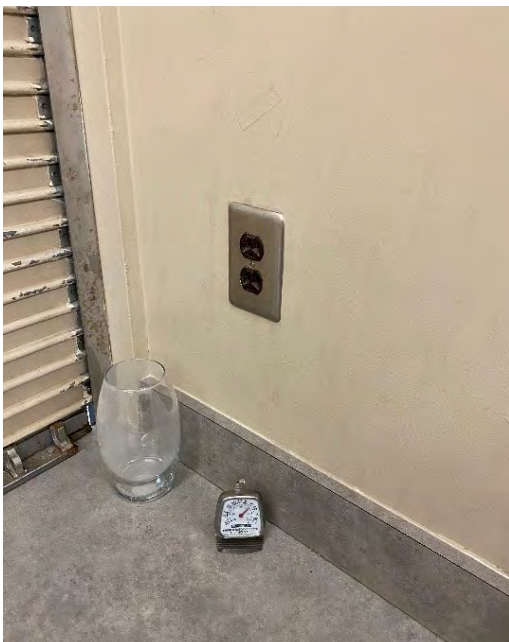
All receptacles in the Kitchen must have ground-fault circuit-interrupter (GFCI) protection as required by NEC 210.8. The circuit breakers feeding receptacles in the kitchen are also not GFCI. Provide receptacles with GFCI protection or GFCI circuit breakers for the safety of personnel in the kitchen.

Kitchen Receptacle

Recommendations - Miscellaneous Electrical			
Item	Description	Condition	Action Required
1.8.4	Receptacle(s) in Kitchen	IMME	All receptacles in kitchen to be GFCI protected prior to use.
1.8.5	Branch Circuit Wiring	WORK	Replace all branch circuit wiring in future, ideally at the same time as the associated devices and/or fixtures.

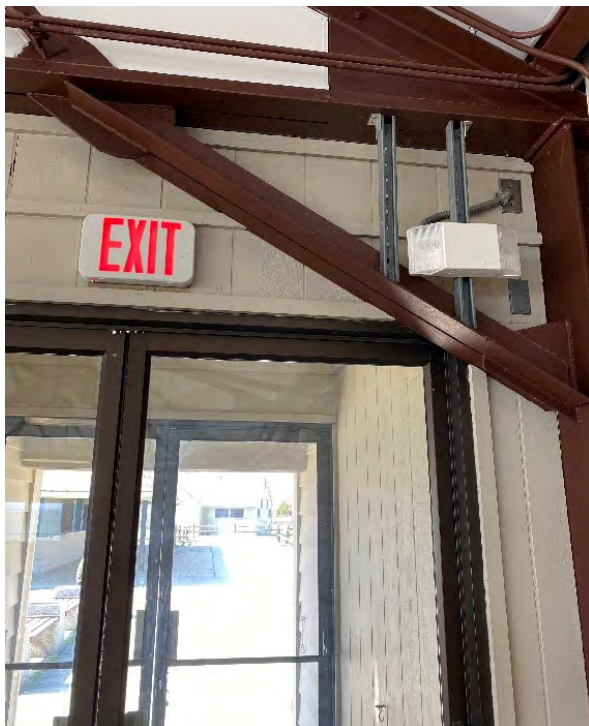
There were only two emergency battery packs used for egress lighting throughout the building. Additional wall packs required to be installed to provide required illuminance along the paths of egress.

Typical Emergency Wall Pack

Recommendations - Lighting			
Item	Description	Condition	Action Required
1.8.6	Exit Signs	WORK	Repair/replace non-illuminated exit sign.
1.8.7	Restroom Light Switches	WORK	Lower light switches in restrooms to 46" above finished floor to comply with ADA requirements. Refer to ADA report in Appendix A for additional information.
1.8.8	Interior Lighting	WORK	Replace with LED fixtures in future.
1.8.9	Egress Lighting	IMME	Replace existing emergency battery packs with LED. Install new lighting fixture(s) to provide required egress illuminance throughout building.

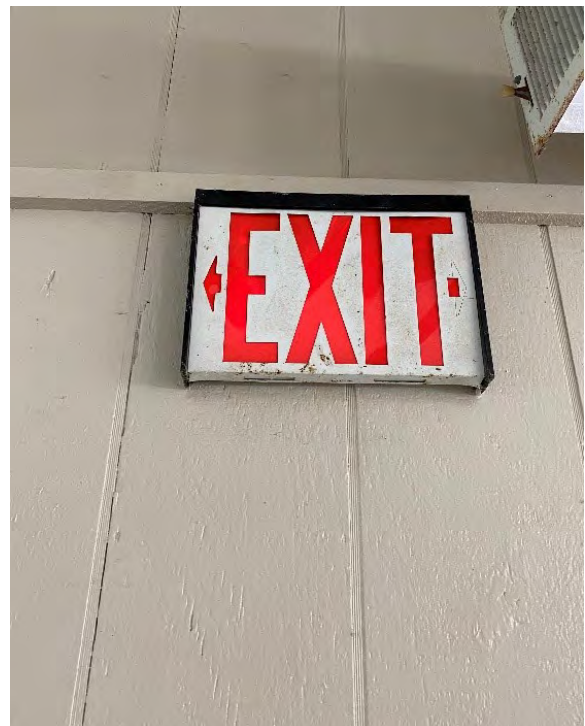
There is an exit sign just outside of the women’s restroom that appears to be damaged, not illuminated and should be replaced with new. All other exit signs in the building were internally illuminated, mounted properly, and good working condition.

Damaged/Non-illuminated Exit Sign

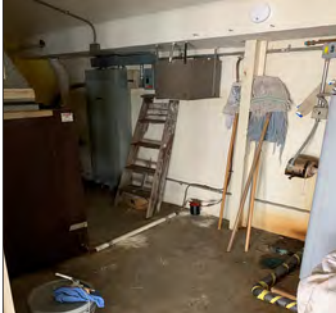
WORK
Mech. Room	Insufficient space to adequately store cleaning supplies. Currently, there is no mop sink and rack to hang mops and to empty mop buckets.

POOR

Recommendations - Kitchen			
Item	Description	Condition	Action Required
1.6	Mechanical Room	POOR	Provide mop sink and rack in mechanical room.
1.7	Plumbing Requirements		The new 3-compartment sink for warewashing requires indirect waste lines with 1" air gap above the rim of the floor sink. The hand sink will require direct waste.
1.8	Electrical Requirements		Provide 120 volts, 20.0 amp. circuit each for new heated cabinet and ice machine.

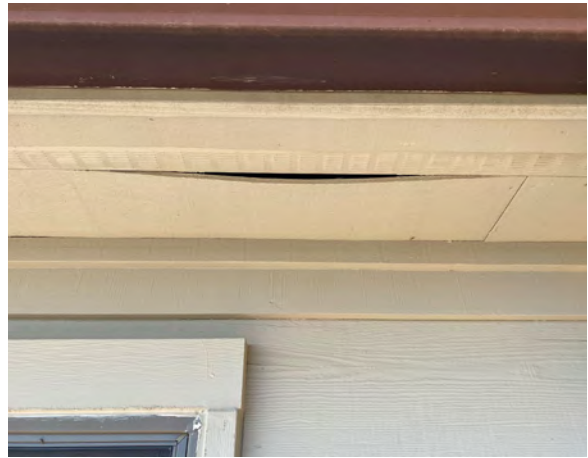
Soffit damage

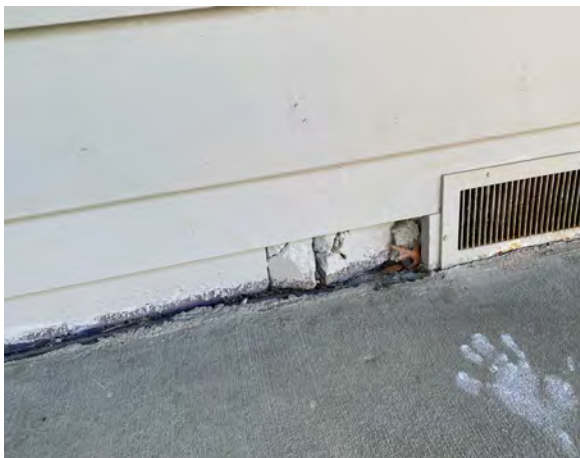
Foundation damage

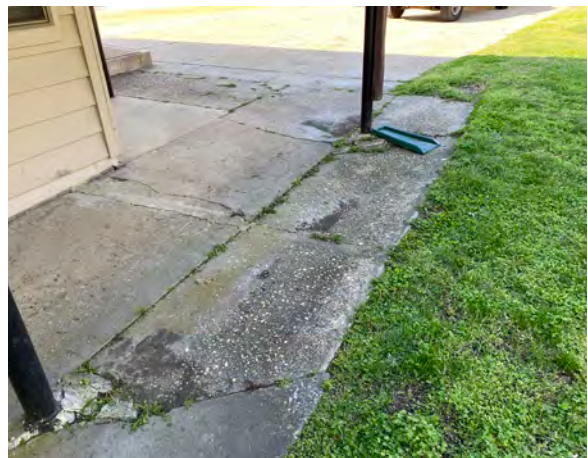
Sidewalk damage

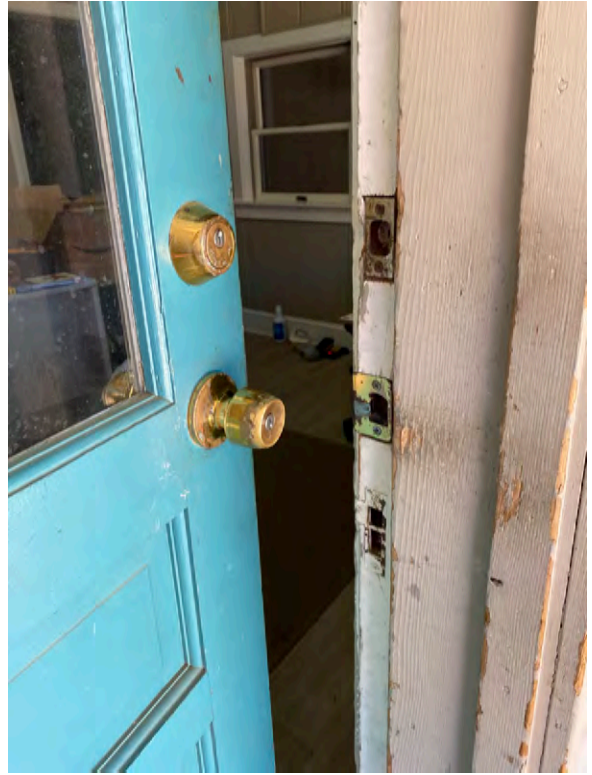
Door 202/A

Recommendations - Door			
Door #	Finish	Hardware	Action Required
201/A	GWC	GWC	Continue routine maintenance.
201/B	POOR	POOR	Lower corner of frame is rotted out and door is damaged. Door and frame should be replaced.
202/A	WORK	WORK	Door finish and hardware are very worn and aged. Door jambs and trim are damaged and worn in several places. Door and frame should be replaced in the near term.
202/B	WORK	WORK	Door finish and hardware are worn and aged. Door latch is cracked. Door and frame should be replaced in the next one to three years.
202/C	GWC	GWC	Continue routine maintenance.
202/D	GWC	GWC	Continue routine maintenance.
203/A	GWC	GWC	Continue routine maintenance.
204/A	GWC	GWC	Continue routine maintenance.
204/B	GWC	GWC	Continue routine maintenance.
204/C	GWC	GWC	Continue routine maintenance.
205/A	GWC	GWC	Continue routine maintenance.
205/B	GWC	GWC	Continue routine maintenance.
206/A	WORK	WORK	Door finish and hardware are worn and aged. Doorknob and deadbolt area is cracked. Door and frame should be replaced in the next one to three years.

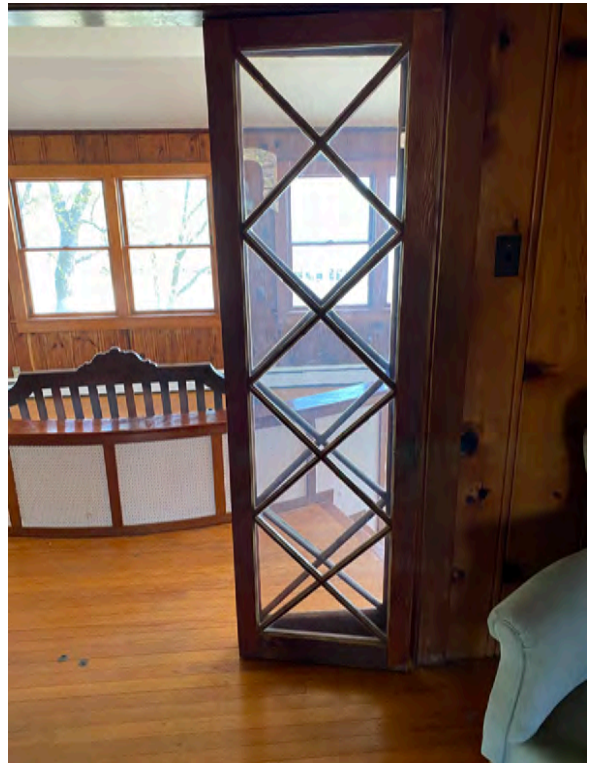
Door leaf for 209/A

209/A	WORK	WORK	Door finish and hardware are worn and aged. Door should be refinished.
210/A	WORK	WORK	Door finish and hardware are worn and aged. Refinish door, frame, and trim.
210/B	WORK	WORK	Door finish and hardware are worn and aged. Bottom door panel is damaged. Paint door and panel should be replaced in the next one to three years.
211/A	WORK	WORK	Door finish and hardware are worn and aged.
213/A	WORK	WORK	Door finish and hardware are worn and aged. Paint door, frame, and trim.
213/B	WORK	WORK	Door finish and hardware are worn and aged. Paint door, frame, and trim.
213/C	WORK	WORK	Door finish and hardware are worn and aged. Paint door, frame, and trim.
213/D	WORK	WORK	Door finish and hardware are worn and aged. Paint door, frame, and trim.
214/A	WORK	WORK	Door finish and hardware are worn and aged. Paint door, frame, and trim.
214/B	WORK	WORK	Door finish and hardware are worn and aged. Paint door, frame, and trim.

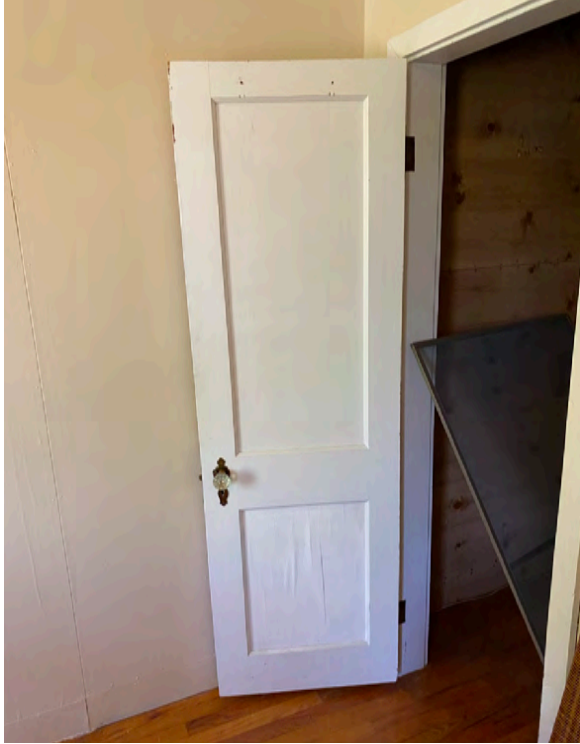
Lower panel damage at 210/B

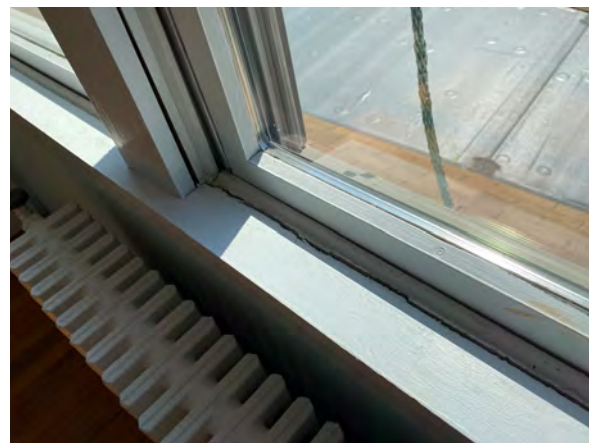
W23 damage

Recommendations - Windows			
Item	Window #	Condition	Action Required
2.3.1	All	GWC	Continue routine maintenance.
2.3.2	W8	WORK	Install screen
2.3.3	W12	WORK	Replace damaged screen
2.3.4	W23	WORK	Replace wood sill and surrounding trim

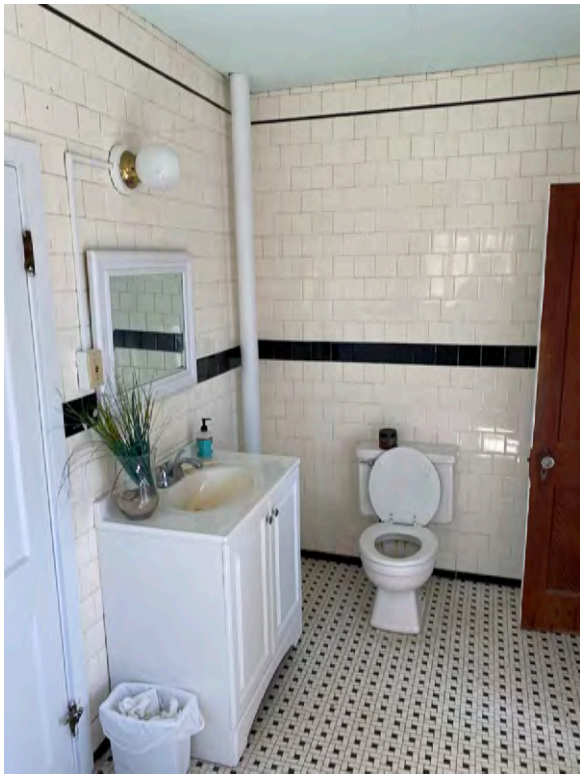
212	Dining	WD		WDP	15"x30" ACT	Ceiling tiles are sagging.
213	Bathroom	Tile	Tile	4x4 Tile	PTD WDP	Walls, floor, and ceiling are aged.
214	Dressing	WD		PTD WDP	PTD WDP	Walls and ceiling are aged.
215	Balcony	WD		WD		Deck and railing are aged and in very poor condition.
1	Stair	8x8 Tile	WD	PTD WDP	PTD GWB	
2	Stair	Carpet	WD	PTD WDP & GWB	PTD GWB

2.4.10	Dining 212	WORK	Replace ceiling with new GWB.
2.4.11	Bathroom 213	WORK	Replace ceiling with new GWB and re-grout wall tile. Alternative option is to remove all wall tile and replace with new tile.

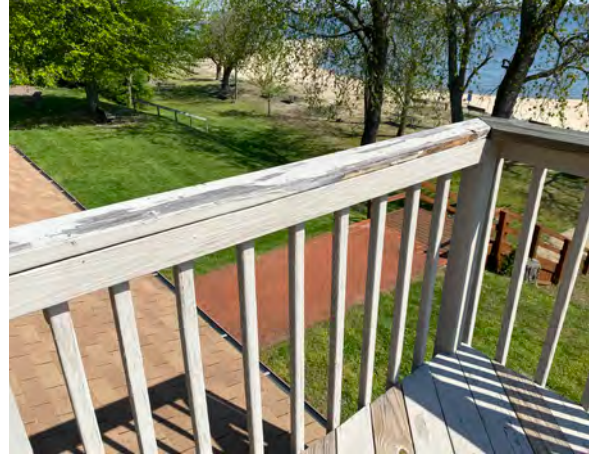
Balcony 215 - Deck boards

We observed the second-floor deck to be weathered and likely not designed for assembly use. Additionally, we suspect the railing has openings exceeding the 4-inch maximum required by code. There is a 4x4 post that has twisted and is recommended to be replaced with a new post.

2.4.12	Dressing 214	WORK	Replace walls and ceiling with new GWB and WD trim.
2.4.13	Balcony 215	POOR	Replace all decking boards and railings.

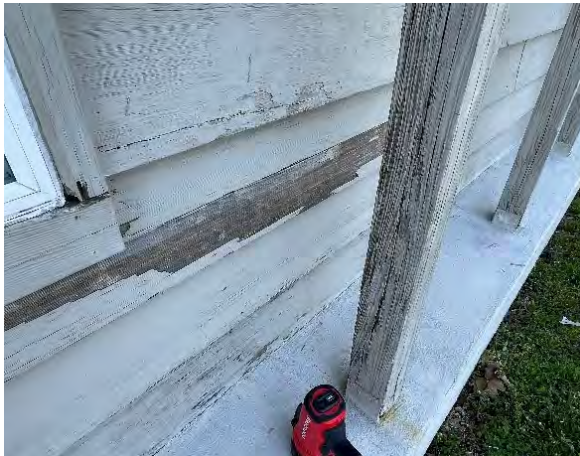
From discussions with on-site park personnel, we understand there are concerns along the water side elevation along the corridor wall of the adjoining glass pavilion. The roof area below the second level deck has no gutters and is interrupted with a series of wood posts supporting the second level deck. We understand this has been an ongoing concern and repair attempts have been made to create a concrete wash surface to divert water way from the wall.

Exterior view of area below second level deck.

Recommendations are to provide for a gutter system and install flashing to protect the wood siding.

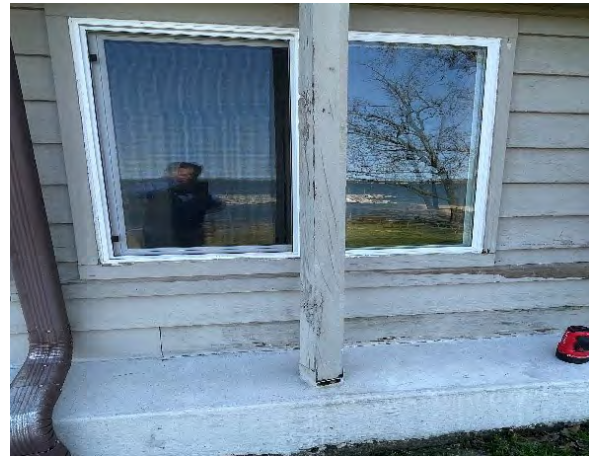
View of twisted column and concrete wash repair.

Recommendations - Park Offices Building Structure			
Item	Description	Condition	Action Required
2.5.1	Twisted deck column	WORK	Replace with new column
2.5.2	Foundation wall top wash surface	POOR	Recommend reworking detail to install flashing and provide guttering below deck.
2.5.3	Exterior slabs	WORK	Replace areas to provide positive drainage away from structure.
2.5.4	Column base at roof overhang	WORK	Correct slab depression to protect column base from moisture damage.
2.5.5	Second Floor Deck	WORK	Evaluate design capacity for use, improve railing to meet code

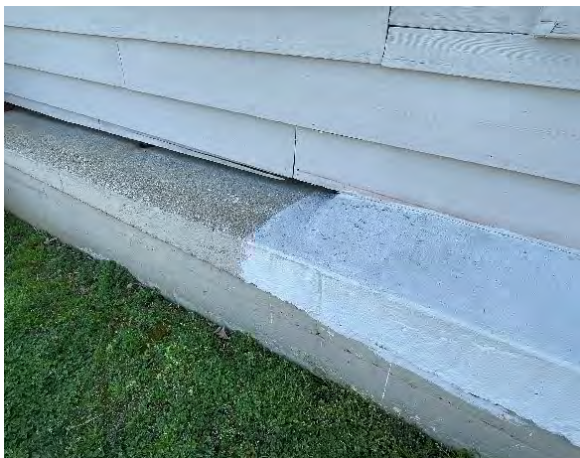
Unfortunately, concrete has been placed against wood siding and likely with no flashing, with the resulting condition allowing ongoing water infiltration and damage to the siding and likely to the concealed framing.

Exterior Foundation wall where concrete wash was installed.

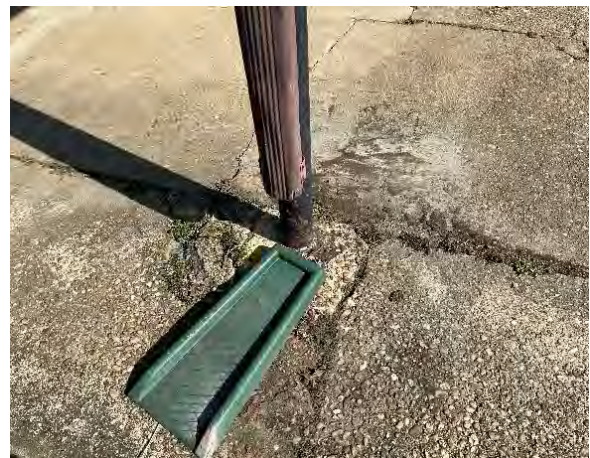
We observed the ground floor roof overhang projection to be supported on steel perimeter columns. The bases of several columns are depressed and collects surface water that will promote deterioration to the column bases. We recommend infilling and patching of the concrete to enhance the service life of the steel columns.

Steel column base with deteriorated concrete and missing downspout extension.

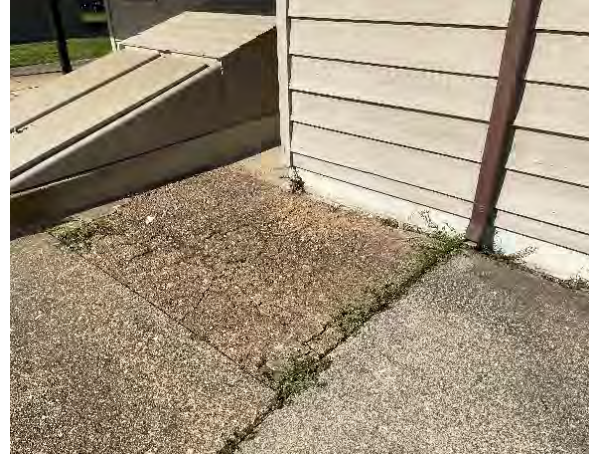
The exterior slabs have settled and at locations directing surface run off towards the structure. We recommend replacing the affected portions of slab to provide for positive drainage away from the building.

View of settled exterior concrete slab.

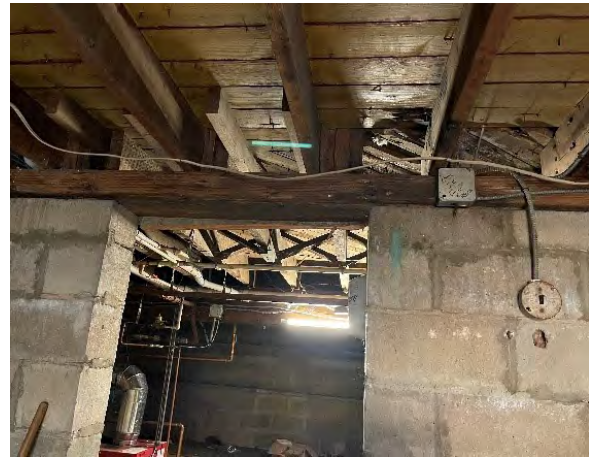
We observed areas where framing reinforcement has been completed with sistering of floor joists and newer plywood decking where area of water damage has occurred.

View of area where former water damage occurred.

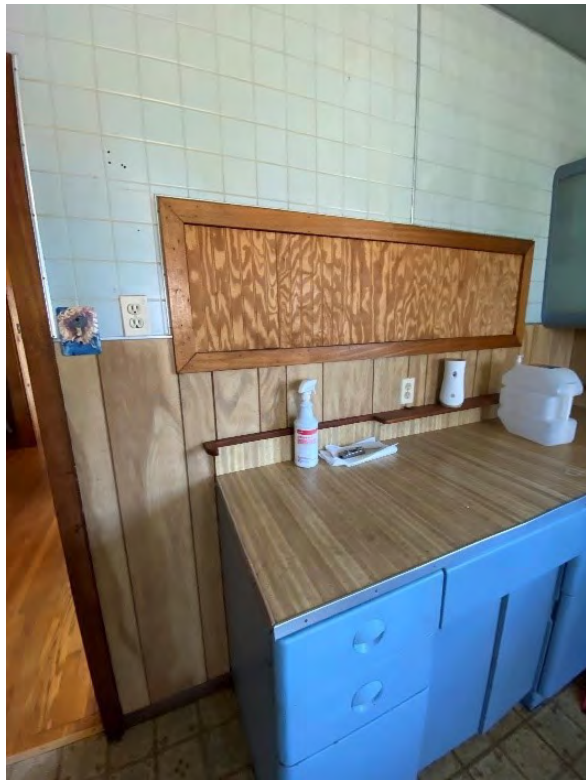
All receptacles in the basement must have ground-fault circuit-interrupter (GFCI) protection as required by NEC 210.8. The circuit breakers feeding receptacles in the basement are also not GFCI. There is another case in the kitchen on the second floor where the receptacle is installed to serve countertop surfaces and must have GFCI protection per NEC 210.8. Provide receptacles with GFCI protection or GFCI circuit breakers for the safety of personnel. Miscellaneous obsolete telecommunications and alarm equipment should be removed.

Kitchen Countertop Receptacle

Recommendations - Miscellaneous Electrical			
Item	Description	Condition	Action Required
2.8.3	Receptacles in Basement	IMME	All receptacles in basement to be GFCI prior to use.
2.8.4	Receptacle in 2nd Floor Kitchen	IMME	Kitchen countertop receptacle to be GFCI prior to use.
2.8.5	Outdoor Receptacle	IMME	All outdoor receptacles to be GFCI with weatherproof cover.
2.8.6	Receptacle in Floor Molding, Office 202	POOR	Remove or raise receptacle.
2.8.7	Branch Circuit Wiring	WORK	Replace all branch circuit wiring in future, ideally at the same time as the associated devices and/or fixtures.
2.8.8	Obsolete electrical devices throughout building.	POOR	Remove all obsolete electrical devices and equipment per owner request. Exact quantities and locations could not be confirmed via visual site observation.

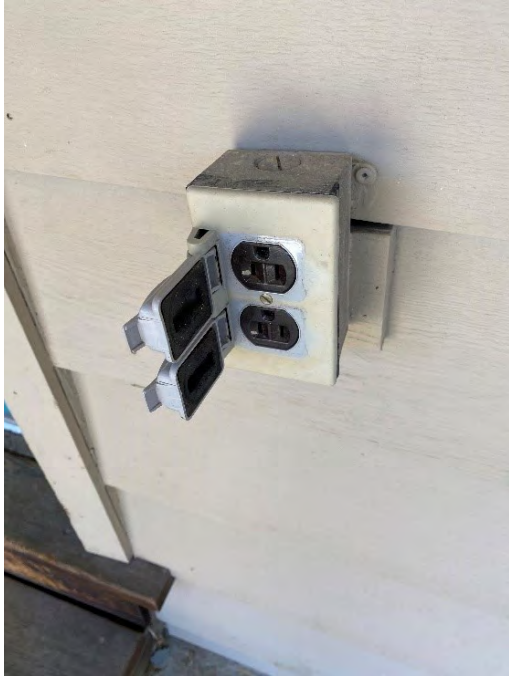
Outdoor Receptacle

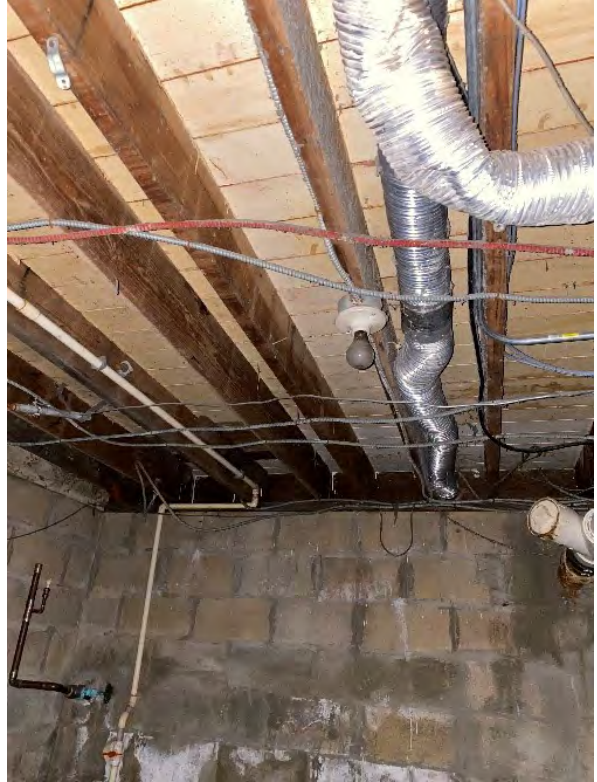
The lighting level in the basement is very low and there were a few lights that were not working. Was unable to turn on many lights on the first floor and it could not be determined whether it was a switching or a lighting issue. First floor did not have any egress lighting or exit signs and should be added immediately. The lights on the 2nd floor were mostly residential or decorative and seemed aged. Recommend replacing all lighting fixtures with LED in next 1-3 years.

Basement Lights

Recommendations - Lighting			
Item	Description	Condition	Action Required
2.8.9	Basement Lights	POOR	Repair/replace non-working lights. Replace all lighting fixtures in basement with LED in next 1-3 years. Add more fixtures for additional illumination.

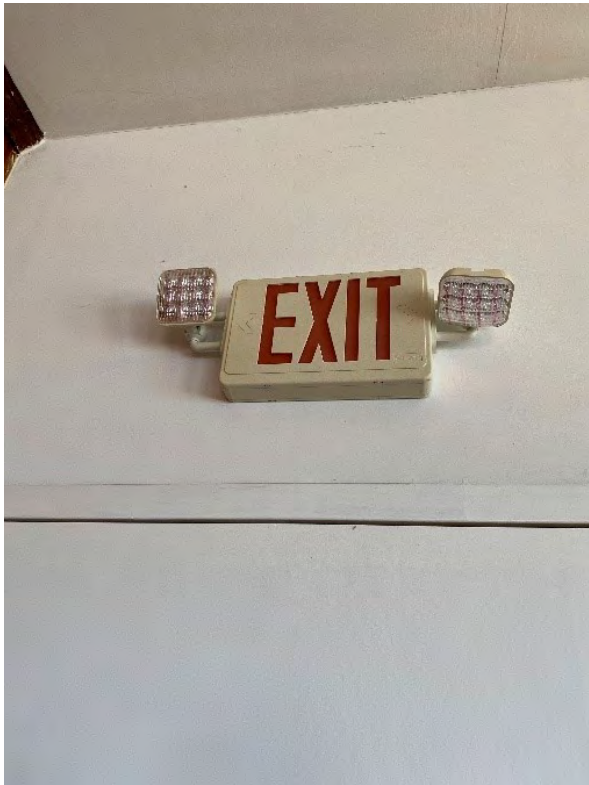
2nd Floor Exit Sign not Illuminated

2.8.13	2nd Floor Lighting	POOR	2nd floor lighting seemed aged. Replace 2nd floor lighting fixtures with LED in next 1-3 years.
2.8.14	2nd Floor Exit Sign	IMME	Exit sign was not illuminated. Test and repair immediately. Exit sign should be replaced if it is not illuminated and the remote heads do not turn on.

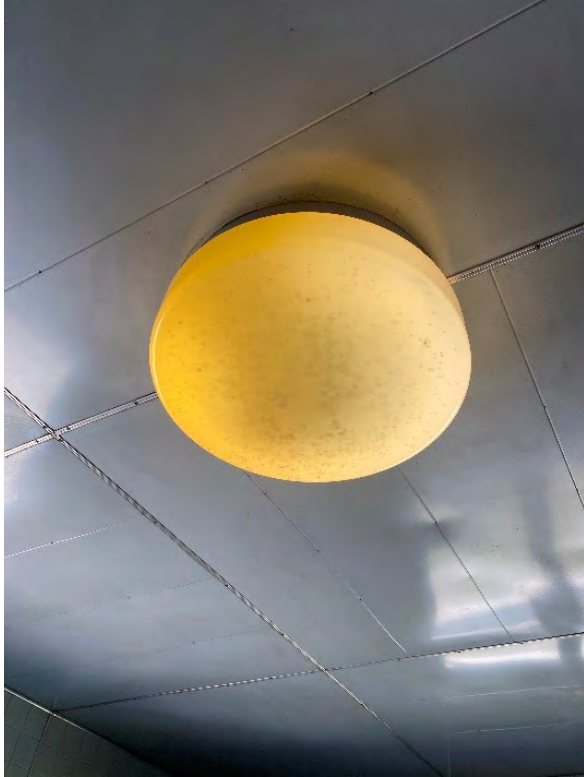
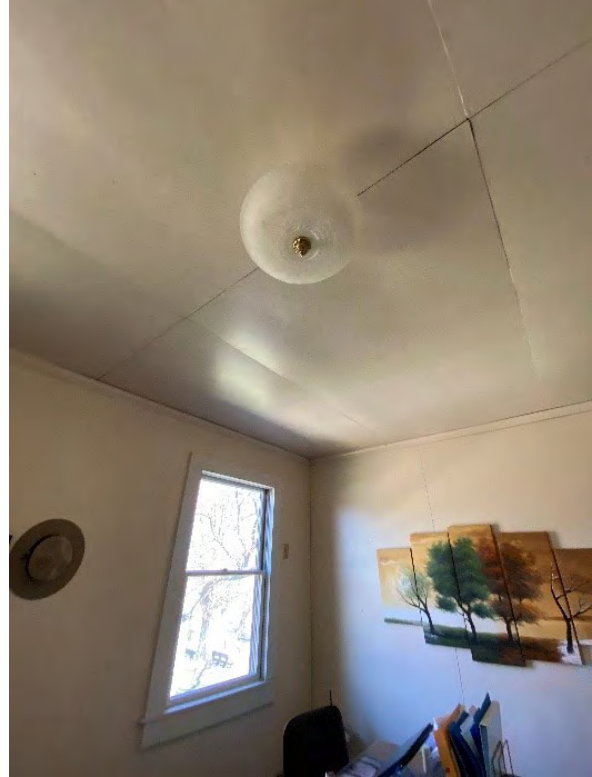
2nd Floor Typical Lighting

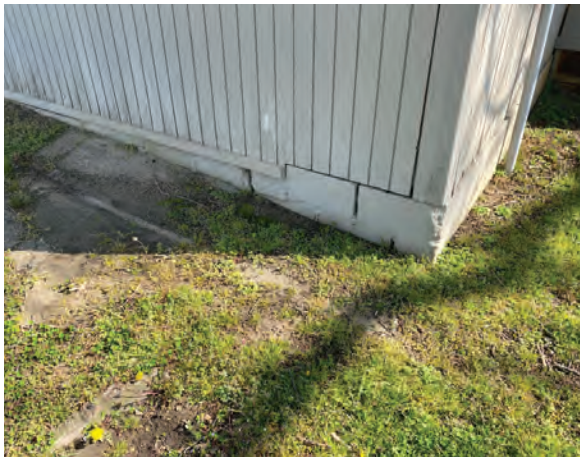
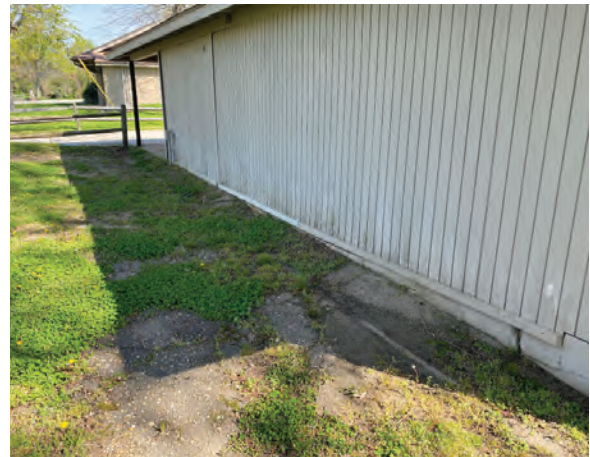
The siding on the wood framed enclosure mentioned above, is vertical T-11 wood panel systems with 1x wood corner boards. It is a replacement material. It has received many coats of paint over the years. It is in fair/poor condition depending upon location.

T-11 Wood Panel System

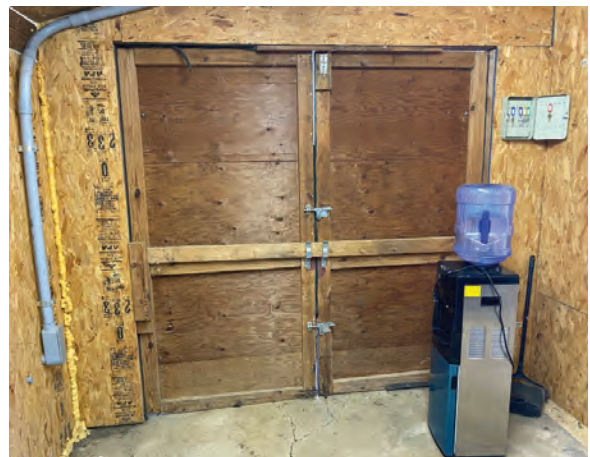
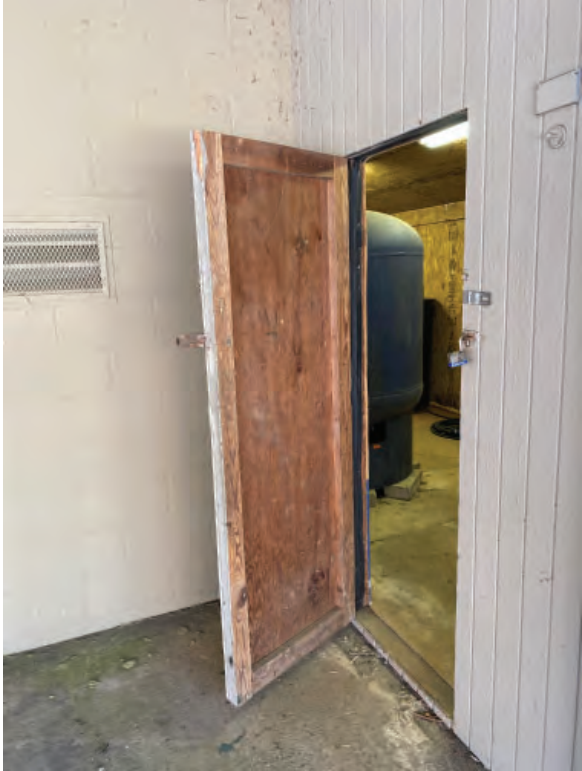
Door 303/A

Door 303/B

Recommendations - Door			
Item	Door #	Finish	Condition/Action Required
3.2.1	302/A	POOR	Demo existing door, frame and all hardware and replace with new 18 Gauge Galvannealed Door and 16 Gauge Galvannealed Frame with lever hardware, heavy duty hinges, dead bolt, kick plate and closer. Paint door and frame when installed.
3.2.2	303/A	POOR	This door is a pair of wood fabricated leaves, it lacks many features of a contemporary door, including weatherstripping and insulating value. Demo existing door, frame and all hardware and replace with a pair of new Hollow Metal doors & frame with lever hardware, heavy duty hinges, dead bolt, kick plate and closer. Paint door and frame when installed.
3.2.3	303/B	POOR	Door finish and hardware are very worn and aged. Door jambs and trim are damaged and worn in several places. Door and frame should be replaced in the near term.

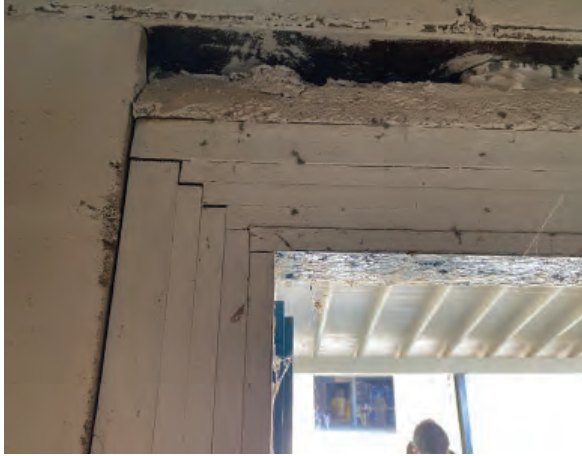
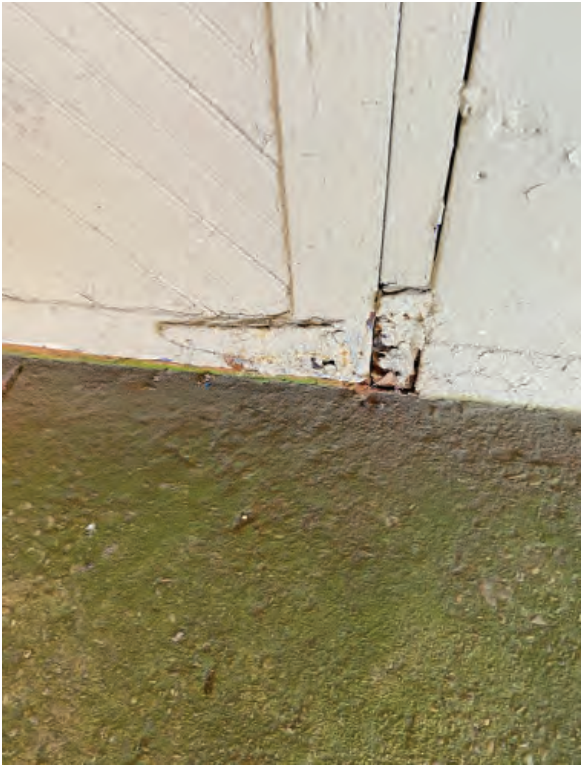
Door 302/A is 3'-0" wide x 6'-8" high patchwork of wood. It appears to date from the original period of construction. The door, frame & hardware are deteriorated and in poor condition.

Door 302/A detail

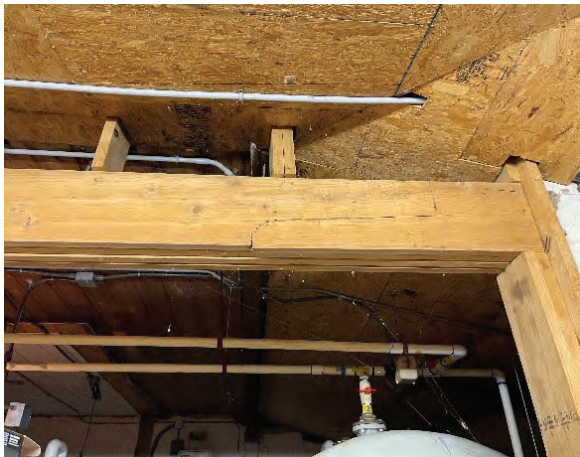
Within the enclosed space, we noted a custom-made angle truss beam that bears onto a wood built-up 4-ply 2x12 header. One of the plies of the header has failed and cracking was observed. We recommend that the lintel be evaluated and reinforced, as necessary.

View of distressed lintel in enclosed portion.

Recommendations - Open Air Pavilion Structure			
Item	Description	Condition	Action Required
3.5.1	Distressed wood beam header in enclosed area.	POOR	Design and repair to the header to be investigated.
3.5.2	Column base repairs where corroded.	POOR	Repairs to stabilize and restore column bases.
3.5.3	Investigate and improve detail of spray-foam wall base.	WORK	Investigate a permanent repair.
3.5.4	Steel roof beam connection enhancement.	WORK	Recommend enhancing the connection detail of the steel beam to column.

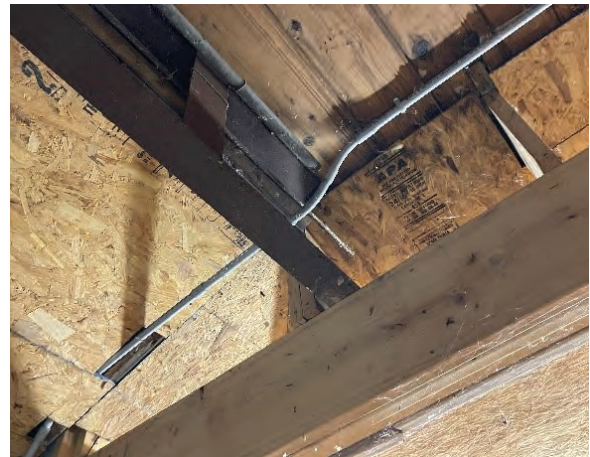
View of header with steel frame bearing.

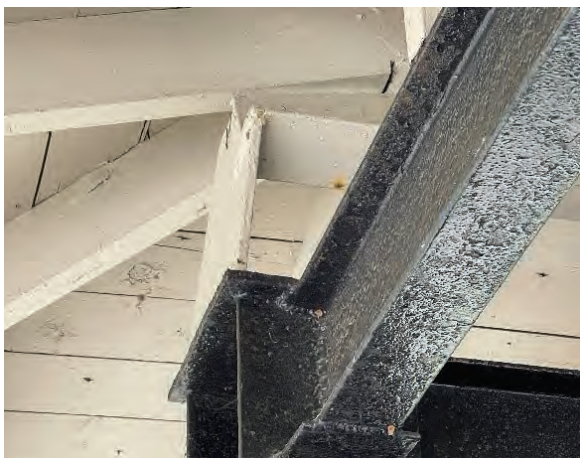
Most of the existing roof framing is exposed for the open area. The area above the enclosed space is concealed by a hard OSB-plywood panel ceiling. The primary steel frame is supported on steel wide flange columns. We observed an unconventional framing system of an angled purlin steel beam that is supported at the ends by steel gusset plates.

Interior view of roof beam connection by a gusset plate. Recommend enhancing this connection.

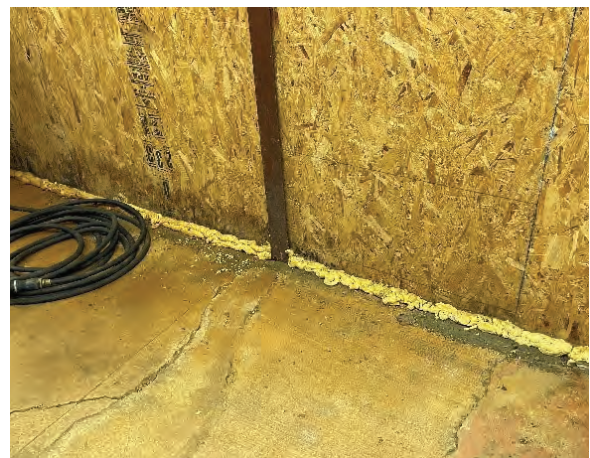
The floor of the structure is a concrete slab on grade. We observed settled and cracking distress of the interior slab at the enclosed portion. Since it is on grade, it is not a structural concern.

Exterior walls of the enclosed areas have been spray-foamed to seal the base. We recommend reviewing the detail and designing a permanent repair to prolong the service life of the wall.

Spray foam sealing of wall base. Note floor cracking.
