MAYO BEACH PARK

4150 Honeysuckle Drive
Edgewater, Maryland 21037

Condition Assessment for Anne Arundel County DEPARTMENT OF RECREATION & PARKS

Contract Number: P582101
Project Number: P582100

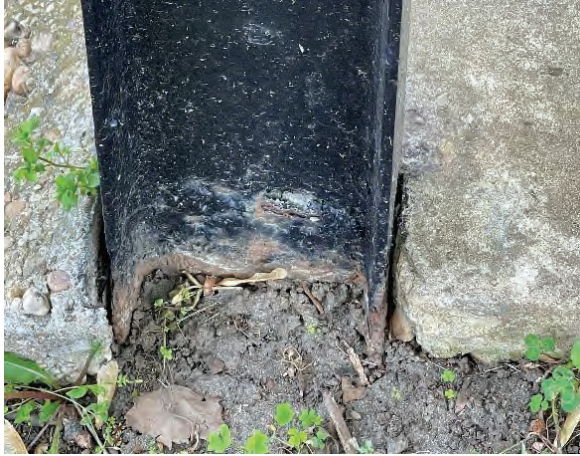
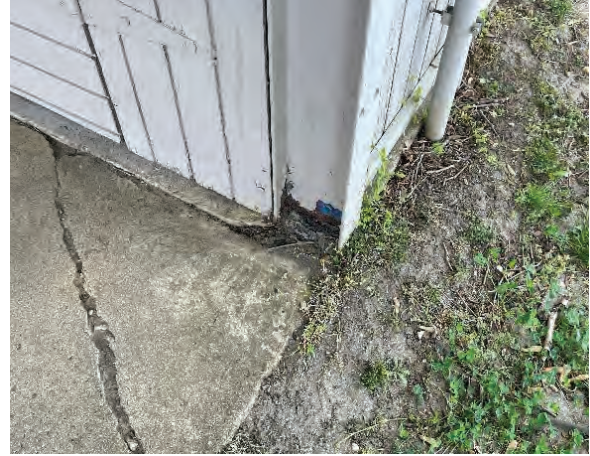
A few of the steel perimeter columns have corroded and require repair. We observed one location where reinforcement of the base was provided. We recommend investigating and designing repairs to restore the deteriorated column bases.

Column base detail with corrosion, Base condition to be repaired.

View of column base requiring repair and stabilization from ongoing deterioration.

Recommendations - Open Air Pavilion Structure			
Item	Description	Condition	Action Required
3.5.1	Distressed wood beam header in enclosed area.	POOR	Design and repair to the header to be investigated.
3.5.2	Column base repairs where corroded.	POOR	Repairs to stabilize and restore column bases.
3.5.3	Investigate and improve detail of spray-foam wall base.	WORK	Investigate a permanent repair.
3.5.4	Steel roof beam connection enhancement.	WORK	Recommend enhancing the connection detail of the steel beam to column.

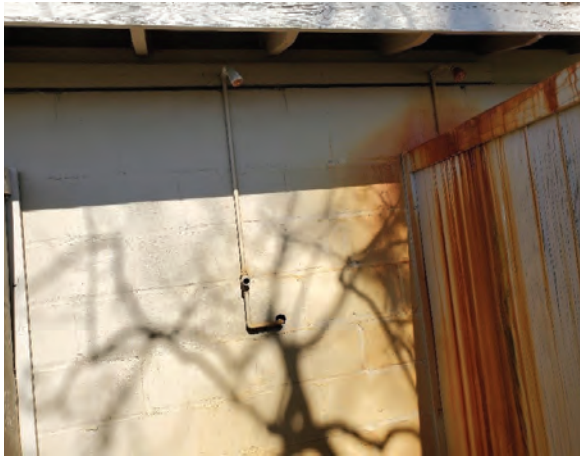
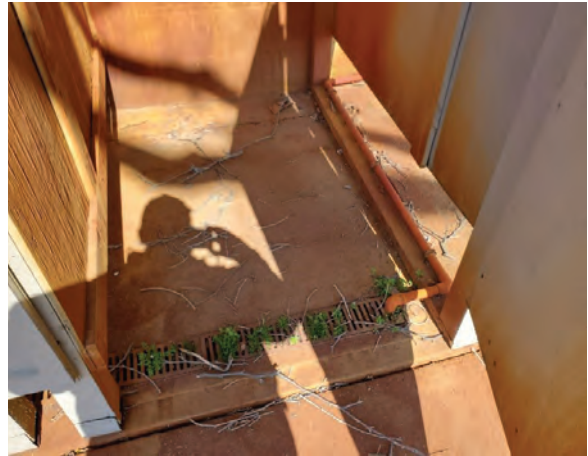
On the exterior wall of the Open Air Pavilion there are shower stalls with cold water only shower heads and trench drains. The shower heads are starting to rust and there is vegetation growing in the trench drains. Their operation cannot be verified because building is winterized for the winter.

Shower Head

Trench Drain

Recommendations - Plumbing Systems			
Item	Description	Condition	Action Required
3.7.1	Shower heads and trench drains	POOR	The showers shall be replaced in kind and the trench drains shall be cleaned out.

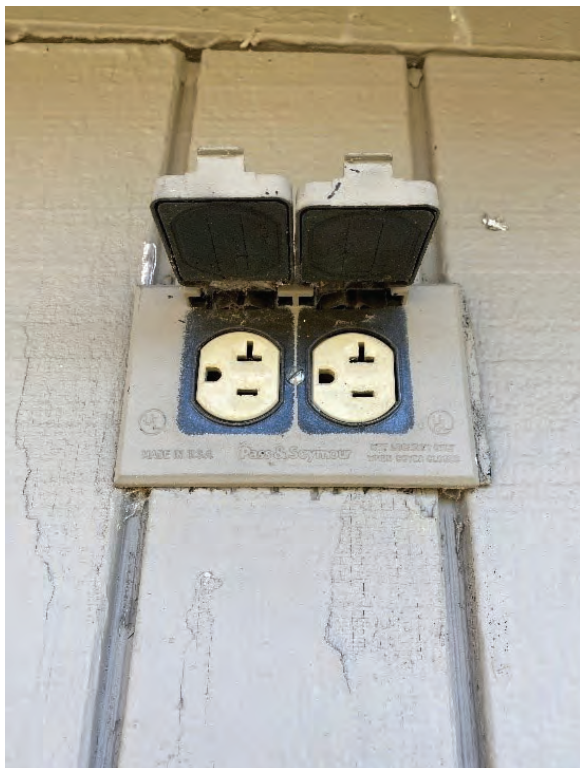
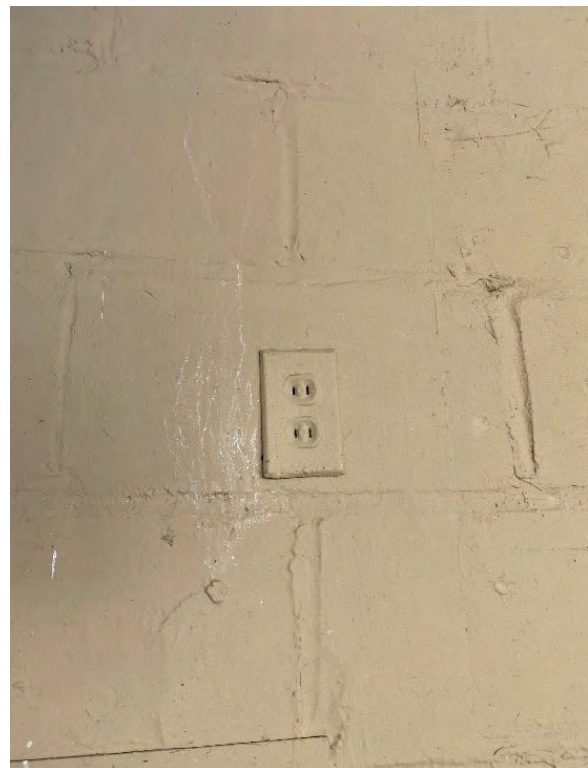
There are a few outdoor receptacles that are not GFCI protected or have a weatherproof cover. If these receptacles are abandoned and not in use, they should be removed. Otherwise, provide receptacles with GFCI protection or GFCI circuit breakers for safety.

Outdoor Receptacle

Recommendations - Miscellaneous Electrical			
Item	Description	Condition	Action Required
3.8.1	Outdoor Receptacles	IMME	Remove all outdoor receptacles that are no longer being used. If outdoor receptacles are still in use, provide GFCI protection and a weatherproof cover.
3.8.2	Branch Circuit Wiring	WORK	Replace all branch circuit wiring in future, ideally at the same time as the associated devices and/or fixtures.

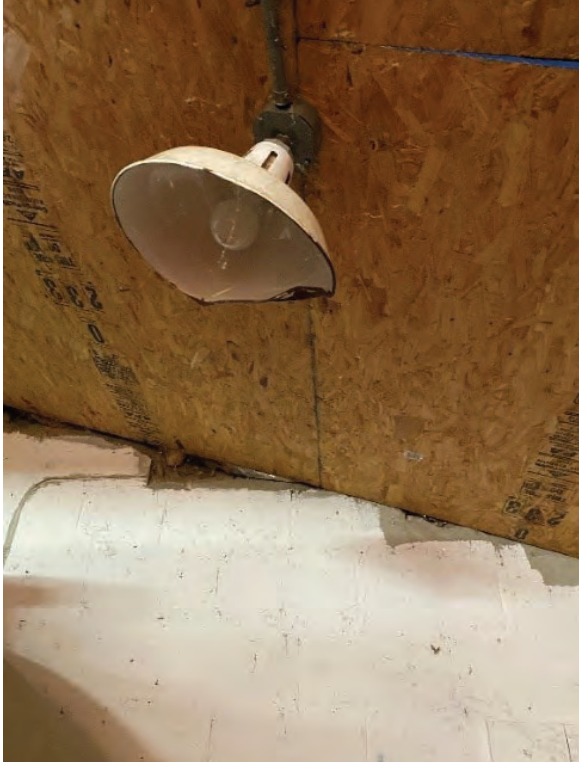
Interior Light not Working

Recommendations - Lighting			
Item	Description	Condition	Action Required
3.8.3	Interior Lighting	WORK	Replace with LED in future.
3.8.4	Light in Water Treatment Equipment Room	POOR	Repair/replace non-working light. Replace with LED in future.
3.8.5	Exterior Lighting	WORK	Replace with LED in future.
3.8.6	Well Control Room Lighting Fixture Bulbs not guarded.	IMME	Provide bulb protectors or install guards on light fixtures.

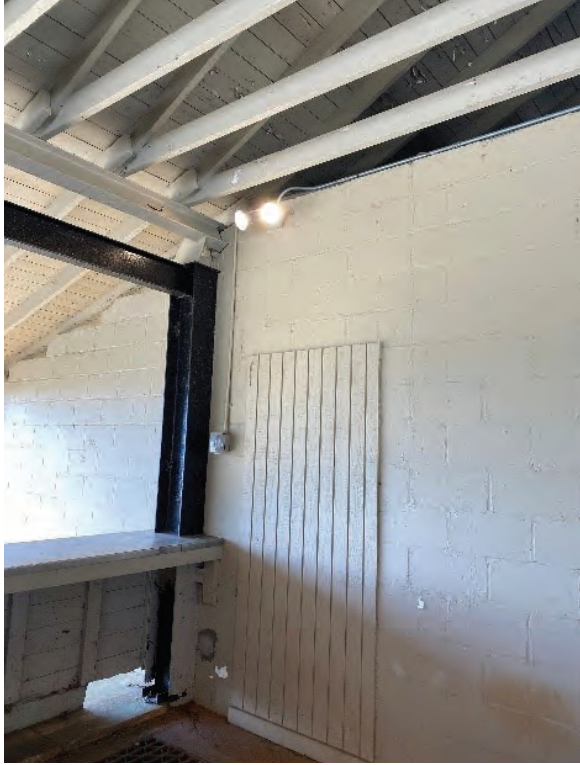
Typical Exterior Lighting

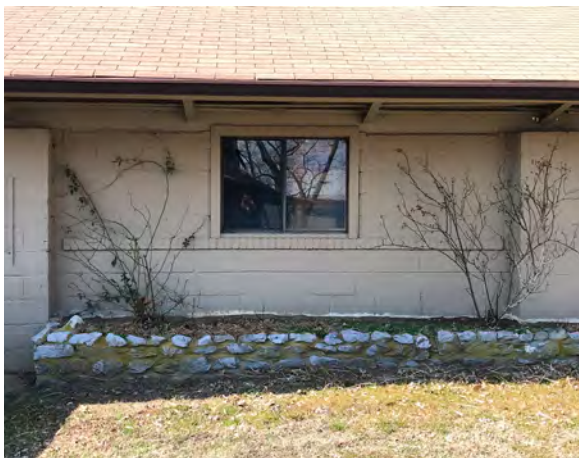
The exterior is a patchwork of repairs and infills carried out over time. Generally it would be categorized as Fair condition with areas of Poor condition in places.

East Elevation Masonry Infill & Patching

Recommendations - Exterior Envelope			
Item	Description	Condition	Action Required
4.1.1	Exterior CMU Walls	WORK/ POOR	Further inspections of the exterior walls and piers for cracking, open joints and settlement should be conducted and all open voids should be repaired to prevent water infiltration.
4.1.2	South Gable End Siding	WORK	Although in fair condition, the cementitious shingle siding should be tested for asbestos content and then a HAZMAT plan put in place to address corrective action.

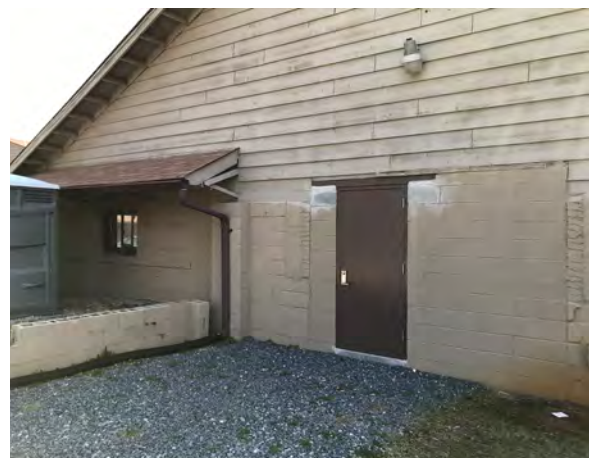
North Elevation Masonry Infill & Patching

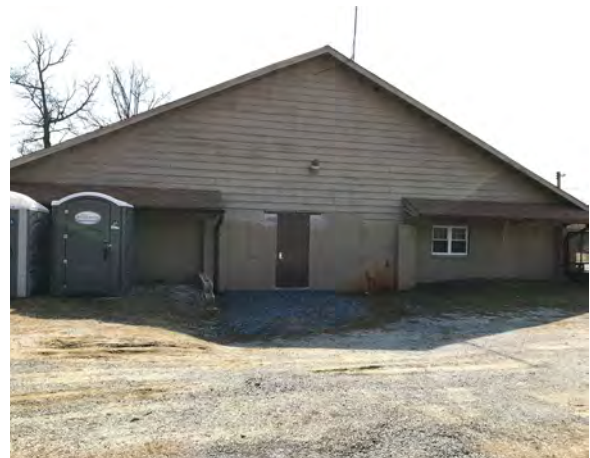
North-facing gable

Above the CMU bearing walls the gable ends are framed in wood. The north facing gable is covered in wood lap siding painted which is in fair condition. The south facing gable end is covered in a painted cementitious shingle which has been linked to possible asbestos material in its manufacturing. This type of siding material tends to be very brittle and subject to cracking/breaking away. Because its location is above 10 feet above grade, damage visible from the ground has been kept to a minimum.

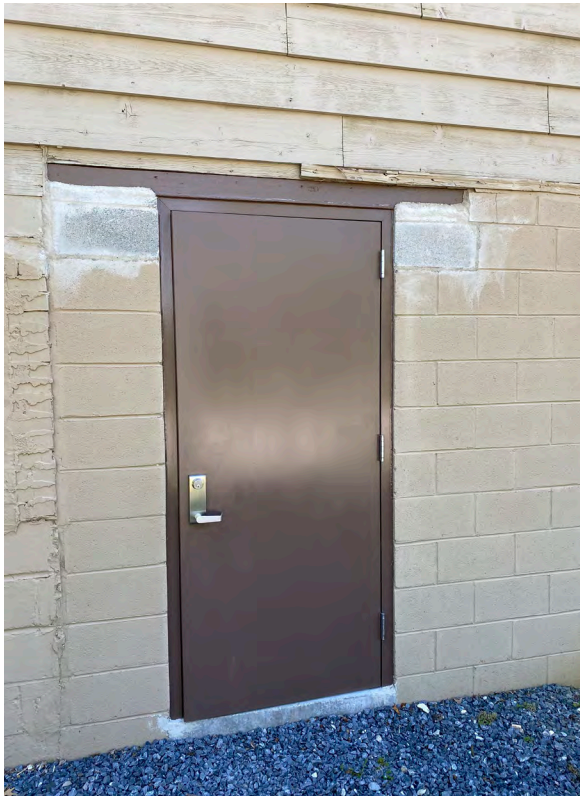
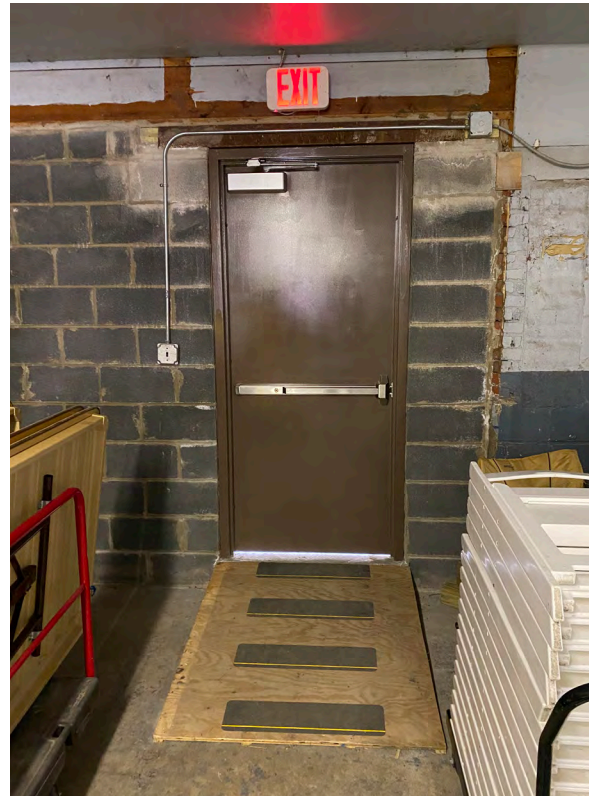
Door 401/A is 3'-0" wide x 6'-8" high hollow metal door and frame with panic hardware exiting device, closer and aluminum threshold. Frame is U.L. rated, door is not rated. Working condition, although the closer did not fully close the door when tested. There is an ADA ramp added on the interior to make up the difference in height from the existing floor slab and the outside grade.

Recommendations - Door	
Door #	Condition/Action Required
General	General: All doors and frames and hardware are in poor condition, wrong size or swing or do not meet the intended use of the space and should be replaced in their entirety, with the exception of the following doors: Door 401/A, Door 401/B, Door 402/C, and Door 407/B.

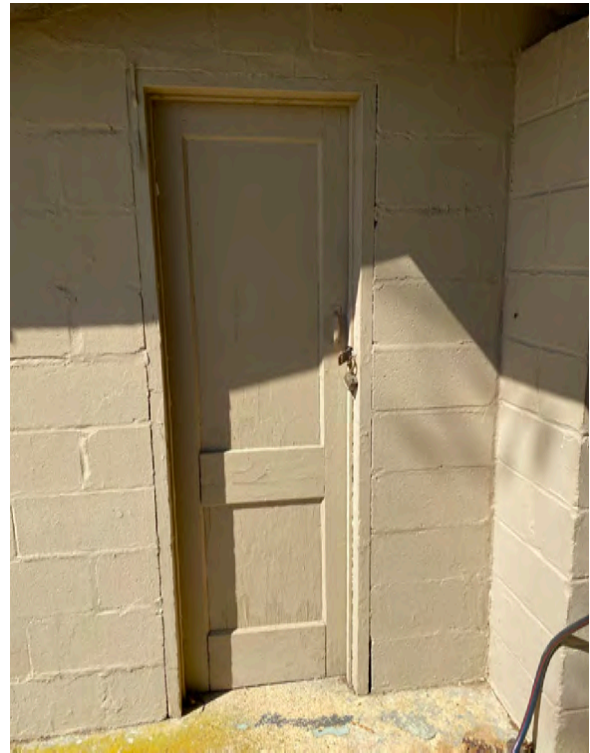
Door 411/A is a 2'-0" wide x 6'-8" high wood paneled door and frame hung with original hinges and a hasp and keyed padlock for the lockset. The door is in-swinging.

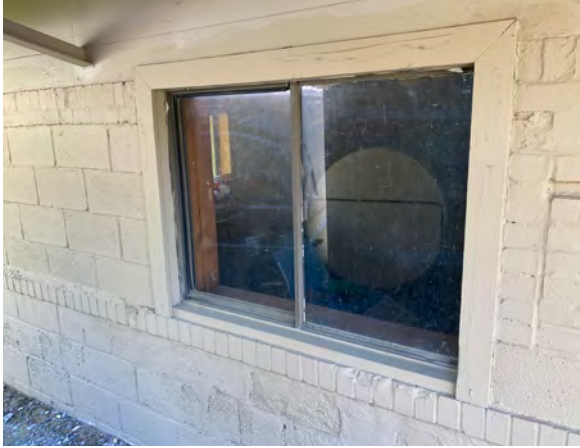
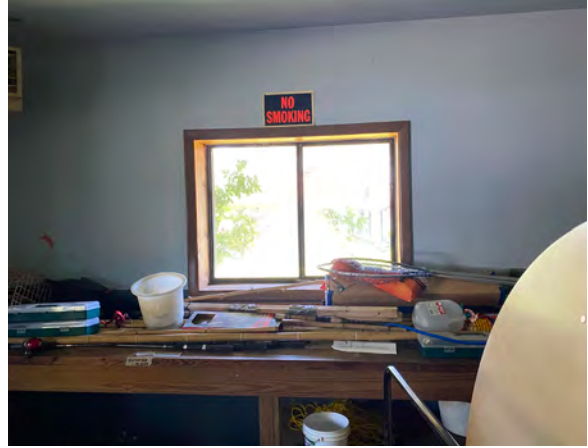
Windows W4 - W5 - W6 Typical

Windows W4 & W5 – Room 405 Storage Room, are replacement sliding pane metal windows 3'-11" wide x 3'-0" high in a bronze finish. The windows appeared in working condition but were not operable.

Window W6 – Room 406 Work Room, is a replacement sliding pane metal window 3'-11" wide x 3'-0" high in a bronze finish. The window appeared in working condition but was not operable.

Recommendations - Windows			
Item	Description	Condition	Action Required
4.3.1	Window W1	WORK	Verify the sliding pane is operable
4.3.2	Window W2	WORK	Verify the sliding pane is operable
4.3.3	Window W3	WORK	Verify the sliding pane is operable
4.3.4	Window W4	WORK	Verify the sliding pane is operable
4.3.5	Window W5	WORK	Verify the sliding pane is operable
4.3.6	Window W6	WORK	Verify the sliding pane is operable
4.3.7	Window W7	POOR	Leaving this window in place may allow water infiltration in the future due to continuing deterioration. Options are replace the window with a Window type W1 or W4 based upon the desired exterior appearance or infill the opening with masonry after removing the existing window.

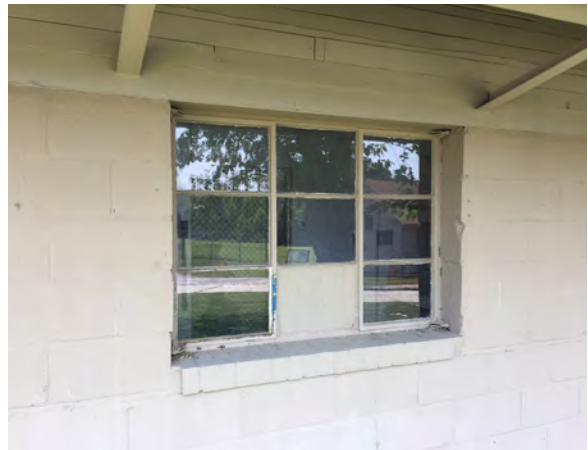
Window W7 – Room 410 Art Supplies is an original steel casement window from the original period of construction. The window was deteriorated with age and fragile. No attempt was made to operate it.

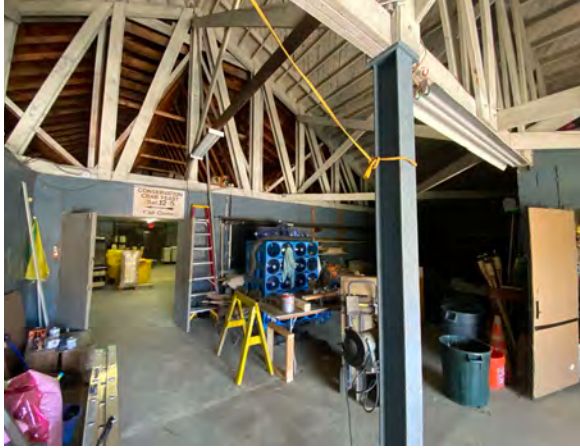
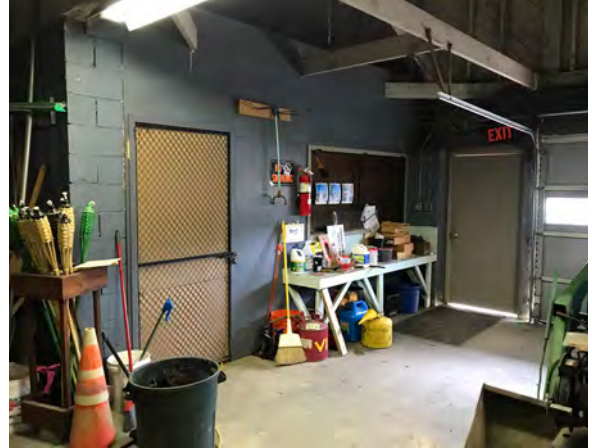
Room 402 - Plywood painted over wood stud partitions, no ceiling, open to original roof framing above. Flooring is original concrete floor. Visible part of floor were covered in motor oil and grease and damaged in places.

Recommendations - Interior Finishes	
Item	Condition/Action Required
General	It is impossible to make recommendations on interior finishes for this building until a detailed building & life safety code analysis is performed. The building has many violations and the current uses are in conflict with each other. Recommend Day Camp be relocated until the building can be brought into compliance. Other option for County consideration involves demolition of this structure and replacing it with a new single use code compliance building elsewhere on site.
4.4.1	TBD
4.4.2	TBD
4.4.3	TBD

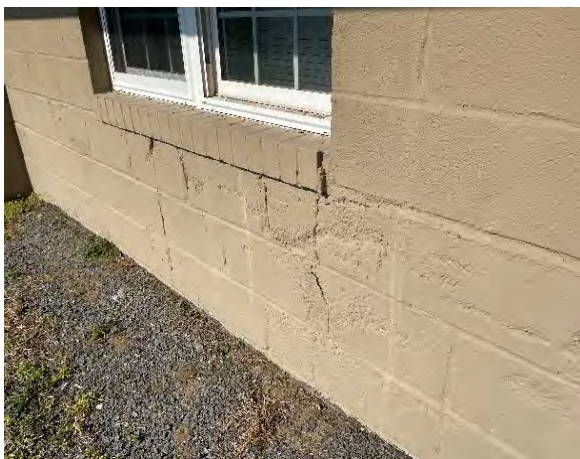
Exterior walls are concrete masonry. We observed areas where the masonry surface has pitted likely from water damage due to lack of gutters. We noted the walls have been coated and appear to have stabilized the masonry.

Exterior masonry area where surface pitting is visible.

Item	Description	Condition	Action Required
4.5.1	No Noted Structural Concerns	GWC	Continued Maintenance, improve guttering.

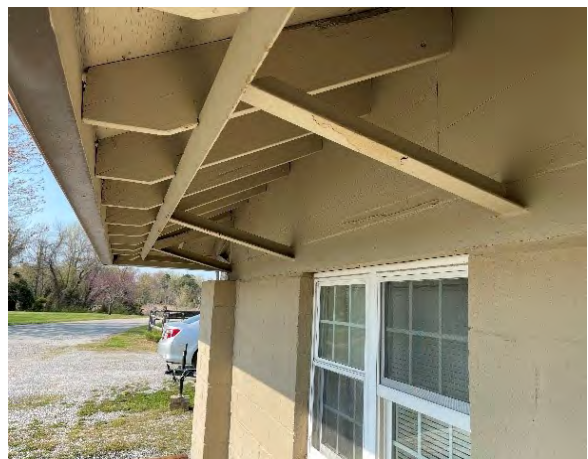
We noted the roof has newer shingles although there are no gutters at the eaves.

Typical roof overhang detail.

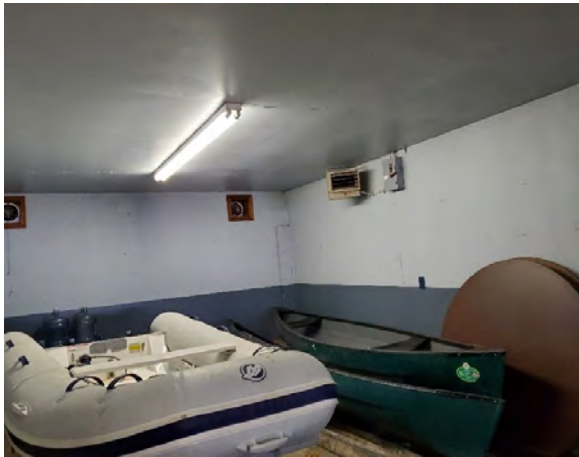
Electric Unit Heater and Exhaust Fan in Storage Area

The window AC units, and space electric unit heaters shall be replaced with a 9 ton split system heat pump unit with electric heat to provide heating and cooling to the building. The unit shall be located in a new mechanical room located in the storage space. An exterior location shall be picked for the location of the condensing unit. The unit shall be provided with ventilation air. The unit shall be ducted and ductwork shall serve the building.

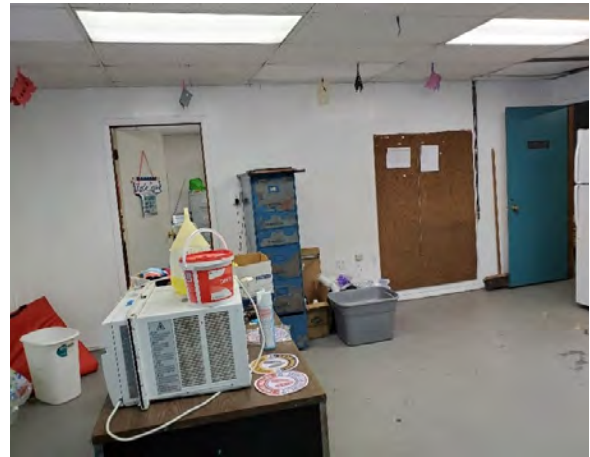
Window AC Unit in Office

Recommendations - Mechanical Systems			
Item	Description	Condition	Action Required
4.6.1	Window AC units	WORK	The window AC units shall be replaced with a cooling system
4.6.2	Exhaust Fan	WORK	The exhaust fans can be removed with the installation of the split system heat pump.
4.6.3	Electric Unit Heaters	WORK	The unit heater can be removed with the installation of the split system heat pump.
4.6.4	Bathroom Exhaust Fan	WORK	No Action Required

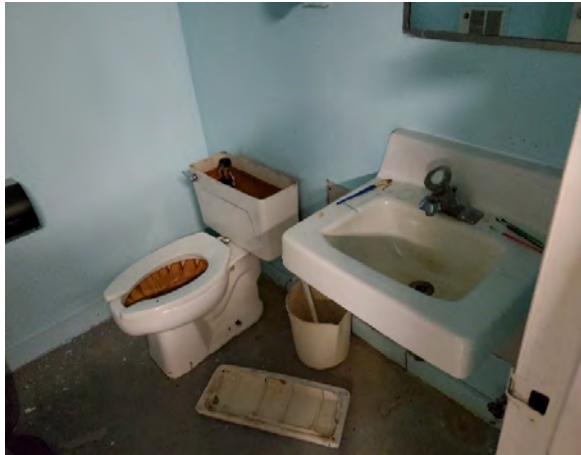
The bathroom contains a single lavatory and tank type water closets. The plumbing fixtures look like they are in good condition without any crack or damages. Their operation cannot be verified because building is winterized for the winter. The water closets are stained from water hardness.

Bathroom 408 Lavatory and Water Closet

Recommendations - Plumbing Systems			
Item	Description	Condition	Action Required
4.7.1	Water Closet	WORK	Should be replaced after campus water hardness is resolved
4.7.2	Lavatory	WORK	No action required.

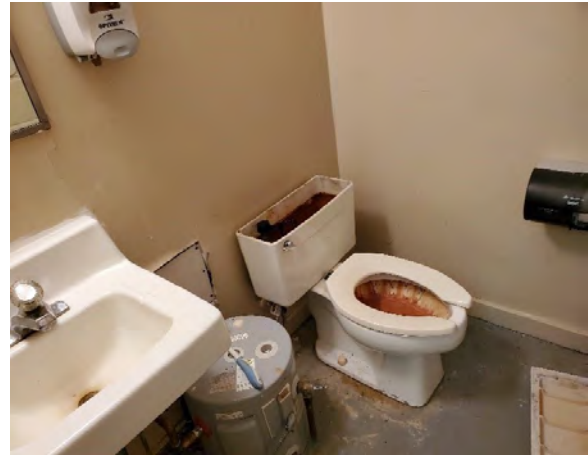
Bathroom 409 Lavatory and Water Closet

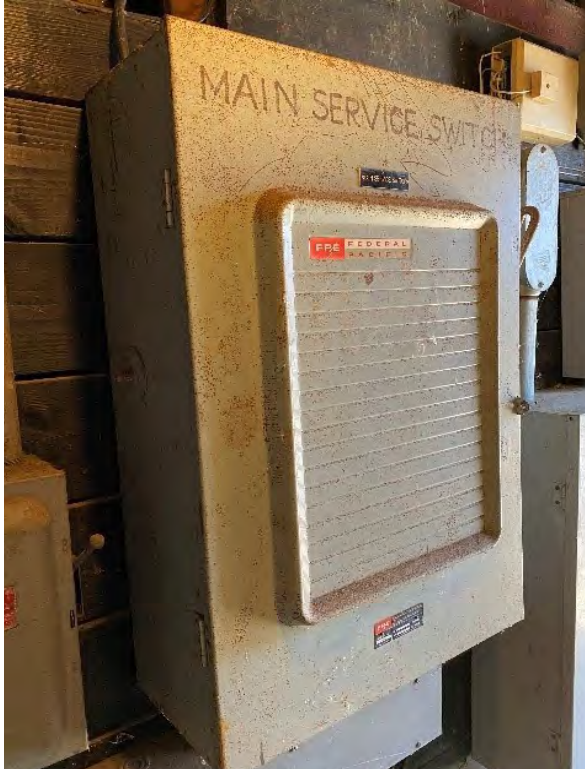
The electrical service for the park enters at this building's main electrical room through the utility CT cabinet and into the main service disconnect. The main service disconnect is rated at 400-ampere, 1-phase, 3-wire, 240V, manufactured by Federal Pacific (FPE) and seems like it was installed with the original construction of the building. From the service disconnect, the load side wiring enters a wire trough and is spliced at multiple points to provide power for a variety of panelboards and disconnects. These panelboards and disconnects distribute power to all other buildings at the park. Not all disconnects and panelboards are clearly labeled to identify which building they serve. All the electrical equipment in the main electrical room is in poor condition and it is recommended that a replacement for the distribution equipment to be budgeted for in the next 1-3 years. When replacing electrical distribution system equipment, all buildings must have a service disconnect per NEC 225.52. The disconnects may be located remotely in the main electrical room of this building.

Room 411 - Main Service Disconnect

Recommendations - Distribution System			
Item	Description	Condition	Action Required
4.8.1	Distribution Equipment	POOR	All electrical equipment is at least 30-40 years old and should be replaced in next 1-3 years. This includes wiring, conduit, junction boxes, wire troughs, etc.
4.8.2	Aged Electrical Equipment	IMME	This equipment appears to be 50+ years old and should be removed or replaced immediately.
4.8.3	Building Grounding System	POOR	Replace building grounding system with distribution replacement in next 1-3 years.

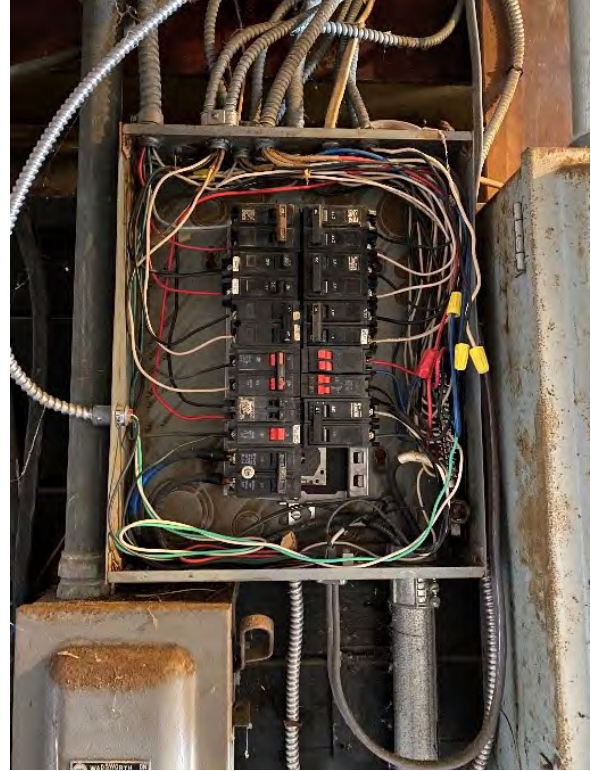
There were many exposed cables discovered throughout the building that are required to be removed per NEC. One of the panelboards in the main electrical room is missing a cover, exposing live parts, and should be provided immediately. Due to the age of the electrical equipment, it is recommended that the grounding system is tested for ground resistance to ensure it complies with NEC. We recommend replacing the grounding system with the main service disconnect in the next 1-3 years. There were two outdoor receptacles that must be provided with GFCI protection immediately. All outdoor receptacles less than 50-amperes must have GFCI protection per NEC 210.8. One of the light switches in the day camp area seemed to be ripped off the wall and should be properly mounted.

Room 411 - Exposed Live Parts

4.8.11	Unused opening in and missing covers on electrical equipment	IMME	Have a qualified electrician inspect and install knockout plug and junction box covers in compliance with NEC.

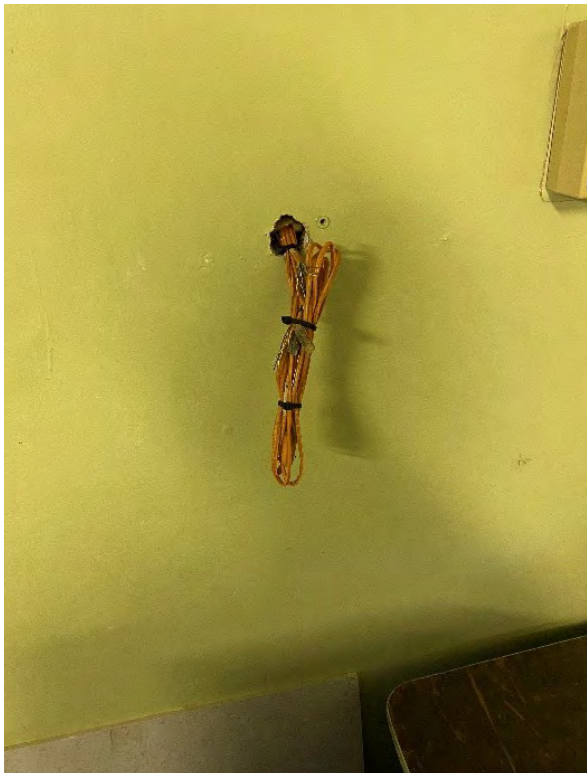
Abandoned Cabling (Typical)

Recommendations - Miscellaneous Electrical			
Item	Description	Condition	Action Required
4.8.4	Abandoned Cabling in Main Elec Rm	POOR	Remove accessible portion of abandoned cables per NEC 725.25.

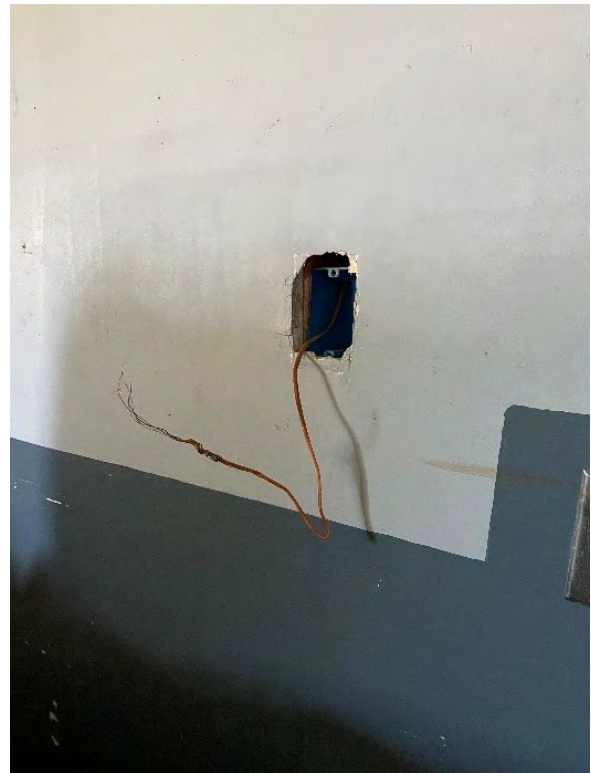
Abandoned Cabling (Typical)

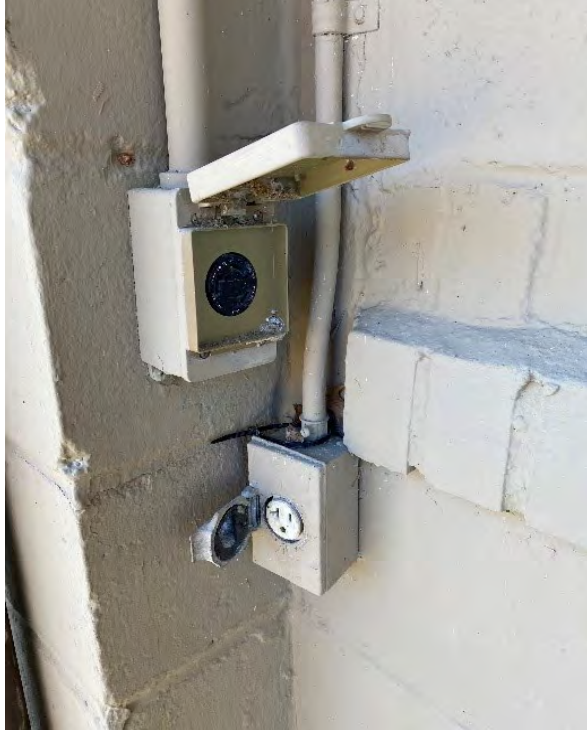
Outdoor Non-GFCI Receptacles

4.8.7	Grounding System	POOR	Replace grounding system simultaneously with the distribution equipment.
4.8.8	Outdoor Receptacles	IMME	Provide GFCI protection for all outdoor receptacles rated 50-amperets or less. This includes the 30-ampere receptacle in the picture above.

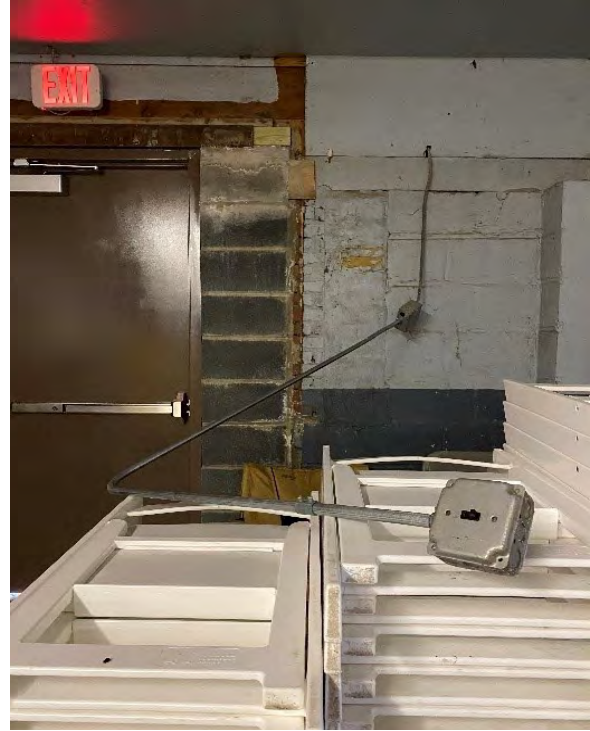
Room 401 - Light Switch Mounting

4.8.9	Light Switch Mounting	POOR	Mount light switch backbox to associated wall. Remove excess conduit as required.
4.8.10	Branch Circuit Wiring	WORK	Replace all branch circuit wiring in future, ideally at the same time as the associated devices and/or fixtures.

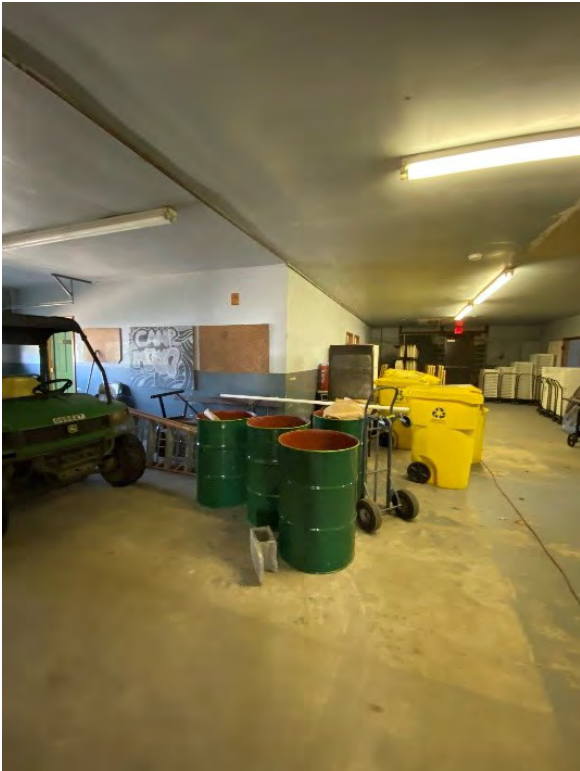
Many of the light switches found during the assessment, controlled lighting that was in a separate room. We recommend these are relocated to their associated controlled rooms. Manual on-off switching should also be replaced with occupancy controls for energy savings in the next 1-3 years (ideally with a lighting fixture replacement). The building did not have any egress illumination which should be added immediately. Some of the exit signage throughout the building was not illuminated and should be replaced with internally illuminated exit signs per NFPA 101. In general, the interior fluorescent lighting in the day camp and storage area is in working condition and should be replaced with LED fixtures in the future. Many of the light fixtures in the maintenance area were missing lamps and flickering. These should be replaced with LED fixtures in the next 1-3 years.

Room 401 - Typical Light Fixtures

4.8.17	Interior Lighting	POOR	Replace all lighting fixtures with LED in the next 1-3 years. The light fixtures in the maintenance area (east) are in very poor shape and should take priority.

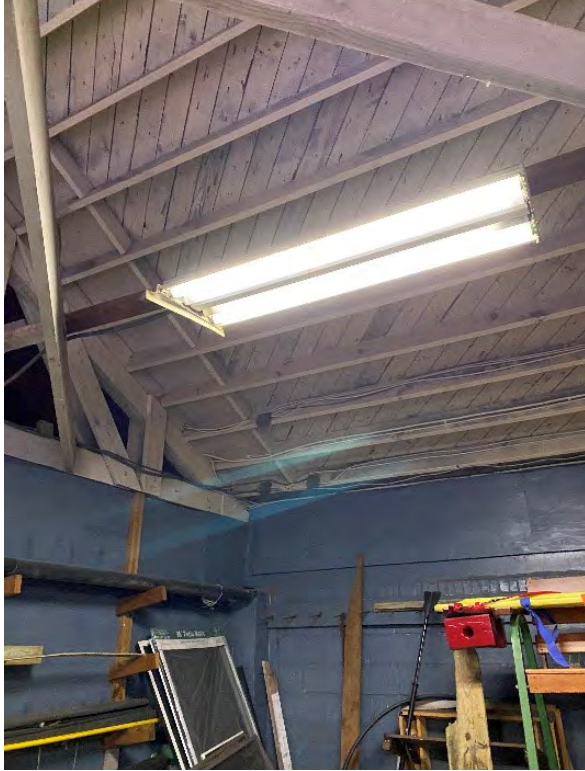
Room 402 - Typical Light Fixture

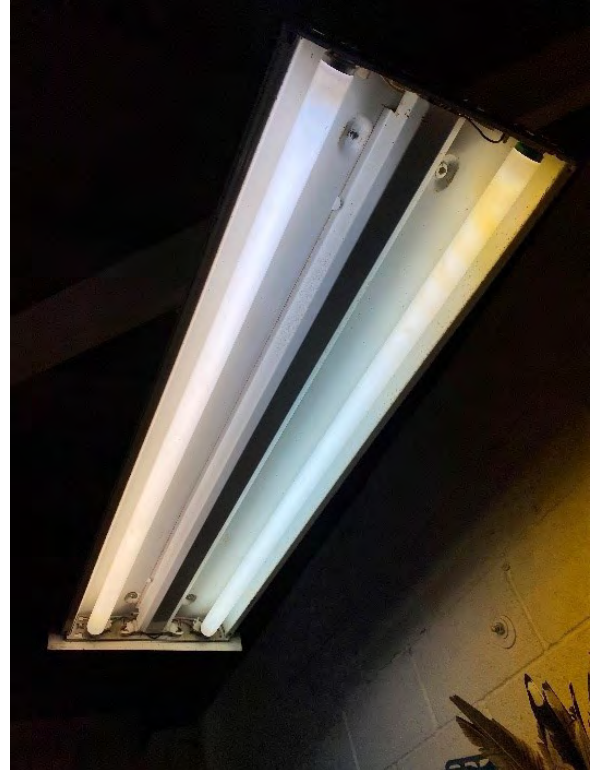
Room 407 - Typical Light Fixture

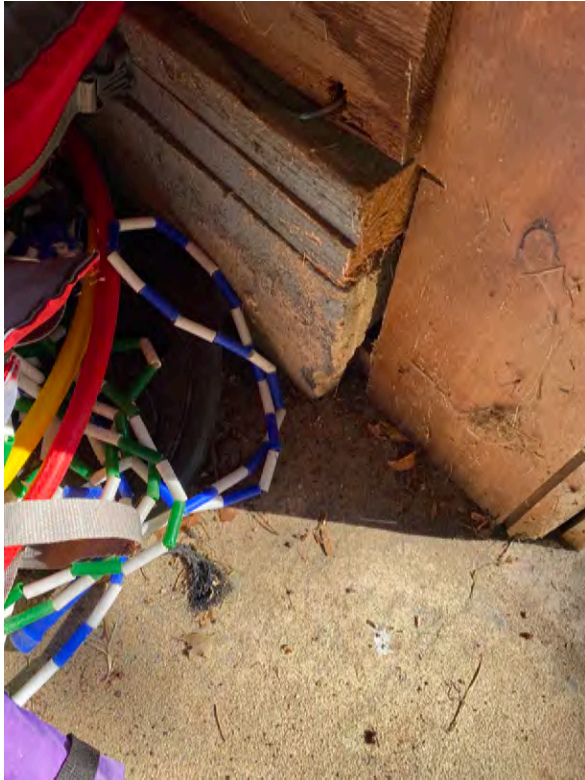
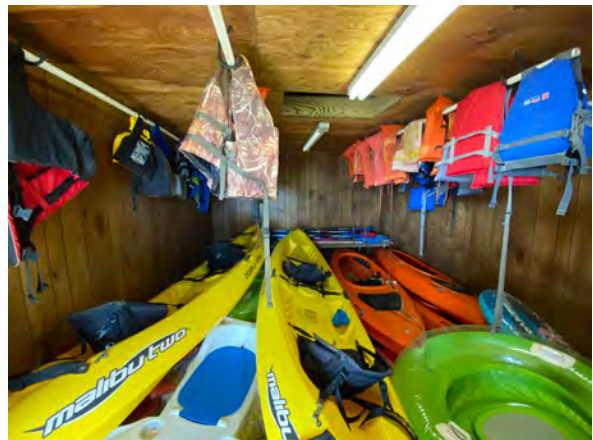
This structure was an earlier building and its current use appears to have been adaptive for aquatic sports equipment storage. The structure was not originally designed for this purpose. Its interior is not organized for maximum efficient organization of the current use. Kayaks and other large items are haphazardly placed about the room rendering it difficult to move about inside. Unclear if the current use has outgrown the limits of the existing space.

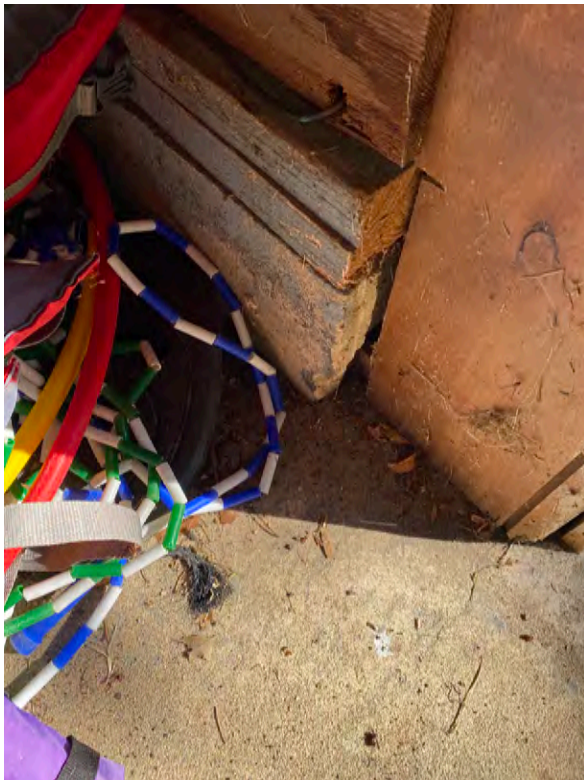
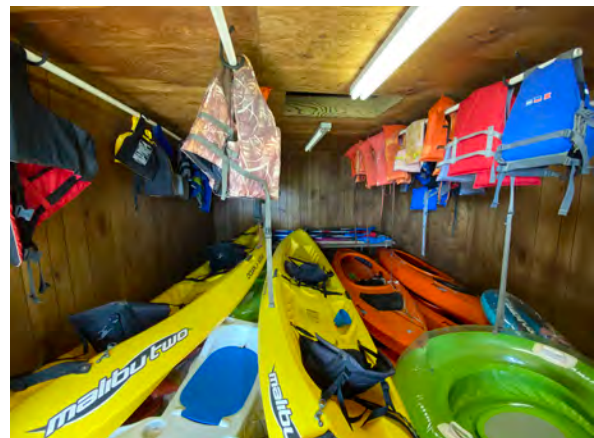
Interior finishes in the one room structure are exposed concrete floor, 4 x8 sheets of 1/8" luan pre-finished wood grained interior wall paneling over wood wall framing members. The ceiling is stained plywood sheets nailed to the underside of roof rafters. There is a 2'-0" x 2'-6" access panel leading to the roof space above the ceiling. The space is utilitarian and the finishes appear to be c.1970.

There is no ventilation in the space and one assumes the kayaks and other aquatic equipment could be stored wet at the end of the day.

Recommendations - Interior Finishes			
Item	Description	Condition	Action Required
5.4.1	Concrete Floor	Unknown (Covered with stacked equipment)	Clean floor and coat with epoxy paint. away from base of structure.
5.4.2	Paneled Walls	WORK/ POOR	Remove and install impact resistance drywall or sheets of 1/2" plywood painted to provide more abuse-resistance storage
5.4.3	Equipment	POOR	Consider adding racks and/or other organizational features with better store the kayaks and equipment off the floor.

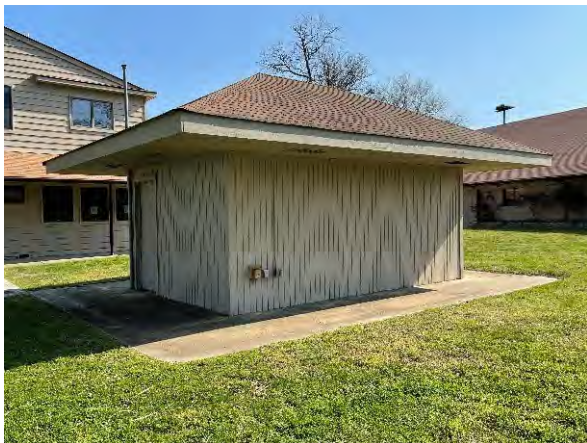
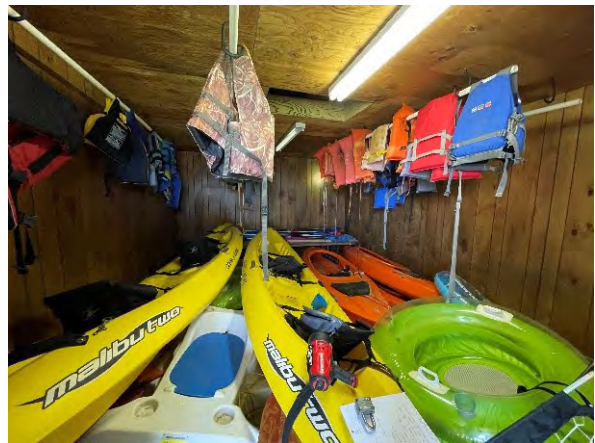
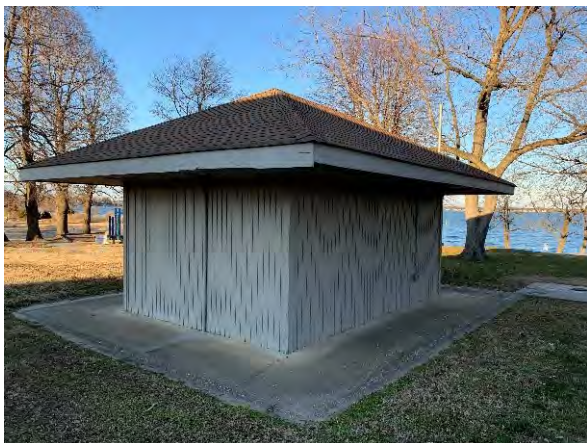
We noted the roof has newer shingles although there are no gutters at the eaves.

We observed no issues or condition that would be of a structural concern.

Recommendations - Storage 1 (Water Sports) Building Structure			
Item	Description	Condition	Action Required
5.5.1	No Noted Structural Concerns	GAN	Continued maintenance, improve guttering.

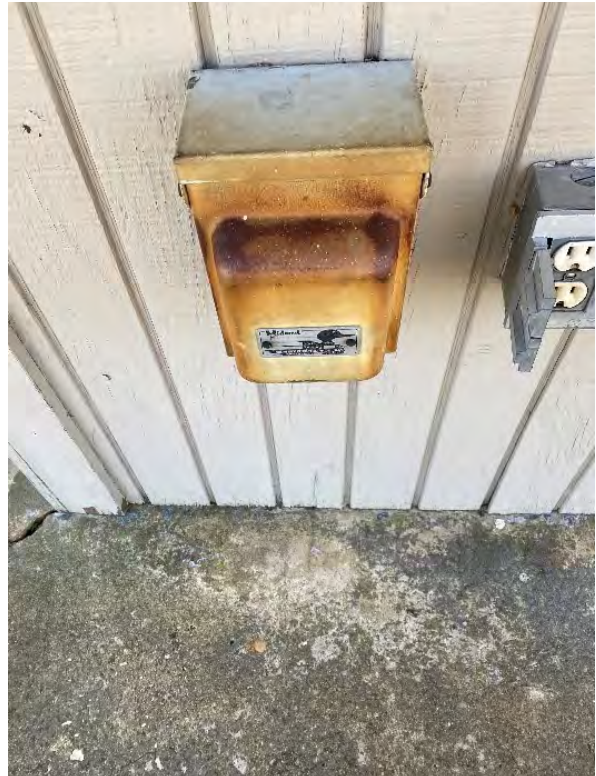
Existing Disconnect

There are multiple outdoor receptacles that do not have GFCI protection or a weatherproof cover. Using a receptacle tester, it was discovered that there is no power coming from these receptacles. If they are not used, they should be removed. There is also an old, rusted disconnect mounted on the exterior wall of the building. This should be replaced if still in use.

Recommendations - Miscellaneous Electrical			
Item	Description	Condition	Action Required
5.8.4	Outdoor Receptacles	IMME	Remove all outdoor receptacles that are no longer being used. If outdoor receptacles are still in use, provide GFCI protection and a weatherproof cover.
5.8.5	Outdoor Disconnect	POOR	Existing aged and rusted disconnect. Replace disconnect in next 1-3 years.
5.8.6	Branch Circuit Wiring	WORK	Replace all branch circuit wiring in future, ideally at the same time as the associated devices and/or fixtures.

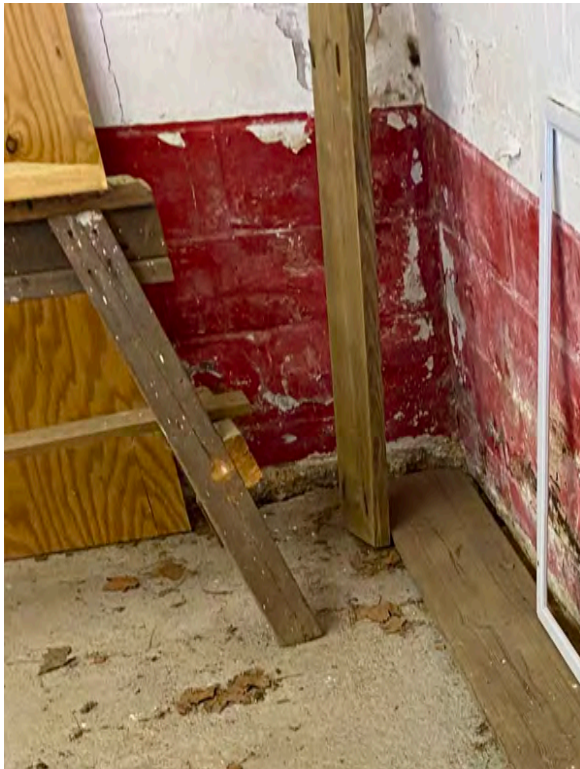
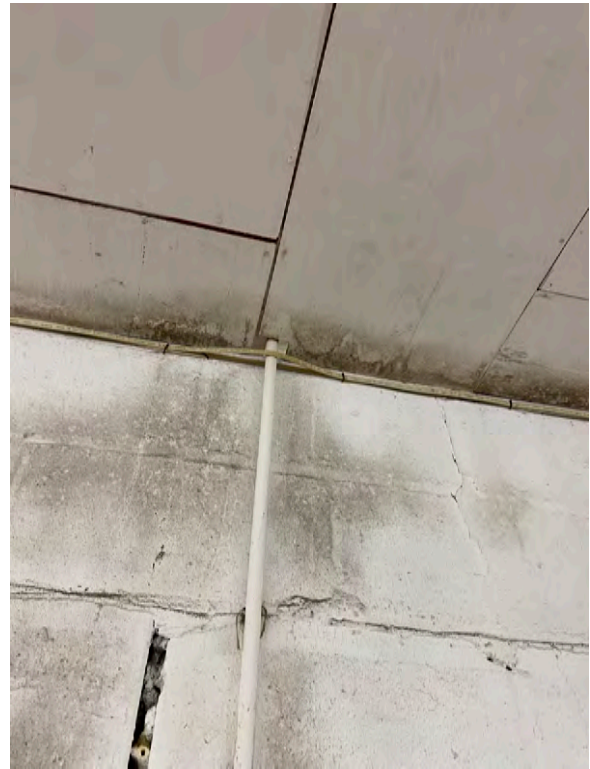
This structure was an earlier building and it appears the space was adapted over time to accommodate the current uses. The structure was not originally designed for this purpose. Depending on the proposed use and occupancy, it should be verified with the Authority Having Jurisdiction (AHJ) if a second egress door is needed from Room 602 to the exterior. Its interior is organized with shelving to address the current use. It appears the uses fill the space provided by the building. There is no paved access to this building connecting it to the hard surface walks and roads of the building compound. It is a building location that could be re-purposed for other uses or program needs of the Park, although due to the work involved in renovating the structure, the building might be demolished and replaced with a new structure that could house the Day Camp use.

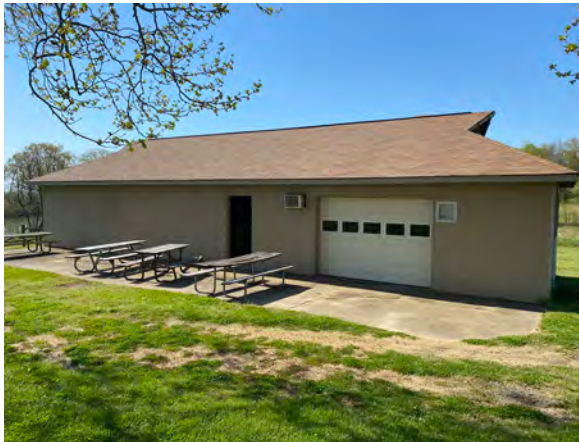
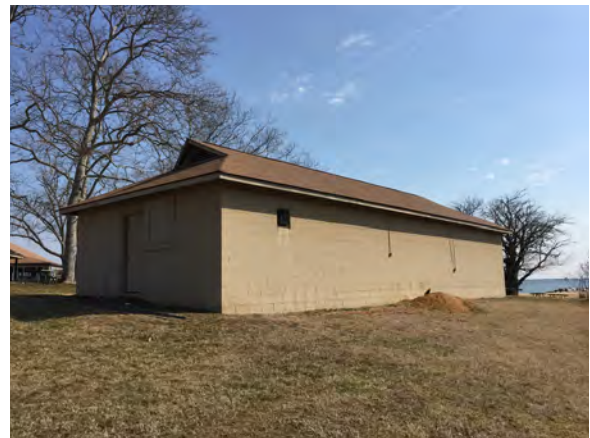
The slab-on-grade, painted CMU bearing walls with stick-framed wood rafters supporting a hip roof. The exterior walls do not appear to be insulated. There is an existing door 601/A and a boarded up window in the northwest wall and an overhead garage door 601/B along the northeast facing wall serving Room 601. There is an existing door 602/A along the northeast facing wall serving Room 602. Running along the entire length of the northeast facing building façade is a 10'-0" wide concrete pad that provides access to the overhead garage door and door 602/A. The condition of the pad shows evidence of cracks, heaving and settlement in numerous locations.

The exterior walls are painted CMU bearing walls. There are numerous infill masonry patches where earlier openings were closed in to make the building secure. The overhead door 601/B is a replacement fiberglass manually operated door which was installed into the wall, as were two exhaust fans and a thru wall portable window A/C unit used to condition Room 601.

Recommendations - Exterior Envelope			
Item	Description	Condition	Action Required
6.1.1	Concrete Pad	POOR	Replace concrete apron with new to create positive drainage away from base of structure.
6.1.2	Roof	WORK	Replace per normal maintenance cycle or if the building is re-purposed for a new use.
6.1.3	CMU Walls	WORK/ POOR	Repair/infill cracks in walls where evident at numerous infill masonry areas.

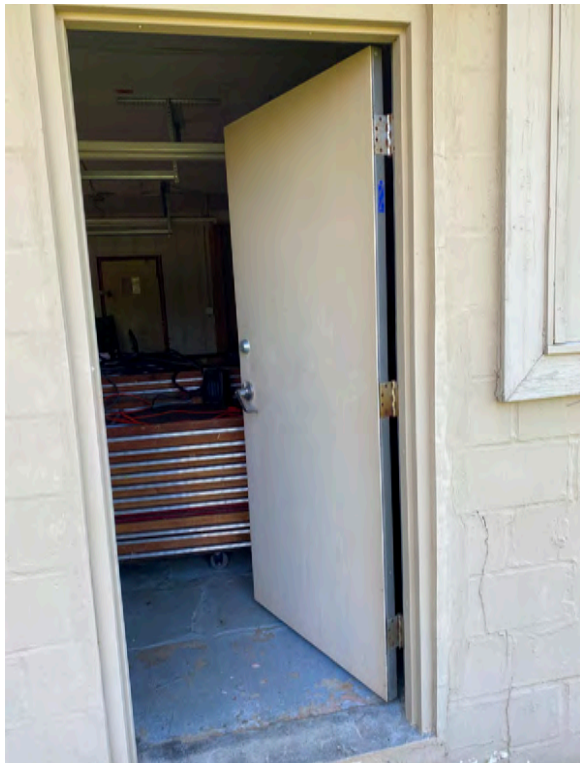
Door 601/A is 3'-0" wide x 6'-8" painted hollow metal door & frame with a 30 minute fire-rating. Lever lockset is damaged. Deadbolt is functional. No closer. The door is in working condition except for lockset.

Recommendations - Door			
Item	Door #	Condition	Action Required
6.2.1	601/A	WORK	Repair/replace lockset.
6.2.2	601/B	WORK	Continue routine maintenance.
6.2.3	602/A	WORK	Repair/replace lockset.
6.2.4	602/B	POOR	The salvage door was installed as a means of communicating between rooms 601 & 602. It should be replaced with a 3'-0" wide x 6'-8" high Hollow Metal Door & Frame rated as required along with the partition it is set in (See 6.5.1 below). Hardware should be consistent with its use.

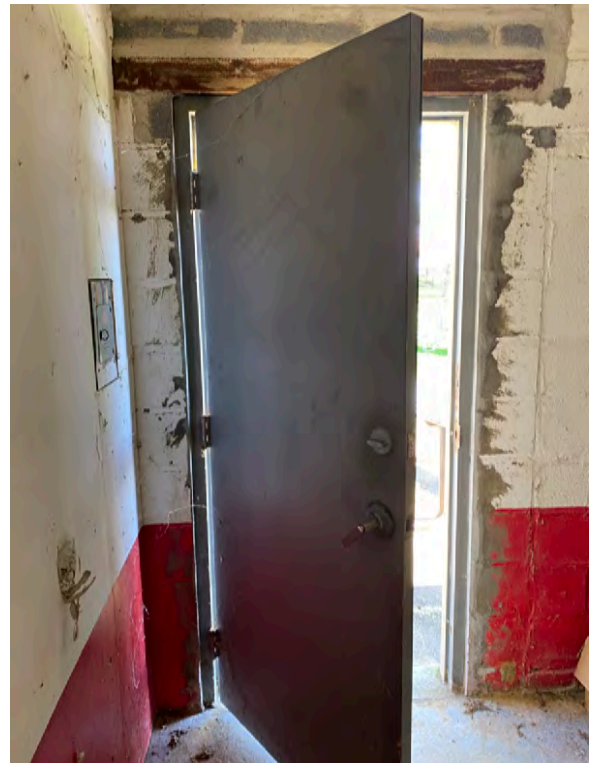
Door 602/A is 3'-0" wide x 6'-8" painted hollow metal door & frame with a 30 minute fire-rating. Lever lockset is damaged. Deadbolt is functional. No closer. The door is in working condition except for lockset.
