MAYO BEACH PARK

4150 Honeysuckle Drive
Edgewater, Maryland 21037

Condition Assessment for Anne Arundel County DEPARTMENT OF RECREATION & PARKS

Contract Number: P582101
Project Number: P582100

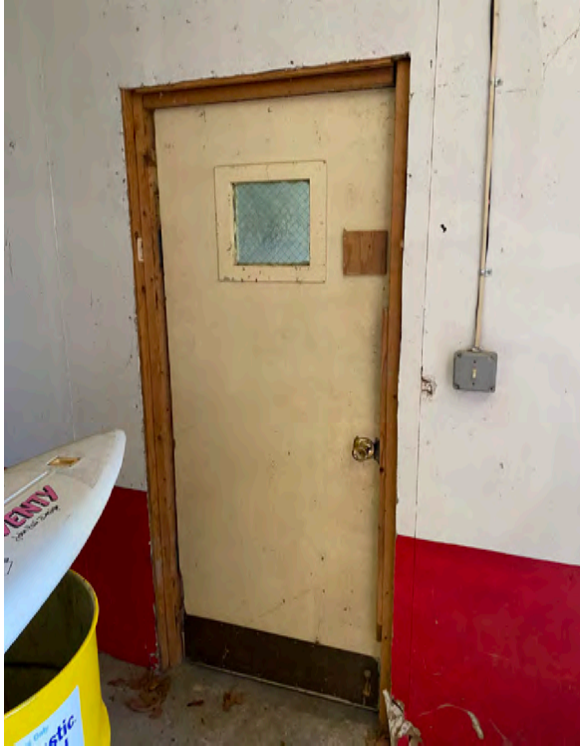
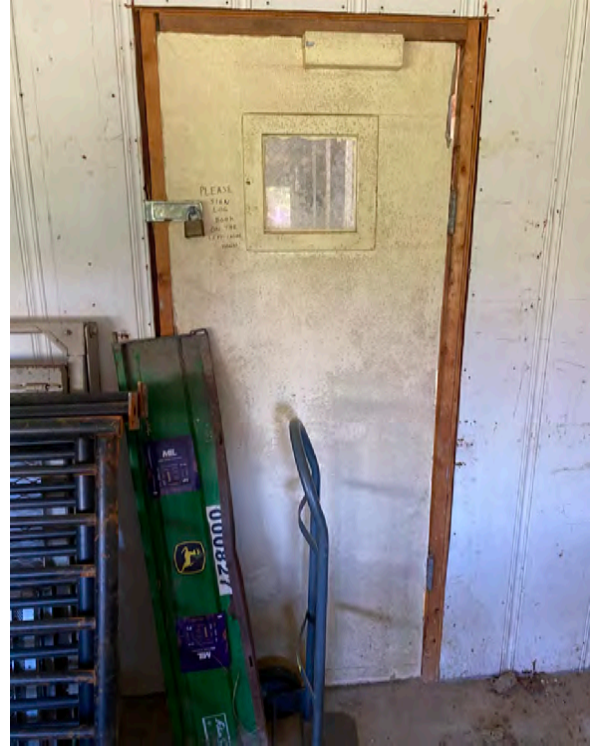
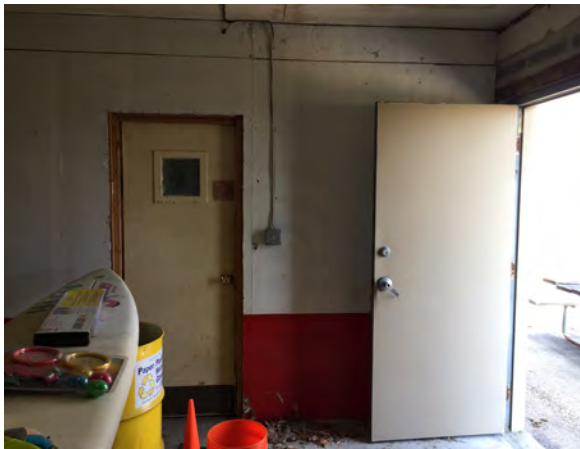
Door 602/B is a salvaged wood door inserted into a wood framed partition. It is secured by a hasp & padlock. It is not a functioning door by conventional standards. It is not rated. It is not consistent with the other doors which are H. M. doors and frames.

Recommendations - Door			
Item	Door #	Condition	Action Required
6.2.1	601/A	WORK	Repair/replace lockset.
6.2.2	601/B	WORK	Continue routine maintenance.
6.2.3	602/A	WORK	Repair/replace lockset.
6.2.4	602/B	POOR	The salvage door was installed as a means of communicating between rooms 601 & 602. It should be replaced with a 3'-0" wide x 6'-8" high Hollow Metal Door & Frame rated as required along with the partition it is set in (See 6.5.1 below). Hardware should be consistent with its use.

Recommendations - Interior Finishes			
Item	Description	Condition	Action Required
6.4.1	Wood Partition between rooms	POOR	Demo existing partition and door. Construct new metal stud and GWB partition, fire-rated as necessary or a new 6" CMU partition if floor slab is capable of supporting the load. Extend partition to underside of roof deck or provide draft stopping in lieu if required by current uses. Paint new wall below the ceiling line and new door & frame .
6.4.2	Plywood Ceilings in both rooms	WORK/ POOR	Consistent with a determination of the use and ratings in the rooms, demo existing plywood sheathing and install new fire-rated GWB ceiling to achieve the necessary rating. Paint when completed.

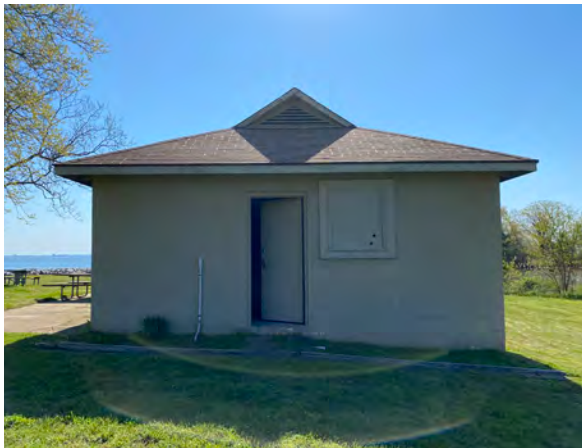
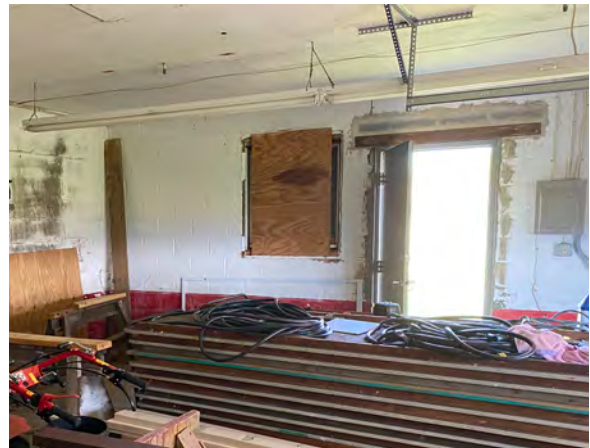
There is one boarded over window opening on the northwest wall next to Door 601/A in room 601.

Exterior view of entombed window opening

Interior view of entombed window opening

Recommendations - Windows			
Item	Window #	Condition	Action Required
6.3.1	Window Opening	POOR	If current use of this room to continue, demo wood barrier and infill the opening with masonry to close off the opening and paint to match building exterior. Alternately, if new use for this space is considered, possible to install new pre-finished window & frame in opening.

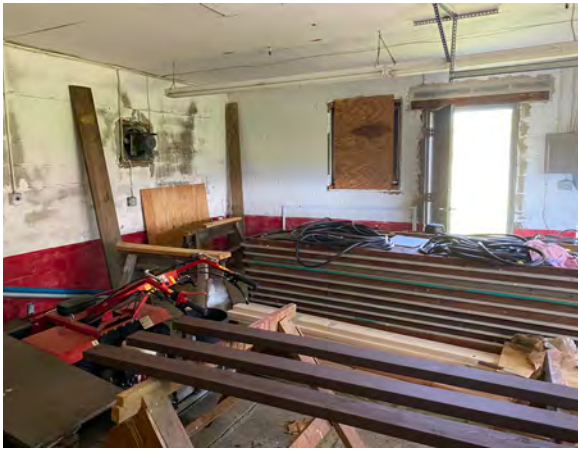
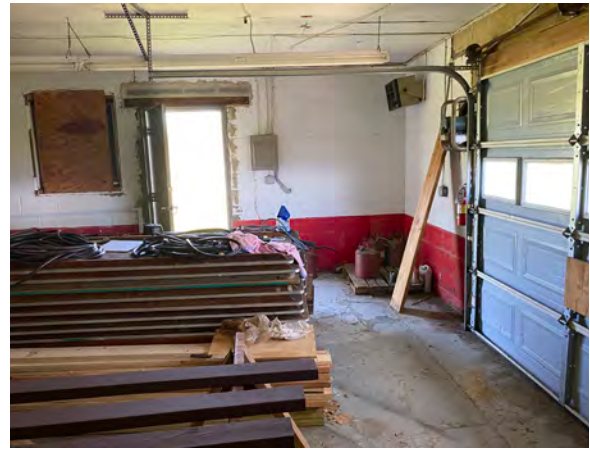
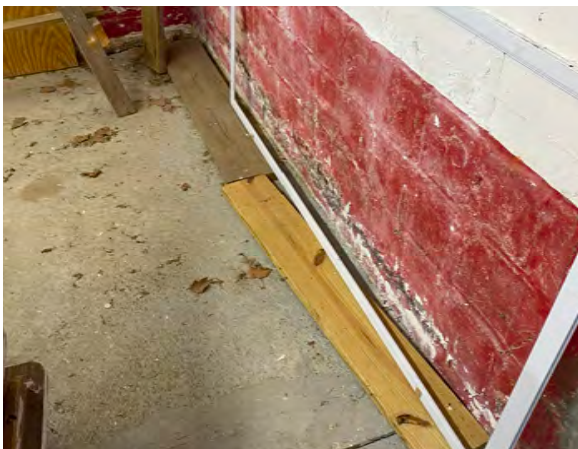
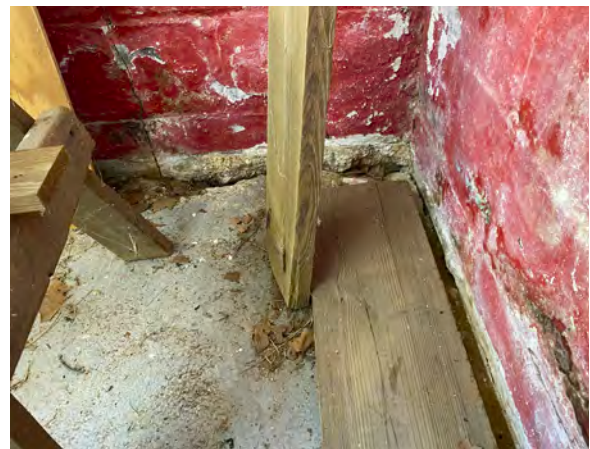
Interior Room 601

Floor is a patchwork of painted concrete slab and what appears to be sections of slate or flagstone from a previous use of the building. Cracks are evident. The concrete floor in the northwest corner of the room has separated from the CMU wall and settled 4 to 5 inches down at the worst location. Interior face of painted CMU walls show signs of moisture damage from rising damp along the northwest and southwest exposures. There is a wood partition separating rooms 601 and 602. It was constructed of salvaged materials and is not a consistent construction type. It provides no rated separation between the uses in the rooms. The ceiling is painted plywood sheets nailed to the underside of the roof framing. Evidence of water staining is visible but unable to discern if recent. Could have been present prior to most recent re-roofing installation

There are two thru-wall motorized exhaust fans and a thru-wall portable window A/C unit in the space.

Recommendations - Room 601			
Item	Description	Condition	Action Required
6.4.3	Concrete Floor	WORK/ POOR	Demo damaged sections for concrete floor and after providing suitable sub-base material pour new concrete floor. When complete install coats of epoxy paint.
6.4.4	CMU Walls	WORK/ POOR	Examine causes of rising damp along the northwest wall and address with the necessary remedial action. Examine outside drainage patterns to see if water was ponding along the wall at this location.
6.4.5	Walls	WORK/ POOR	After repairs are completed, repaint existing CMU walls.

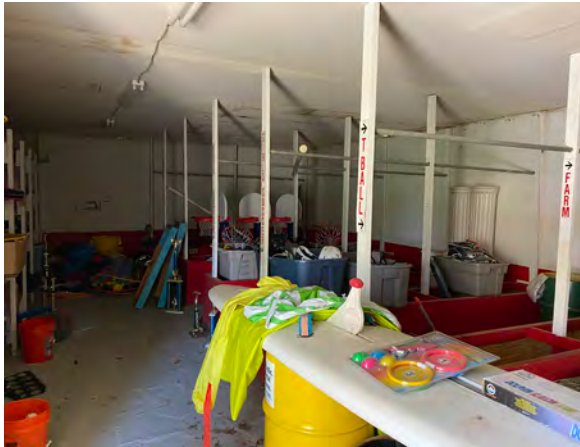
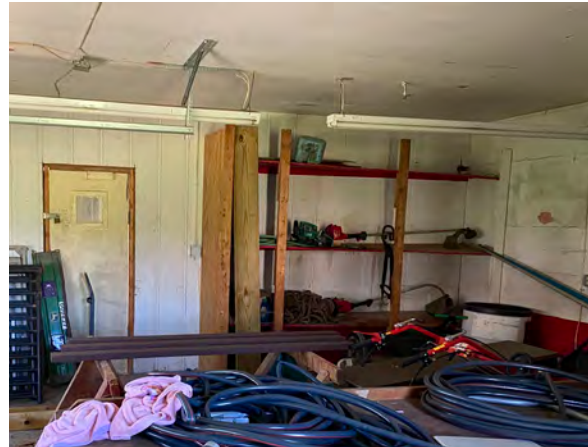
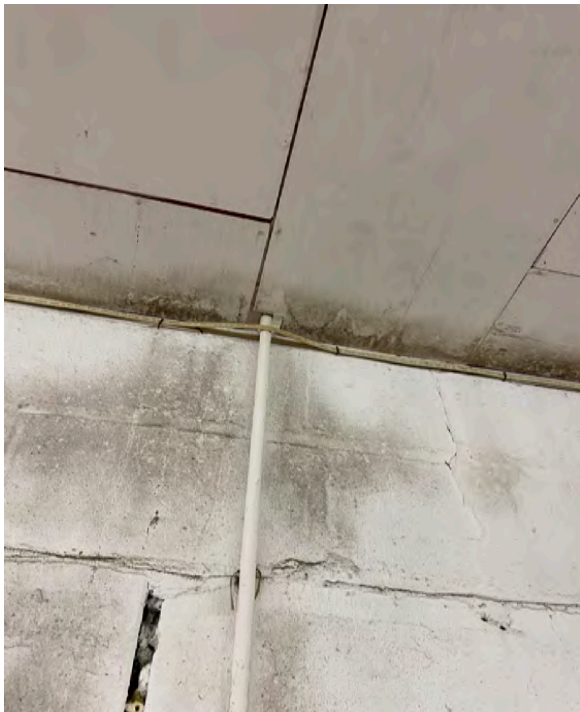
Interior Room 602

Floor is a patchwork of painted concrete slab and what appears to be sections of slate or flagstone from a previous use of the building. Cracks are evident. Interior face of painted CMU walls show signs of moisture damage from rising damp along the northwest and southwest exposures. There is a wood partition separating rooms 601 and 602. It was constructed of salvaged materials and is not a consistent construction type. It provides no rated separation between the uses in the rooms. The ceiling is painted plywood sheets nailed to the underside of the roof framing. Evidence of water staining is visible but unable to discern if recent. Could have been present prior to most recent re-roofing installation.

There is no ventilation in the space.

Recommendations - Room 602			
Item	Description	Condition	Action Required
6.4.6	Concrete Floor	WORK/ POOR	Floor is cracked and uneven in certain locations. Determine if the existing floor conditions affects the beneficial use of the space. Repair those areas as necessary.
6.4.7	CMU Walls	WORK/ POOR	Fill voids and cracks in walls where observed. Repaint all CMU walls.

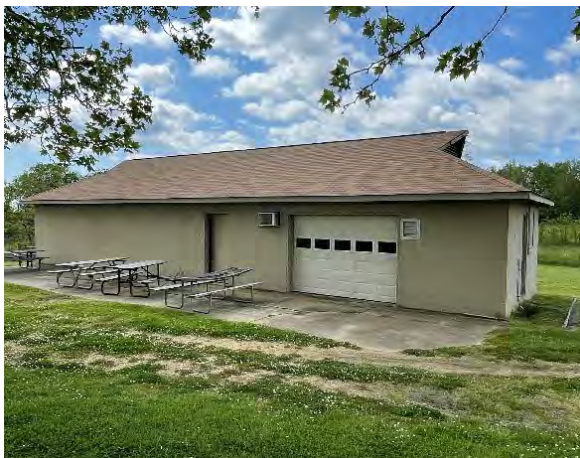
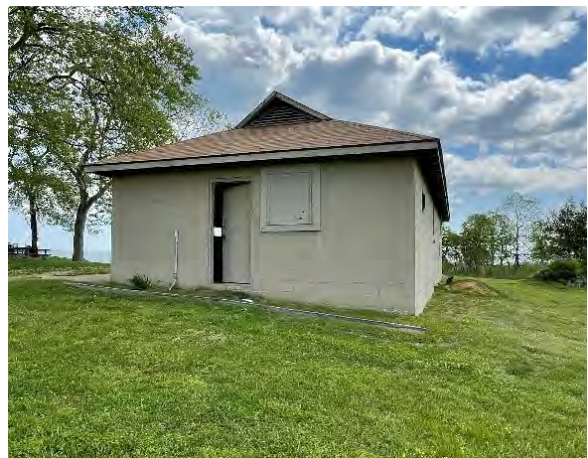
We noted the roof has newer shingles although there are no gutters at the eaves.

No visible condition was observed to indicate a structural concern with the building.

Recommendations - Storage 2 Building Structure			
Item	Description	Condition	Action Required
6.5.1	General Building	GWC	Continued maintenance
6.5.2	Investigate controlling groundhog infestation and ongoing slab undermining.	WORK	Remove access to sub-slab area to prevent slab undermining.
6.5.3	Install gutters/downspouts	WORK	Install gutters to protect building perimeter and enhance service life.

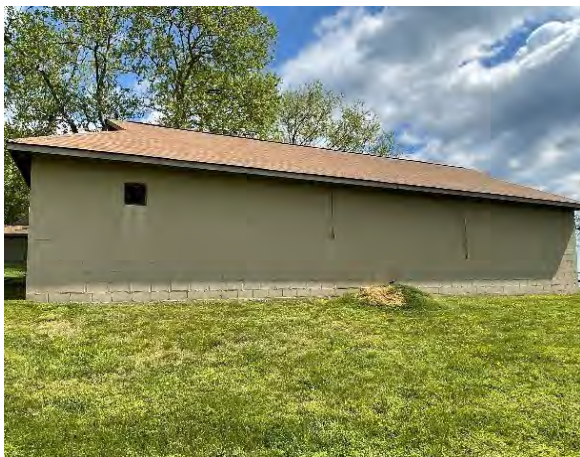
The floor of the structure is a concrete slab on grade. We observed sloping and settlement of the slab at the sports equipment storage portion. Since it is on grade, it is not a structural concern. Although we understand the slab may be undermined by groundhogs burrowing below the slab as evidenced by the raised hill of soil and access hole visible along the back elevation,

Exterior Elevation - South; note the mounded dirt.

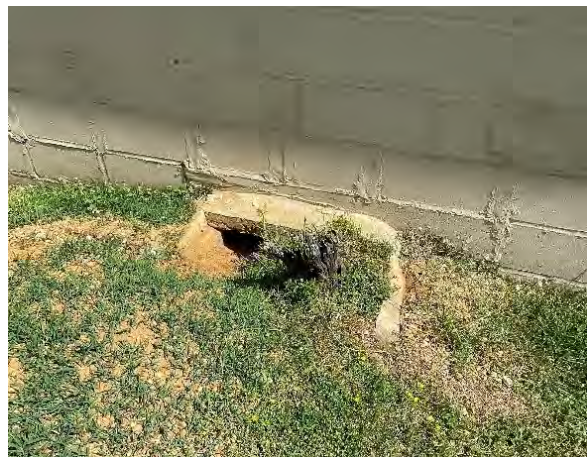
View of access hole for groundhogs

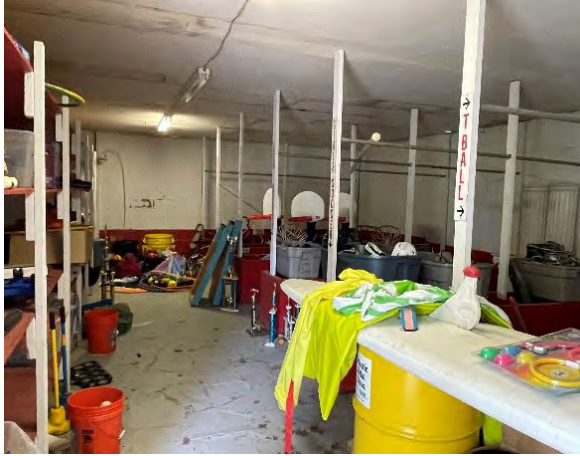
View of the interior at the sports equipment storage.

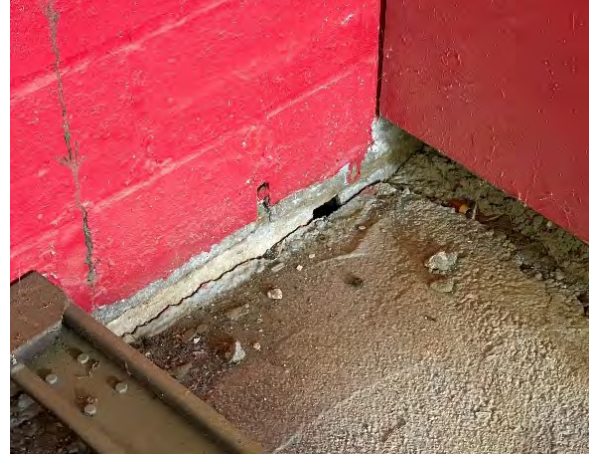
View of settled floor slab in the storage area.

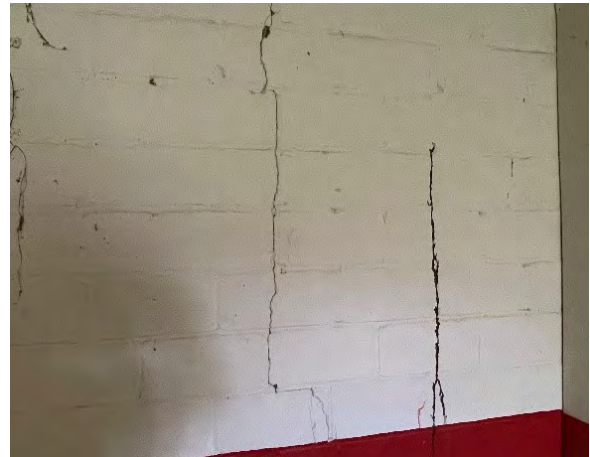
Minor vertical cracking distress in work zone wall.

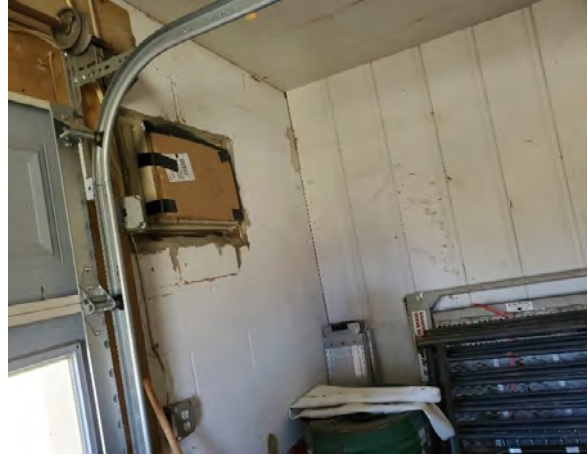
The storage building contains a unit heater and two exhaust fans which look to be in good working condition. The building also has a sleeve through the wall from an old AC unit.

Through the Wall Unit Sleeve

Recommendations - Mechanical Systems			
Item	Description	Condition	Action Required
6.6.1	Unit Heater	WORK	No Action Required
6.6.2	Exhaust Fans	WORK	No Action Required
6.6.3	AC unit sleeve		The AC unit sleeve shall be removed and the existing opening shall be properly closed up.

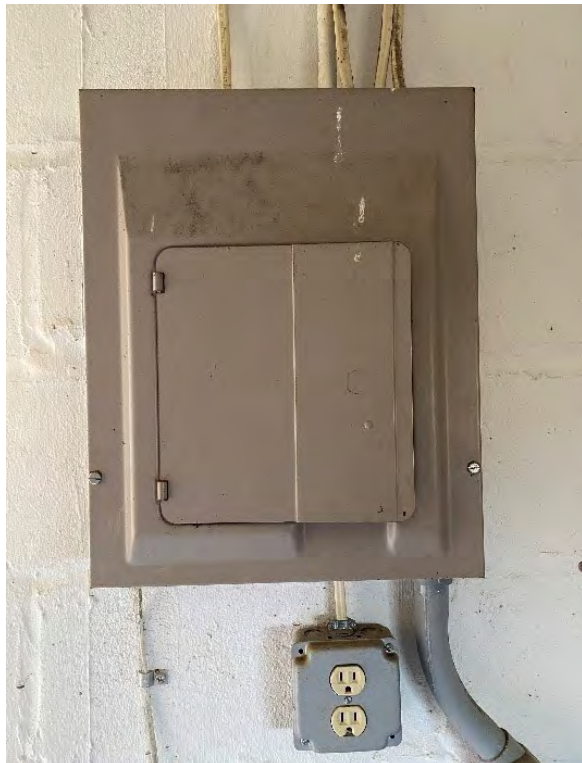
This storage building contains a 1-phase, 3-wire, 120/240V load center. The load center is manufactured by Cutler-Hammer and it could not be determined when it was installed. This load center receives power from the Maintenance Building main electrical room. The life expectancy of a typical panelboard is 30-40 years. Load center is in poor condition and assuming it is at least 30 years old, like all the other electrical equipment on site, it is recommended that a replacement is budgeted for in the next 1-3 years.

Recommendations - Distribution System			
Item	Description	Condition	Action Required
6.8.1	Load Center	POOR	Assumed to be 30+ years old. Replace in next 1-3 years.
6.8.2	Building Grounding System	POOR	Ground rod is corroded. Replace grounding system in next 1-3 years.

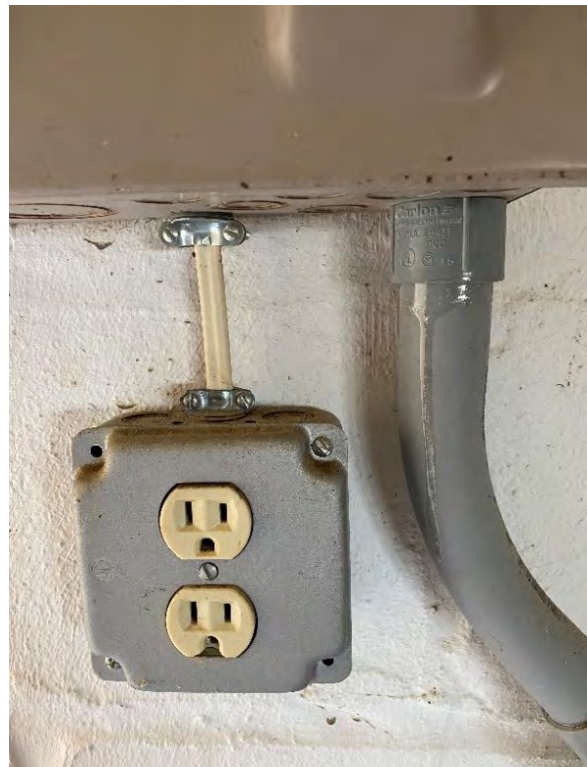
Typical Indoor Receptacle

Recommendations - Miscellaneous Electrical			
Item	Description	Condition	Action Required
6.8.3	Hanging Light Switch and Receptacle	POOR	Secure light switch and receptacle backboxes to the wall.
6.8.4	Indoor Receptacles	IMME	Provide GFCI protection for all indoor receptacles per NEC 210.8.
6.8.5	Indoor Wiring	IMME	Replace all indoor wiring and provide rigid conduit. Type NM not permitted to be exposed in this building.
6.8.6	Outdoor Receptacle	POOR	Remove if not in use. If still being used, needs GFCI protection and weatherproof cover immediately. Receptacle backbox and conduit should be properly secured to the wall.
6.8.7	Outdoor Exposed Wiring	POOR	Unused wiring should be removed back to source.

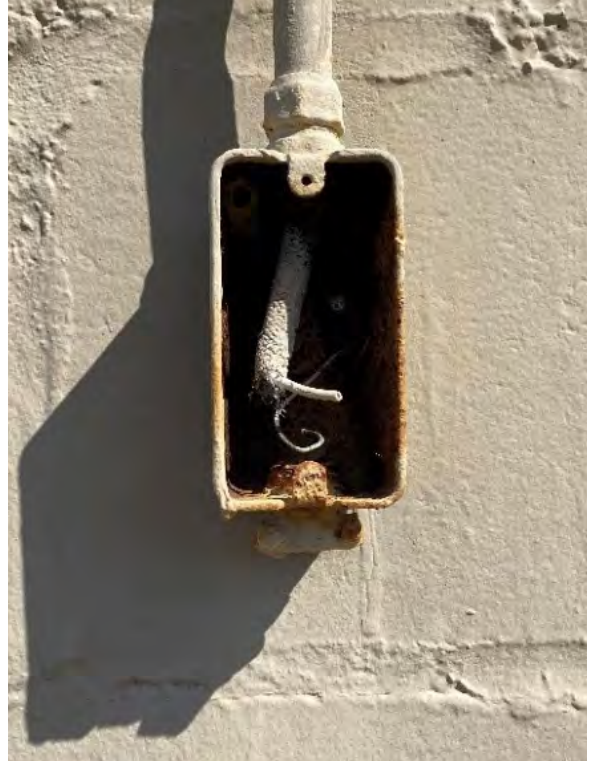
Building construction appears to be Type 3 which is a combination of combustible and non-combustible material. NEC 334.10 only allows Type NM cable in Type 3 building construction if it is concealed within walls, floors, or ceilings. Type NM cabling is exposed throughout the entire building and should be replaced immediately.

Exposed Wiring

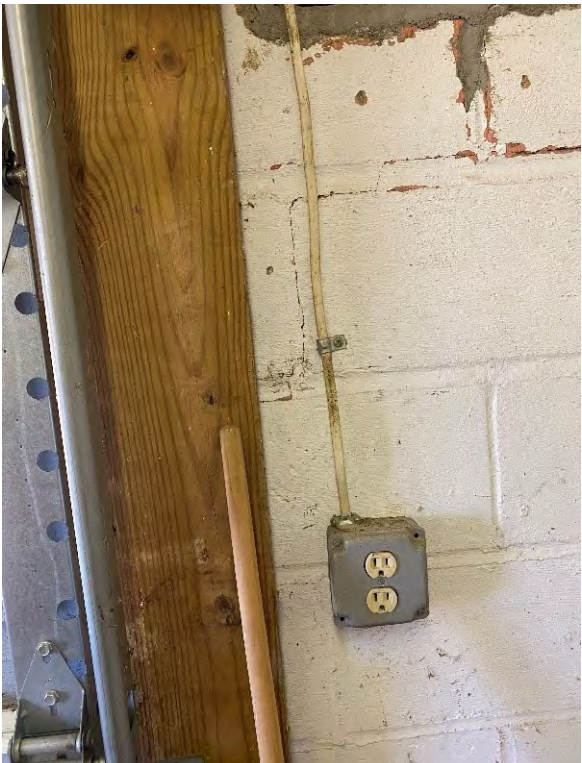
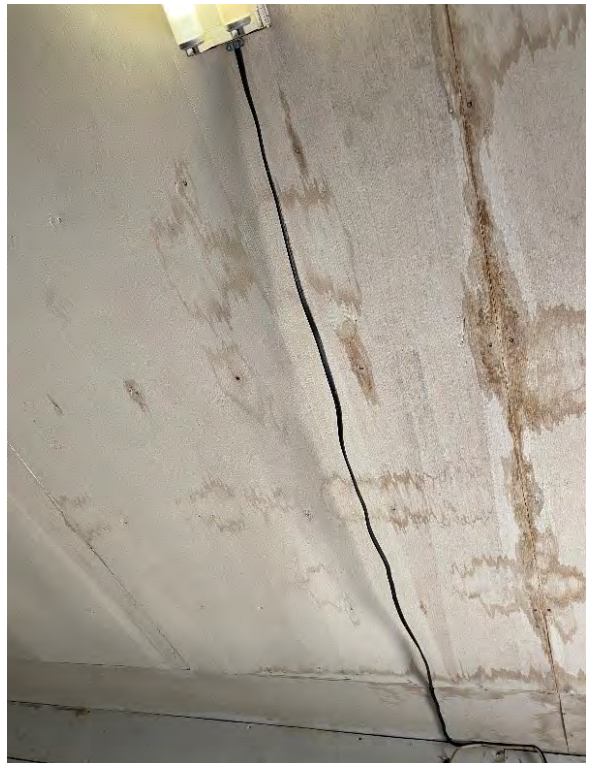
Typical Indoor Wiring

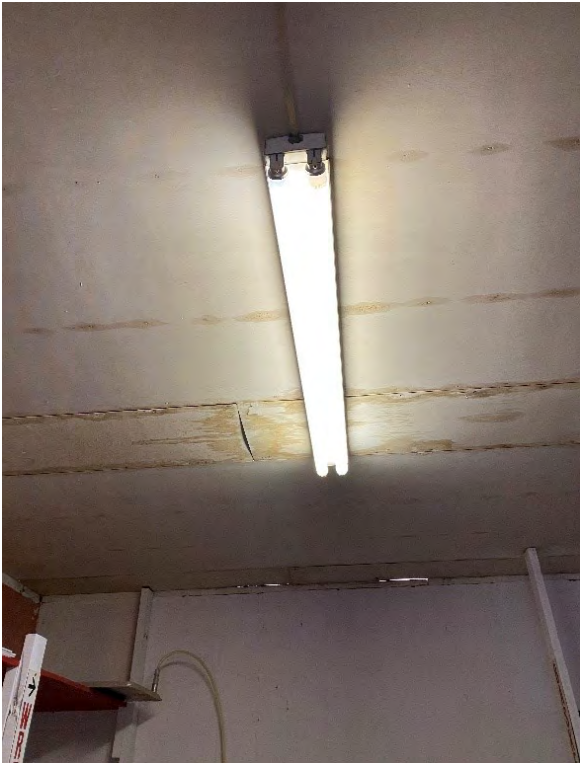
All interior lighting flickers with one of the fixtures not turning on at all. Lighting should be replaced with LED fixtures in next 1-3 years.

Typical Interior Lighting

Recommendations - Lighting			
Item	Description	Condition	Action Required
6.8.8	Interior Lighting	POOR	Replace with LED fixtures in next 1-3 years.
6.8.9	Lighting Fixture Bulbs not guarded.	IMME	Provide bulb protectors or install guards on light fixtures.

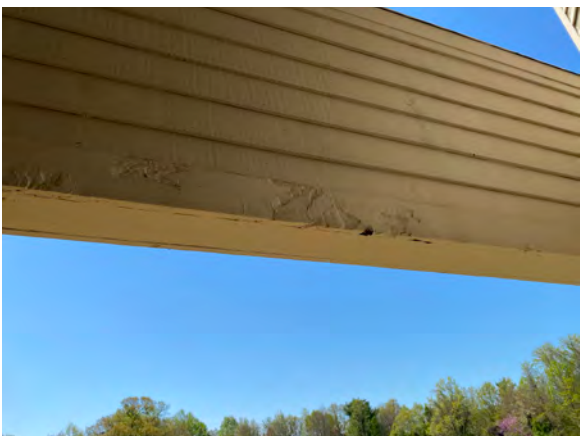
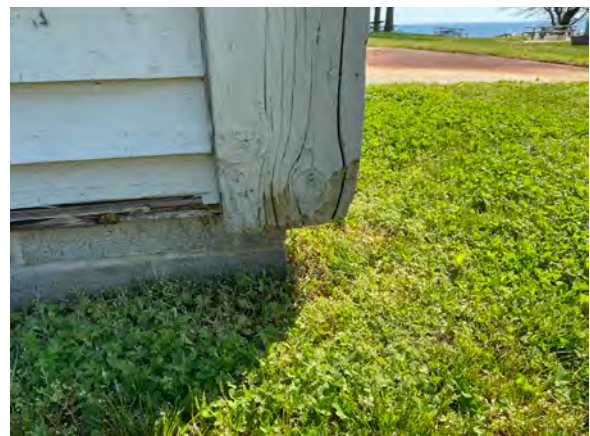
The siding is wood lap siding with 5/4" wood corner boards. It has received many coats of paint over the years. It is in fair condition with some areas near ground contact that show rotted or deteriorated conditions. The area around the exterior shower is further stained by heavy iron content in the water supply.

Wood Lap Siding

Recommendations - Exterior Envelope			
Item	Description	Condition	Action Required
7.1.1	Siding	WORK/ POOR	Repair/replace deteriorated sections of siding and wood corner boards where deterioration/rot is evident.
7.1.2	Siding	WORK/ POOR	Unless another location can be found for the exterior shower, recommend overlaying a water resistant panel on the siding to keep water and continuing staining from occurring on this section of siding.

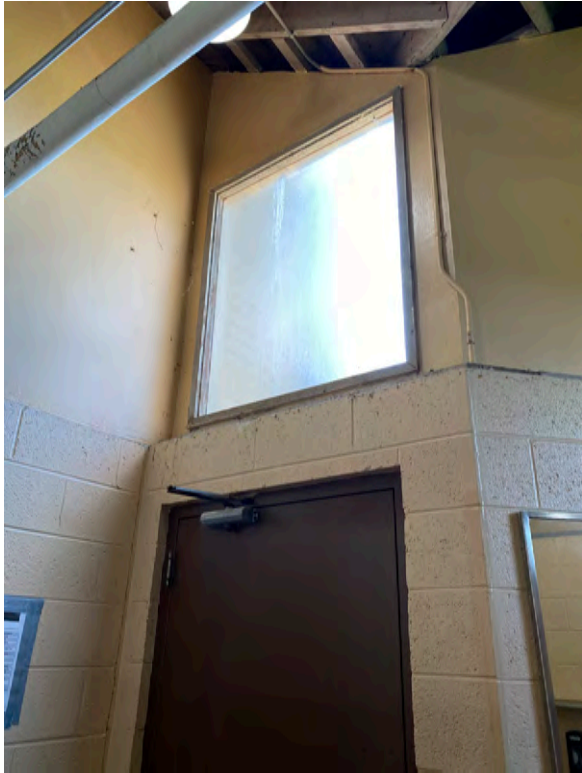
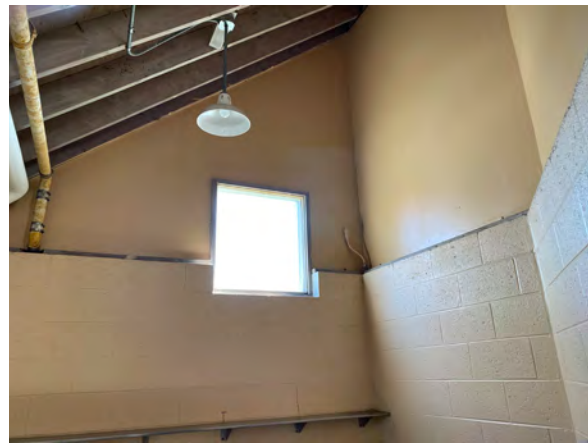
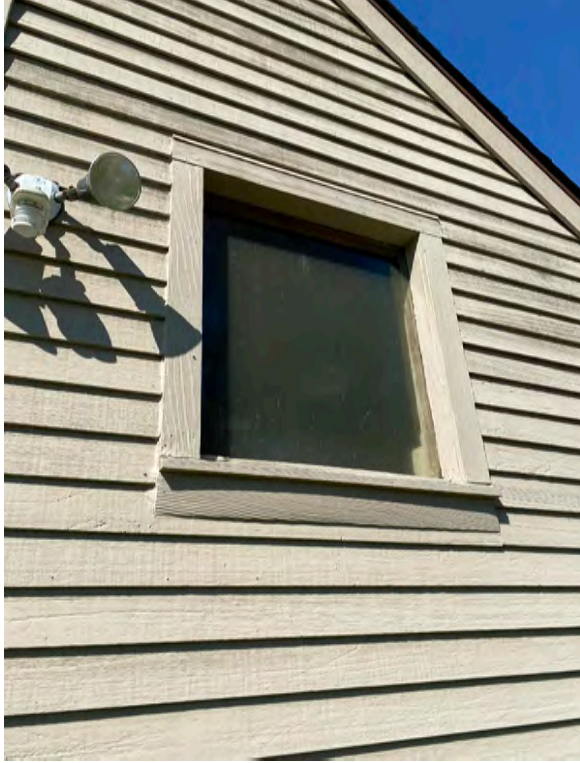
There are six windows in this structure, three in each restroom. They are wood framed and are glazed with single pane 1/8" tempered glass, although the weathering on the glass may indicate they were replaced with Lexan security panels at some point. In the men's restroom the glass was loose in the frame and had dropped down approximately 1 inch, leaving an opening at the head of the window.

Wood-framed Window, Interior View

Wood-framed Window, Exterior View

Recommendations - Windows			
Item	Window #	Condition	Action Required
7.3.1	W1	WORK	Inspect windows for air gaps and deteriorated frames/sills and repair/replace as necessary.
7.3.2	W2	WORK	Inspect windows for air gaps and deteriorated frames/sills and repair/replace as necessary.
7.3.3	W3	WORK	Inspect windows for air gaps and deteriorated frames/sills and repair/replace as necessary.
7.3.4	W4	WORK	Inspect windows for air gaps and deteriorated frames/sills and repair/replace as necessary.
7.3.5	W5	WORK	Inspect windows for air gaps and deteriorated frames/sills and repair/replace as necessary.
7.3.6	W6	WORK	Inspect windows for air gaps and deteriorated frames/sills and repair/replace as necessary.

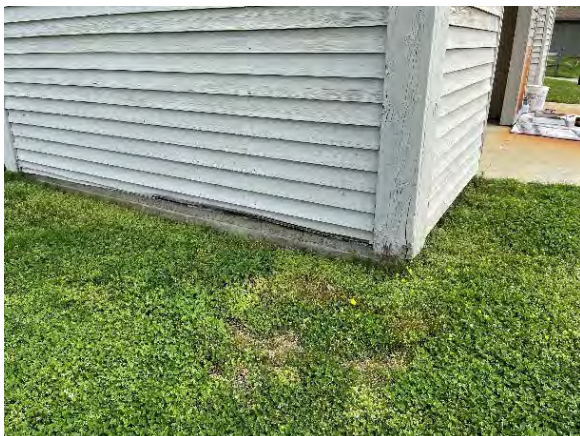
We observed some deterioration of the wood siding along the base of the exterior walls, likely attributable to the lack of a gutter and downspout system.

Exterior Elevation -Note the damage to the siding.

Recommendations - Public Restrooms Building Structure			
Item	Description	Condition	Action Required
7.5.1	General Building	GWC	Continue routine maintenance.
7.5.2	Damaged areas of roof valleys	GWC	Investigate and confirm valley flashing installed and repaired during re-roofing
7.5.3	Install gutters/downspouts	WORK	Install gutters to protect building perimeter and enhance service life.

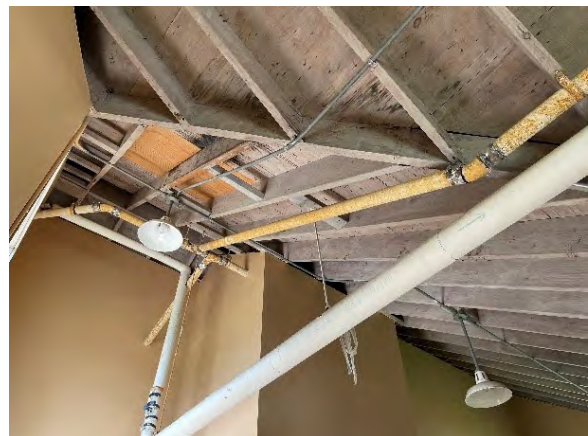
We observed prior damage at the roof valley areas in both sides of the structure. We are of the opinion that this condition was likely addressed with the newer roof installation.

Interior view of the valley with replaced sheathing, Located on the Women's side.

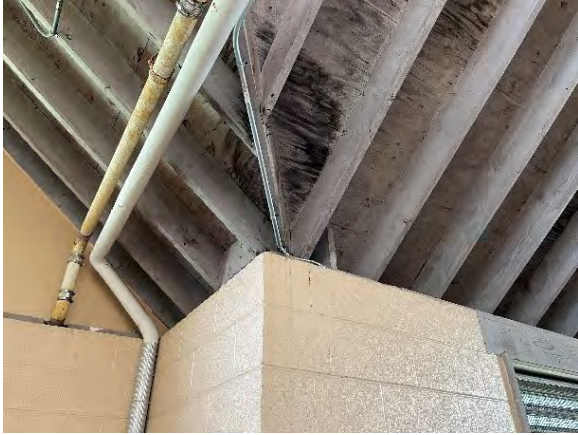
View of the valley conditions of Men's Room side.

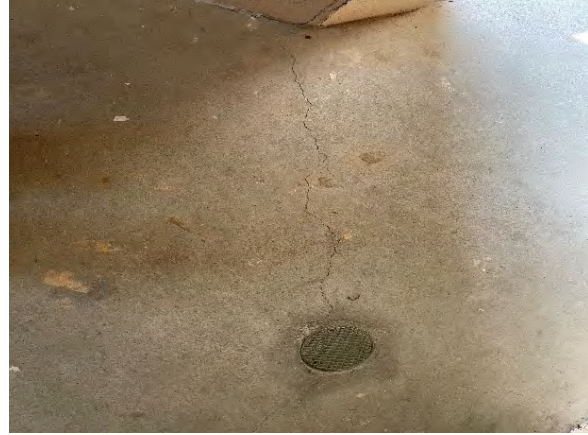
The floor of the structure is a concrete slab on grade. We observed minor cracking distress in the concrete floor slab although not a structural concern.

View of minor shrinkage cracking in floor slab.

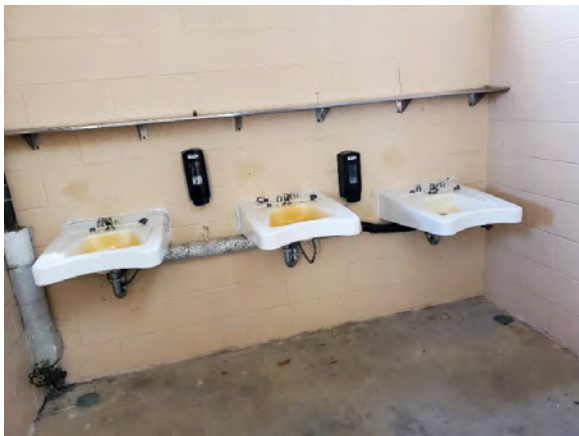
Men's Bathroom Lavatory

The Men's and Women's Bathroom contain metered lavatory, and flush valve water closets and the Men's Bathroom also contain flush valve urinal. The outside of the building has an exterior shower. The plumbing fixtures look like they are in good condition without any crack or damages. Their operation cannot be verified because building is winterized for the winter. The lavatory and shower only receive domestic cold water. The lavatory, water closets and urinal are stained from water hardness.

Recommendations - Plumbing Systems			
Item	Description	Condition	Action Required
7.7.1	Water Closet	WORK	Should be replaced after campus water hardness is resolved
7.7.2	Urinal	WORK	Should be replaced after campus water hardness is resolved
7.7.3	Lavatory	WORK	Should be replaced after campus water hardness is resolved
7.7.4	Shower	WORK	No action required.
7.7.5	Piping insulation	IMME	The domestic water pipe insulation and jackets shall be replaced.

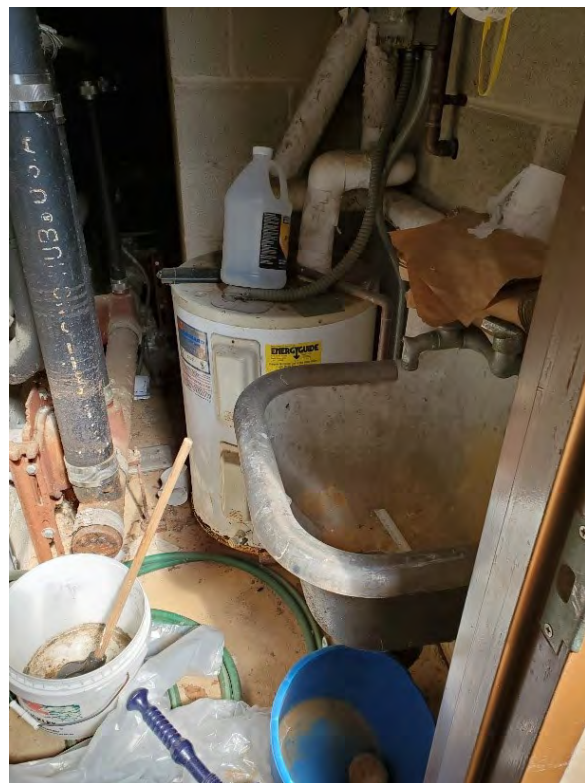
The janitor sink is served a by a 30 gallon 4.5 KW domestic water heater. The water heater is manufactured by Vanguard and is starting to rust.

Recommendations - Plumbing Systems			
Item	Description	Condition	Action Required
7.7.6	Domestic Water Heater	IMME	The water heater shall be replaced in kind and an expansion tank shall be added to the system.

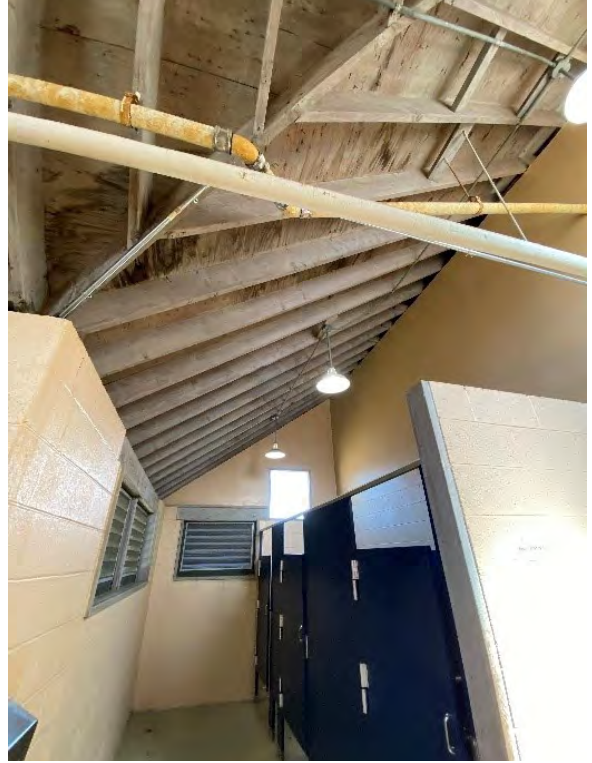
Lighting switches in both restrooms do not comply with ADA mounting height requirements. Interior lighting should be replaced with LED fixtures in the future. Exterior lighting is in poor condition and should be replaced with LED fixtures in next 1-3 years. Exterior lighting would not turn on and it is assumed to be because of the time clock in the mechanical chase.

Recommendations - Lighting			
Item	Description	Condition	Action Required
7.8.6	Interior Lighting	WORK	Replace with LED in future.
7.8.7	Restroom Light Switches	WORK	Lower light switches in restrooms to 46" above finished floor to comply with ADA requirements.
7.8.8	Exterior Lighting	POOR	Replace with LED in next 1-3 years.

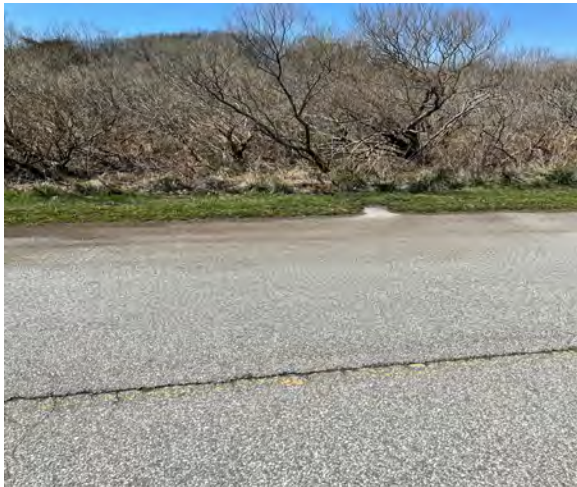
8.1.1 Cracked asphalt pavement at entrance road.

Recommendations - Pavement / Parking			
Item	Description	Condition	Action Required
8.1.1	Cracked pavement at entrance.	WORK	Mill and overlay existing drive aisle, re-stripe and repair any subbase as needed.

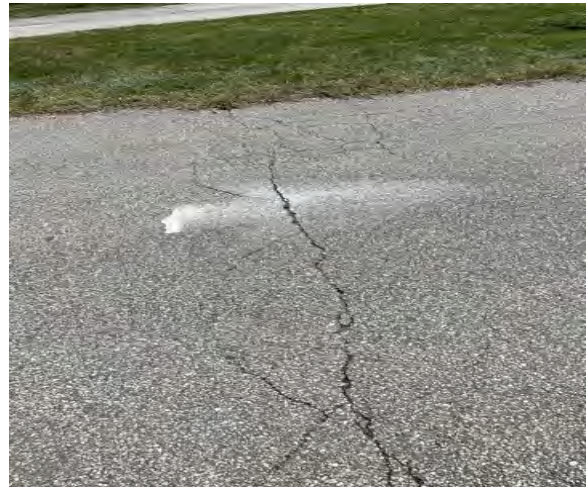
8.1.2 Alligator cracking in pavement.

8.1.2	Alligator cracking in pavement.	WORK	Mill and overlay cracked areas, and repair any subbase as needed.
8.1.3-4	Gravel parking in poor condition.	POOR	Add addition gravel material (or asphalt), compact and grade to provide positive drainage. Add wheel stops to delineate parking spaces.

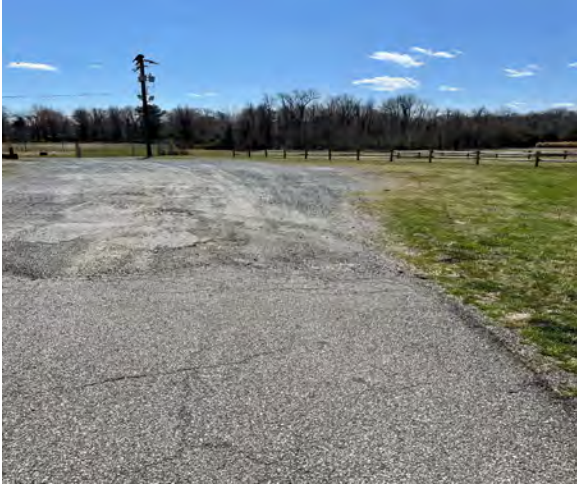
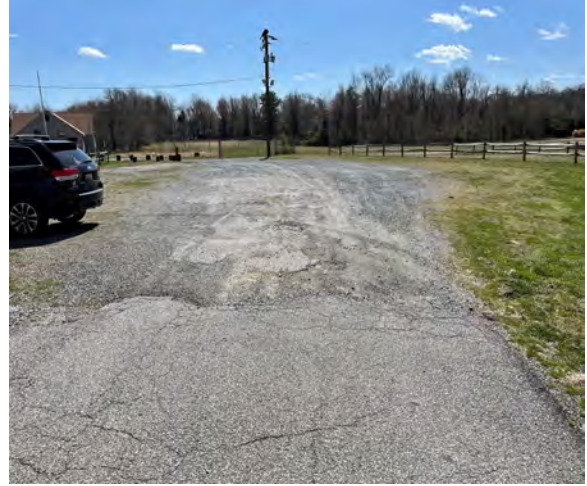
8.1.3 Transition from paved entrance drive to gravel parking area.

8.1.4. Transition from paved entrance drive to gravel parking area.

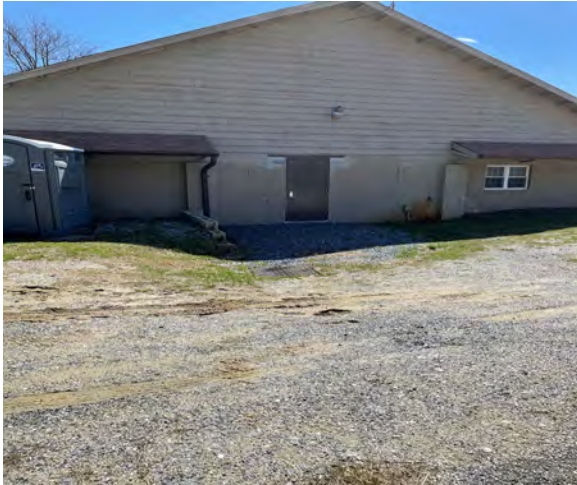
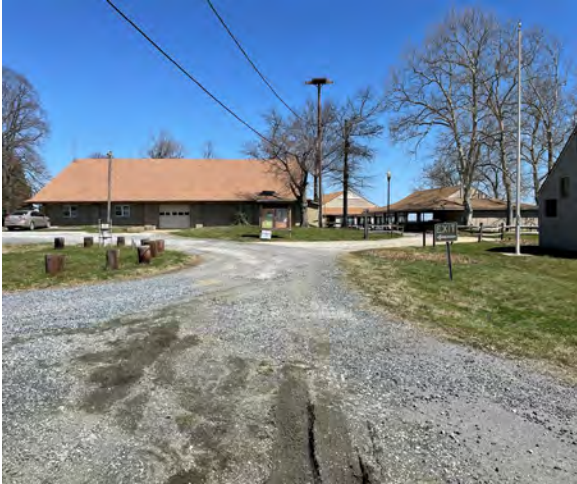
8.1.5. Example of gravel service drive.

8.1.7 Gravel drive serving as the exit point from the parking area.

8.1.5 & 7	Gravel services drives in poor condition.	POOR	Add addition gravel material (or asphalt), compact and grade to provide positive drainage.
8.1.6	Accessible parking spaces.	IMME	Grade, resurface with pavement\concrete, stripe spaces and aisles, and replace signage. All work shall be in accordance with ADA regulations.

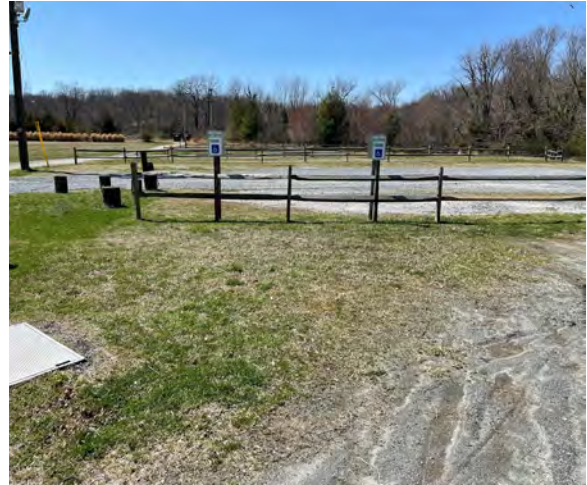
8.1.6. Accessible Parking spaces.

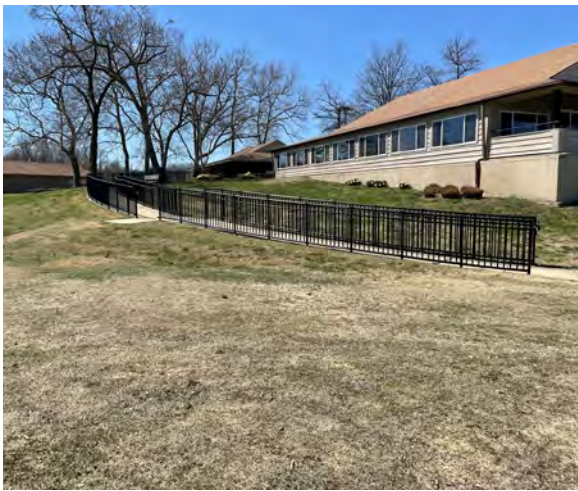
8.2.1 Existing ADA pathway and ramp towards the beach area (accessible route).

Recommendations - Sidewalks and Trail Systems			
Item	Description	Condition	Action Required
8.2.1	Existing pathway and ramp towards the beach area.	POOR	While the ramp and rails appear in good condition it appears that there are areas of the ramp that exceed 8.33% (1:12). The ramp should be resurfaced such that the running slope does not exceed 8.33% with a cross slope not to exceed 2.0% (1:50).

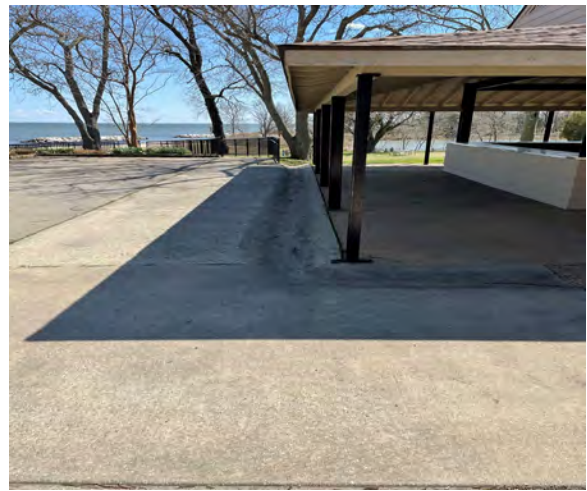
8.2.2 Example of concrete sidewalks around pavilion structures.

8.2.2	Example of concrete sidewalks around pavilion structures.	IMME	In general, all sidewalks should be free of tripping hazards. In this particular case the concrete drain trough should be cut out and replaced with a trench drain with a pedestrian friendly style grate flush with the adjacent sections of concrete.

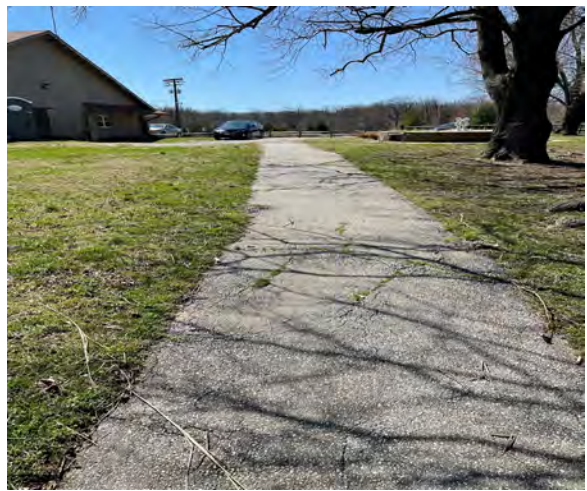
8.2.4 Existing asphalt pathway to Pavilion and Storage buildings (accessible route).

8.2.4	Existing asphalt pathway to Pavilion and Storage buildings.	WORK	The existing asphalt sidewalk should be reconstructed as to not exceed a running slope of 5.0% (1:20) and be free of heaving and other tripping hazards.

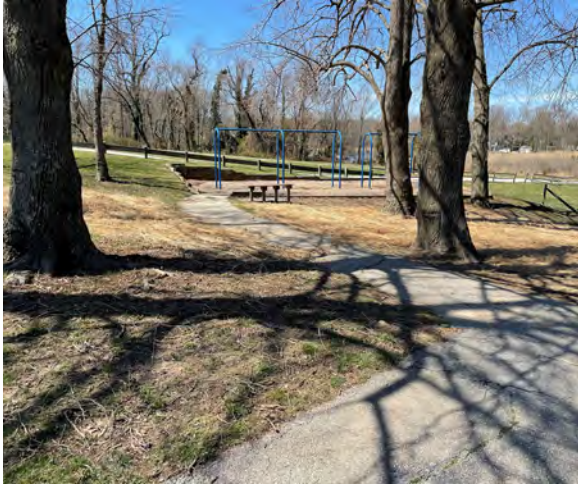
8.2.5 Existing asphalt pathway to playground area (accessible route).

8.2.5	Existing asphalt pathway to playground area.	WORK	The existing asphalt sidewalk should be reconstructed as to not exceed a running slope of 5.0% (1:20) and be free of heaving and other tripping hazards.

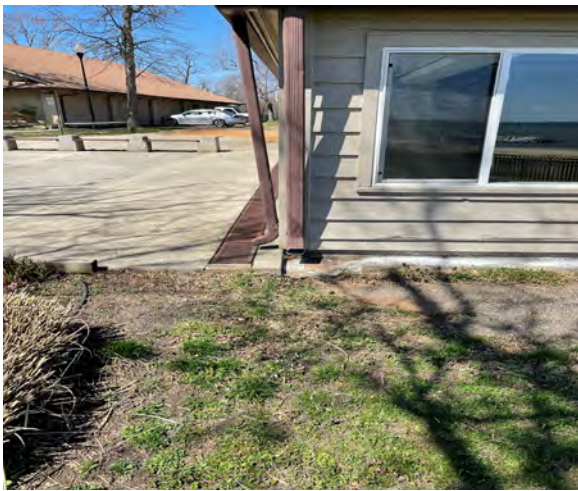
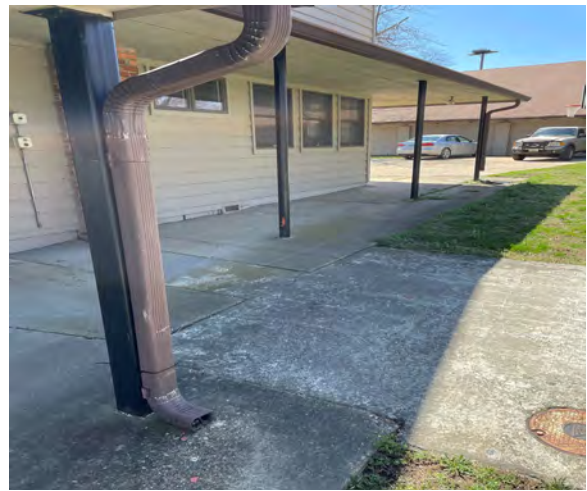
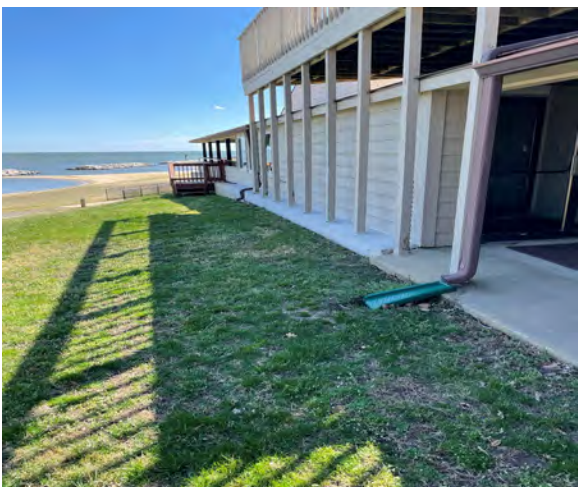
8.4.1 Example of downspout discharge.

8.4.2 Example of downspout discharge.

8.4.3 Example of downspout discharge.

Recommendations - Drainage			
Item	Description	Condition	Action Required
8.4.1-3	Example of downspout discharge.	WORK	Install consistent outlet protection via splash blocks, etc. Potential opportunity for rain gardens, rain barrels, or other non-structural water quality devices that would not be intrusive which could additionally serve as educational examples of stormwater management practices.

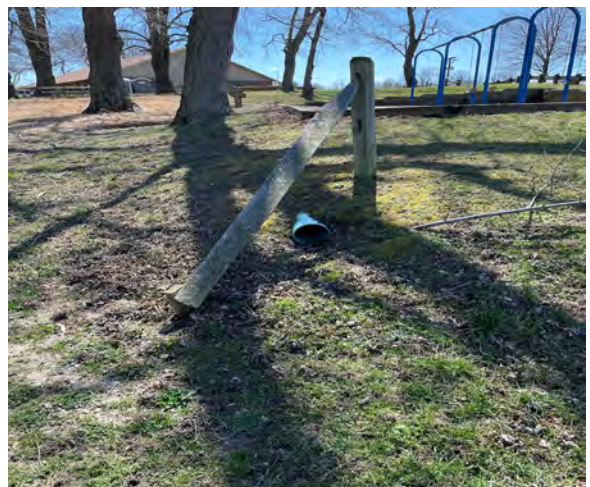
8.4.4 Pipe discharge with no outfall protection.

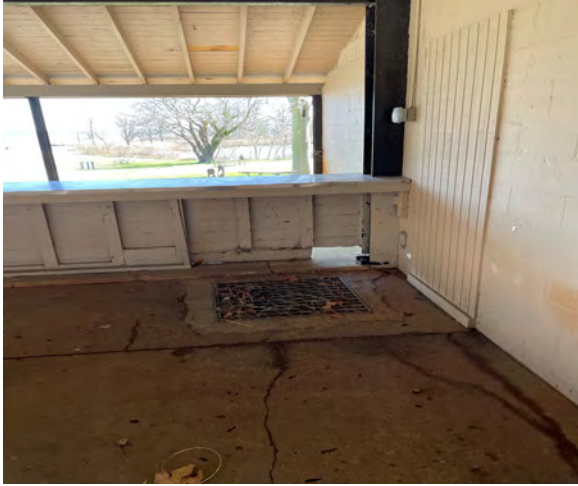
8.4.5 Storm inlet structure within the pavilion.

8.4.5	Storm inlet structure within the pavilion.	POOR	Replace existing grate with a pedestrian friendly-type, accessible grate.
8.4.6	Concrete trough drain.	IMME	The concrete drain trough should be cut out and replaced with a trench drain with a pedestrian friendly style grate flush with the adjacent sections of concrete.

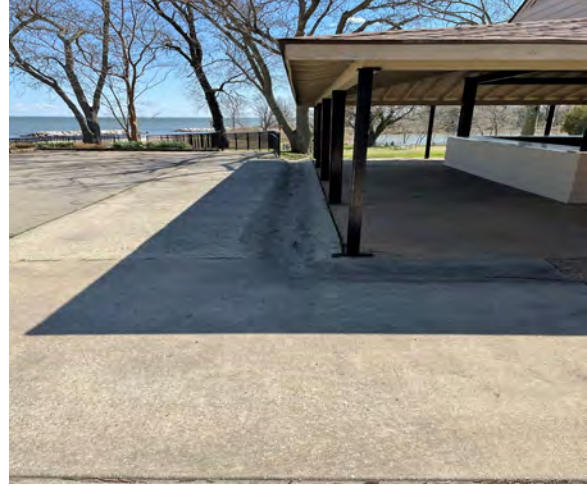
8.4.6 Drainage trough in sidewalk.

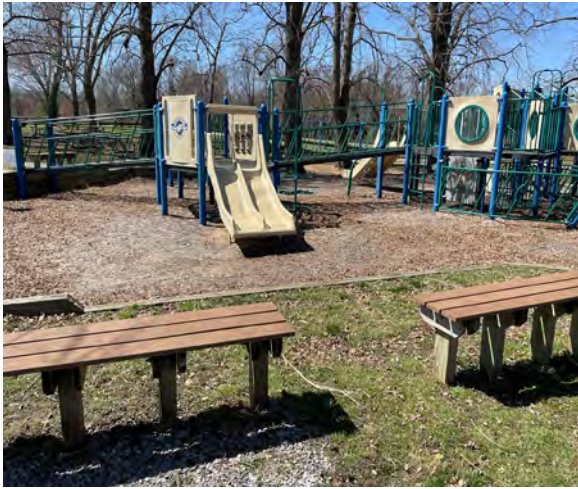
8.5.1 Existing playground area #1.

Recommendations - Playground \ Ballfields			
Item	Description	Condition	Action Required
8.5.1-6	Existing playground area #1.	WORK	Repair existing walkway to remove tripping hazards. Refurnish engineered wood fiber play area material. Both play areas appear to have walls requiring a railing. A railing or fencing should be installed where the vertical change in grade is greater than 30" (IBC 1003.2.11.1).
8.5.7-8	Existing ballfield and backstop.	WORK	Replace backstop with current standards or treat corroded metal as needed.
