MAYO BEACH PARK

4150 Honeysuckle Drive
Edgewater, Maryland 21037

Condition Assessment for Anne Arundel County DEPARTMENT OF RECREATION & PARKS

Contract Number: P582101
Project Number: P582100

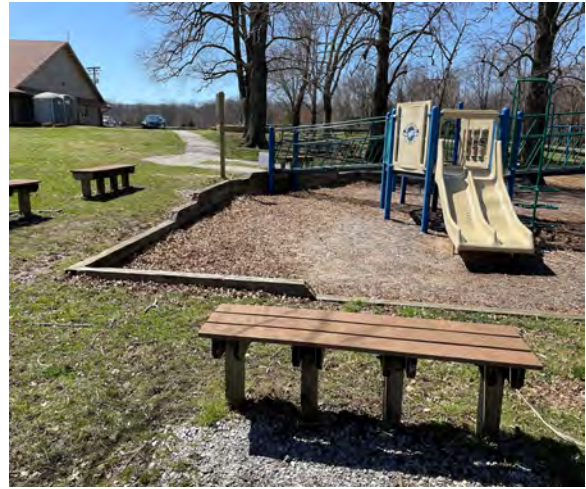
8.5.2 Existing playground area #1.

Recommendations - Playground \ Ballfields			
Item	Description	Condition	Action Required
8.5.1-6	Existing playground area #1.	WORK	Repair existing walkway to remove tripping hazards. Refurnish engineered wood fiber play area material. Both play areas appear to have walls requiring a railing. A railing or fencing should be installed where the vertical change in grade is greater than 30" (IBC 1003.2.11.1).
8.5.7-8	Existing ballfield and backstop.	WORK	Replace backstop with current standards or treat corroded metal as needed.

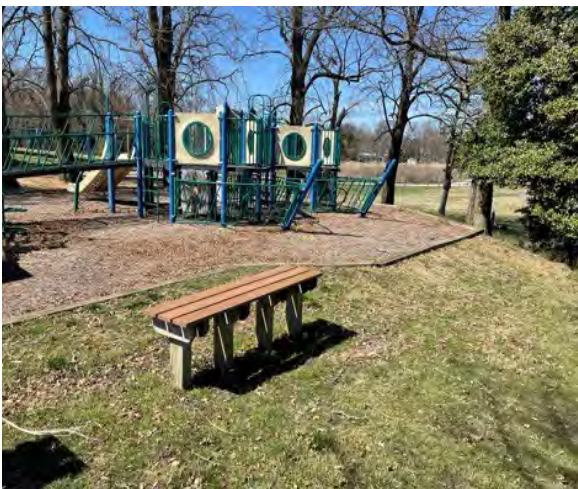
8.5.3 Existing playground area #1.

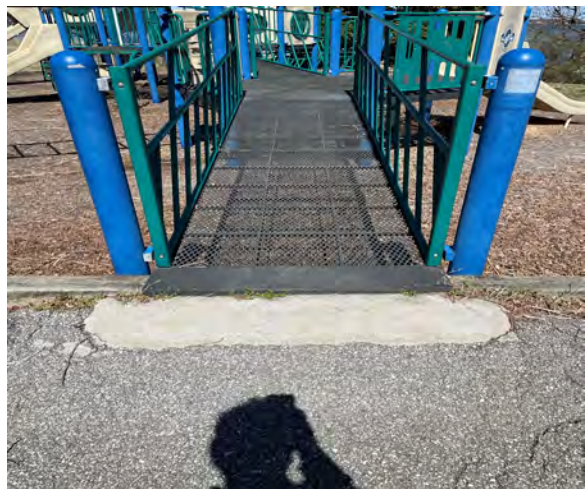
8.5.4 Existing playground area #1.

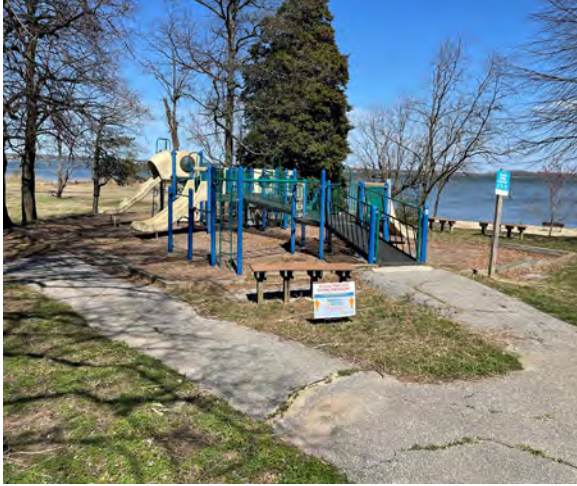
8.5.5 Pathways leading to playground area #1.

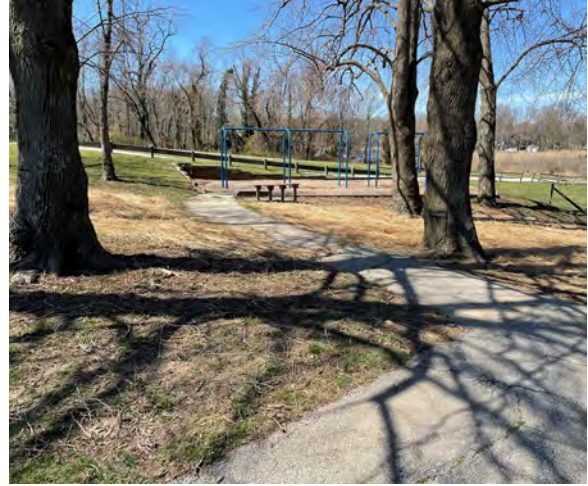
8.5.6 Path leading to playground area #2.

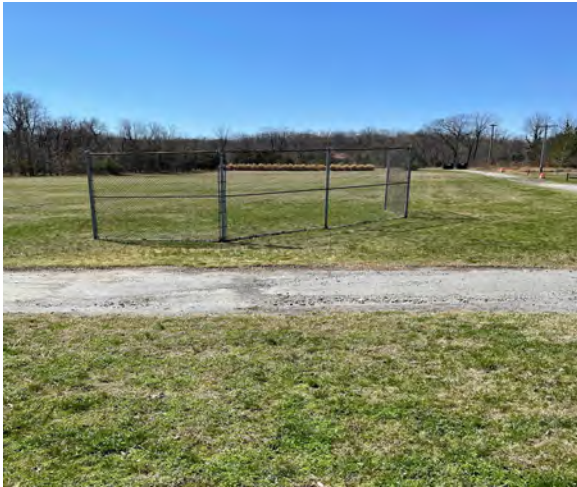
8.5.7 Grassed play field and backstop.

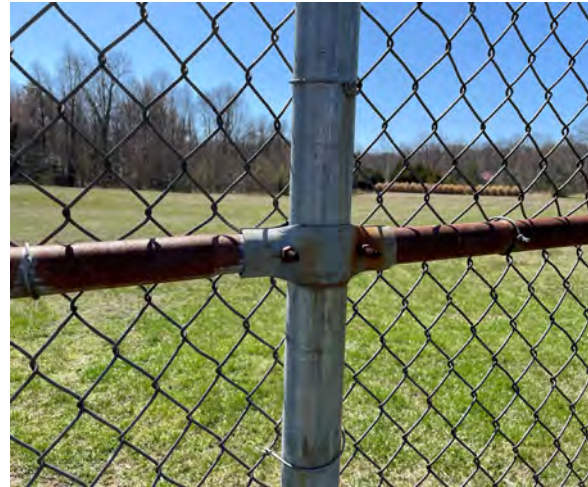
8.5.8 Existing backstop.

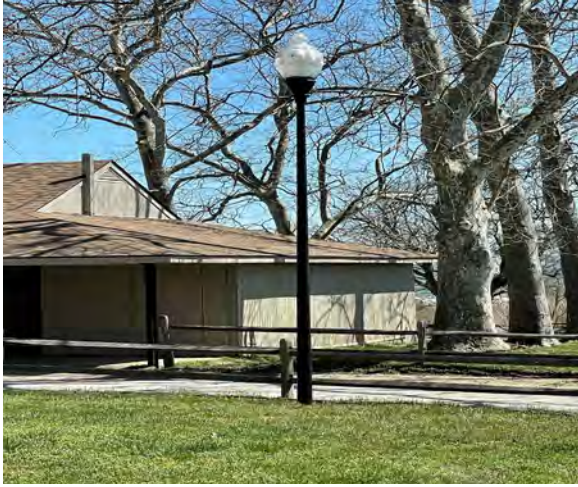
8.6.1 Existing site light poles.

Recommendations - Site Lighting			
Item	Description	Condition	Action Required
8.6.1	Example of existing site light poles.	WORK	If the parking area is improved and paved, additional and upgraded light poles would be recommended.
8.6.2-3	Example of existing spotlights.	WORK	None required.

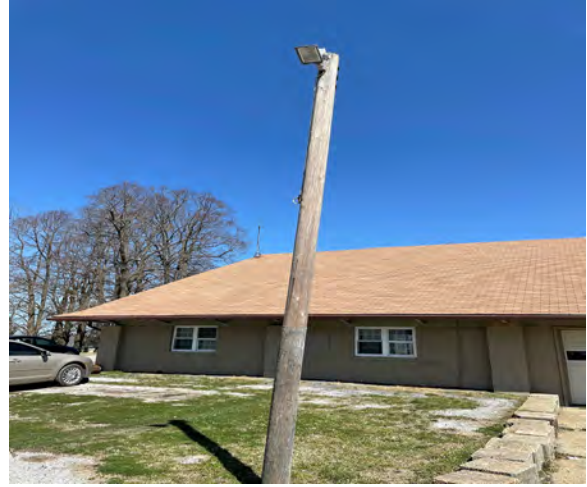
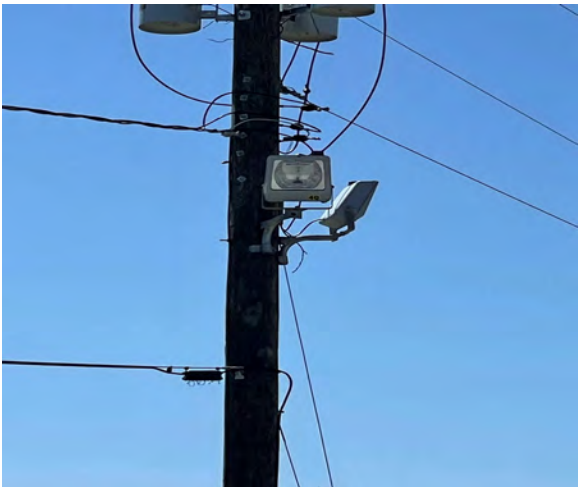
8.6.2 Existing spotlights on wooden pole

8.6.3 Existing site lighting on BGE pole.

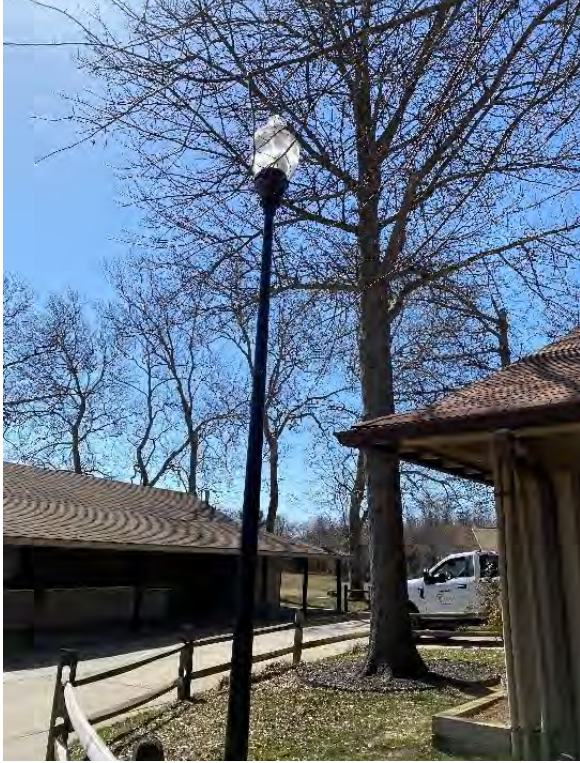
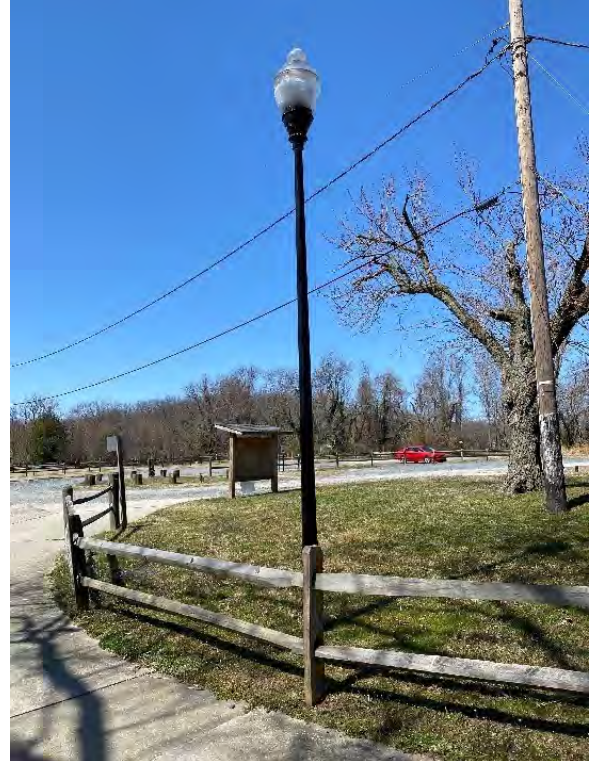
There were two post lights seen on site adjacent to the Maintenance Building. The posts seem to be in good working condition and should not need to be replaced in next 1-3 years. The condition of the light fixture heads and illumination output could not be determined during the day assessment, but the fixtures should be replaced with LED in the future. Additional lighting should be provided at the courtyard and playground per Illuminating Engineering Society (IES) recommendations. Only one of the post lights is illuminating the courtyard with minimal lighting coming from the buildings.

Recommendations - Lighting			
Item	Description	Condition	Action Required
8.7.4	Post Lights	WORK	Replace light fixtures heads with LED in future. Posts may be replaced for aesthetic purposes.
8.7.5	General Site Lighting	POOR	Provide additional post lights or building fixtures for illumination in the courtyard. Provide post light(s) for illumination of the playground. All new light fixtures should be LED. Provide time clock and photocell for all site lighting.

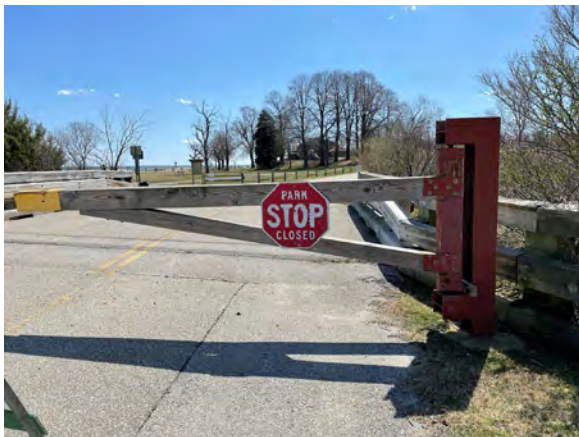
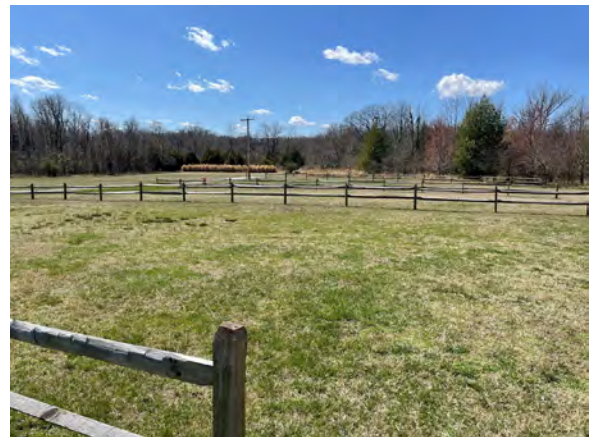
8.8.1 Wood gate at park entrance

8.8.2 Example of split rail wood fencing

Recommendations - Miscellaneous Site Furnishings			
Item	Description	Condition	Action Required
8.8.1-2	Existing fencing	WORK	Recommend inspecting split rail fence and replace any rotting posts and/or damaged rails.
8.8.3-4	Existing signage	POOR	Recommend establishing a signage program to eliminate the consistency and ADA accessibility issues.
8.8.5-6	Existing benches	WORK	Over time, replace benches with back support type benches and provide access per the ADA survey.
8.8.7	Existing tables	WORK	Over time, replace standard tables with picnic units with mobility features provide access per the ADA survey.
8.8.8	Existing dumpsters	WORK	Over time, consider adding concrete dumpster pad and enclosure with gates.

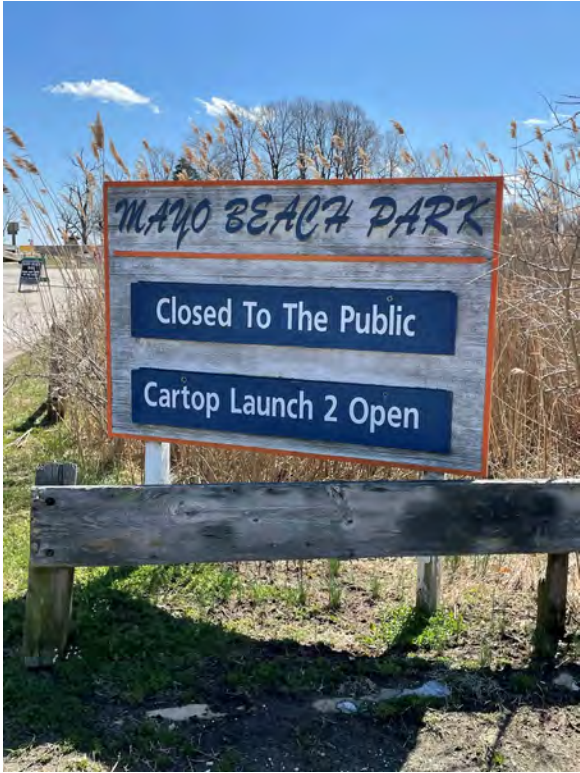
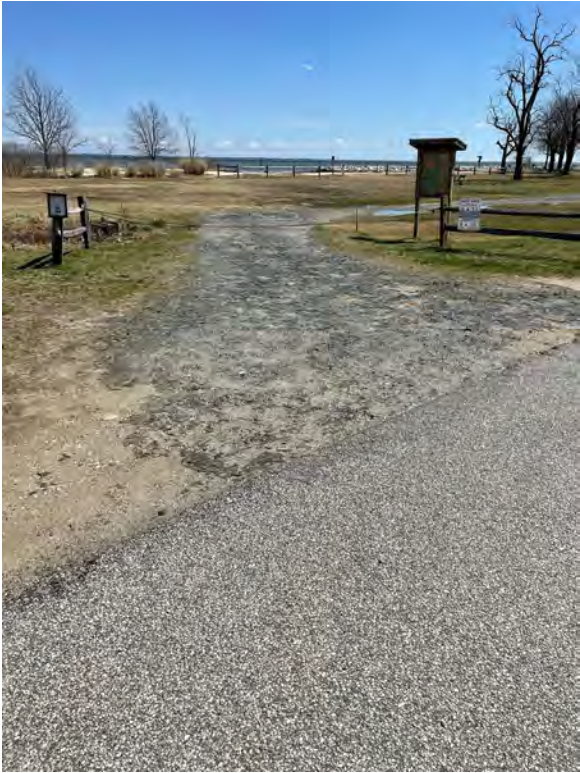
8.8.3 Existing entrance signage

8.8.4 Existing miscellaneous signage

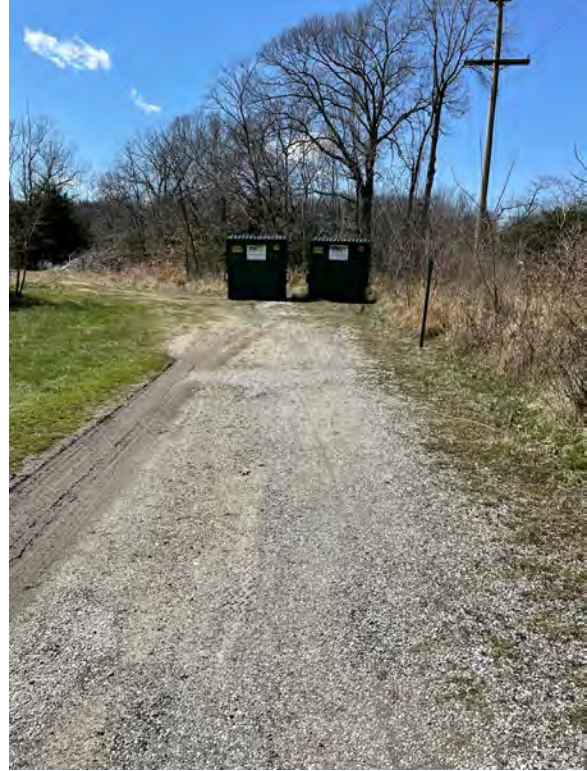
8.8.8 Existing Park dumpsters

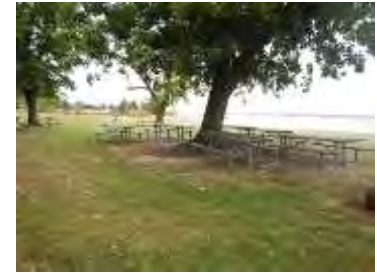
<p><u>Open Picnic Area at Playground</u> Provide picnic units with mobility features</p> <p>There are 11 standard picnic tables in grass. There is no accessible route to the open picnic area.</p> <p>Design a new accessible open space picnic area. Alternatively, replace the existing picnic tables with accessible models such that at least 20 percent of the total number of units are accessible, having at least one wheelchair seating space a minimum of 30 by 48 inches for each 24 linear feet of usable space around the perimeter of a tabletop and placed on an accessible route with a minimum 36 inch clear floor space around usable sides . Select units with a minimum 27 inch knee clearance under the table for a depth of a minimum 17 inches. Table tops shall be 28 to 34 inches above the floor or ground surface.</p> <p><i>Estimate for open space picnic area with 3 accessible tables, new asphalt path 50 ft x 6 ft.</i></p> <p>Reference: <i>ABAS-Outdoor F245.2, 1011</i> Photo: MayoBeachPark-099 Record #: 1896</p>	<p>Priority 1 - Critical</p>	<p>\$7,500</p>	<p>300</p>

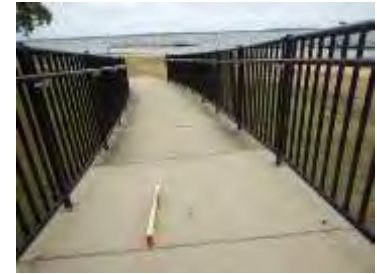
<p><u>Ramp to Beach</u> Modify existing pathway</p> <p>There are 2 sections of the concrete ramp to the beach that have a running slope up to 10.3%.</p> <p>Resurface the concrete ramp not to exceed a running slope of 8.33% and a cross slope of 2.08% measured on every section of the walking surface.</p> <p><i>Estimate to install top finish concrete 50 ft x 6 ft</i></p> <p>Reference: <i>ADA 402</i> Photo: MayoBeachPark-091 Record #: 1899</p>	<p>Priority 1 - Critical</p>	<p>\$1,500</p>

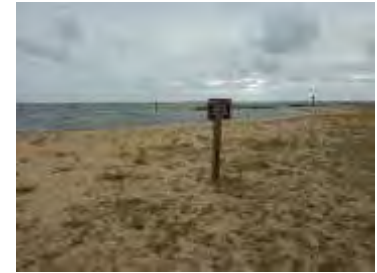
<p><u>Beach</u></p>	<p><i>Provide accessible route at beach to water</i></p>	<p>Priority 1 -</p>	<p>\$5,000</p>	
	<p>There is no accessible route over the beach sand surface to the high tide level along the shoreline which stretches 1/4 mile.</p>	<p>Critical</p>			
	<p>Provide at least one beach access route for each one-half mile of beach shoreline managed by the County. The beach access routes must coincide with or be located in the same general area as pedestrian access points that serve the beach. The beach access routes must connect an entry point to the beach to the high tide level at tidal beaches. The beach access route should be a minimum 60 inch clear width and running slope preferably no greater than 5%, but up to 8-10% with resting intervals in accordance with the accessibility standards.</p>

<p><i>Estimate portable path system 200 ft.</i></p>				
	<p>Reference: <i>ABAS-Outdoors F248, 1018</i></p>				
	<p>Photo: MayoBeachPark-102</p>				
	<p>Record #: 1900</p>

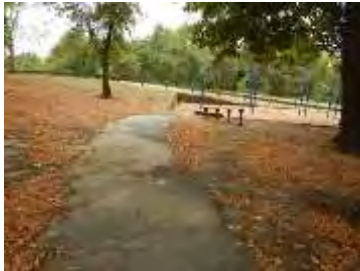
<p><u>Parking to Playground and Beach - North</u> Install/extend accessible route</p> <p>There is no continuous accessible route connecting the site arrival point/parking to the park amenities north of the banquet facility. The current path from the park drive is through gravel and asphalt in poor condition with excessive heaves and a running slope up to 11.3%. There is no accessible route from the playground to the waterfront, beach or open space picnic area.</p> <p>Install a continuous accessible route connecting the site arrival point/parking with the park amenities on the north side of the banquet facility, including the open picnic area, playground, and waterfront features.</p> <p><i>Est asphalt path 300 ft x 6 ft</i></p> <p>Reference: ADA 402</p> <p>Photo: MayoBeachPark-128</p> <p>Record #: 1906</p>	<p>Priority 1 - Critical</p>	<p>\$7,000</p>	<p>1,800</p>

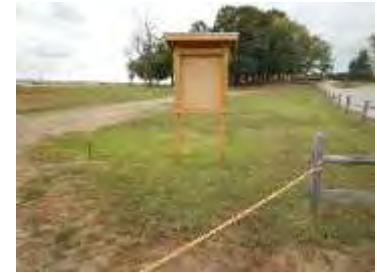
<p><u>Entry to Cartop Boat Launch</u></p>	<p>Provide accessible approach to read signage/information kiosk</p>	<p>Priority 2 -</p>	<p>\$1,200</p>	<p>100</p>
	<p>The information kiosk is located outside of the accessible route in grass. The sign is not cane detectable with the bottom leading edge higher than 27 inches above the ground surface.</p> <p>Either relocate the sign to an accessible route or extend the accessible surface for clear ground space for viewing the sign. Install a horizontal cross bar between the sign support posts to provide cane detection with the bottom edge no higher than 27 inches above the ground. Consider presentation of visitor orientation and wayfinding information. Develop a tactile map and/or model to effectively communicate locations of attractions, topography, features, and points of interest to orientate visitors with visual or cognitive impairments.</p> <p><i>Estimate to install decomposed granite 10 ft x 10 ft; and horizontal wood cross bar.</i></p> <p>Reference: ADA 305, 402 Photo: MayoBeachPark-140 Record #: 1889</p>	<p>Serious</p>

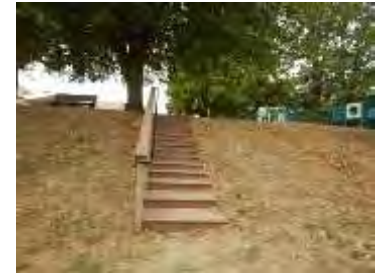
<p><u>Exterior Stairs to Playground</u></p>	<p>Install handrails at stairs</p>	<p>Priority 2 -</p>	<p>\$1,200</p>	
	<p>The wood stairs to the playground only have a handrail on one side.</p> <p>Install handrails on both sides of stairs. Handrails shall be continuous within the full length of each stair flight or ramp run. Top of gripping surfaces of handrails shall be 34 inches to 38 inches maximum vertically above walking surfaces or stair nosings. At the top of a stair flight, handrails shall extend horizontally above the landing for 12 inches. At the bottom, handrails shall extend at the slope of the stair flight for a horizontal distance at least equal to one tread depth beyond the last riser nosing.</p> <p><i>Estimate to install metal handrail 30 ft.</i></p> <p>Reference: ADA 504, 505 Photo: MayoBeachPark-098 Record #: 1904</p>	<p>Serious</p>

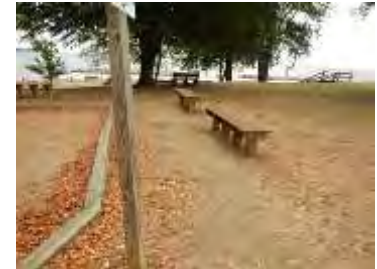
<p><u>Playground</u></p>	<p>Provide clear ground space adjacent to bench</p>	<p>Priority 2 -</p>	<p>\$5,800</p>	
		<p>Wood benches are provided throughout the park.</p>	<p>Serious</p>		
		<p>Where provided at parks, it is recommended at least 20 percent of outdoor constructed features shall be accessible. For benches, provide styles with back supports and at least one armrest along with a minimum clear ground space 36 x 48 inches positioned near the bench with one side of the space adjoining an accessible route, outdoor recreation access route or trail. The clear ground space shall not overlap the accessible route or trail, or another clear ground space. As benches are installed, repaired or replaced, ensure a minimum of 20 percent are accessible, adjacent to the accessible route with clear ground space for wheelchair seating.</p>

<p><i>Estimate 2 new benches and adjacent 3 ft x 4 ft clear floor space.</i></p>			
	<p>Reference: ABAS-Outdoor 1011</p>				
	<p>Photo: MayoBeachPark-115</p>				
	<p>Record #: 1907</p>				
	<p><u>Playground - Ramp to Composite Structure</u></p>	<p>Correct changes in level/openings for accessible route</p>	<p>Priority 2 -</p>	<p>\$400</p>

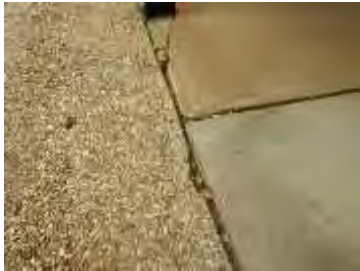
Open Plaza Between Main Entrance and Pavilion

Correct changes in level/openings for accessible route

There are gaps, cracks and openings in ground concrete surface greater than 1/2 inch diameter.

Patch and fill the gaps, cracks and openings in the concrete ground surface not to exceed an opening of 1/2 inch diameter.

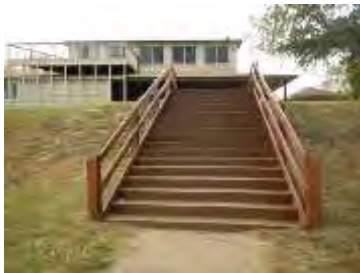
Exterior Stairs to Beach

Install handrails at stairs

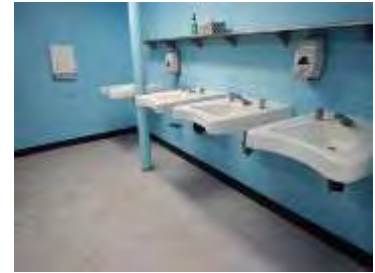
<p><u>Men's Restroom</u></p>	<p>Insulate exposed pipes at lavatory</p>	<p>Priority 2 -</p>	<p>\$75</p>	
		<p>The lavatory pipes are exposed.</p>	<p>Serious</p>		
		<p>Insulate the exposed pipes at the lavatory to protect from burn or abrasion.</p>			
		<p><i>Estimate install lavatory pipe cover.</i></p>			
		<p>Reference: ADA 606.5</p>			
		<p>Photo: MayoBeachPark-064</p>			
		<p>Record #: 1912</p>

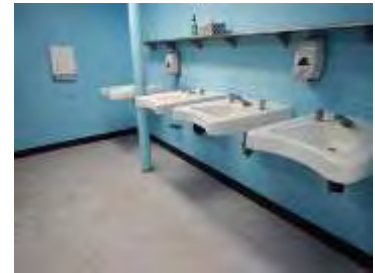
<p><u>Men's Restroom</u></p>	<p>Install/lower for accessible shelves</p>	<p>Priority 2 -</p>	<p>\$50</p>	
		<p>A courtesy shelf is provided above the lavatories, however the unit is outside of the reach range at 55 inches above the finish floor.</p>	<p>Serious</p>		
		<p>Either lower the shelf to within the accessible reach range or install an additional accessible shelf. Accessible shelves shall be 40 to 48 inches above the finish floor.</p>

<p><i>Estimate to install lower shelf.</i></p>			
		<p>Reference: ADA 222, 803, 903</p>			
		<p>Photo: MayoBeachPark-064</p>			
		<p>Record #: 1913</p>

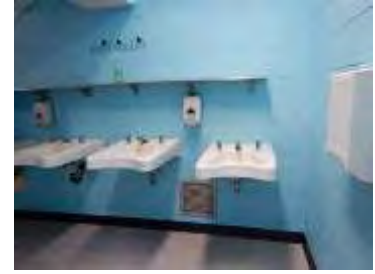
<p><u>Women's Restroom</u></p>	<p>Insulate exposed pipes at lavatory</p>	<p>Priority 2 -</p>	<p>\$75</p>	
		<p>The lavatory pipes are exposed.</p>	<p>Serious</p>		
		<p>Insulate the exposed pipes at the lavatory to protect from burn or abrasion.</p>			
		<p><i>Estimate install lavatory pipe cover.</i></p>			
		<p>Reference: ADA 606.5</p>			
		<p>Photo: MayoBeachPark-054</p>			
		<p>Record #: 1919</p>

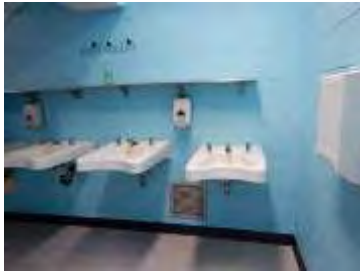
Women's Restroom

Install/lower for accessible shelves

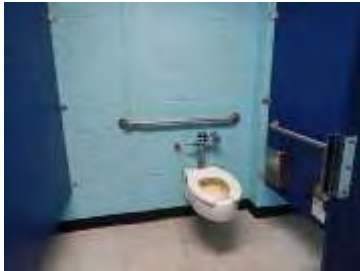
Women's Restroom

Provide directional signage to accessible features

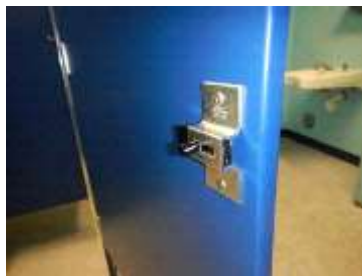
Men's Restroom

Install door pull

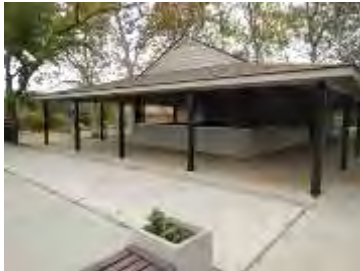
Building Exterior

Correct changes in level/openings for accessible route

There is a 15-20 inch wide drain gutter on the ground surface of patio at the pavilion. The drain gutter has up to a 20% running slope resulting in up to a 4 inch change in level that could be a tipping or tripping hazard for people with mobility or visual impairments.

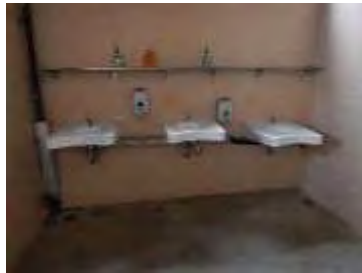
Men's Restroom

Insulate exposed pipes at lavatory

Insulate the exposed pipes at the lavatory to protect from burn or abrasion. Adjust the lavatory metering faucet to stay open for a minimum of 10 seconds.

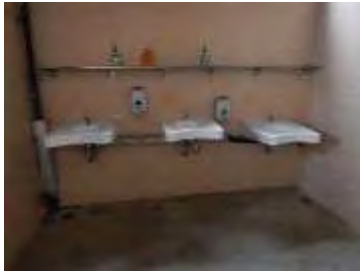
Men's Restroom

Install/lower for accessible shelves

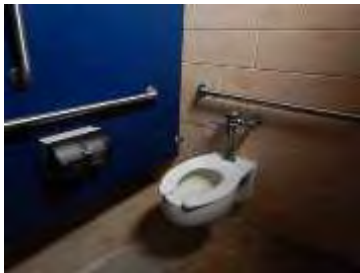
Men's Restroom

Install/replace/relocate toilet for accessible toilet compartment

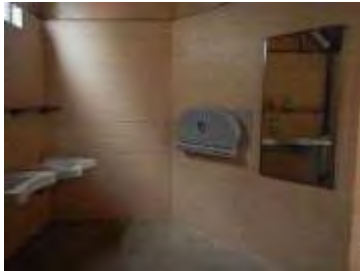
Men's Restroom

Raise/lower or relocate the diaper changing table

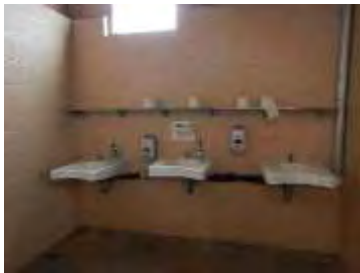
Women's Restroom

Insulate exposed pipes at lavatory

Insulate the exposed pipes at the lavatory to protect from burn or abrasion. Adjust the lavatory metering faucet to stay open for a minimum of 10 seconds.

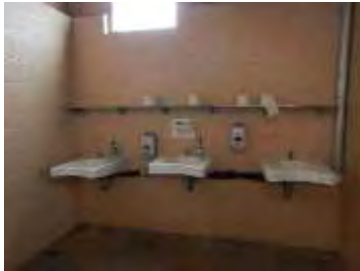
Women's Restroom

Install/lower for accessible shelves

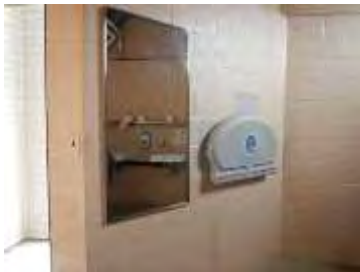
Women's Restroom

Raise/lower or relocate the diaper changing table

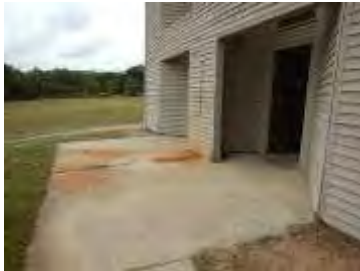
Outdoor Rinsing Shower - Building Exterior

Modify shower controls, faucets, shower spray

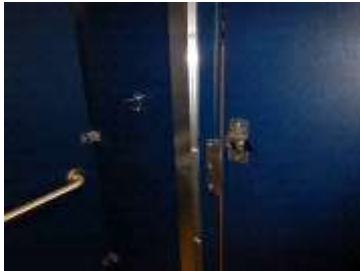
Women's Restroom

Install door pull

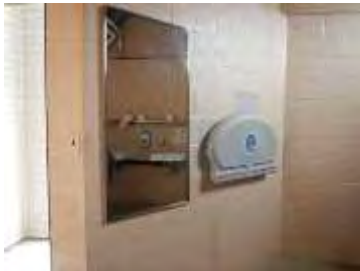
Women's Restroom

Lower light switch

When the control is altered or replaced, relocate the light switch so that the operating mechanism is within the reach range and does not exceed 48 inches above the finished floor.

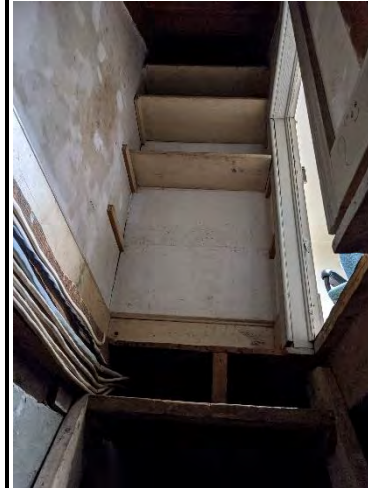
Top of stairs with unsteady shelf

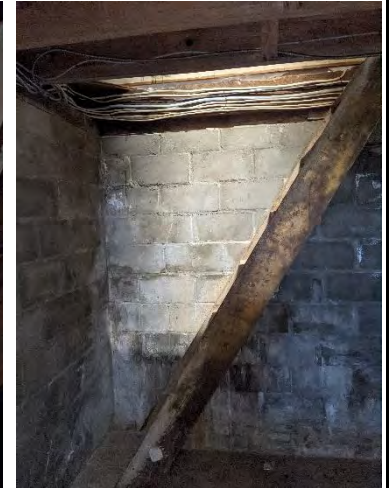
Stairs with no stair rails

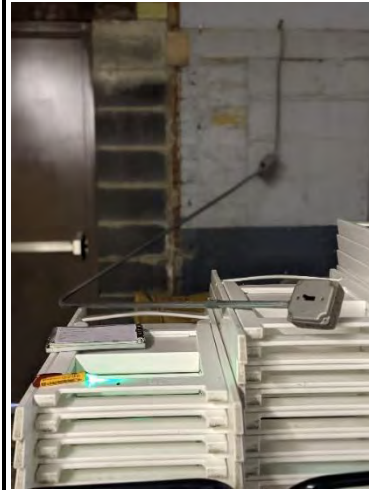
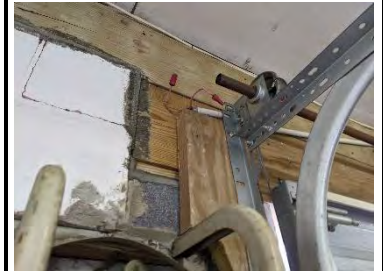
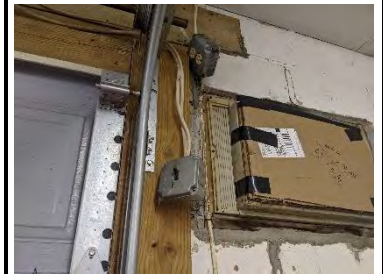
A: Conduit and switch laying on stack of chairs

B: Loose conduit and switch boxes

NFPA 70 334.15(B): Cable (Non-Metallic) shall be protected from physical damage where necessary.

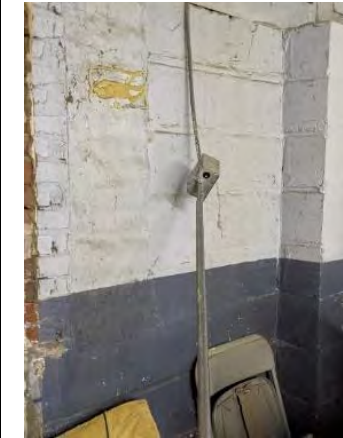
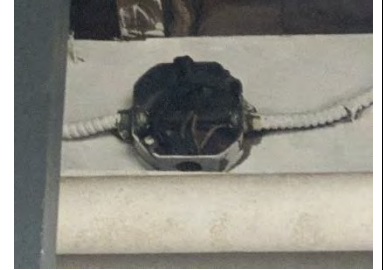
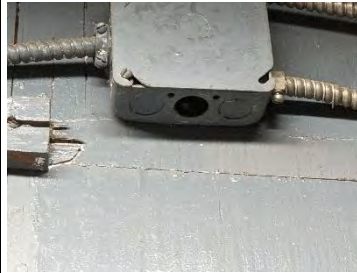
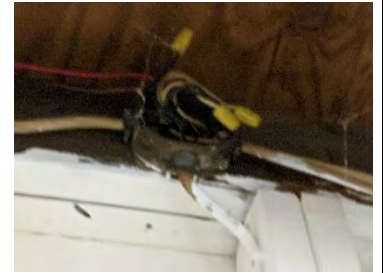
A: Storage Hall
B: Outer Maintenance Shop

Hazard 4: Unused opening in and missing covers on electrical equipment.

C: Multiple junction boxes were missing the cover.

C: Missing junction box covers

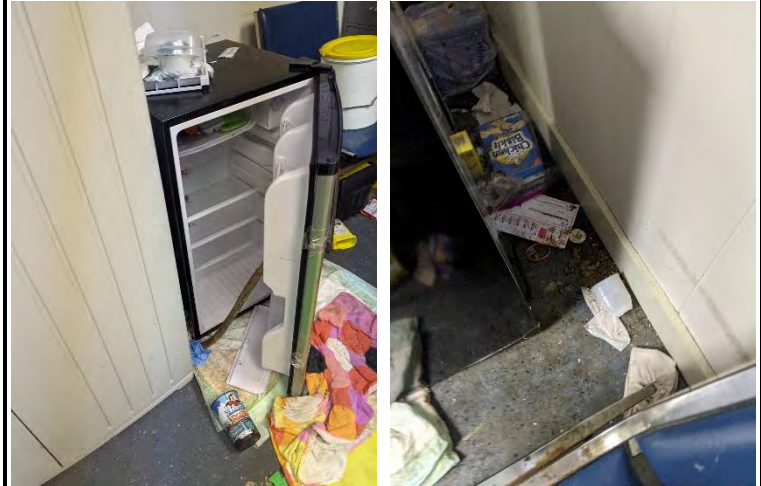
Hazard 5: Rodent feces, insect carcasses, and open food.

Open food containers were observed in the mini refrigerator and on the floor. Rodent feces and insect carcasses were observed on the floor and furniture to include the refrigerator, desk, and chairs. Informed that waste was left from last season.

Refrigerator and open food

Food and rodent feces

Recommendation: Clean and disinfect areas where insects and rodent feces were found. Develop a plan for cleaning and securing food items and preparing room for winter storage. Develop a regular plan to deal with insects and rodents if they persist after proper preparation for winter.

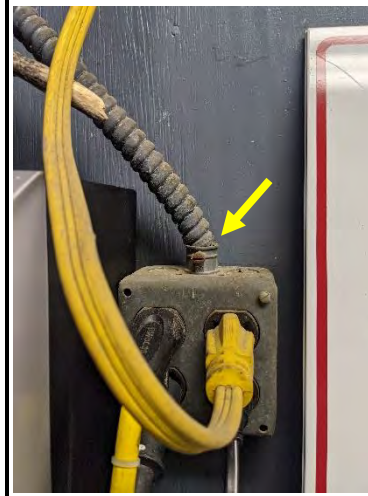
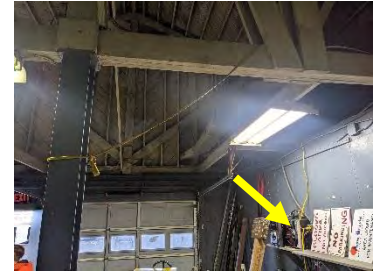
Receptacle location

Hazard 7: Metal Clad pulled away from receptacle
Metal clad wiring pulling away from receptacle box, exposing inner conductors

Shock or electrocution if conductors are damaged, metal cable is not grounded, and or cable is energized.

Lack of strain relief

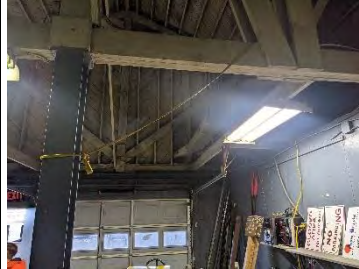
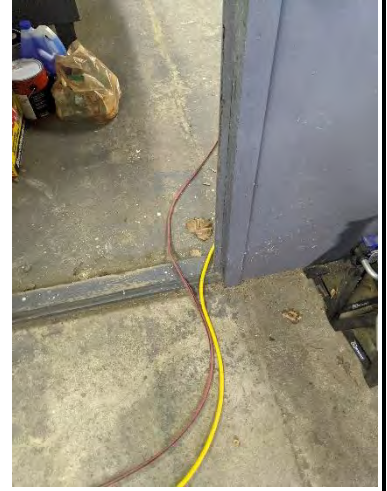
Hazard 8: Improper extension cord use.

All: Shock or fire hazard from damaged extension cord.

A: Cord used as permanent wiring

B: Unprotected Cord through door

All: Extension cord should be removed and put away at the end of each shift to prevent damage, if has to be run through a door temporarily it should be protected from being pinched by the door and foot traffic. Training is recommended for all personnel on the proper use of extension cords and general electrical safety.

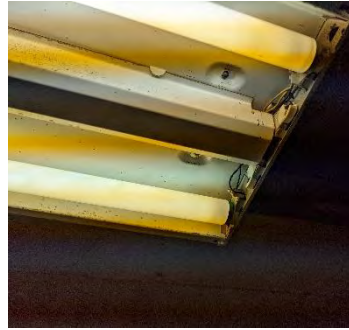
Damaged light fixture in maintenance shop

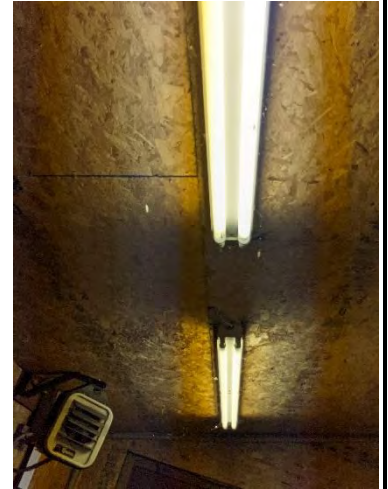
Unguarded bulbs in Well Control Room

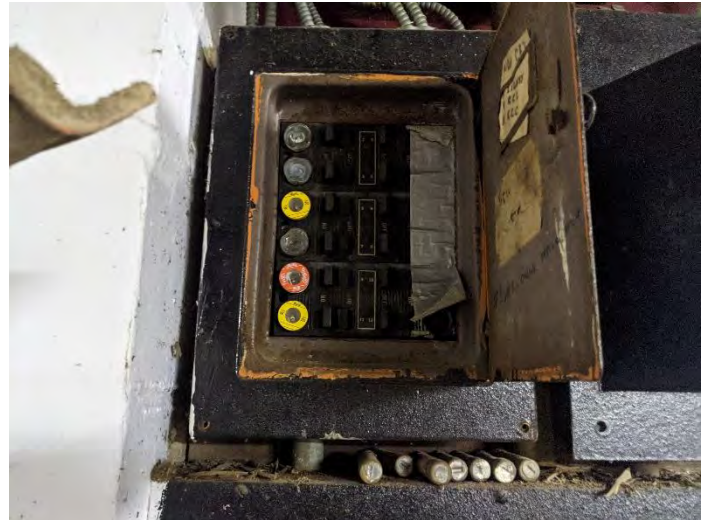
Breaker box with empty fuse opening covered with tape

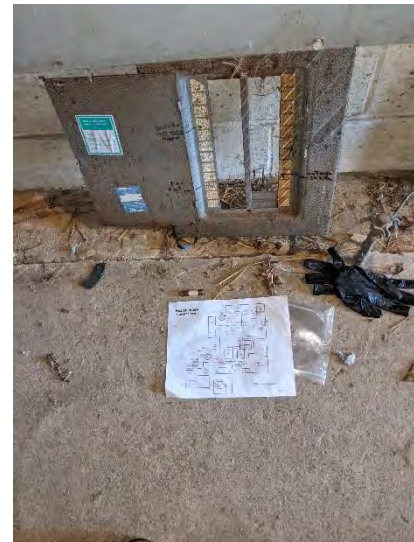
Dead front below panel.

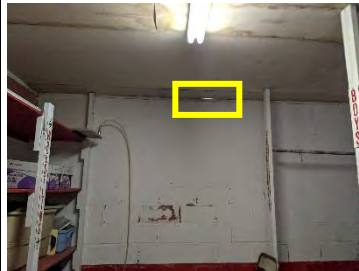
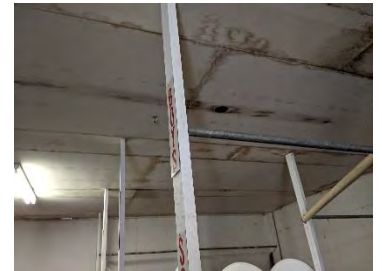
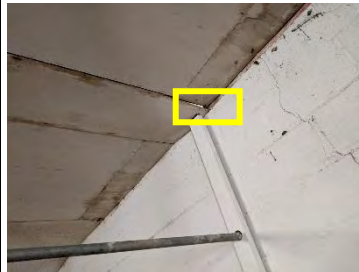
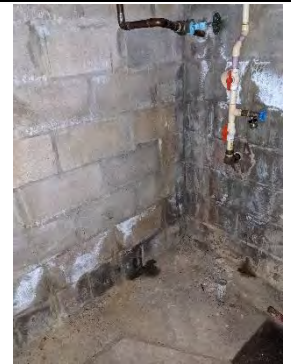
Water damaged ceiling

Water leaking in block
