**Anne Arundel County
Department of Public Works**

Peninsula Park Expansion Lake Ogleton Tributary Construction Monitoring Report

April 2025

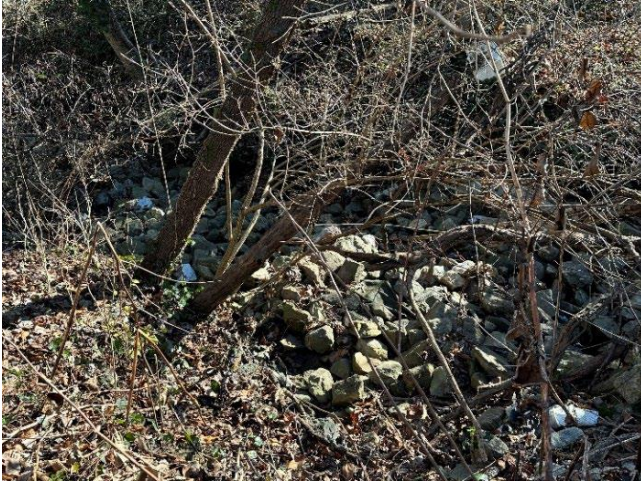
Photo 3 – Riprap protection, oriented downstream

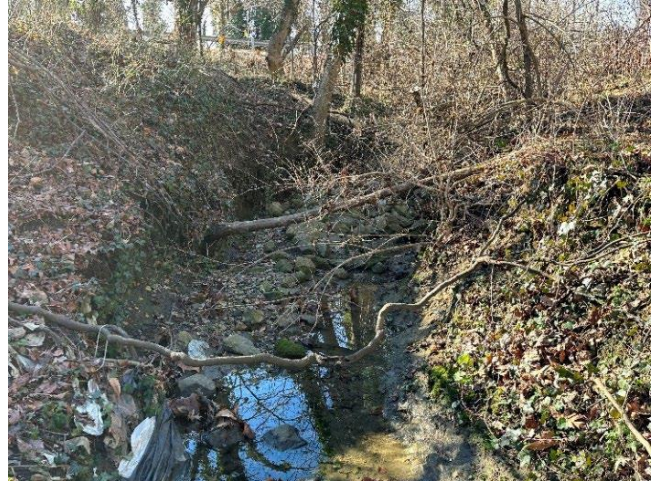
The 60-inch by 38-inch RCCP culvert functions as the primary hydraulic conveyance for stormwater runoff originating from PAL Park (Photo 1). An additional 42-inch reinforced concrete pipe (RCP) provides secondary inflow to the tributary from the Bay Ridge Road drainage area (Photo 2). The primary RCCP outfall is equipped with a cast-in-place concrete headwall, which appeared structurally sound and exhibited no observable signs of distress or deterioration at the time of inspection. Immediately downstream of the culvert there is a one- to two-foot deep head cut, followed by approximately 80 LF of riprap lining (Photo 3). Beyond the limit of the riprap, there is an approximate four-foot-deep head cut that is propagating upstream (Photo 4).

Photo 4 – Head cut in channel, oriented upstream

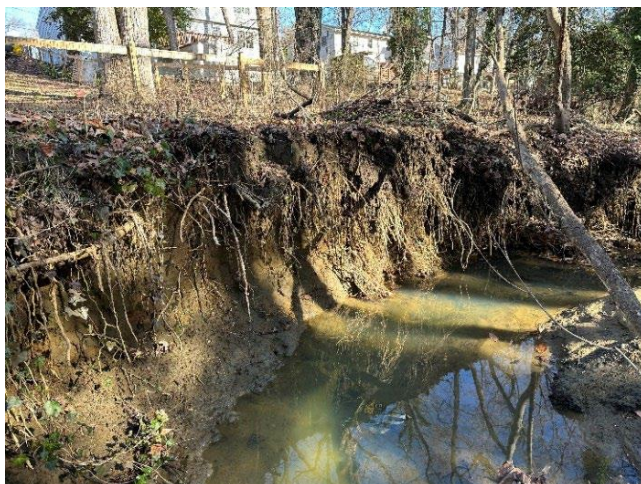
Downstream of the head cut the tributary consists of a single-thread channel characterized by channel incision and bank erosion (Photos 5 and 6) (Figure 3, Photo Points 1, 2, 3, and 4). Progressive downcutting has increased in-channel discharge capacity, reduced floodplain attenuation, diminished hydraulic complexity, and stressed floodplain vegetation due to prolonged disconnection. Bank heights range from approximately 0.5 to 4 feet and are composed primarily of fine to medium sand and silt. LO Cross Sections 1, 2, and 3 are located along this portion of the reach.

Photo 6 – Raw, vertical left bank, oriented downstream

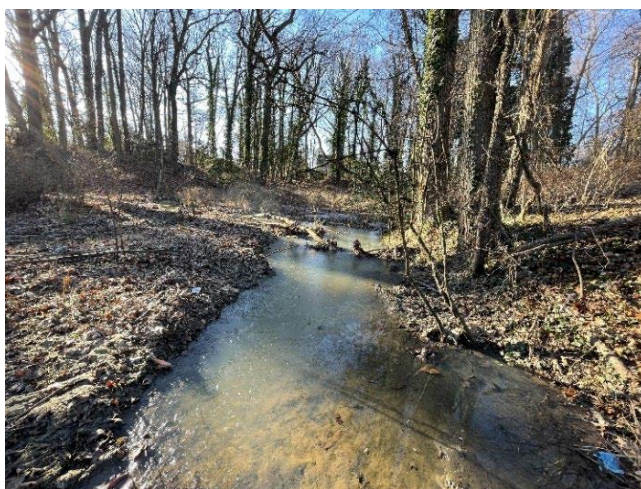
Further downstream the tributary transitions into a reach characterized by aggradation driven by the local sediment supply upstream (Photo 8) (Figure 3, Photo Point 7), before it reaches a backwater pool. LO Cross Section 6 is located within this portion of the reach.

Photo 8 – Reach representative photograph, oriented downstream

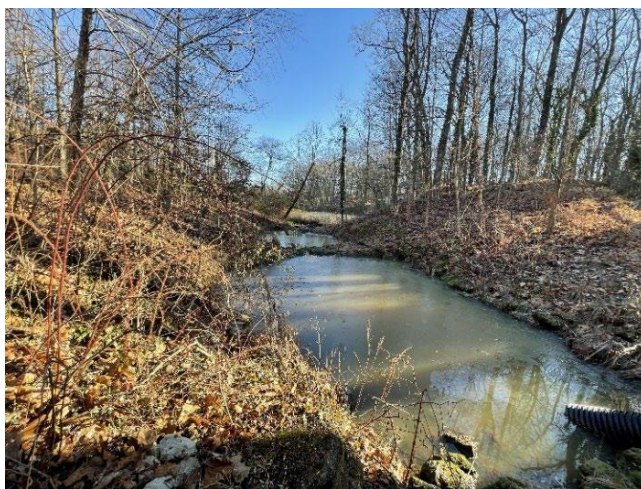
A corrugated plastic pipe (CPP) has been installed through the weir to regulate water levels and prevent excessive ponding or upstream flooding associated with beaver activity. The pool upstream of the weir functions as a sediment sink, capturing fine sediments and organic material under base flow conditions. However, during high-flow storm events, sediment is likely transported through the weir to the downstream SPSC system (Photo 10).

Photo 10 – SPSC System downstream of rock-weir oriented downstream

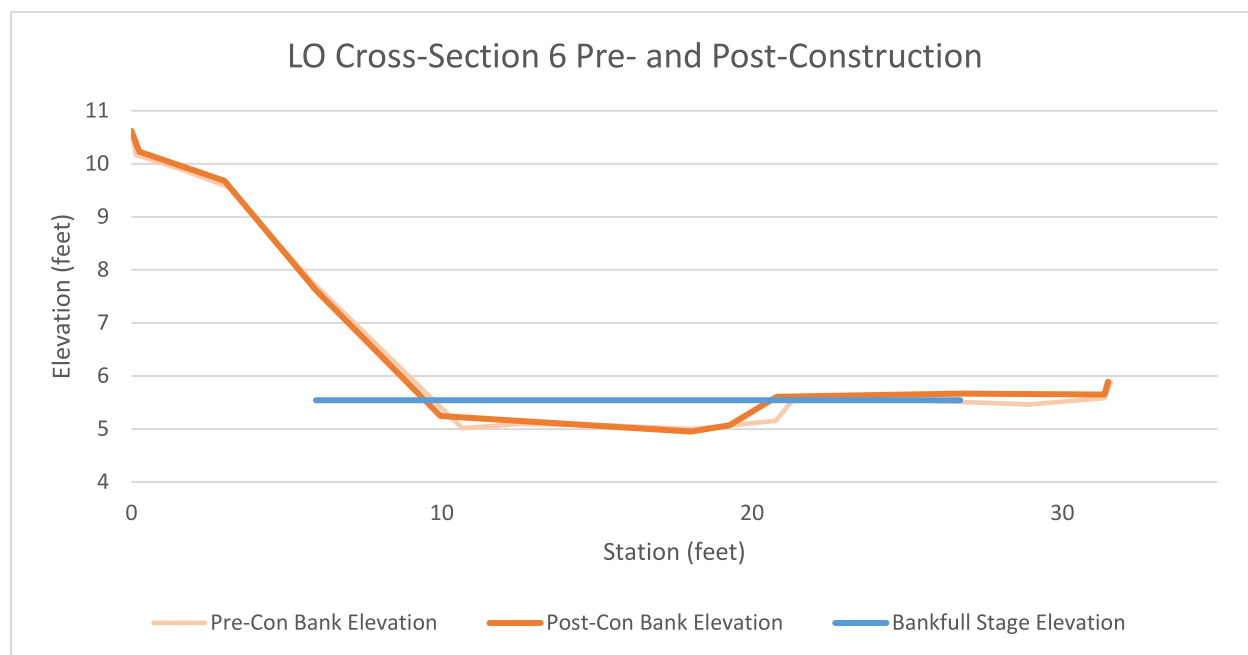
Figure 4-7 – LO Cross Section 6

LO Cross Section 6 is located upstream of the backwater influence from the riffle-weir structure within a laterally active section of the tributary. Post-construction monitoring documented minor morphological adjustments at LO Cross Section 6. Channel width decreased by approximately 4%, largely due to sediment deposition along the right bank. Although mean depth remained constant, maximum channel depth increased by 0.1 foot, likely reflecting localized scour adjacent to areas of deposition. The changes led to a slight reduction in cross-sectional area and a 4% increase in the width-to-depth ratio.
