Aquatic Biological Assessment of the Watersheds of Anne Arundel County, Maryland: 2013 Round Two—Year Five

November 2013 - Final

Anne Arundel County
Department of Public Works
Watershed, Ecosystem, and Restoration Services
Ecological Assessment Program

KCI Technologies, Inc. 936 Ridgebrook Road Sparks, Maryland 21152

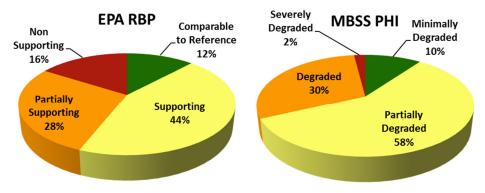
Figure 3 - Summary of Physical Habitat Conditions for Sites Assessed in 2013 (n=50)

'Comparable to Reference' (12 percent). All five sampling units received PHI ratings of 'Partially Degraded' as determined by the sampling unit mean. Over half of the total sites sampled resulted in a PHI rating of 'Partially Degraded' (58 percent), approximately one-third of the total sites received 'Degraded' ratings (30 percent), ten percent resulted in 'Minimally Degraded' ratings, and a very small percentage of sites received 'Severely Degraded' ratings (two percent).

Physical habitat assessment results indicate that three of the five sampling units, as determined by the sampling unit mean, received ratings of 'Partially Supporting' (RBP; Table 12). Approximately half (44 percent) of the total sites sampled resulted in a RBP rating of 'Supporting' and approximately one-fourth of the samples (28 percent) resulted in a 'Partially Supporting' rating (Figure 3). Only a small proportion of sites were rated as either 'Non Supporting' (16 percent) or

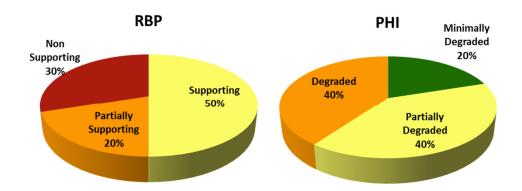
Figure 9 – Cabin Branch Physical Habitat Conditions (n=10)

Half of the sites sampled in the Cabin Branch sampling unit (50 percent) received a 'Supporting' narrative RBP rating, while 30 percent of the sites received a 'Non Supporting' rating, and the remaining 20 percent of sites received a 'Partially Supporting' rating (Figure 9). The average RBP score was 118.6 ± 20.3 resulting in a 'Partially Supporting' habitat condition for the sampling unit. Overall RBP scores for individual sites ranged from 85 ('Non Supporting') to 141 ('Supporting'). The PHI rated 40 percent of the sites as 'Partially Degraded,' 40 percent as 'Degraded,' and the remaining 20 percent as 'Minimally Degraded.' The average PHI score for the sampling unit was 72.4 ± 10.1 with a habitat condition rating of 'Partially Degraded.' Individual site scores for PHI ranged from a minimum of 56.4 ('Degraded') to a maximum of 92.7 ('Minimally Degraded'), which was one of the highest scoring sites in 2013. With the exception of R2-23-04, R2-23-07, and R2-23-09, sites received marginal to sub-optimal scores for instream habitat and epifaunal substrate. Instream woody debris, bank stability, and remoteness were variable between reaches. Riparian vegetation was suboptimal to optimal for all sites.

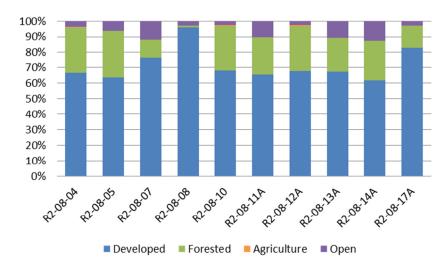
Figure 12 - Lower Magothy Land Use

With a drainage area of 12,697 acres, the Lower Magothy sampling unit is located on the eastern edge of the County (Figure 1) and drains directly into the Magothy River which drains into the Chesapeake Bay. The ten sampling sites, all 1st order streams, have drainage areas ranging from 106 to 708 acres (Figure 13). With 19 percent of the Lower Magothy sampling unit comprised of impervious surface, this was the most developed sampling unit assessed in 2013. Site-specific drainage areas ranged from 18.0 to 47.9 percent impervious, which is the highest percentage for all sites sampled in 2013. Developed land comprised 64 percent of the total land use in the Lower Magothy sampling unit, including numerous business parks and residential developments (Figure 12). In addition, Route 2 (Ritchie Highway) and Anne Arundel Community College campus are both located in the western portion of this sampling unit. Forested land comprised only 29 percent of the land cover, the lowest proportion of all sampling units assessed in 2013.

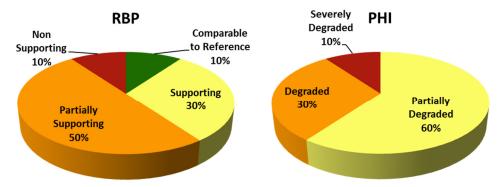
Figure 14 – Lower Magothy Physical Habitat Conditions (n=10)

Sixty percent of sites assessed received a PHI rating of 'Partially Degraded,' while 30 percent received a 'Degraded' rating, and the remaining 10 percent received a rating of 'Severely Degraded.' The average PHI rating was 67.3 ± 10.6 ('Partially Degraded') with individual sites ranging from 44.7 at site R2-08-08 ('Severely Degraded'), which was a concrete trapezoid channel and the lowest scoring site in 2013, to 77.9 at site R2-08-07 ('Partially Degraded'). All of the sites received poor to marginal epifaunal substrate scores in addition to having poor to marginal riffle/run quality. Vegetative bank protection, pool variability, and remoteness were variable between the reaches assessed. With the exception of sites R2-08-04 and R2-08-10, bank stability was suboptimal to optimal at all sites. Refuse was observed in abundant or moderate amounts at all sites assessed.

Based on the RBP scores, one-half of the Lower Magothy sites received a rating of 'Partially Supporting,' 30 percent received a 'Supporting' rating, and the remaining 20 percent of sites were equally split between a rating of 'Non Supporting' and 'Comparable to Reference' (Figure 14). Overall, the Lower Magothy sampling unit received the lowest average RBP score (117.0 ± 28.8). Individual RBP scores ranged from a minimum of 51 at site R2-08-08 ('Non Supporting'), which was a concrete trapezoid channel and the lowest scoring site in 2013, to a maximum of 162 at site R2-08-05 ('Comparable to Reference'), which was the highest scoring site in 2013. However, it should be noted, that the single site with a score of 51 for site R2-08-08 skewed the average, and the average value for this PSU would be 124 ('Partially Supporting') if this site was not included.

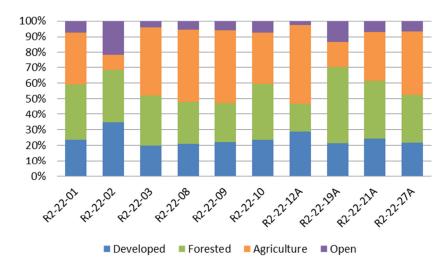
Figure 17 - Lyons Creek Land Use

The Lyons Creek sampling unit is located in the southern portion of the County along the border with Calvert County (Figure 1), and has a total drainage area of 6,154 acres, which drains to the Patuxent River. Of the 10 sites assessed, six were located on 1st order streams and four on 2nd order streams. Drainage areas to sampling sites ranged from 89 to 6,645 acres (Figure 18), with one site in the Lyons Creek sampling unit (R2-22-21A) including drainage that extends into Calvert County. Land use in the Lyons Creek sampling unit is comprised primarily of forested land (38 percent) and agriculture (31 percent) followed by developed land (24 percent). One-half of the sites have agriculture as the dominant land use, while 40 percent of sites are dominated by forested land, with the remaining 10 percent of sites dominated by developed land (Figure 17). Impervious surfaces account for just 4.4 percent of the Lyons Creek sampling unit, with individual sites ranging from 3.1 to 7.3 percent imperviousness.

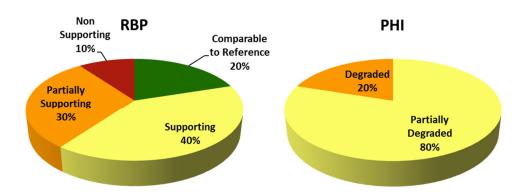
Figure 19 – Lyons Creek Physical Habitat Conditions (n=10)

According to the PHI, the majority of sites were rated as 'Partially Degraded' (80 percent), while 20 percent received a rating of 'Degraded.' The average PHI rating was 'Partially Degraded' with a score of 71.9 ± 6.1 . Individual site scores ranged from 59.3 ('Degraded') to 79.3 ('Partially Degraded'). All of the reaches sampled received marginal to suboptimal scores for instream physical habitat and epifaunal substrate. Bank stability, instream woody debris, and vegetative bank protection were variable between reaches. However with the exception of site R2-22-12A, all sites received suboptimal to optimal scores for riparian vegetative width.

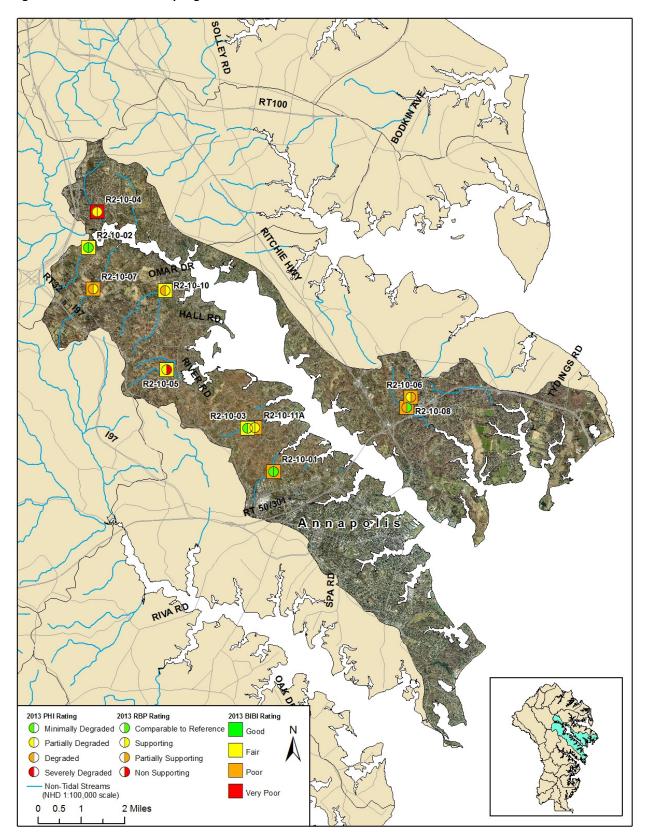
Figure 22 - Severn River Sampling Sites

The Severn River sampling unit, which consists of direct tributaries to the Severn River, is located on the eastern side of the County (Figure 1) and has a drainage area of 28,920 acres. The city of Annapolis is located in the southern portion of the Severn River sampling unit with Route 50/301 traveling through the center of the sampling unit. The ten sampling sites (nine 1st order and one 2nd order streams) have drainage areas ranging from 215 to 1,364 acres (Figure 22). Land use in the Severn River sampling unit is primarily comprised of developed land (57 percent), followed by forested land (32 percent). Seventy percent of sites sampled in the Severn River sampling unit have predominantly developed land cover with 30 percent of sites predominantly forested (Figure 23). Impervious surfaces comprise 18.9 percent of the overall sampling unit, with individual sites ranging from 6.4 percent to 36.0 percent.

Located 120 feet upstream of West Benfield Road and adjacent to Pixie Drive, site R2-10-04 (Figure 22) received the lowest BIBI score of 1.86 with a 'Very Poor' rating. Sixteen taxa were present in this sample, which was predominantly comprised of midges including Cricotopus/Orthocladius (TV = 7.7) that accounted for 52 percent of the sample. Although this sample contained three EPT taxa, Ephemeroptera, scraper taxa, or taxa intolerant to urban stressors were not present. Two sites, R2-10-02 and R2-10-10, received the highest BIBI score of 3.57, resulting in a 'Fair' biological condition rating. Located within the Severn Run Natural Environment Area approximately 0.25 mile upstream of the Severn River, site R2-10-02 is a multi-thread channel through thickly vegetated wetland with an abundance of rootwads providing stable habitat for benthics. Of the 23 taxa identified in this sample, five were EPT taxa with one scraper taxa. This sample also had high percentages of climber taxa (22 percent) and taxa intolerant to urban stressors (47 percent). Site R2-10-10, located just downstream of the confluence of Gumbottom Branch and Plum Creek, had the highest percentage of taxa intolerant to urban stressors and was dominated by pollution intolerant black flies (Stegopterna TV = 2.4). Of the 19 taxa identified in this sample, five were EPT including one Ephemeroptera taxa. This site also had the largest drainage area (1,364 acres) in the Severn River sampling unit.

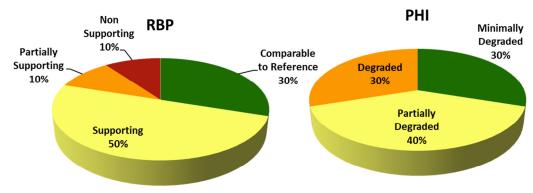
Figure 24 – Severn River Physical Habitat Conditions (n=10)

Based on the RBP index, the majority of sites were rated as either 'Supporting' (50 percent) or 'Comparable to Reference' (30 percent). Only one site received a rating of 'Non Supporting' (10 percent), and one site received a 'Partially Supporting' rating (10 percent; Figure 24). With an average RBP score of 137.5 ± 19.8 and a narrative rating of 'Supporting,' this sampling unit received the highest average RBP score in 2013. Individual RBP scores ranged from a minimum of 96 ('Non Supporting') to a maximum of 160 ('Comparable to Reference').

The PHI rated 40 percent of sites as 'Partially Degraded,' 30 percent as 'Minimally Degraded,' and the remaining 30 percent as 'Degraded'. The average PHI rating was 'Partially Degraded' with a score of 75.2 ± 10.1, which was the highest average PHI score for a sampling unit in 2013. Individual PHI scores ranged from 61.8 ('Degraded') to 90.9 ('Minimally Degraded'), which was one of the highest scoring sites in 2013. The majority of sites received marginal to suboptimal scores for instream habitat, epifaunal substrate, riffle/run quality, and pool variability. All but two sites (R2-10-05 and R2-10-11A) received suboptimal to optimal scores for bank stability. Riparian vegetative zone width was optimal at most sites.

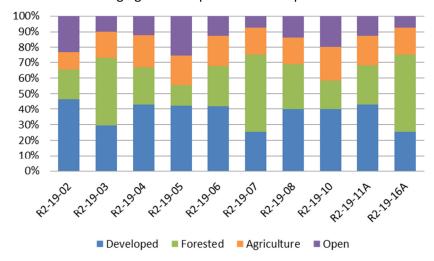
Figure 27 - Stocketts Run Land Use

The Stocketts Run sampling unit, which drains to the Patuxent River, is located in the south central portion of the County, east of Crain Highway and south of Route 50/301 (Figure 1), and has a drainage area of 8,714 acres. The ten sampling sites (eight 1st order and two 2nd order streams) have drainage areas ranging from 62 to 3,666 acres (Figure 28). Land use in the Stocketts Run sampling unit is primarily comprised of forested land (44 percent), followed by developed land (29 percent) and agriculture (18 percent). The majority of sites sampled in the Stocketts Run sampling unit have predominantly developed land cover (70 percent) with approximately one-third of sites predominantly forested (Figure 27). Impervious surfaces comprise just 4.9 percent of the overall sampling unit, with individual sites ranging from 3.9 percent to 11.5 percent.

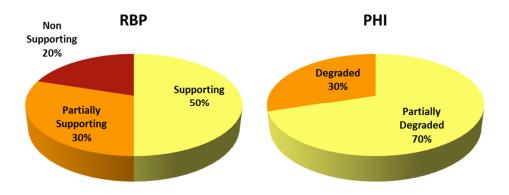
Figure 29 – Stocketts Run Physical Habitat Conditions (n=10)

Half of the sites sampled in the Stocketts Run sampling unit (50 percent) received a 'Supporting' narrative RBP rating, while 30 percent of the sites received a 'Partially Supporting' rating and the remaining 20 percent of sites received a 'Non Supporting' rating (Figure 29). The average RBP score for the sampling unit was 118.6 ± 19.4 and the corresponding narrative rating was 'Partially Supporting.' Individual RBP scores ranged from a minimum of 78 ('Non Supporting') to a maximum of 135 ('Supporting').

The PHI rated 70 percent of sites as 'Partially Degraded' and 30 percent as 'Degraded'. The average PHI rating was 'Partially Degraded' with a score of 68.0 ± 5.6 . Individual PHI scores ranged from 60.2 ('Degraded') to 75.8 ('Partially Degraded'). The majority of sites received suboptimal scores for instream habitat, epifaunal substrate, sediment deposition, pool variability, and velocity/depth diversity. Bank stability, sinuosity, and remoteness was variable between sites. Riparian vegetative zone width was optimal at most sites.

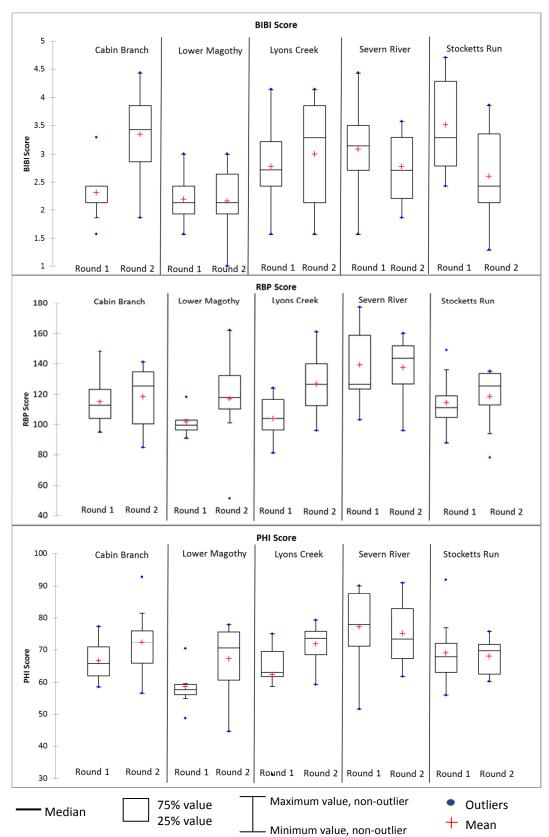
Figure 32 - Box plots comparing mean BIBI, RBP, and PHI scores between Round 1 and Round 2

This section presents a brief comparison of the biological and physical habitat assessment results from Round 1 and Round 2 for each of the five primary sampling units assessed in 2013. Refer to Figure 32 for box plots comparing mean BIBI, RBP, and PHI results from Round 1 and Round 2 in the Cabin Branch, Lower Magothy, Lyons Creek, Severn River, and Stocketts Run sampling units.

$$(Q_1 - Q_2) \pm 1.645[SE_1^2 + SE_2^2]^{1/2}$$

where Q_1 and Q_2 are two independent estimates of the mean of a variable (i.e., BIBI, RBP, PHI) and SE_1 and SE_2 are the associated standard errors. The null hypothesis that $(Q_1 - Q_2)$ is equal to zero was tested (at the 10 percent nominal level) by examining whether the 90 percent confidence interval contains zero. The null hypothesis that the two means are equal was rejected if and only if the interval did not contain zero (Schenker and Gentleman, 2001), resulting in a statistically significant difference between those two values.

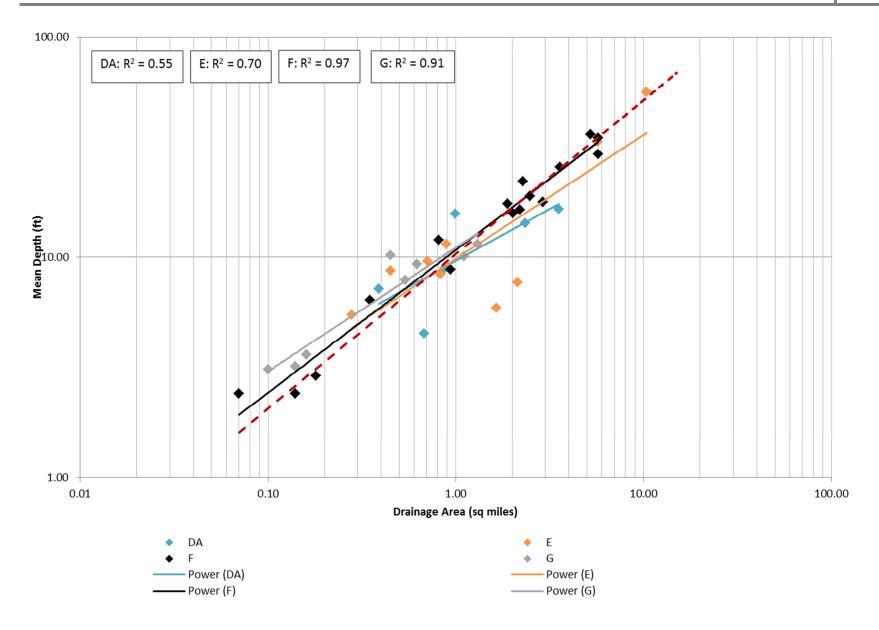
Figure 35 - Comparison of the Bankfull Cross-Sectional Area - Drainage Area Relationship between Field Data and Regional Relationship Curve Data

Comparisons of bankfull cross-sectional area values show the trendlines for DA type ($R^2 = 0.55$), E type ($R^2 = 0.70$), F type ($R^2 = 0.97$), and G type ($R^2 = 0.91$) channels closely matching the MCP curve (Figure 35).

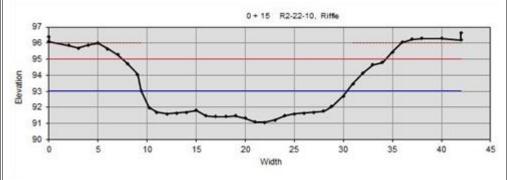
Rosgen Level II Classification Data

Drainage Area (mi²)	5.73	Cross Sectional Area (ft ²)	29.3
Bankfull Width (ft)	21	Water Surface Slope (%)	0.098
Mean Bankfull Depth (ft)	1.39	Sinuosity	1.1
Floodprone Width (ft)	26.8	D50 (mm)	0.062
Entrenchment Ratio	1.3	Adjustments?	None
Width to Depth Ratio	15.1	Rosgen Stream Type	F6
