Aquatic Biological Assessment of the Watersheds of Anne Arundel County, Maryland: 2009

August 2011

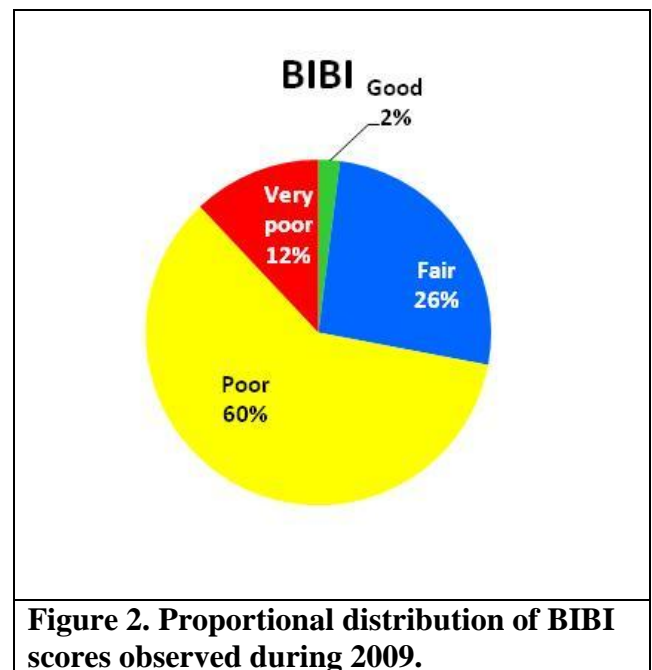
Figure 2. Proportional distribution of BIBI scores observed during 2009.

Overall, the BIBI scores throughout the sampling units were variable, with a little less than three-quarters of the sites (72%) falling within the “Poor” (60%) and “Very Poor” (12%) categories (**Figure 2**). Twenty-six percent of the sites were rated as “Fair,” and 2% rated as “Good.” Three of the five sampling units had BIBI scores that put them in the “Poor” category (**Table 7**). West River and Rock Branch (PSU 14 and 20, respectively) had the highest mean B-IBI scores, 2.89 and 3.03 respectively. Marley Creek, and the Lower North and Little Patuxent Rivers had the lowest scores, ranging from 1.83-2.60. At many of the sites, the benthic macroinvertebrate assemblage was dominated by midges (Diptera: Chironomidae). Blackflies (Diptera: Simuliidae), sowbugs

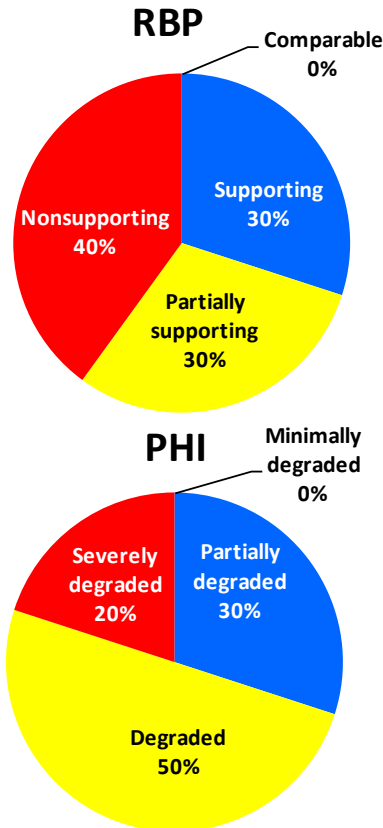
Figure 6. Proportional distribution of physical habitat quality assessments (RBP and MPH) for the Marley Creek PSU.

Forty percent of the Marley Creek streams were rated as “Non-Supporting” by the RBP method, 30% “Partially Supporting” and 30% “Supporting” (**Figure 6**). The MBSS PHI results showed no streams (0%) as “Minimally Degraded,” 50% as “Degraded,” and 30% as “Partially Degraded” and 20% were “Severely Degraded.” The mean RBP habitat score was 103.0 ± 30.2 (**Table 7**), with individual sites ranging from 55 to 143. Streams with the worst RBP scores had altered channels or unstable banks, as well as sedimentation and disturbed riparian zones. The mean PHI score was 60.5 ± 12.0 , with individual sites ranging from 35.8 – 77.3. The site scoring lowest for the PHI had very low scores for remoteness, trash, and woody debris, and shading.

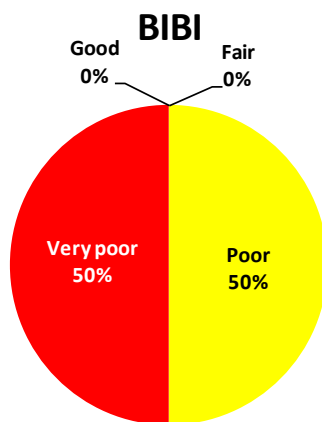
Figure 7. Proportional distribution of B-IBI assessment results for the Marley Creek PSU.

Sites in the PSU were rated as either “Poor” (50%) or “Very Poor” (50%) (**Figure 7**); no sites were rated as either “Good” or “Fair.” The mean B-IBI score was 1.83 ± 0.47 (**Table 7**), and scores at

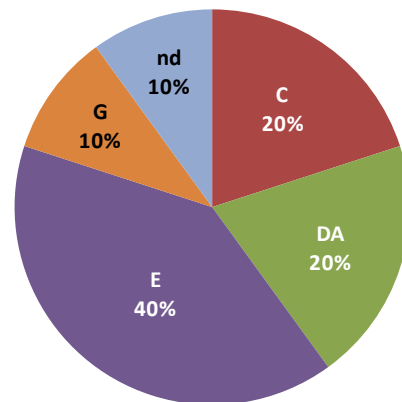
Figure 8. Summary of Rosgen stream types in the Marley Creek PSU.

The E stream type was the most frequently observed type in this sampling unit, making up 40% of observed channels. As shown in **Figure 8**, the C and D/DA types were observed at 20% of sites while the G type was observed at 10% of reaches. One site (R2-05-04) was not classified due to the highly impacted condition of the reach.

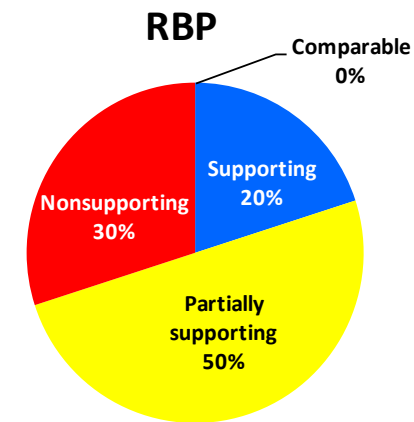
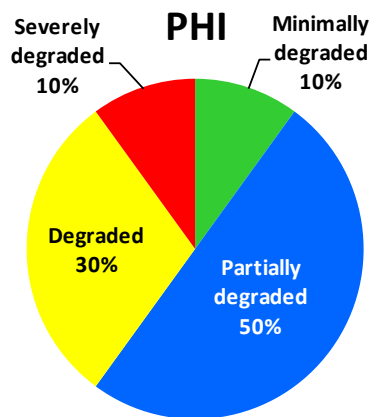
Figure 11. Proportional distribution of physical habitat quality assessments (RBP and MPHI) for the Lower North River PSU.

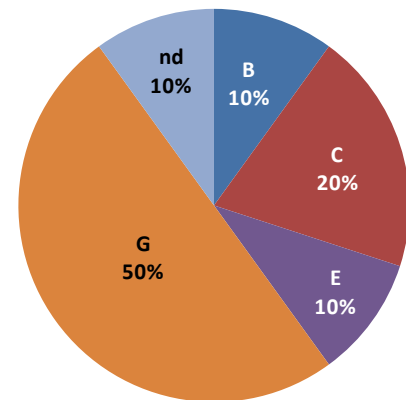
Figure 12. Summary of Rosgen stream types found in the Lower North River PSU.

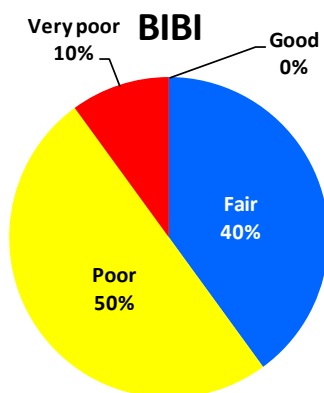
Figure 10. Proportional distribution of B-IBI assessment results for the Lower North River PSU.

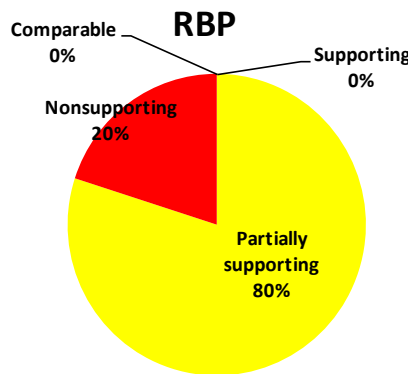
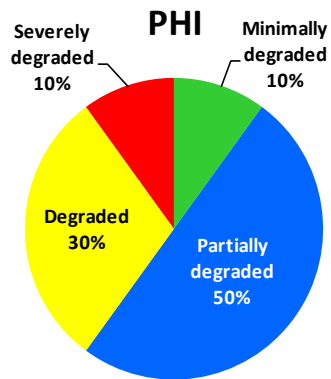
Figure 14. Proportional distribution of physical habitat quality assessments (RBP and MPHI) for the West River PSU.

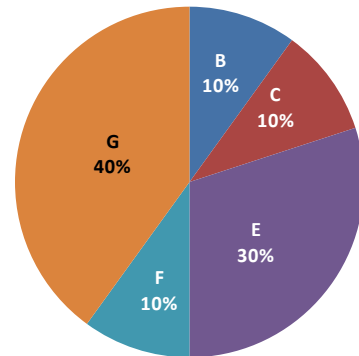
Figure 16. Summary of Rosgen stream types in the West River PSU.

For the G type streams in this PSU, the sinuosity was significantly smaller than the average reported in Rosgen (1998) for the G5 type. There were no significant differences observed in average width to depth or ER between G types in this PSU and the G5 averages reported in Rosgen (1996).

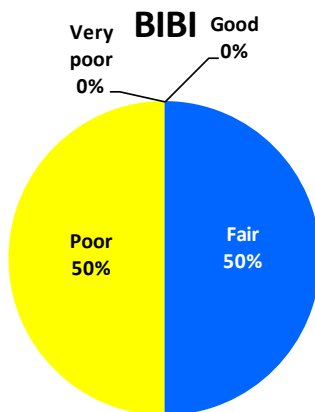
Figure 15. Proportional distribution of B-IBI assessment results for the West River PSU.

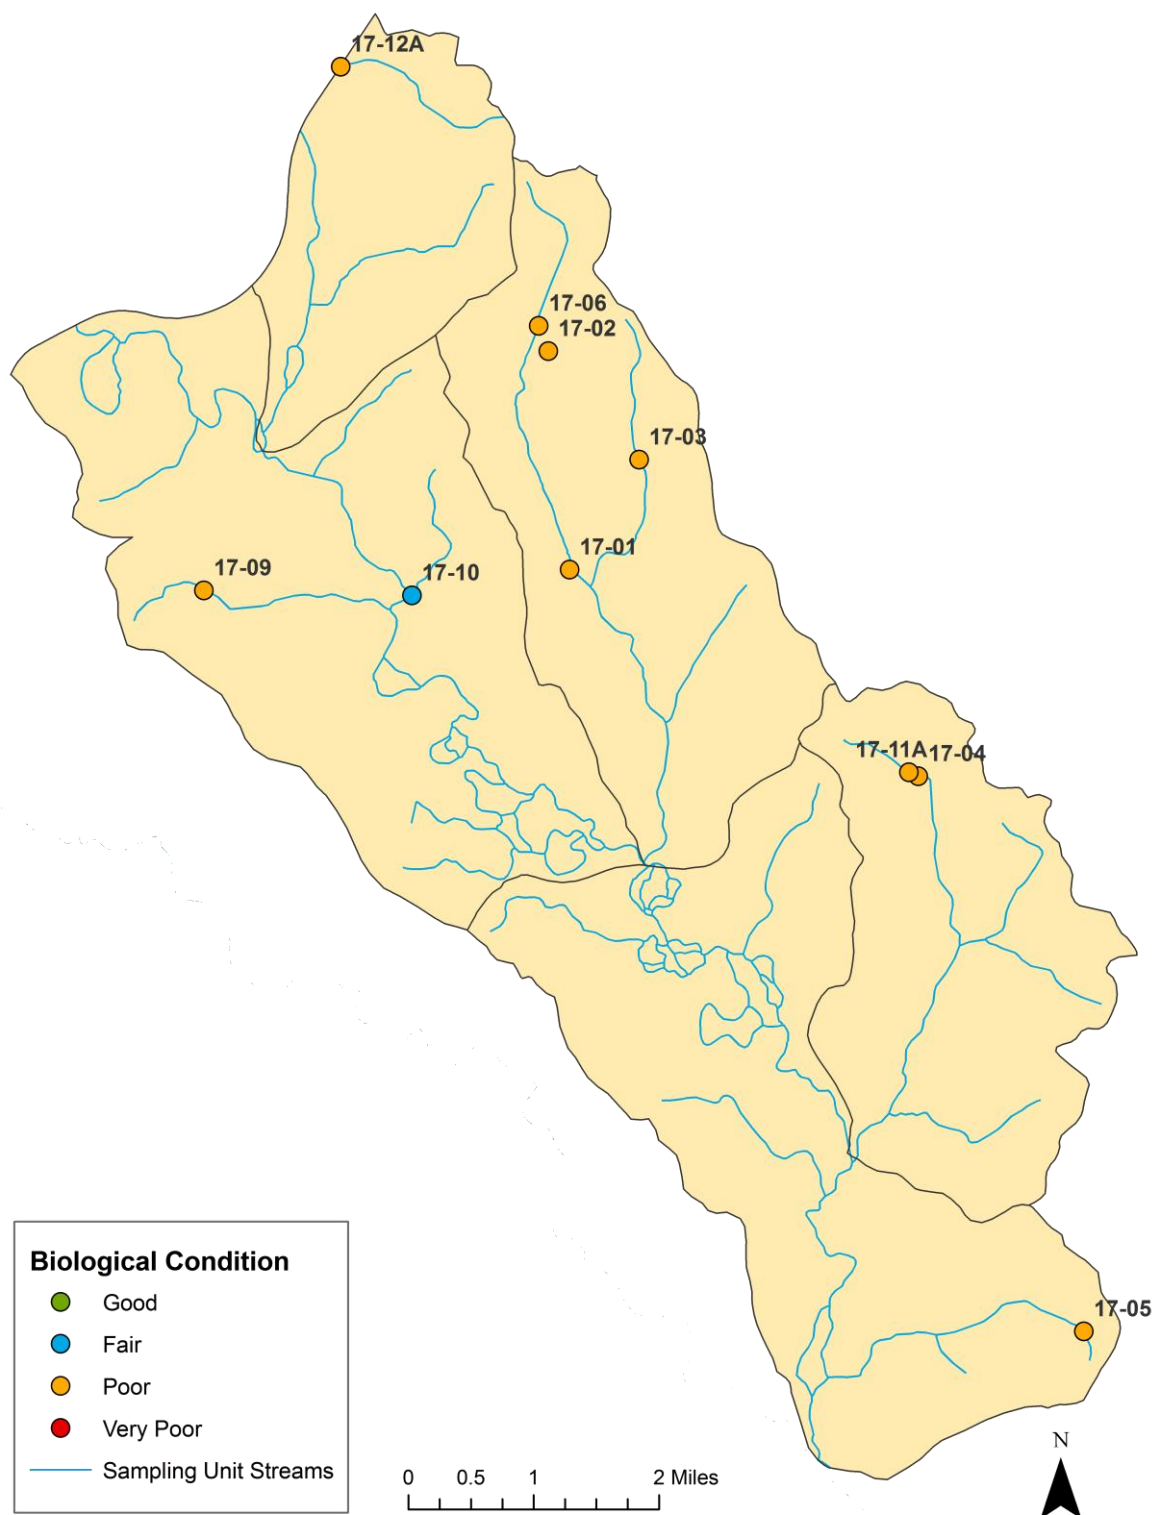
Figure 17. Sampling locations in the Little Patuxent River primary sampling unit.

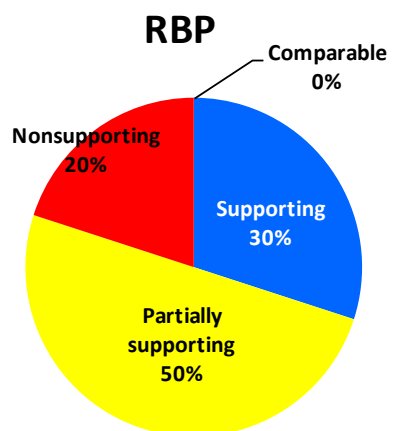
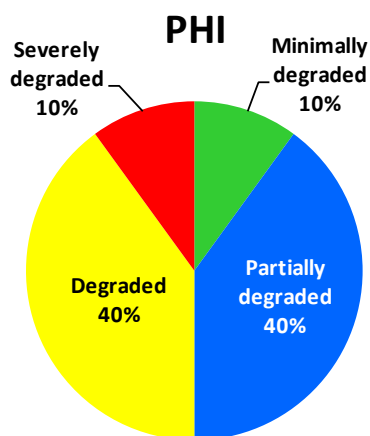
Figure 19. Proportional distribution of physical habitat quality assessments (RBP and PHI) for the Little Patuxent River PSU.

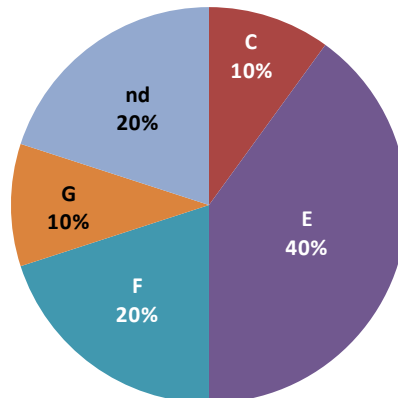
Figure 20. Summary of Rosgen stream types in the Little Patuxent River PSU.

For the E type streams in this PSU, there are significant differences when compared to reference reach conditions (Starr et al. 2009). Both entrenchment and width to depth ratios were significantly lower in E types found here than in E types found at reference sites. Conversely, there were no significant differences observed in sinuosity between the two groups.

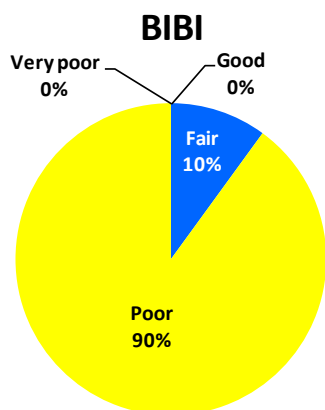
Figure 18. Proportional distribution of B-IBI assessment results for the Little Patuxent River PSU.

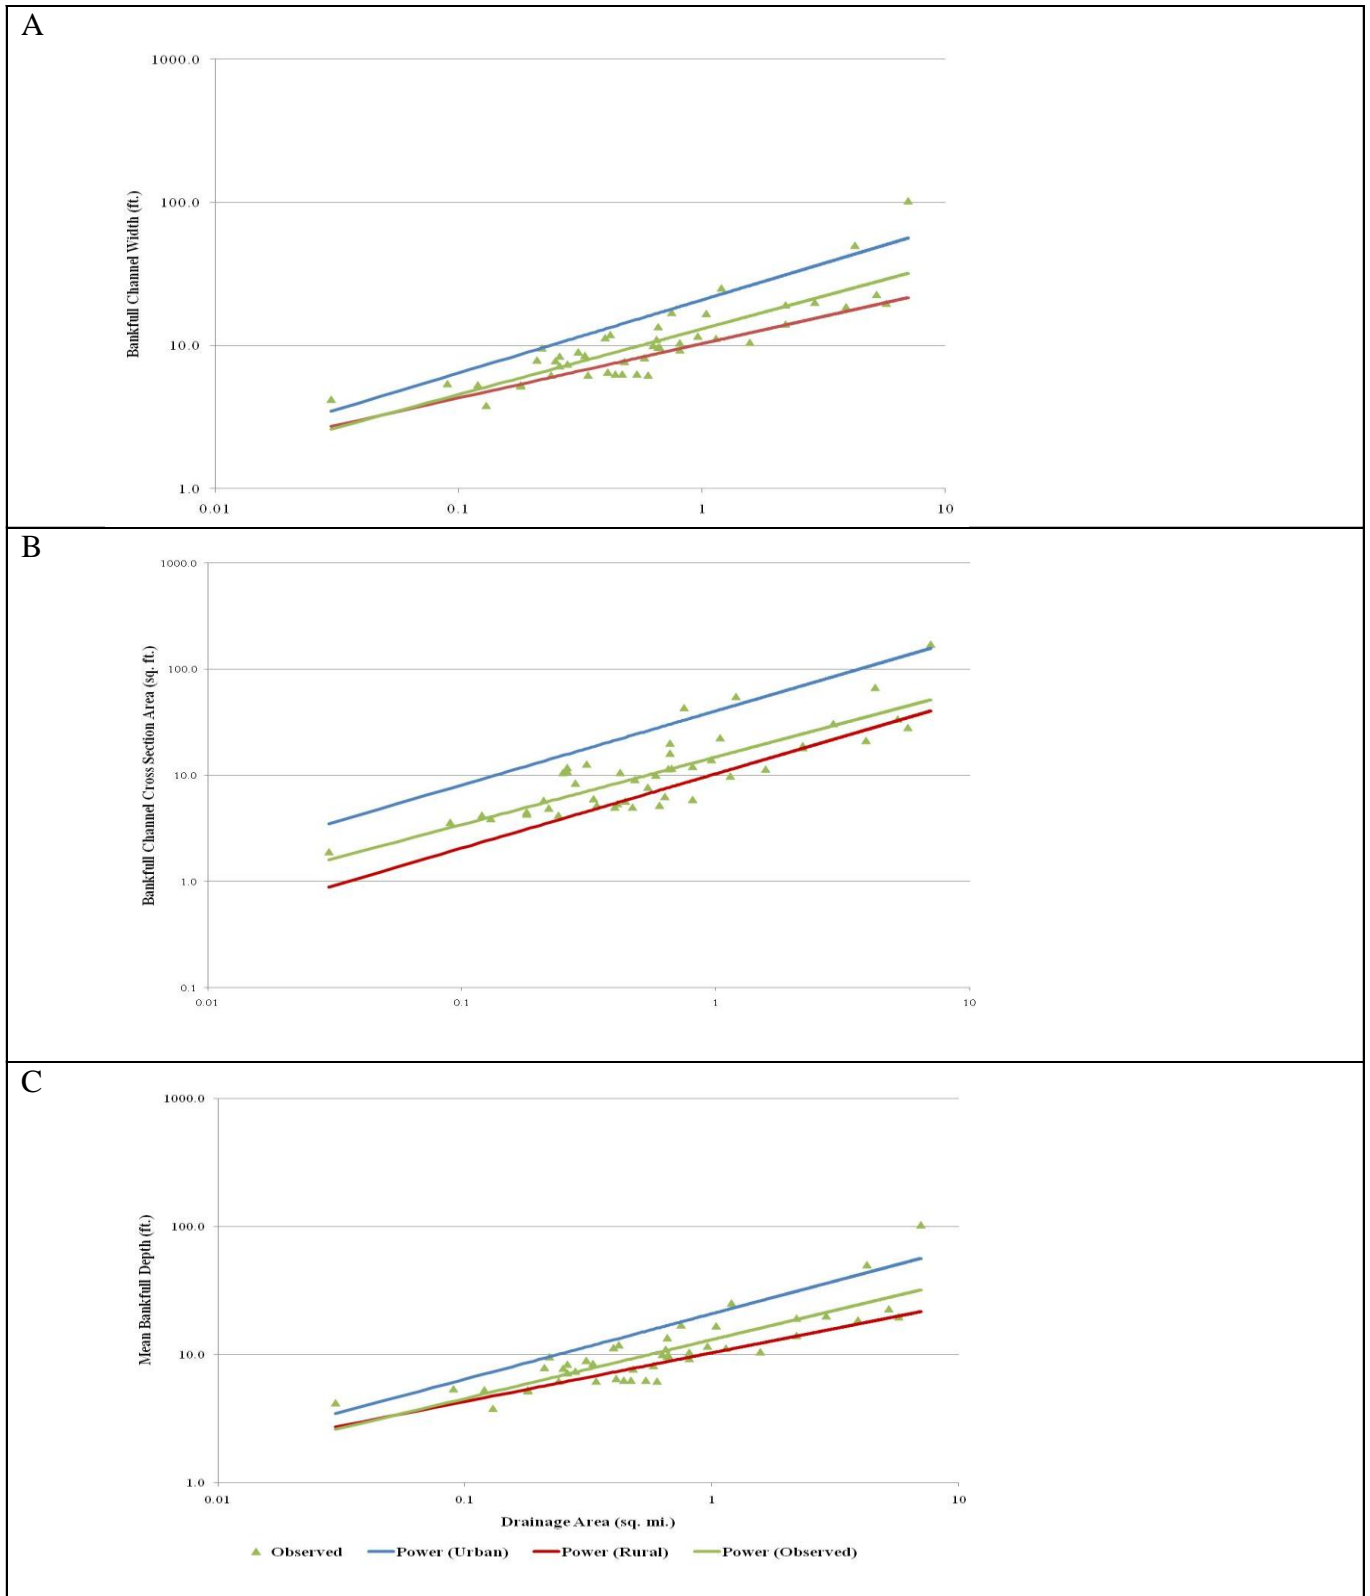
Figure 25. Comparison of 2009 PSU sample sites A) bankfull channel widths, B) bankfull channel areas, and C) bankfull channel mean depths with Coastal Plain regional relationships developed for Rural and Urban watersheds.

Finally, these baseline geomorphic assessment field data can be compared to the Maryland Coastal Plain regional relationships of bankfull channel geometry developed for relatively rural channels (McCandless 2003) and for urbanized watersheds (AAC 2002) in order to determine whether bankfull characteristics observed in the field at sites where the discharge is unknown depart from USGS gages where bankfull conditions are known. This comparison is shown in **Figure 25**

As shown in **Figure 25**, nearly all values fall somewhere between the rural and urban bankfull channel regional curves. The implications of this observation on stream channel evolution in these sampling units is unclear, but it likely means that these reaches are in some state of transition where the dominant process is floodplain incision due to a disturbance in the discharge regime associated with impervious surface occurrence. Typically, lateral adjustment follows such incision as the stream resets itself into an

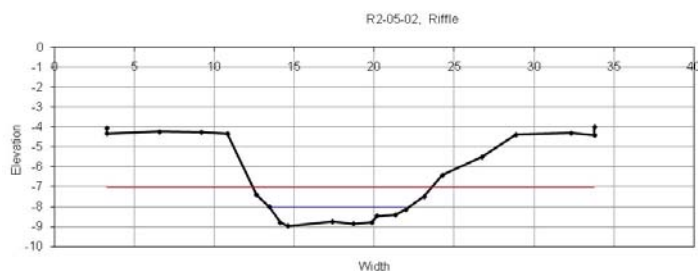
Geomorphic Assessments**Rosgen Level II Classification Data**

Drainage Area (mi ²)	0.33	Cross Sectional Area (ft ²)	6.0
Bankfull Width (ft)	8.5	Water Surface Slope (%)	0.3
Mean Bankfull Depth (ft)	0.7	Sinuosity	1.3
Floodprone Width (ft)	11.2	D50 (mm)	0.062
Entrenchment Ratio	1.3	Adjustments?	↓WD
Width to Depth Ratio	12.1	Rosgen Stream Type	G6c

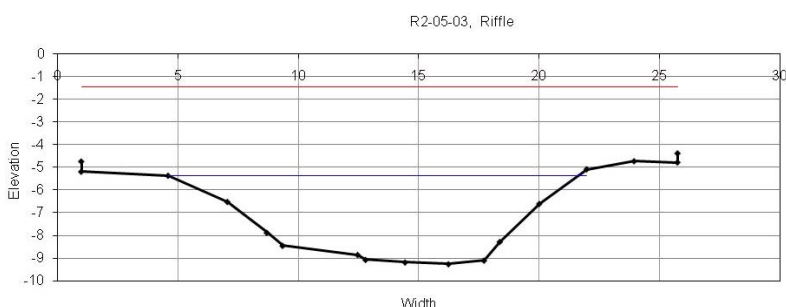
Rosen Level II Classification Data

Drainage Area (mi ²)	0.75	Cross Sectional Area (ft ²)	43.2
Bankfull Width (ft)	17.0	Water Surface Slope (%)	0.45
Mean Bankfull Depth (ft)	2.5	Sinuosity	1.2
Floodprone Width (ft)	160	D50 (mm)	0.21
Entrenchment Ratio	9.4	Adjustments?	↑Sin
Width to Depth Ratio	6.7	Rosen Stream Type	E5

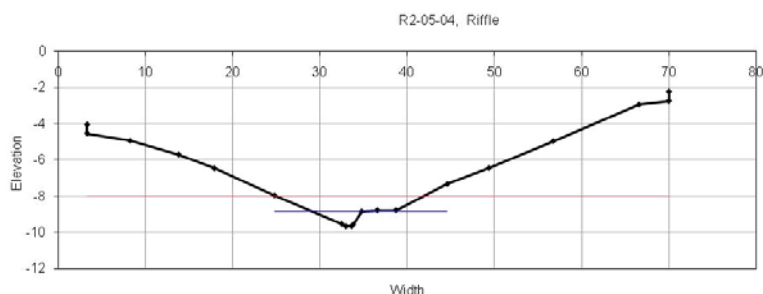
Geomorphic Assessments**Rosgen Level II Classification Data**

Drainage Area (mi ²)	0.33	Cross Sectional Area (ft ²)	—
Bankfull Width (ft)	—	Water Surface Slope (%)	—
Mean Bankfull Depth (ft)	—	Sinuosity	—
Floodprone Width (ft)	—	D50 (mm)	—
Entrenchment Ratio	—	Adjustments?	—
Width to Depth Ratio	—	Rosgen Stream Type	—

NOTE: Classification not performed because this site contains a concrete channel acting as a bedrock control.

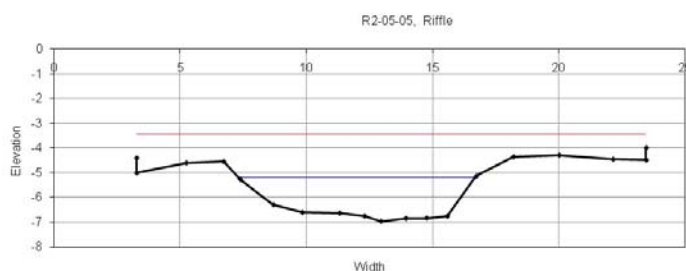
Rosen Level II Classification Data

Drainage Area (mi ²)	0.81	Cross Sectional Area (ft ²)	12.1
Bankfull Width (ft)	9.3	Water Surface Slope (%)	0.31
Mean Bankfull Depth (ft)	1.3	Sinuosity	1.0
Floodprone Width (ft)	82	D50 (mm)	0.31
Entrenchment Ratio	8.8	Adjustments?	↑Sin
Width to Depth Ratio	7.2	Rosen Stream Type	E5

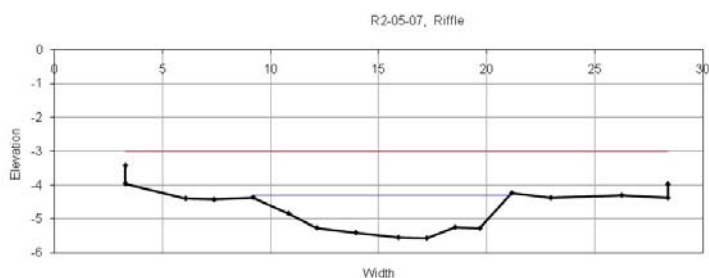
Geomorphic Assessments**Rosgen Level II Classification Data**

Drainage Area (mi ²)	0.42	Cross Sectional Area (ft ²)	10.6
Bankfull Width (ft)	11.9	Water Surface Slope (%)	0.39
Mean Bankfull Depth (ft)	0.9	Sinuosity	1.1
Floodprone Width (ft)	108	D50 (mm)	0.35
Entrenchment Ratio	9.1	Adjustments?	↑Sin
Width to Depth Ratio	13.3	Rosgen Stream Type	E5

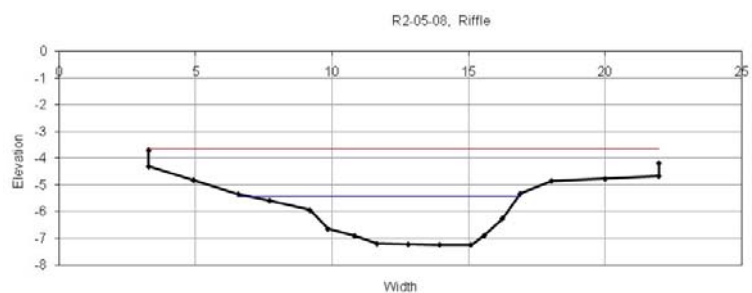
Rosgen Level II Classification Data

Drainage Area (mi ²)	0.67	Cross Sectional Area (ft ²)	11.6
Bankfull Width (ft)	9.7	Water Surface Slope (%)	0.75
Mean Bankfull Depth (ft)	1.2	Sinuosity	1.5
Floodprone Width (ft)	72	D50 (mm)	0.067
Entrenchment Ratio	7.4	Adjustments?	None
Width to Depth Ratio	8.2	Rosgen Stream Type	E6

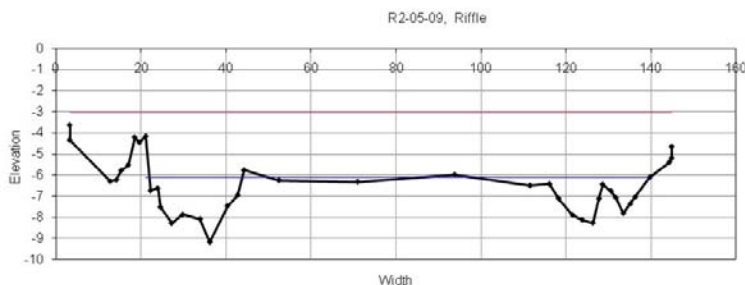
Geomorphic Assessments**Rosgen Level II Classification Data**

Drainage Area (mi ²)	4.25	Cross Sectional Area (ft ²)	67.0
Bankfull Width (ft)	50.1	Water Surface Slope (%)	0.38
Mean Bankfull Depth (ft)	1.3	Sinuosity	1.0
Floodprone Width (ft)	143	D50 (mm)	0.12
Entrenchment Ratio	2.9	Adjustments?	None
Width to Depth Ratio	37.4	Rosgen Stream Type	DA5

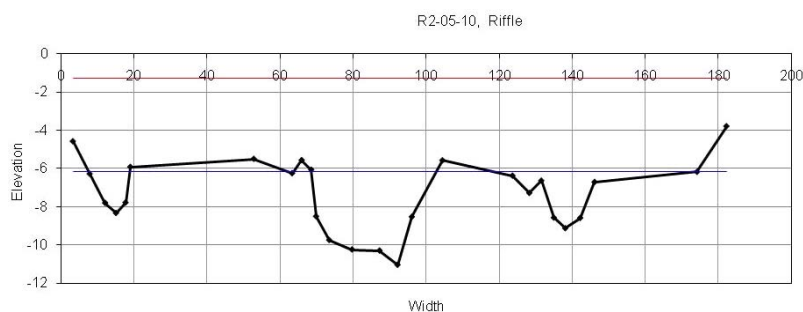
Geomorphic Assessments**Rosgen Level II Classification Data**

Drainage Area (mi ²)	7.01	Cross Sectional Area (ft ²)	171.1
Bankfull Width (ft)	102.6	Water Surface Slope (%)	0.053
Mean Bankfull Depth (ft)	1.7	Sinuosity	1.2
Floodprone Width (ft)	198	D50 (mm)	0.2
Entrenchment Ratio	1.9	Adjustments?	None
Width to Depth Ratio	61.5	Rosgen Stream Type	DA5

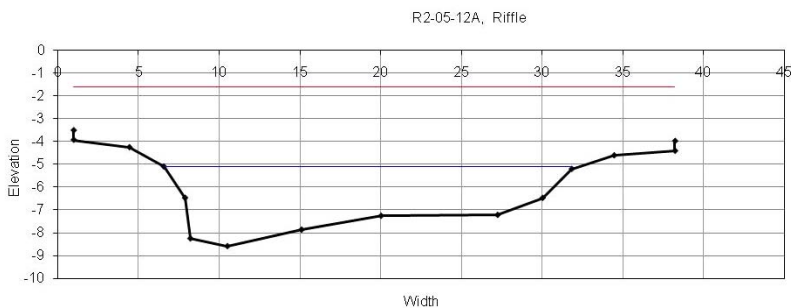
Geomorphic Assessments**Rosgen Level II Classification Data**

Drainage Area (mi ²)	1.20	Cross Sectional Area (ft ²)	55.1
Bankfull Width (ft)	25.2	Water Surface Slope (%)	0.021
Mean Bankfull Depth (ft)	2.2	Sinuosity	1.2
Floodprone Width (ft)	197	D50 (mm)	0.22
Entrenchment Ratio	7.8	Adjustments?	↑WD
Width to Depth Ratio	11.5	Rosgen Stream Type	C5

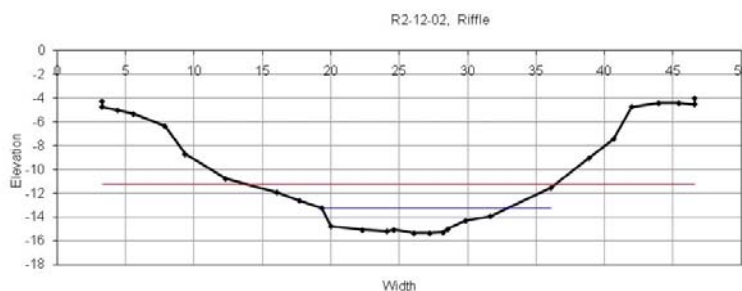
Geomorphic Assessments**Rosgen Level II Classification Data**

Drainage Area (mi ²)	0.66	Cross Sectional Area (ft ²)	20.0
Bankfull Width (ft)	13.5	Water Surface Slope (%)	0.38
Mean Bankfull Depth (ft)	1.5	Sinuosity	1.1
Floodprone Width (ft)	22	D50 (mm)	0.3
Entrenchment Ratio	1.6	Adjustments?	↓ER
Width to Depth Ratio	9.1	Rosgen Stream Type	G5c

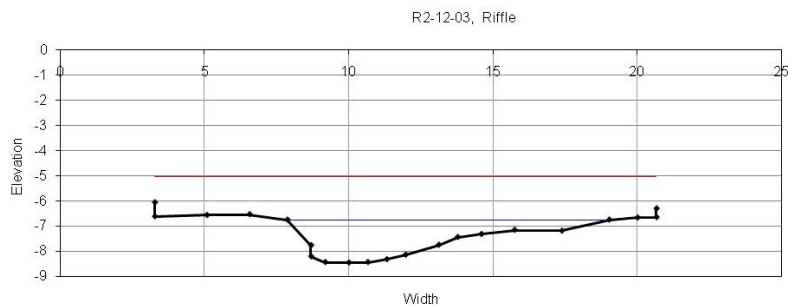
Geomorphic Assessments**Rosgen Level II Classification Data**

Drainage Area (mi ²)	1.14	Cross Sectional Area (ft ²)	9.8
Bankfull Width (ft)	11.2	Water Surface Slope (%)	0.55
Mean Bankfull Depth (ft)	0.9	Sinuosity	1.7
Floodprone Width (ft)	177	D50 (mm)	0.2
Entrenchment Ratio	15.9	Adjustments?	None
Width to Depth Ratio	12.7	Rosgen Stream Type	C5

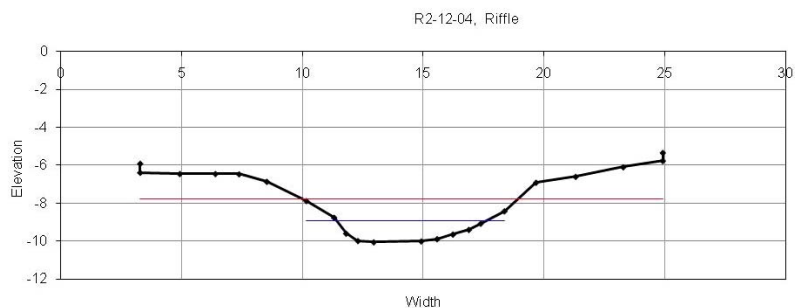
Geomorphic Assessments**Rosgen Level II Classification Data**

Drainage Area (mi ²)	0.34	Cross Sectional Area (ft ²)	5.2
Bankfull Width (ft)	6.2	Water Surface Slope (%)	1.1
Mean Bankfull Depth (ft)	0.8	Sinuosity	1.1
Floodprone Width (ft)	9.3	D50 (mm)	0.19
Entrenchment Ratio	1.5	Adjustments?	↓ER
Width to Depth Ratio	7.3	Rosgen Stream Type	G5c

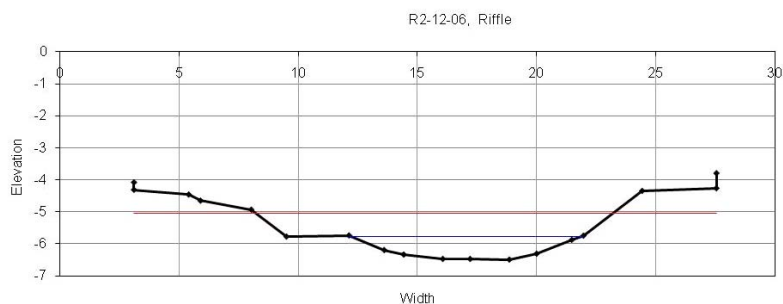
Geomorphic Assessments**Rosgen Level II Classification Data**

Drainage Area (mi ²)	0.20	Cross Sectional Area (ft ²)	4.9
Bankfull Width (ft)	9.6	Water Surface Slope (%)	0.22
Mean Bankfull Depth (ft)	0.5	Sinuosity	1.0
Floodprone Width (ft)	15	D50 (mm)	0.14
Entrenchment Ratio	1.6	Adjustments?	↑Sin
Width to Depth Ratio	18.9	Rosgen Stream Type	B5c

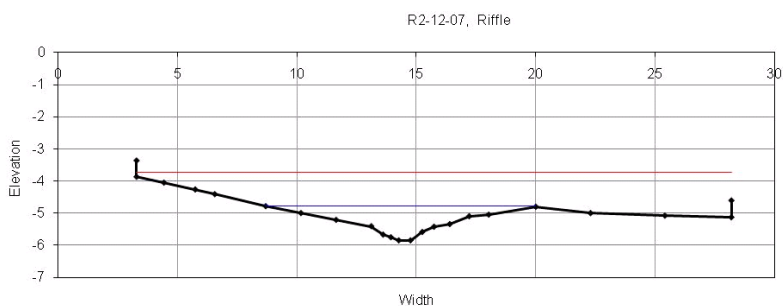
Geomorphic Assessments**Rosgen Level II Classification Data**

Drainage Area (mi ²)	0.4	Cross Sectional Area (ft ²)	5.0
Bankfull Width (ft)	11.3	Water Surface Slope (%)	0.54
Mean Bankfull Depth (ft)	0.4	Sinuosity	1.1
Floodprone Width (ft)	121	D50 (mm)	0.26
Entrenchment Ratio	10.7	Adjustments?	↑Sin
Width to Depth Ratio	25.6	Rosgen Stream Type	C5

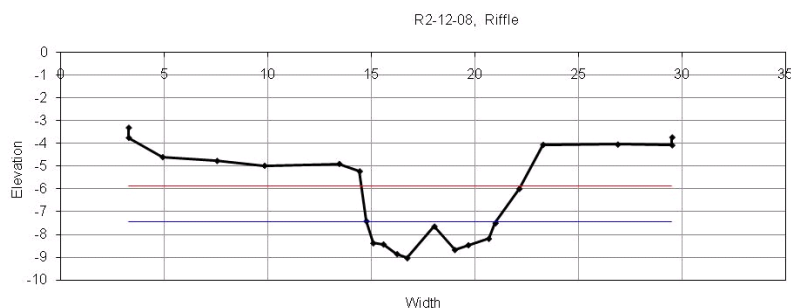
Geomorphic Assessments**Rosgen Level II Classification Data**

Drainage Area (mi ²)	0.44	Cross Sectional Area (ft ²)	5.7
Bankfull Width (ft)	6.3	Water Surface Slope (%)	0.44
Mean Bankfull Depth (ft)	0.9	Sinuosity	1.2
Floodprone Width (ft)	9.0	D50 (mm)	0.062
Entrenchment Ratio	1.4	Adjustments?	None
Width to Depth Ratio	6.8	Rosgen Stream Type	G6c

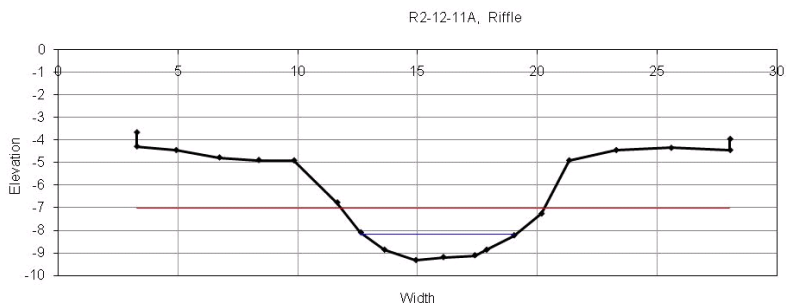
Rosgen Level II Classification Data

Drainage Area (mi ²)	0.47	Cross Sectional Area (ft ²)	5.0
Bankfull Width (ft)	6.3	Water Surface Slope (%)	0.52
Mean Bankfull Depth (ft)	0.8	Sinuosity	1.2
Floodprone Width (ft)	9.3	D50 (mm)	0.062
Entrenchment Ratio	1.5	Adjustments?	↓ER
Width to Depth Ratio	8.0	Rosgen Stream Type	G6c

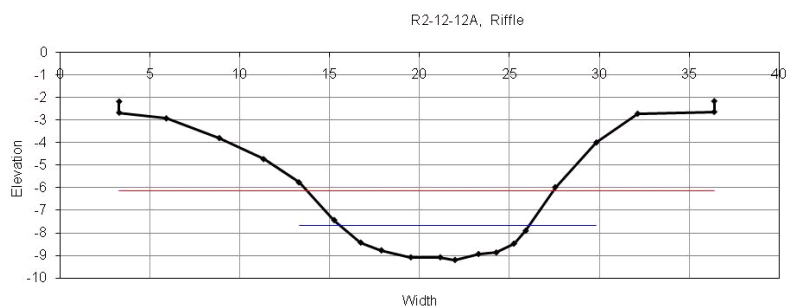
Rosgen Level II Classification Data

Drainage Area (mi ²)	1.57	Cross Sectional Area (ft ²)	11.4
Bankfull Width (ft)	10.5	Water Surface Slope (%)	0.38
Mean Bankfull Depth (ft)	1.1	Sinuosity	1.5
Floodprone Width (ft)	16.7	D50 (mm)	0.27
Entrenchment Ratio	1.6	Adjustments?	↓ER
Width to Depth Ratio	9.6	Rosgen Stream Type	G5c

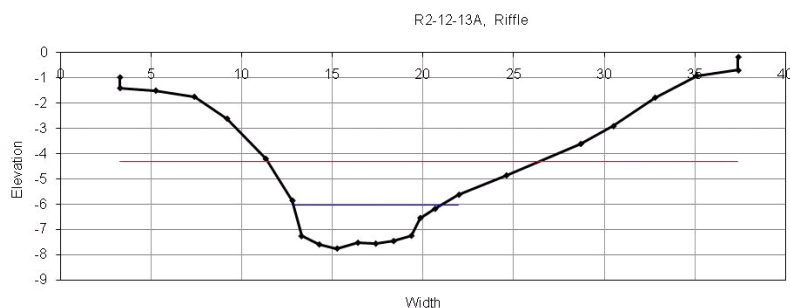
Rosgen Level II Classification Data

Drainage Area (mi ²)	0.58	Cross Sectional Area (ft ²)	10.0
Bankfull Width (ft)	8.2	Water Surface Slope (%)	0.73
Mean Bankfull Depth (ft)	1.2	Sinuosity	1.0
Floodprone Width (ft)	17.3	D50 (mm)	0.081
Entrenchment Ratio	2.1	Adjustments?	↑ER, Sin
Width to Depth Ratio	6.6	Rosgen Stream Type	E5

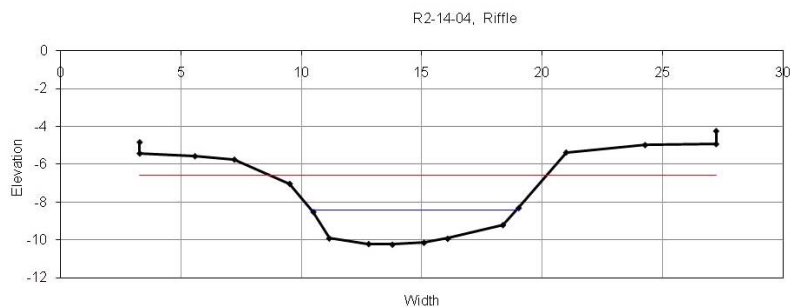
Geomorphic Assessments**Rosgen Level II Classification Data**

Drainage Area (mi ²)	0.26	Cross Sectional Area (ft ²)	11.8
Bankfull Width (ft)	8.4	Water Surface Slope (%)	0.55
Mean Bankfull Depth (ft)	1.4	Sinuosity	1.1
Floodprone Width (ft)	9.8	D50 (mm)	0.062
Entrenchment Ratio	1.2	Adjustments?	↑Sin
Width to Depth Ratio	6.0	Rosgen Stream Type	G6c

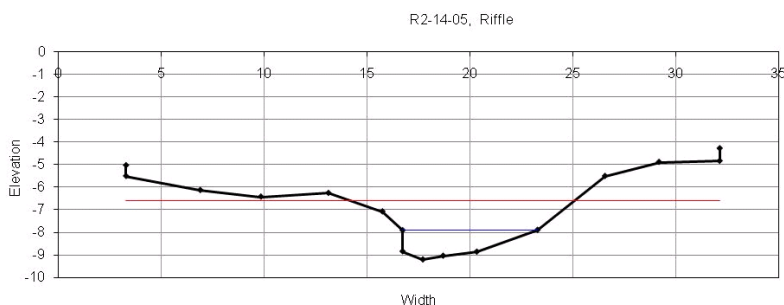
Geomorphic Assessments**Rosgen Level II Classification Data**

Drainage Area (mi ²)	0.26	Cross Sectional Area (ft ²)	5.4
Bankfull Width (ft)	6.5	Water Surface Slope (%)	0.61
Mean Bankfull Depth (ft)	0.8	Sinuosity	1.2
Floodprone Width (ft)	9.8	D50 (mm)	0.22
Entrenchment Ratio	1.5	Adjustments?	↓ER
Width to Depth Ratio	7.9	Rosgen Stream Type	G5c

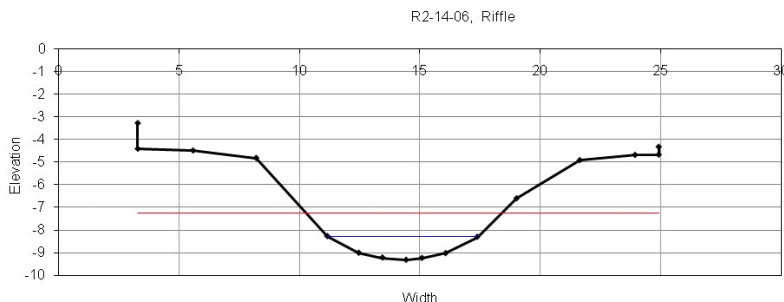
Geomorphic Assessments**Rosgen Level II Classification Data**

Drainage Area (mi ²)	0.24	Cross Sectional Area (ft ²)	4.2
Bankfull Width (ft)	6.2	Water Surface Slope (%)	0.98
Mean Bankfull Depth (ft)	0.7	Sinuosity	1.1
Floodprone Width (ft)	8.2	D50 (mm)	0.24
Entrenchment Ratio	1.3	Adjustments?	↑Sin
Width to Depth Ratio	9.1	Rosgen Stream Type	G5c

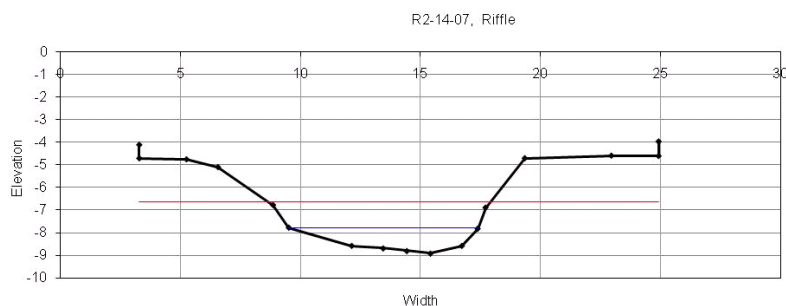
Geomorphic Assessments**Rosgen Level II Classification Data**

Drainage Area (mi ²)	0.21	Cross Sectional Area (ft ²)	5.8
Bankfull Width (ft)	7.9	Water Surface Slope (%)	0.98
Mean Bankfull Depth (ft)	0.7	Sinuosity	1.1
Floodprone Width (ft)	9.3	D50 (mm)	0.25
Entrenchment Ratio	1.2	Adjustments?	↑Sin
Width to Depth Ratio	10.7	Rosgen Stream Type	G5c

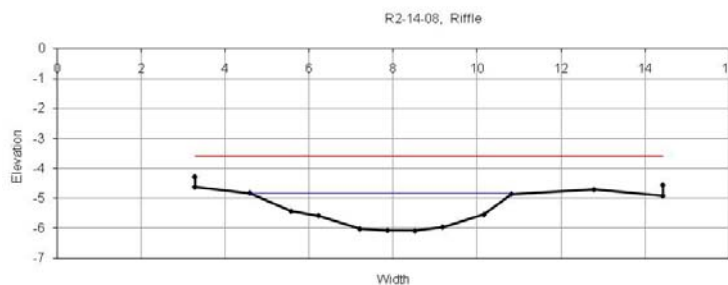
Geomorphic Assessments**Rosgen Level II Classification Data**

Drainage Area (mi ²)	0.6	Cross Sectional Area (ft ²)	5.2
Bankfull Width (ft)	6.2	Water Surface Slope (%)	0.42
Mean Bankfull Depth (ft)	0.8	Sinuosity	1.0
Floodprone Width (ft)	138	D50 (mm)	0.1
Entrenchment Ratio	22.2	Adjustments?	↑Sin
Width to Depth Ratio	7.4	Rosgen Stream Type	E5

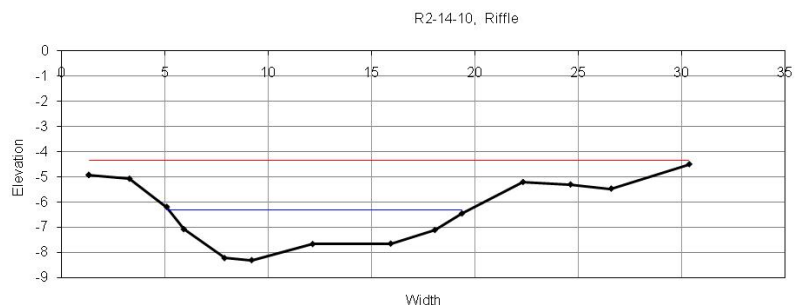
Geomorphic Assessments**Rosgen Level II Classification Data**

Drainage Area (mi ²)	2.2	Cross Sectional Area (ft ²)	18.2
Bankfull Width (ft)	14.1	Water Surface Slope (%)	0.38
Mean Bankfull Depth (ft)	2.0	Sinuosity	1.0
Floodprone Width (ft)	38	D50 (mm)	0.076
Entrenchment Ratio	2.7	Adjustments?	↑Sin
Width to Depth Ratio	11.0	Rosgen Stream Type	E5

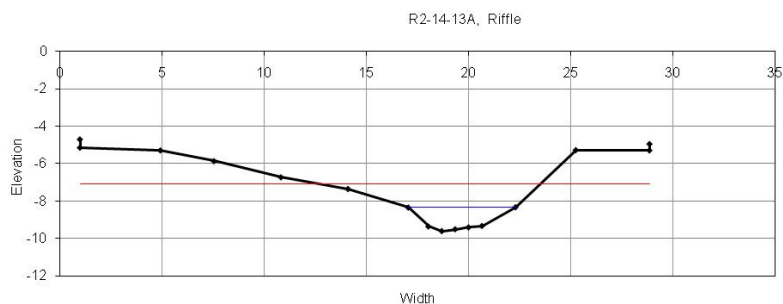
Geomorphic Assessments**Rosgen Level II Classification Data**

Drainage Area (mi ²)	0.18	Cross Sectional Area (ft ²)	4.3
Bankfull Width (ft)	5.2	Water Surface Slope (%)	0.74
Mean Bankfull Depth (ft)	0.8	Sinuosity	1.4
Floodprone Width (ft)	10.9	D50 (mm)	0.39
Entrenchment Ratio	2.1	Adjustments?	↑ER
Width to Depth Ratio	6.4	Rosgen Stream Type	E5

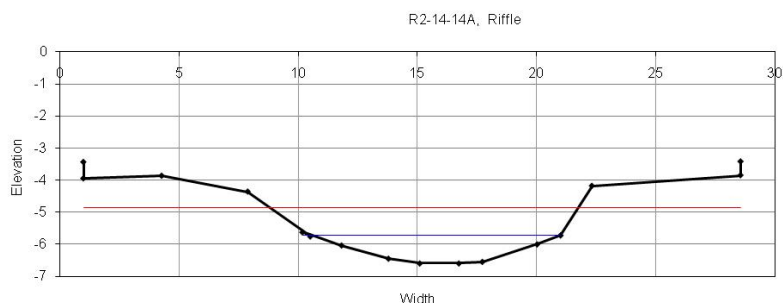
Geomorphic Assessments**Rosgen Level II Classification Data**

Drainage Area (mi ²)	0.81	Cross Sectional Area (ft ²)	5.9
Bankfull Width (ft)	10.4	Water Surface Slope (%)	0.15
Mean Bankfull Depth (ft)	0.6	Sinuosity	1.1
Floodprone Width (ft)	13	D50 (mm)	0.17
Entrenchment Ratio	1.3	Adjustments?	↑Sin
Width to Depth Ratio	18	Rosgen Stream Type	F5

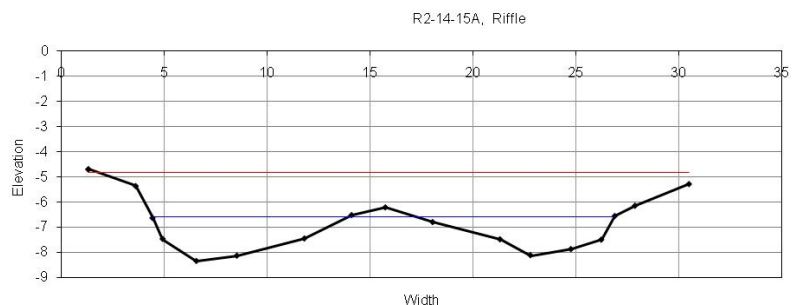
Drainage Area (mi ²)	2.2	Cross Sectional Area (ft ²)	19.0
Bankfull Width (ft)	19.2	Water Surface Slope (%)	0.27
Mean Bankfull Depth (ft)	1.0	Sinuosity	1.0
Floodprone Width (ft)	50	D50 (mm)	0.13
Entrenchment Ratio	2.6	Adjustments?	↑Sin
Width to Depth Ratio	19.3	Rosgen Stream Type	C5

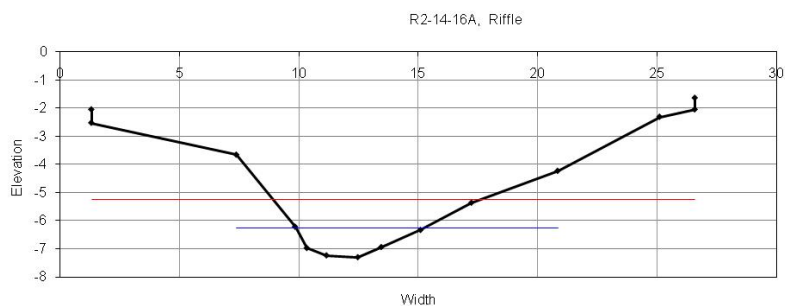
Drainage Area (mi ²)	0.09	Cross Sectional Area (ft ²)	3.6
Bankfull Width (ft)	5.4	Water Surface Slope (%)	1.03
Mean Bankfull Depth (ft)	0.7	Sinuosity	1.23
Floodprone Width (ft)	10.8	D50 (mm)	0.23
Entrenchment Ratio	2.0	Adjustments?	↑WD
Width to Depth Ratio	8.0	Rosgen Stream Type	B5c

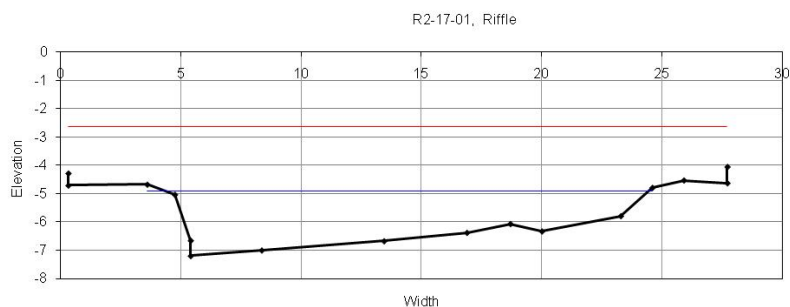
Drainage Area (mi ²)	2.9	Cross Sectional Area (ft ²)	30.6
Bankfull Width (ft)	20	Water Surface Slope (%)	0.62
Mean Bankfull Depth (ft)	1.5	Sinuosity	1.1
Floodprone Width (ft)	459	D50 (mm)	0.4
Entrenchment Ratio	22.9	Adjustments?	↑Sin
Width to Depth Ratio	13.1	Rosgen Stream Type	C5

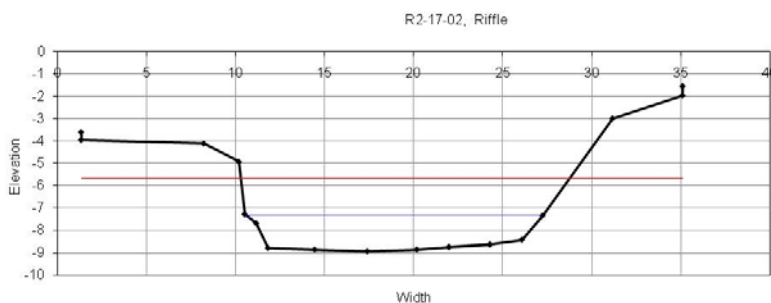
Drainage Area (mi ²)	1.04	Cross Sectional Area (ft ²)	22.5
Bankfull Width (ft)	16.7	Water Surface Slope (%)	0.65
Mean Bankfull Depth (ft)	1.3	Sinuosity	1.0
Floodprone Width (ft)	20.2	D50 (mm)	11
Entrenchment Ratio	1.2	Adjustments?	↑Sin
Width to Depth Ratio	12.4	Rosgen Stream Type	F4

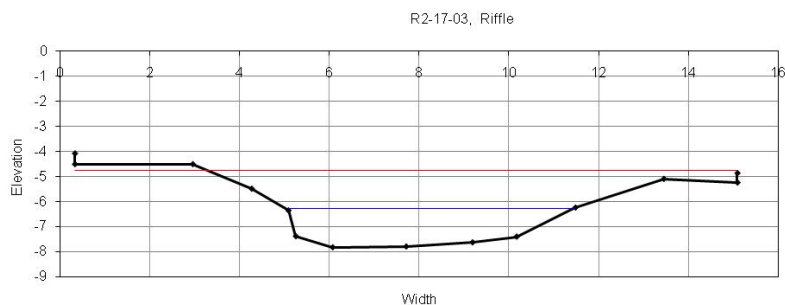
Drainage Area (mi ²)	0.54	Cross Sectional Area (ft ²)	7.7
Bankfull Width (ft)	6.3	Water Surface Slope (%)	0.66
Mean Bankfull Depth (ft)	1.2	Sinuosity	1.0
Floodprone Width (ft)	26	D50 (mm)	0.6
Entrenchment Ratio	4.1	Adjustments?	↑Sin
Width to Depth Ratio	5.2	Rosgen Stream Type	E5

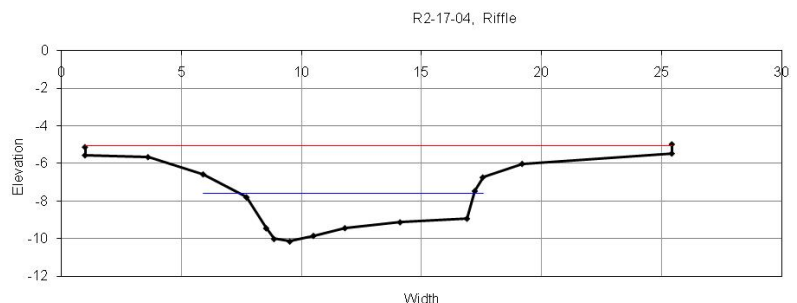
Drainage Area (mi ²)	0.66	Cross Sectional Area (ft ²)	16.1
Bankfull Width (ft)	9.7	Water Surface Slope (%)	0.37
Mean Bankfull Depth (ft)	1.7	Sinuosity	1.3
Floodprone Width (ft)	112	D50 (mm)	2.6
Entrenchment Ratio	11.5	Adjustments?	↑Sin
Width to Depth Ratio	5.9	Rosgen Stream Type	E4

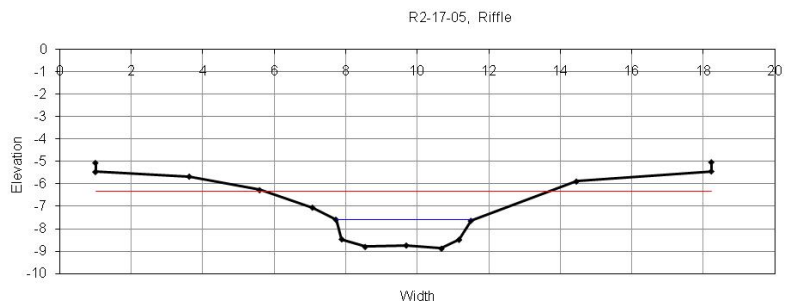
Drainage Area (mi ²)	0.13	Cross Sectional Area (ft ²)	3.9
Bankfull Width (ft)	3.8	Water Surface Slope (%)	1.4
Mean Bankfull Depth (ft)	1.0	Sinuosity	1.4
Floodprone Width (ft)	8	D50 (mm)	0.19
Entrenchment Ratio	2.1	Adjustments?	↑Sin, ER
Width to Depth Ratio	3.6	Rosgen Stream Type	E5

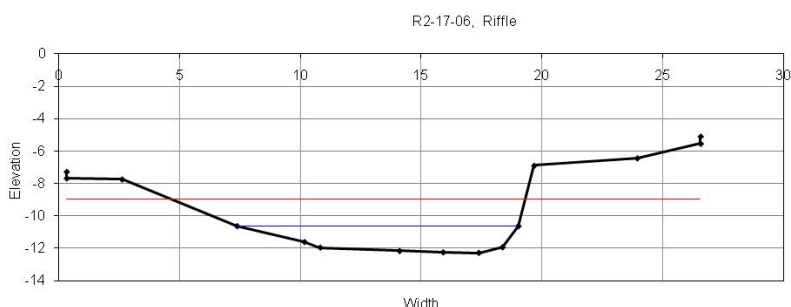
Drainage Area (mi ²)	0.92	Cross Sectional Area (ft ²)	14
Bankfull Width (ft)	11.6	Water Surface Slope (%)	0.4
Mean Bankfull Depth (ft)	1.2	Sinuosity	1.0
Floodprone Width (ft)	16.1	D50 (mm)	4.7
Entrenchment Ratio	1.4	Adjustments?	↑Sin
Width to Depth Ratio	9.7	Rosen Stream Type	G4

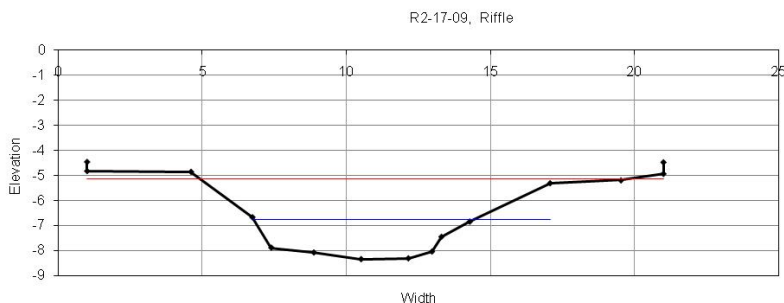
Drainage Area (mi ²)	0.48	Cross Sectional Area (ft ²)	9.1
Bankfull Width (ft)	7.7	Water Surface Slope (%)	0.46
Mean Bankfull Depth (ft)	1.2	Sinuosity	1.4*
Floodprone Width (ft)	14.8	D50 (mm)	0.47
Entrenchment Ratio	1.9	Adjustments?	↑ER, Sin
Width to Depth Ratio	6.5	Rosgen Stream Type	E5

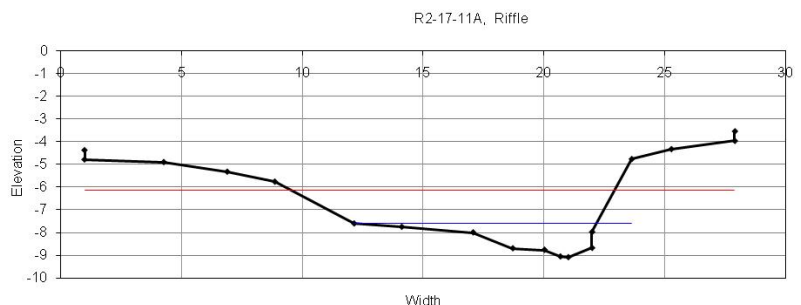
Drainage Area (mi ²)	0.63	Cross Sectional Area (ft ²)	6.3
Bankfull Width (ft)	10.0	Water Surface Slope (%)	0.79
Mean Bankfull Depth (ft)	0.6	Sinuosity	1.2
Floodprone Width (ft)	12.4	D50 (mm)	11
Entrenchment Ratio	1.2	Adjustments?	None
Width to Depth Ratio	16	Rosgen Stream Type	F4

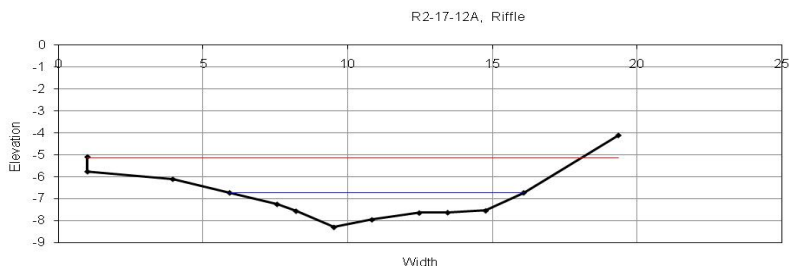
Not classified due to concrete lining of right bank over entire assessment reach.

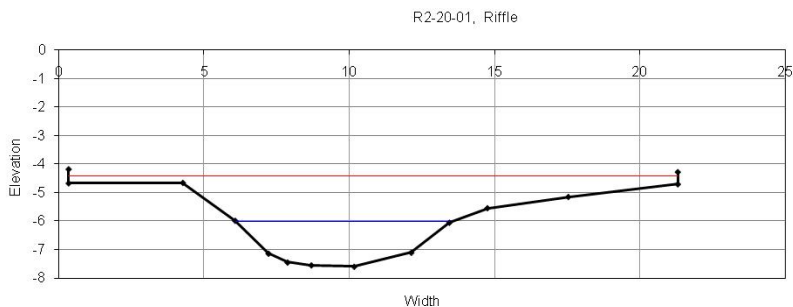
Drainage Area (mi ²)	0.28	Cross Sectional Area (ft ²)	8.4
Bankfull Width (ft)	7.4	Water Surface Slope (%)	0.52
Mean Bankfull Depth (ft)	1.1	Sinuosity	1.2
Floodprone Width (ft)	259	D50 (mm)	0.16
Entrenchment Ratio	35.2	Adjustments?	↑Sin
Width to Depth Ratio	6.4	Rosgen Stream Type	E5

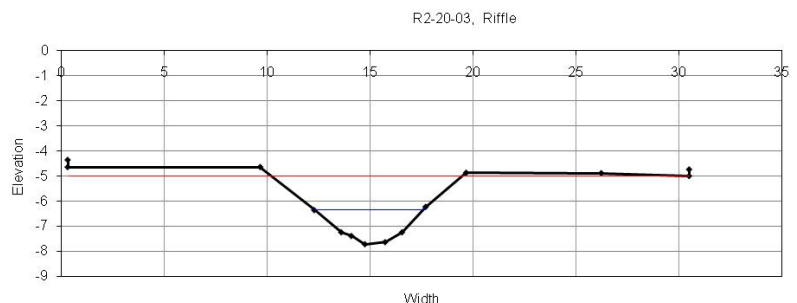
Geomorphic Assessments**Rosgen Level II Classification Data**

Drainage Area (mi ²)	0.18	Cross Sectional Area (ft ²)	4.5
Bankfull Width (ft)	5.3	Water Surface Slope (%)	1.5
Mean Bankfull Depth (ft)	0.9	Sinuosity	1.1
Floodprone Width (ft)	9.5	D50 (mm)	0.062
Entrenchment Ratio	1.8	Adjustments?	↓ER
Width to Depth Ratio	6.2	Rosgen Stream Type	G6c

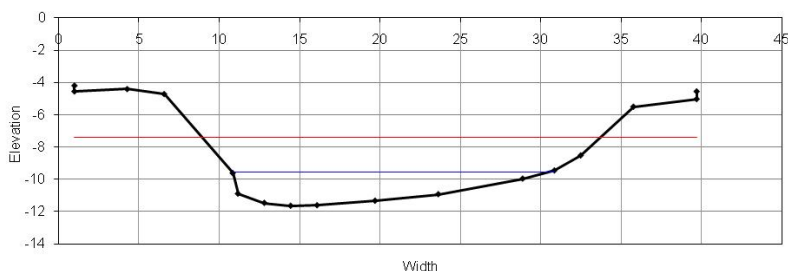
R2-20-04, Riffle

Drainage Area (mi ²)	5.7	Cross Sectional Area (ft ²)	28.1
Bankfull Width (ft)	19.7	Water Surface Slope (%)	0.13
Mean Bankfull Depth (ft)	1.4	Sinuosity	1.1
Floodprone Width (ft)	23	D50 (mm)	9.6
Entrenchment Ratio	1.2	Adjustments?	↑Sin
Width to Depth Ratio	13.8	Rosen Stream Type	F4

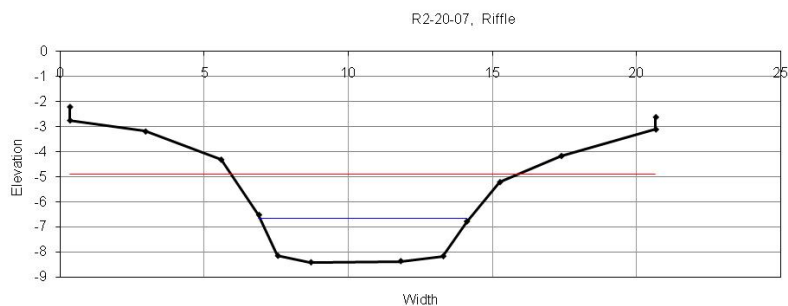
Geomorphic Assessments**Rosgen Level II Classification Data**

Drainage Area (mi ²)	0.26	Cross Sectional Area (ft ²)	10.9
Bankfull Width (ft)	7.2	Water Surface Slope (%)	0.87
Mean Bankfull Depth (ft)	1.5	Sinuosity	1.0
Floodprone Width (ft)	10	D50 (mm)	0.21
Entrenchment Ratio	1.4	Adjustments?	↑Sin
Width to Depth Ratio	4.7	Rosgen Stream Type	G5

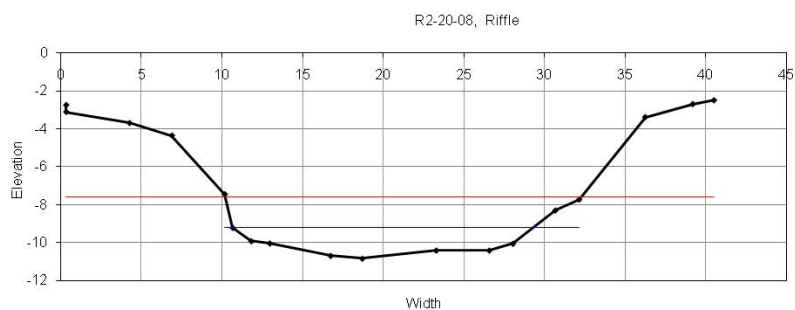
Geomorphic Assessments**Rosgen Level II Classification Data**

Drainage Area (mi ²)	3.9	Cross Sectional Area (ft ²)	21.2
Bankfull Width (ft)	18.6	Water Surface Slope (%)	0.25
Mean Bankfull Depth (ft)	1.1	Sinuosity	1.0
Floodprone Width (ft)	35	D50 (mm)	0.17
Entrenchment Ratio	1.9	Adjustments?	↑Sin
Width to Depth Ratio	16.4	Rosgen Stream Type	B5c

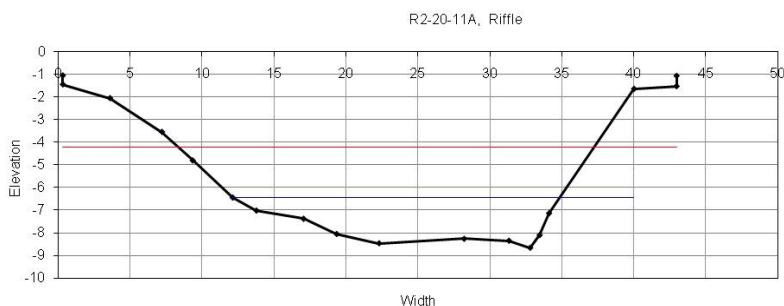
Geomorphic Assessments**Rosgen Level II Classification Data**

Drainage Area (mi ²)	5.2	Cross Sectional Area (ft ²)	33.8
Bankfull Width (ft)	22.7	Water Surface Slope (%)	0.57
Mean Bankfull Depth (ft)	1.5	Sinuosity	1.0
Floodprone Width (ft)	29	D50 (mm)	0.48
Entrenchment Ratio	1.3	Adjustments?	↑Sin
Width to Depth Ratio	15.3	Rosgen Stream Type	F5

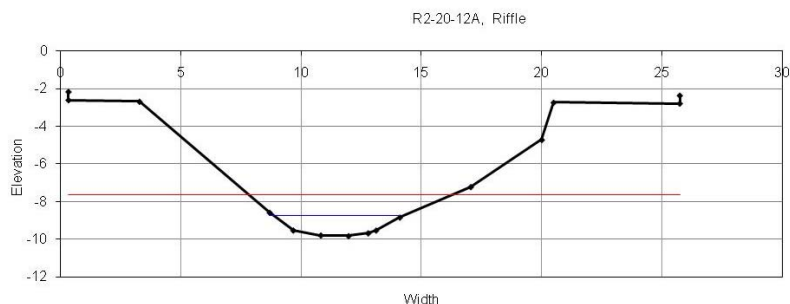
Geomorphic Assessments**Rosgen Level II Classification Data**

Drainage Area (mi ²)	0.12	Cross Sectional Area (ft ²)	4.2
Bankfull Width (ft)	5.3	Water Surface Slope (%)	0.51
Mean Bankfull Depth (ft)	0.8	Sinuosity	1.0
Floodprone Width (ft)	6.2	D50 (mm)	0.13
Entrenchment Ratio	1.2	Adjustments?	↑Sin
Width to Depth Ratio	6.5	Rosgen Stream Type	G5c
