Aquatic Biological Assessment of the Watersheds of Anne Arundel County, Maryland: 2009

August 2011

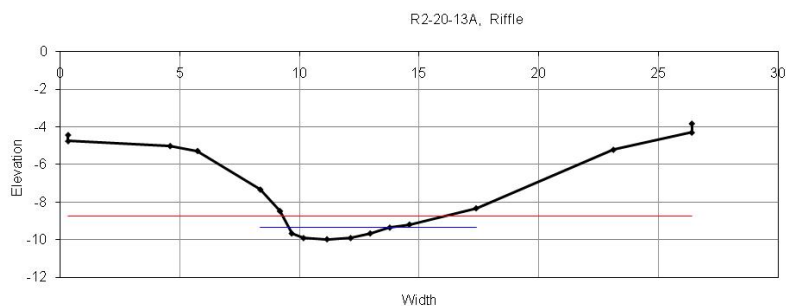
Geomorphic Assessments**Rosgen Level II Classification Data**

Drainage Area (mi ²)	0.03	Cross Sectional Area (ft ²)	1.9
Bankfull Width (ft)	4.2	Water Surface Slope (%)	2.4
Mean Bankfull Depth (ft)	0.4	Sinuosity	1.1
Floodprone Width (ft)	6.8	D50 (mm)	0.21
Entrenchment Ratio	1.6	Adjustments?	↓ER, ↑Sin
Width to Depth Ratio	9.5	Rosgen Stream Type	G5

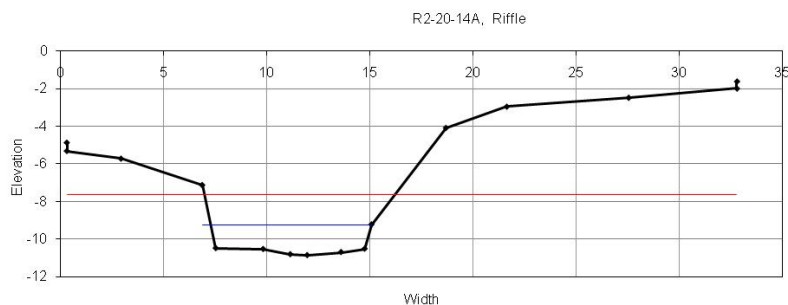
Geomorphic Assessments**Rosen Level II Classification Data**

Drainage Area (mi ²)	0.25	Cross Sectional Area (ft ²)	10.6
Bankfull Width (ft)	7.8	Water Surface Slope (%)	1.2
Mean Bankfull Depth (ft)	1.4	Sinuosity	1.3
Floodprone Width (ft)	9.3	D50 (mm)	0.23
Entrenchment Ratio	1.2	Adjustments?	None
Width to Depth Ratio	5.7	Rosen Stream Type	G5c

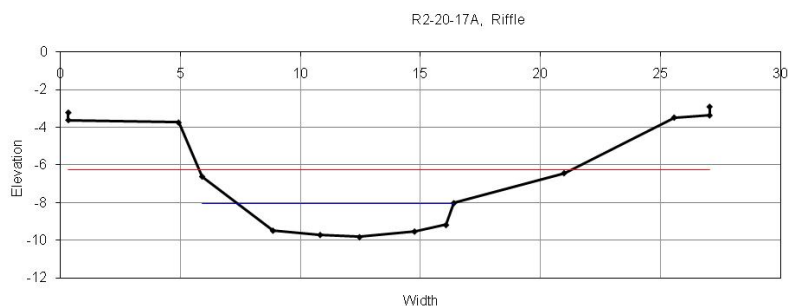
Geomorphic Assessments**Rosgen Level II Classification Data**

Drainage Area (mi ²)	0.31	Cross Sectional Area (ft ²)	12.7
Bankfull Width (ft)	9.0	Water Surface Slope (%)	0.96
Mean Bankfull Depth (ft)	1.4	Sinuosity	1.2
Floodprone Width (ft)	15	D50 (mm)	0.062
Entrenchment Ratio	1.7	Adjustments?	↑W/D
Width to Depth Ratio	6.4	Rosgen Stream Type	B6c
