**STUDY OF
NON-POINT SOURCE THERMAL POLLUTION
IN
JABEZ BRANCH**

**KENNETH YETMAN
POWER PLANT AND ENVIRONMENTAL REVIEW DIVISION
OF THE
TIDEWATER ADMINISTRATION
MARYLAND DEPARTMENT OF NATURAL RESOURCES**

February, 1991

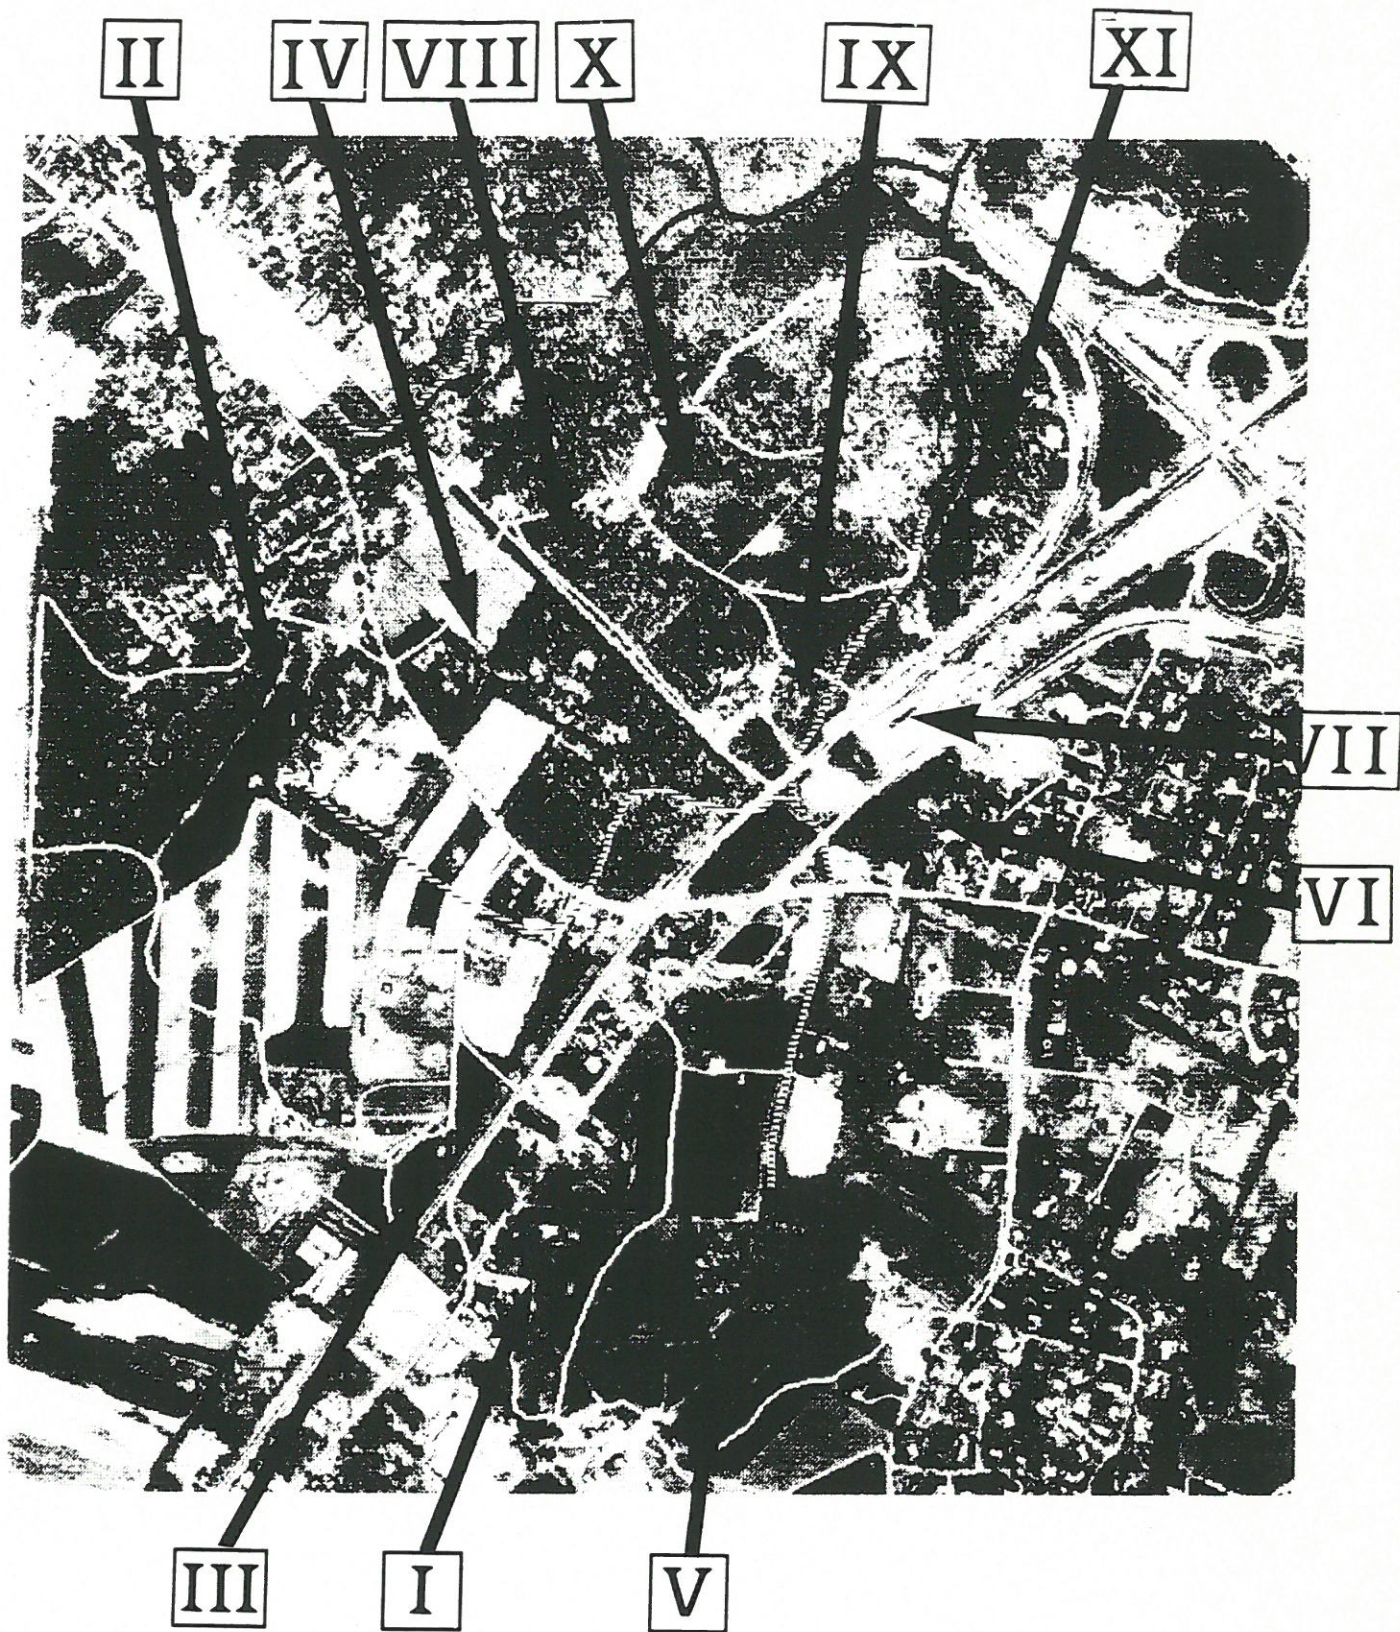
Figure 3. MIPS photomap showing the 11 subdrainage areas in the upper left fork of Jabez Branch.

At the beginning of the study, the upper watershed of the left fork of Jabez Branch was divided into 11 subdrainage basins. A photomap showing the subdrainage areas is presented in Figure 3. Once the drainage patterns in the upper watershed of the left fork were known, sampling stations were established at points where the runoff from one or more subdrainage areas concentrated. In most cases, the temperature probes were located in intermittent channels either above or below road crossings. The probes were suspended on a stick just above the bottom of the intermittent channel and measurements were taken at 5 minute intervals using Ryan Tempmentors. Due to equipment and time constraints, monitoring stations were not established in all 11 subdrainage basins (Table 2). Priority in establishing and maintaining stations was given to sites that drained an area dominated by a single land use type.

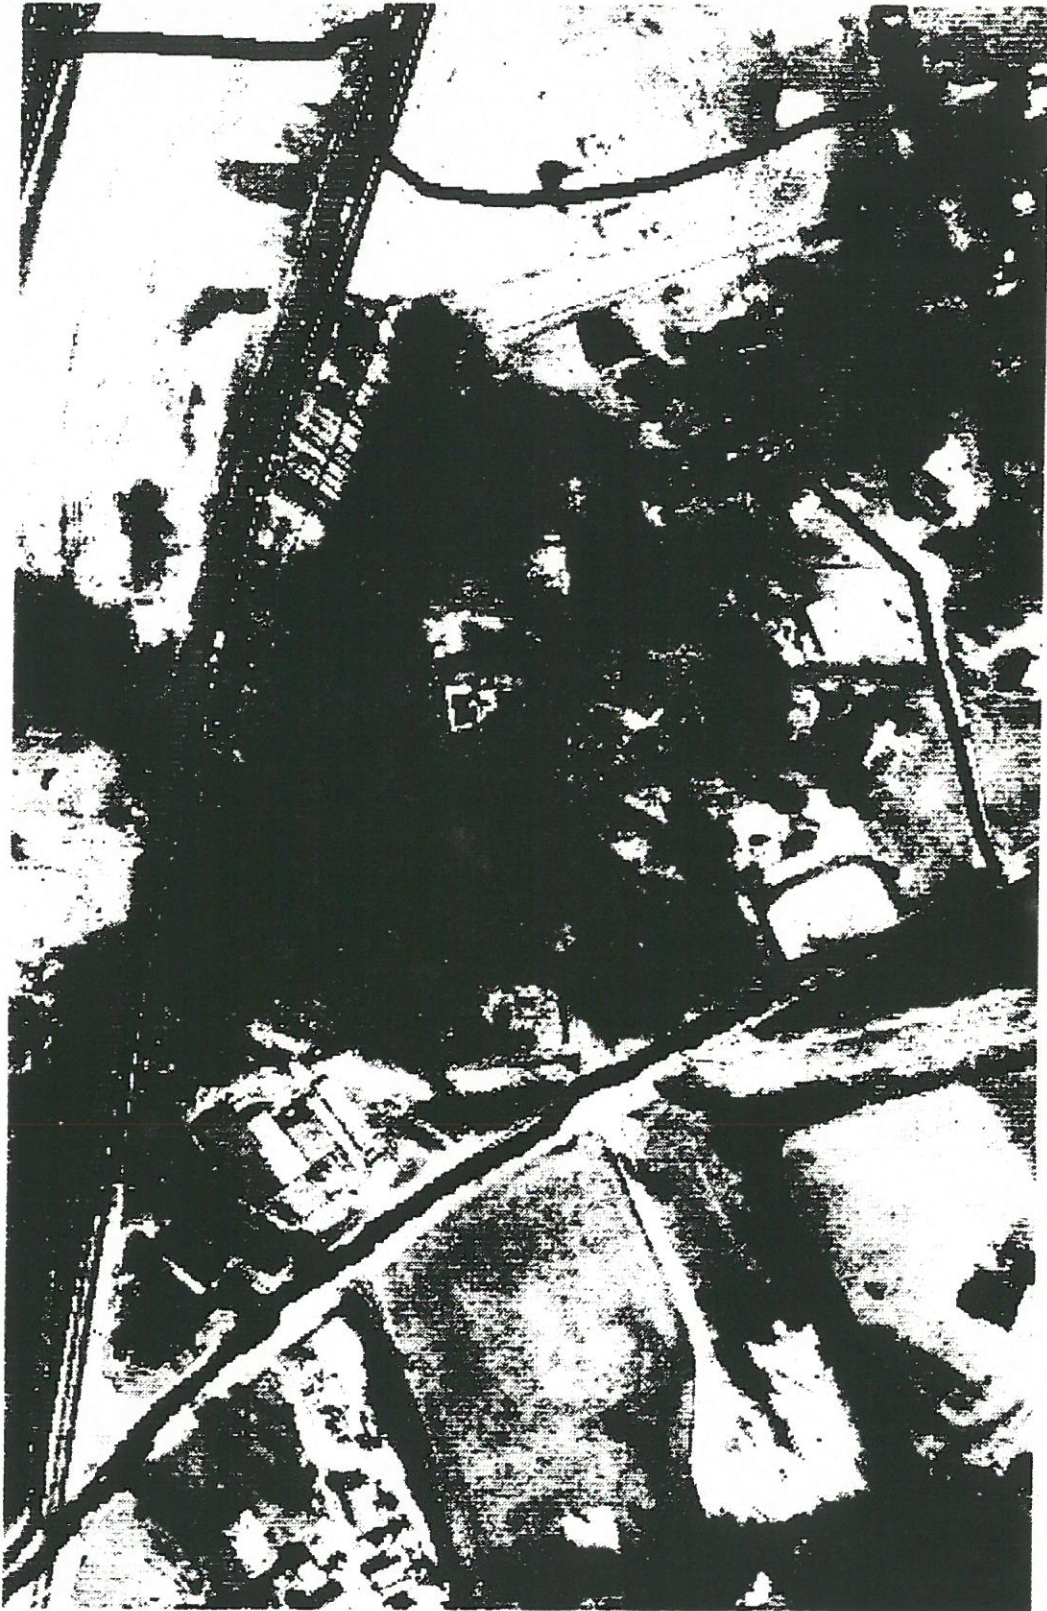
Figure 4. Enlargement of subdrainage area VI. The MIPS enlargement was produce from a low altitude aerial photograph taken on February 13, 1990.

Land use in the upper watershed of the left fork of Jabez Branch was determined from photographs taken during a low altitude aerial survey done on February 13, 1990. Photographs were scanned into the Department's "Map and Image Processing System" (MIPS). The MIPS raster images were then registered and a second registered vector file of the 11 subdrainage basins was overlaid onto the original raster images. Land use in each subdrainage basin was then determined using the planimeter function in MIPS. In addition to estimating the land use areas, the MIPS planimeter was used to estimate the total amount of impervious area in each basin. A MIPS photomap showing one of the delineated subdrainage basins is presented in Figure 4.

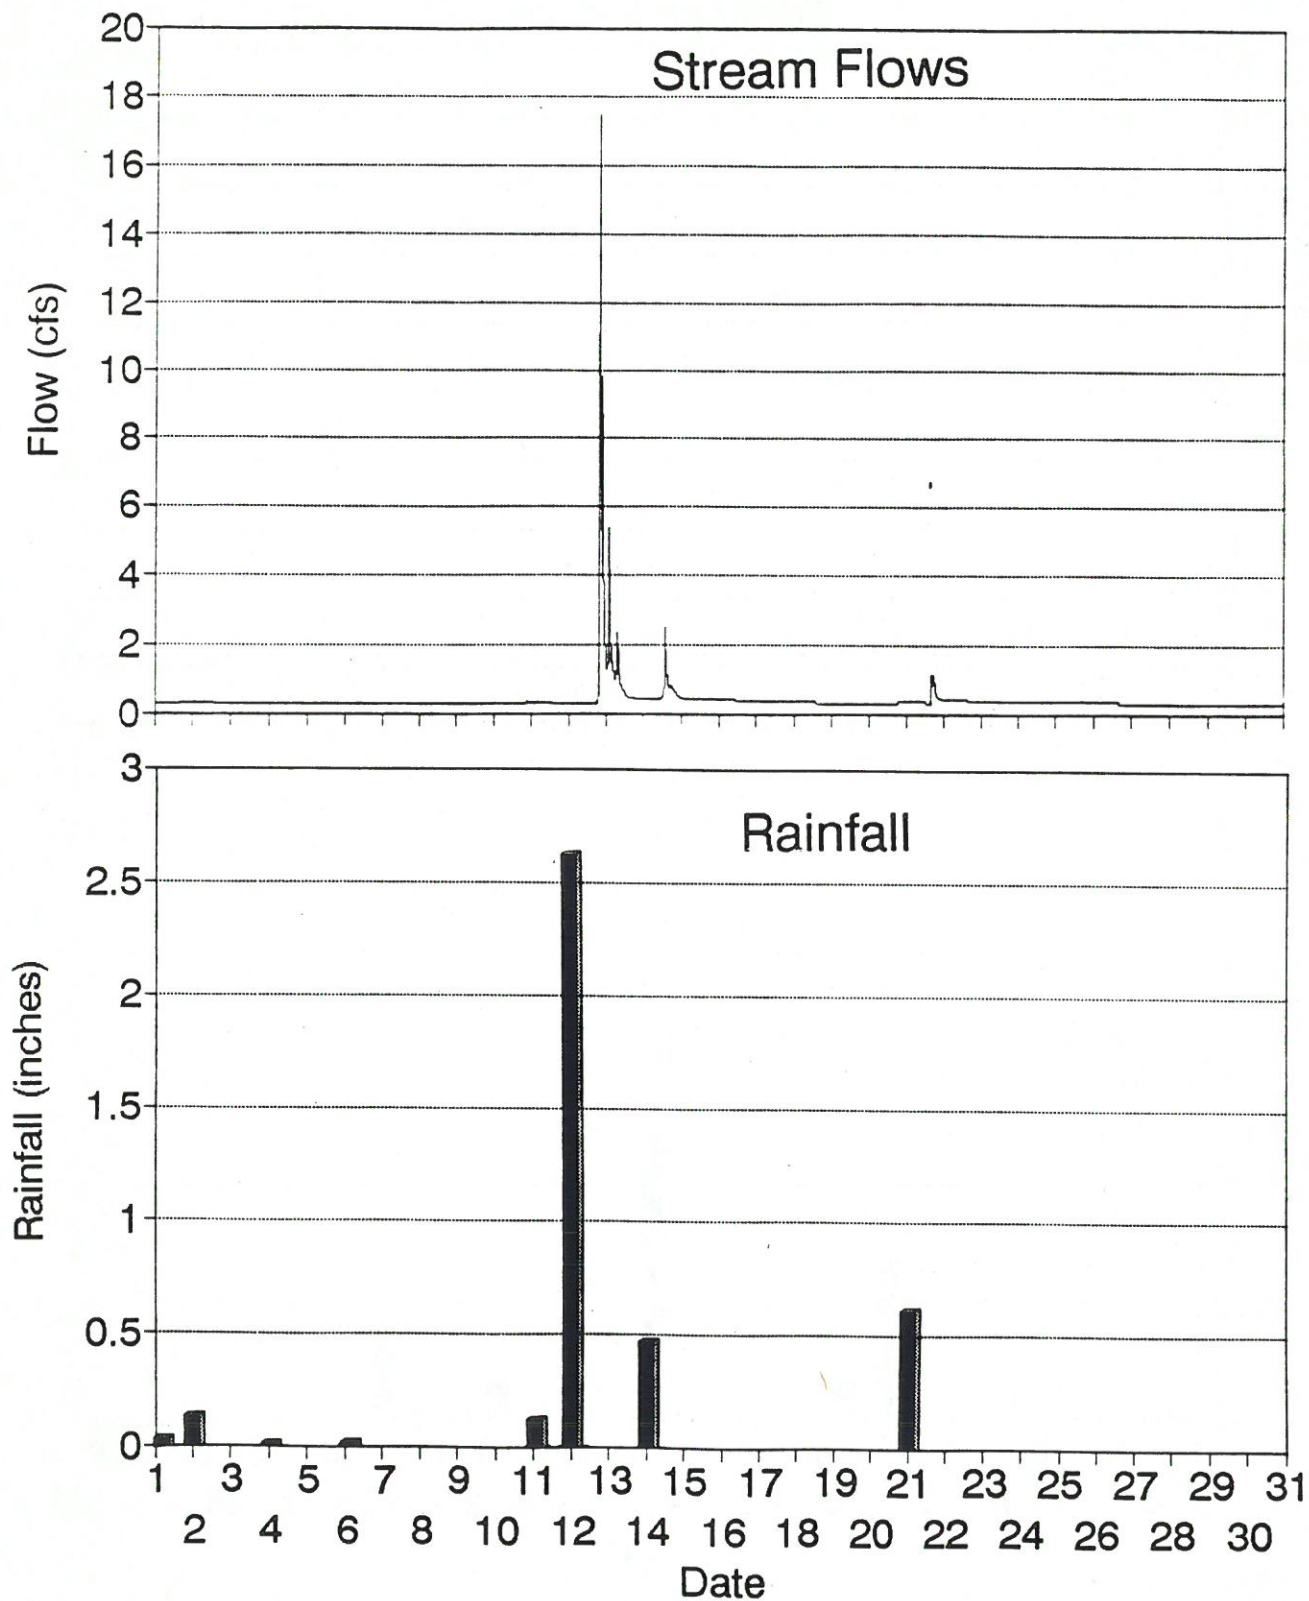
Figure 7. Graphs of stream flow (top) at Station L001 on the left fork of Jabez Branch and total daily rainfall (bottom) at the Lake Median weather station during July, 1990.

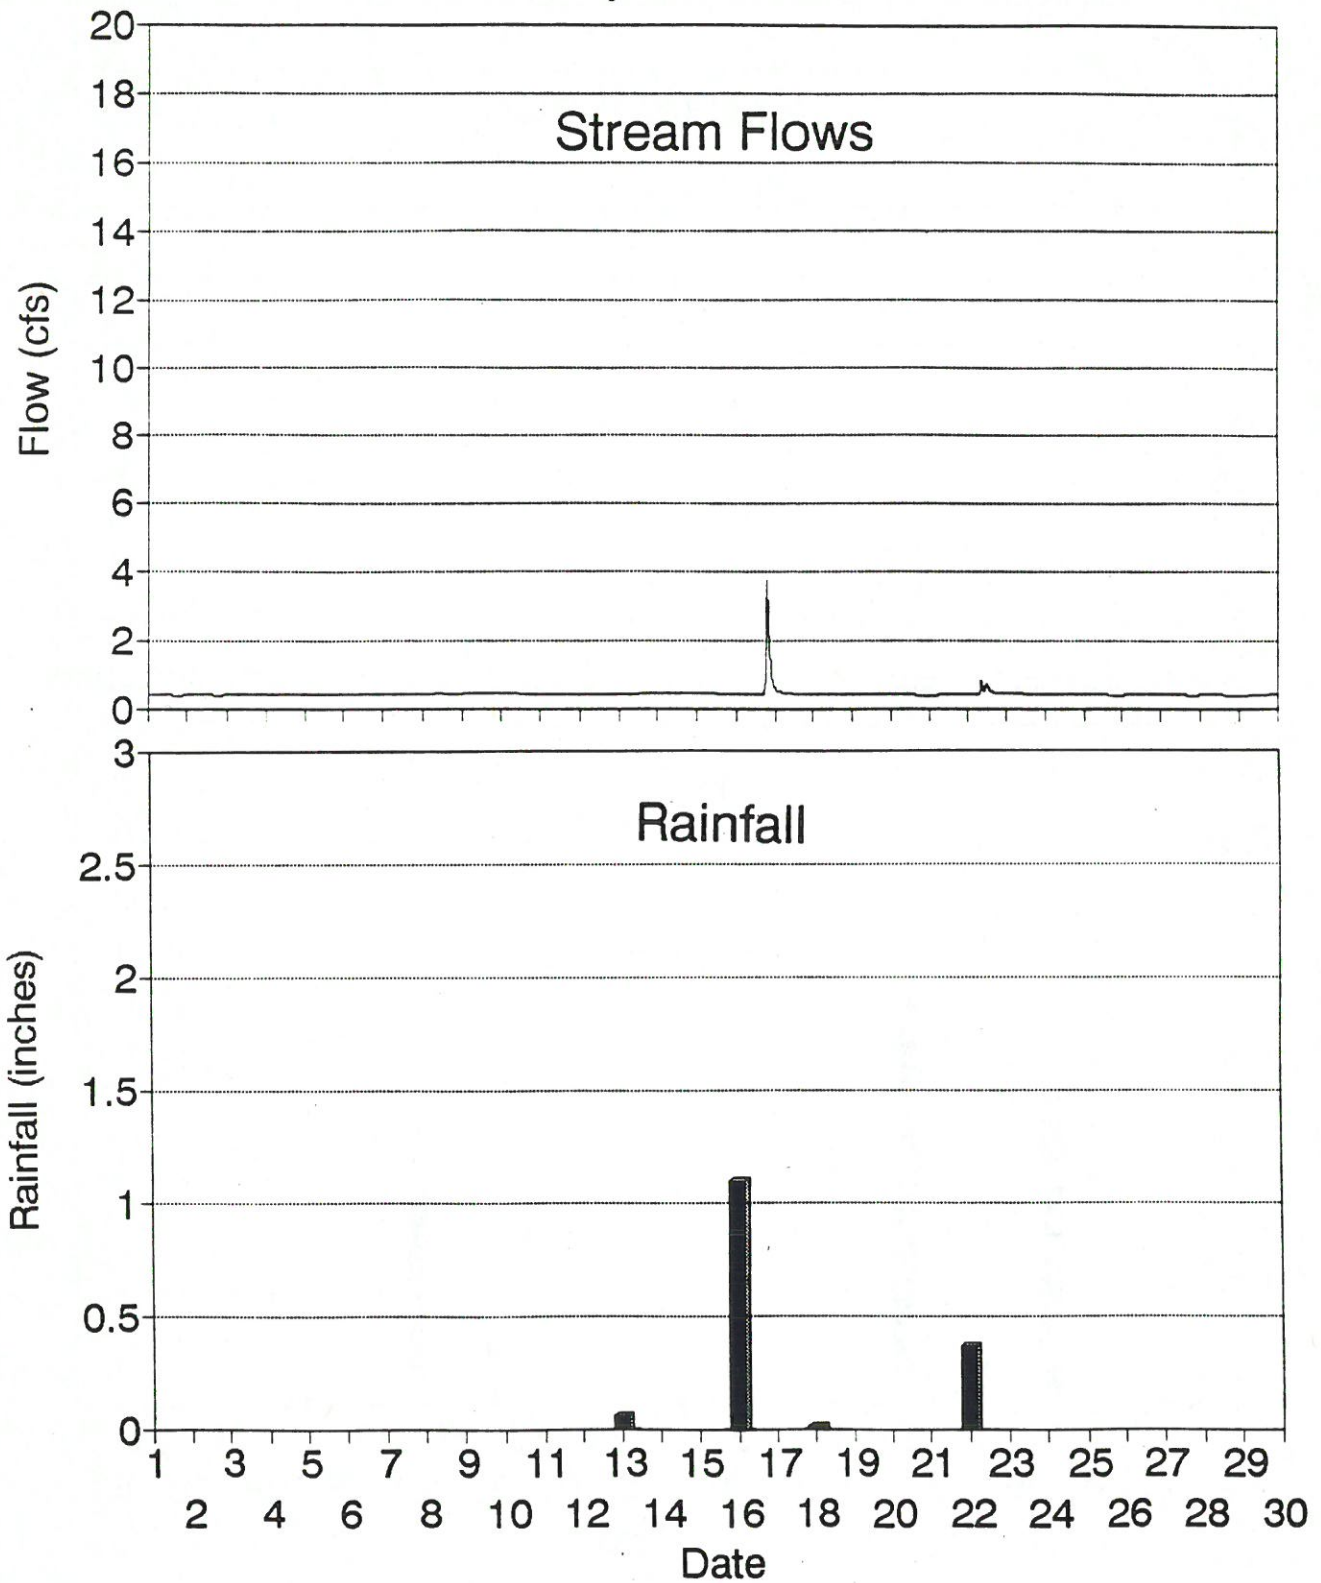
Figure 9. Graphs of stream flow (top) at Station L001 on the left fork of Jabez Branch and total daily rainfall (bottom) at the Lake Median weather station during September, 1990.

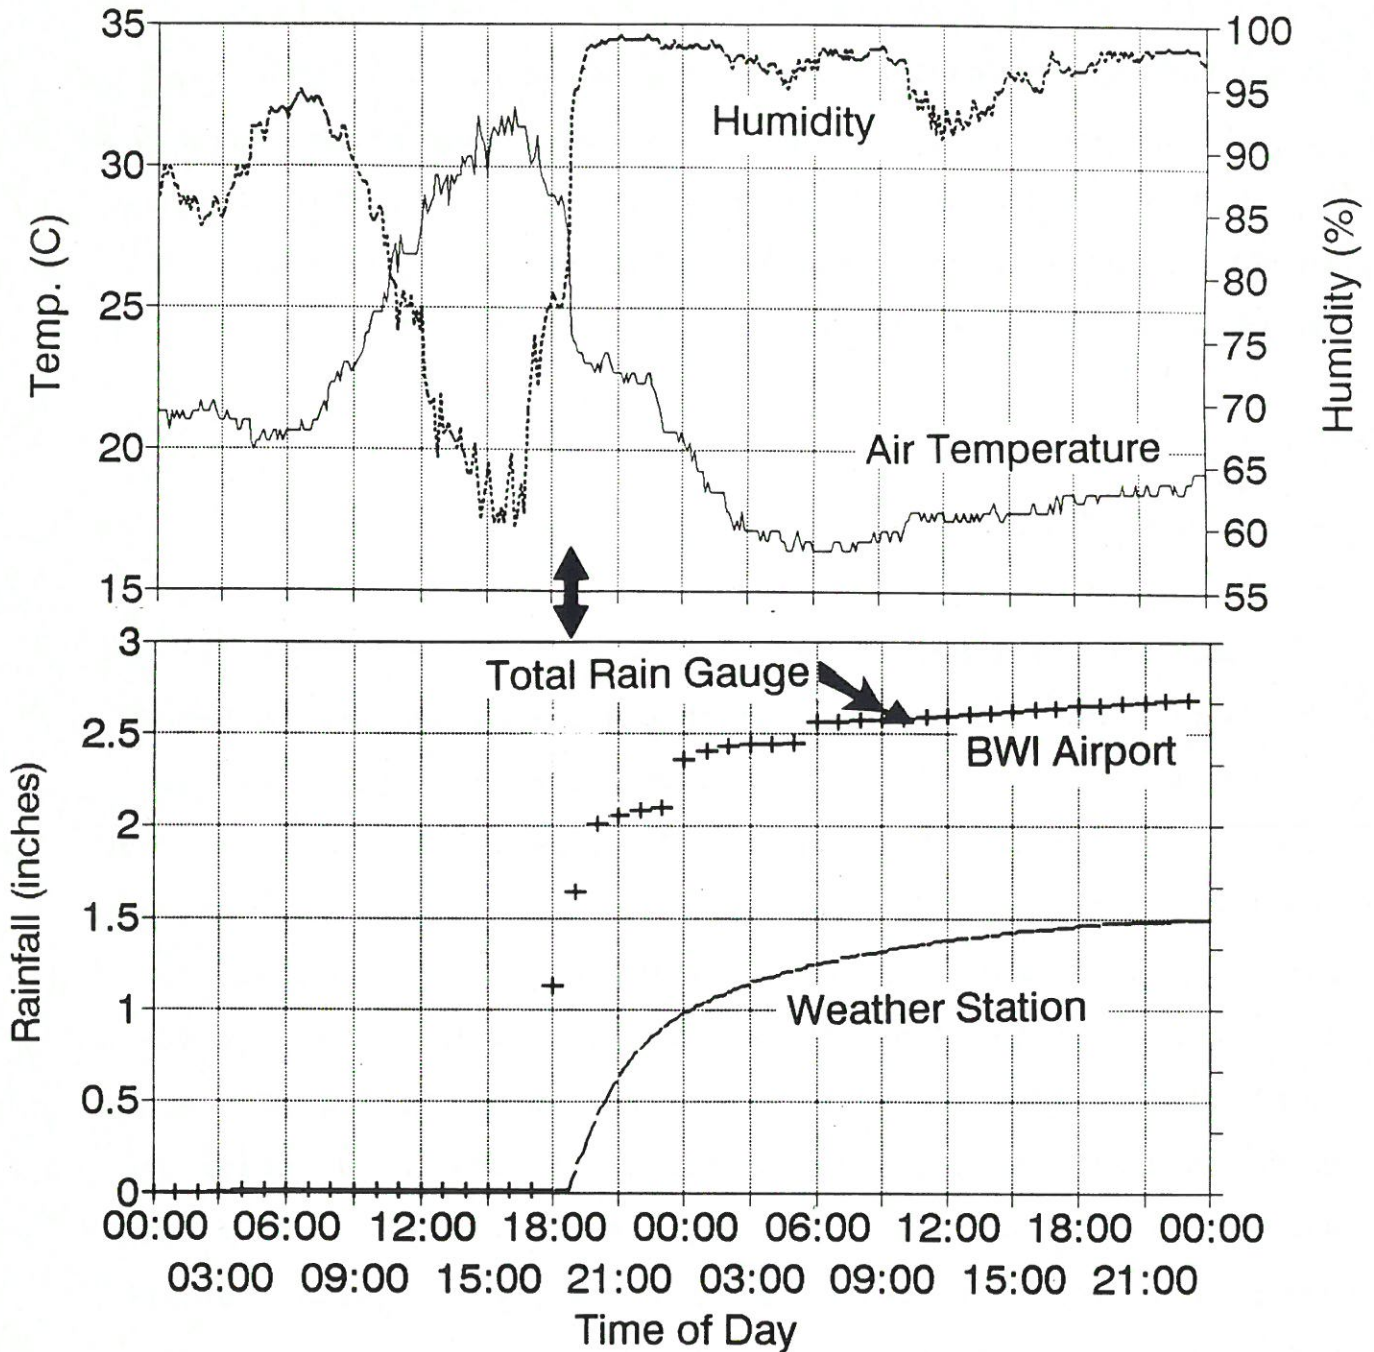
Figure 10. Graphs showing air temperature (top), humidity (top) and rainfall (bottom) at Lake Median weather station and BWI airport on July 12 and 13, 1990. Arrows indicates beginning of rain event.

Other measurements from the Jabez Branch weather station are shown in Figure 10. Air temperatures on July 12 reached a high

of 31.7°C (89.1°F) at 15:41 in the afternoon and cooled to around 29°C (84.2°F) before it began to rain. At the start of the rain event, air temperatures dropped to 23°C (73.4°F). No monitoring devices were established in 1990 to measure the temperature of the rain water. It is believed, however, that during the rain event the temperature of the rain water will be approximately the same as the recorded air temperature. Additional measurements will be needed to verify this.

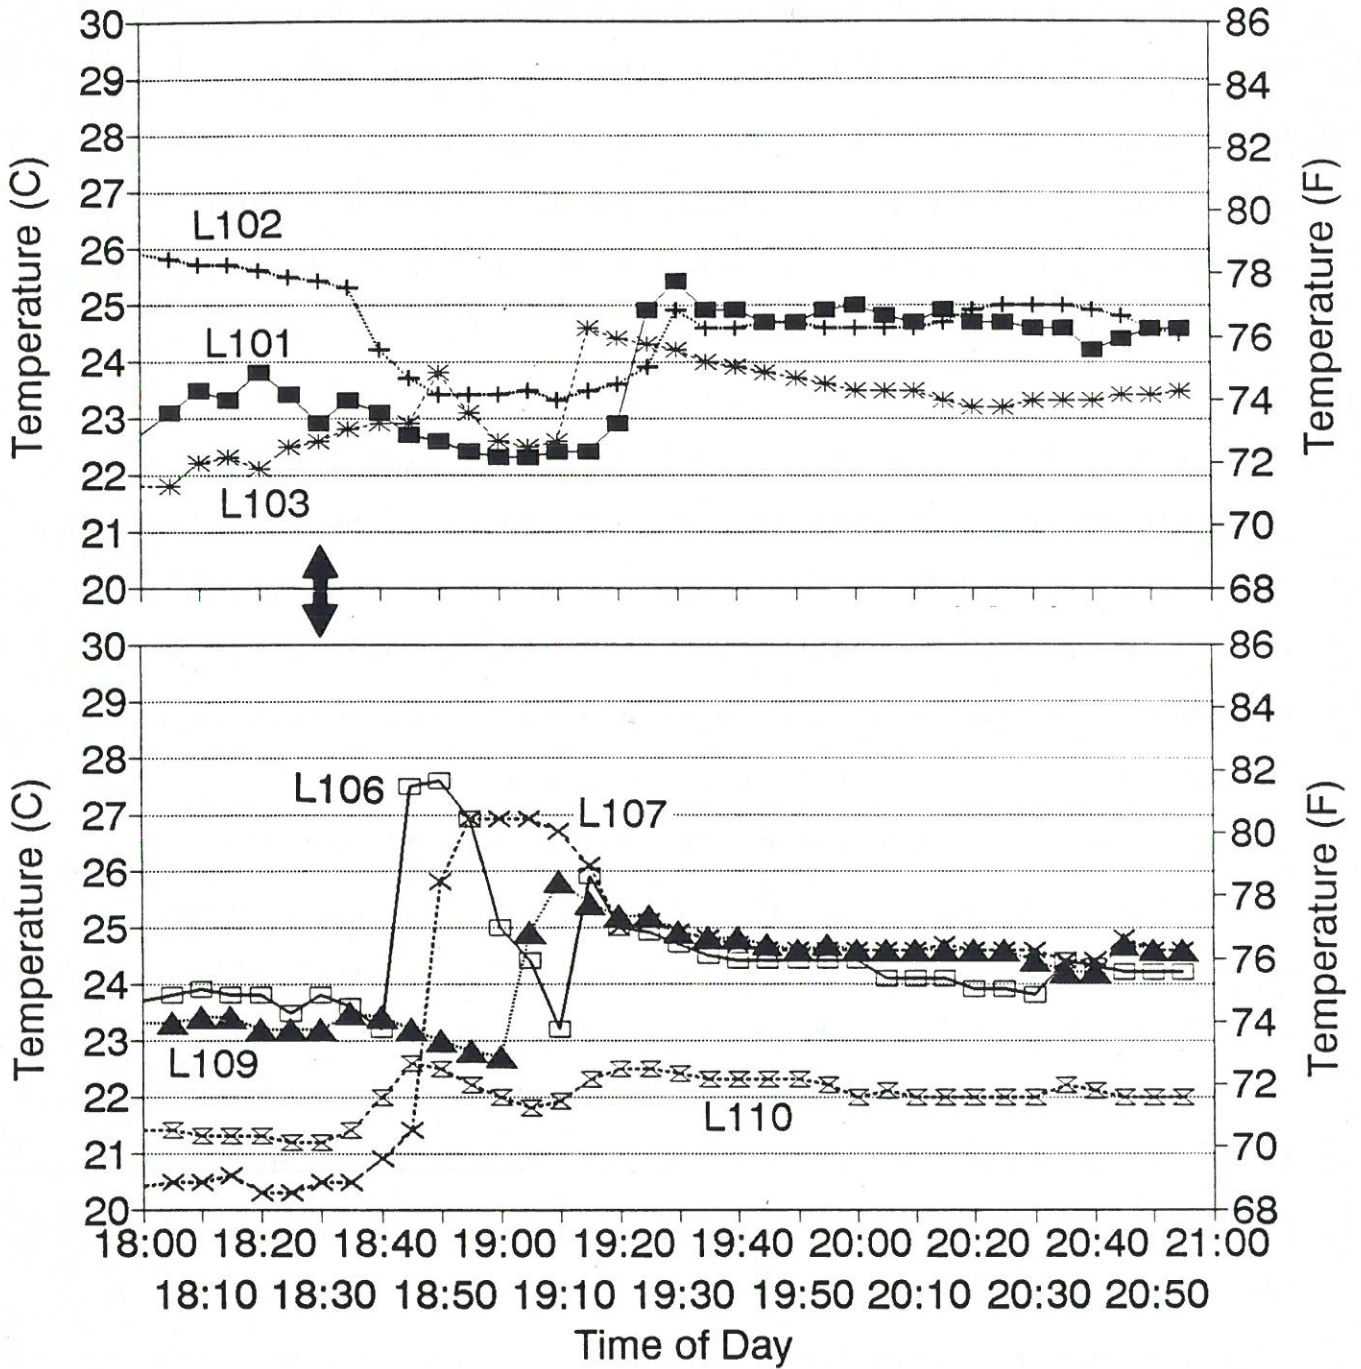
Figure 13. Temperature measurements from intermittent drainage channels in the upper left fork of Jabez Branch on July 12, 1990 between 18:00 and 21:00. Arrows indicate beginning of rain event.

Temperature monitoring results in the upper intermittent channels of the left fork of Jabez Branch are shown in Figure 13. The arrow on the graphs indicates the start of the July 12 rain event. Prior to the beginning of the rain event, the temperature recorders are measuring air temperatures in the intermittent stream channels. Temperature recorders at Stations L101, L102 and L103 monitored the runoff primarily from agriculture land. Results indicated that at the beginning of the rain event, the temperature of the runoff at these stations, as initially around 23°C (73.4°F). As the storm progressed temperature measurements at these stations rose to 25°C (77°F). Stations L106 and L107, on the other hand, receive runoff from the more urbanized sections of the watershed (Table 3). The temperature monitors at these stations showed that the runoff from the more urbanized sections was initially above 27°C (80.6°F) and then dropped to just below 25°C (77°F). In contrast to these stations in the upper watershed, Station L110 measured the temperature of runoff from a 96 % forested drainage basin. The temperature of the runoff from the forested section of the left fork remained fairly constant at around 22°C (71.6°F).

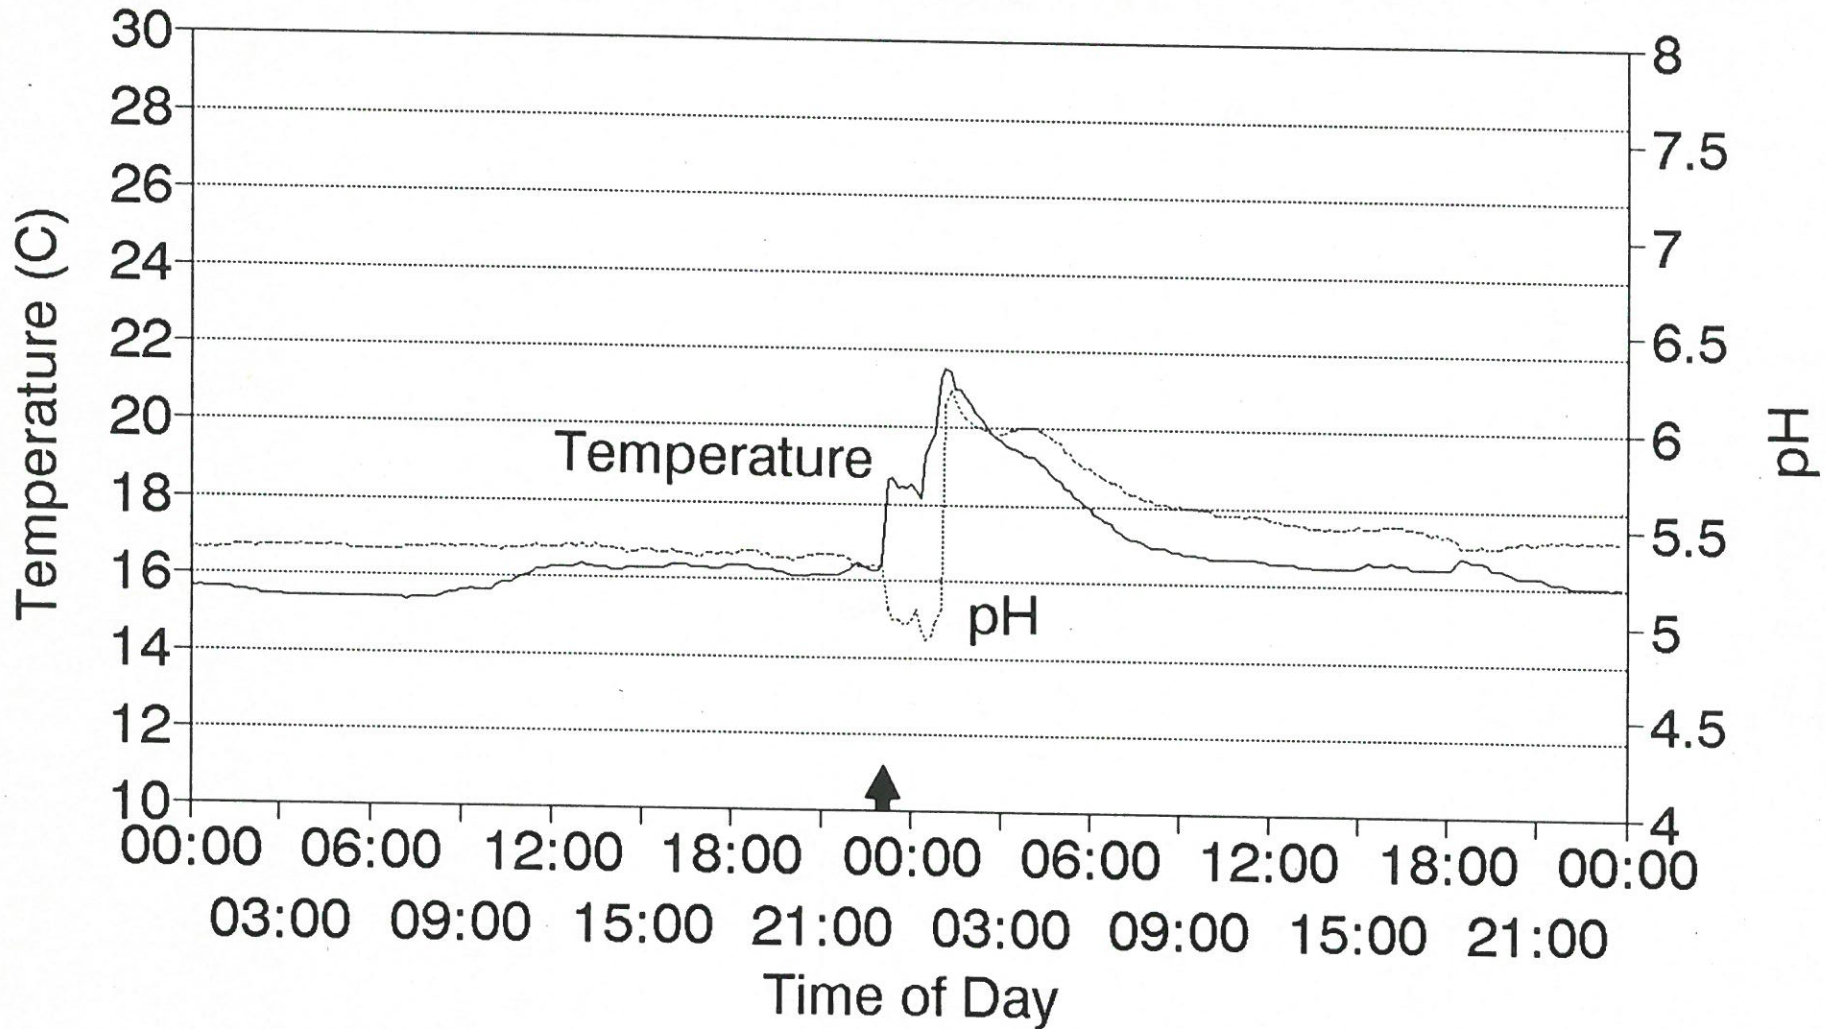
Figure 17. Graphs showing continuous temperature and pH measurements from the left fork of Jabez Branch on August 5 and 6, 1990. Arrow indicate beginning of rain event.

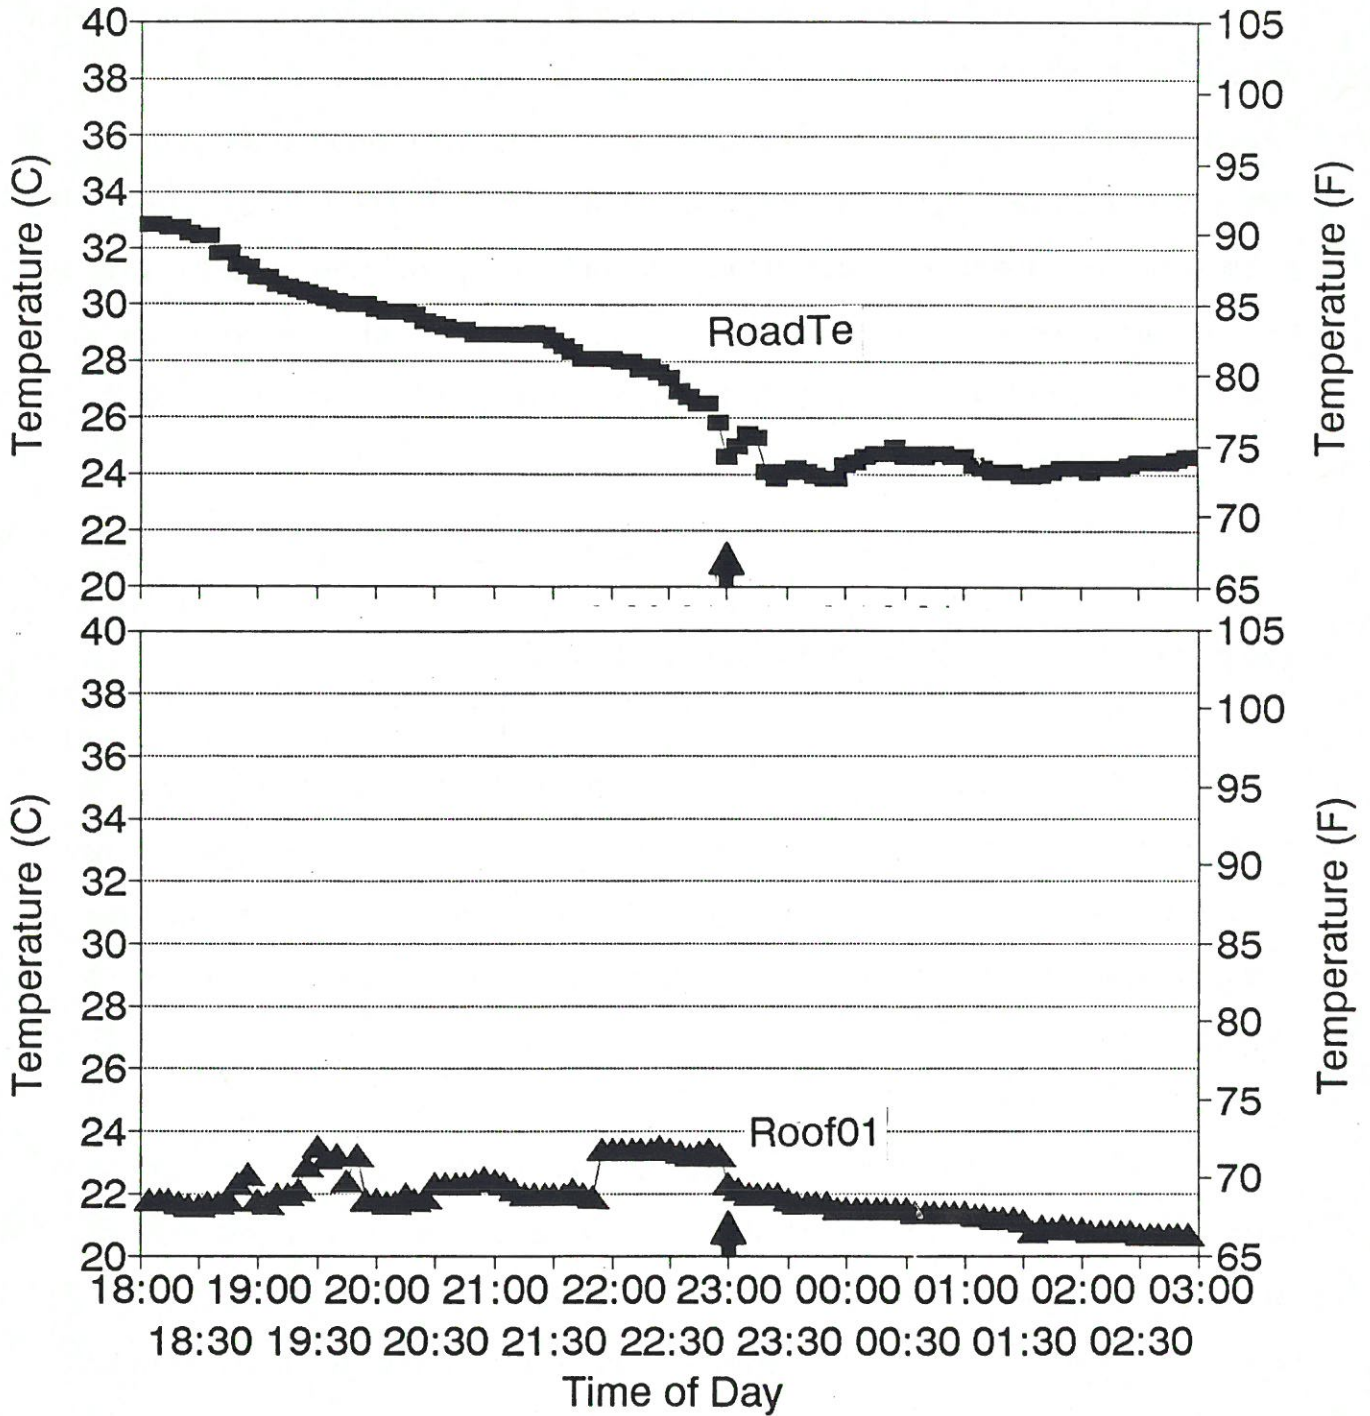
Figure 19. Temperature measurements from the special land use monitoring stations in the upper watershed of the left fork of Jabez Branch on August 5 and 6, 1990 between 18:00 and 3:00. In the top graph Station RoadTe shows the temperature of the surface of Rt. 3, and the bottom graph shows the temperatures measured in the drain from an industrial roof in the watershed. Arrows indicate beginning of rain event.

Results from the two special land use monitoring sites are given in Figure 19. The temperature of the road's surface reached a high of 37.2°C (98.6°C) at 12:45 and cooled to 26°C (78.8°F) at the beginning of the rain event. Due to equipment problems, no measurements of the temperature of the runoff for the highway were obtained. The temperature of the water from an industrial roof was 23°C (73.4°C) at first and dropped to 22°C (71.6°C) later in the storm.

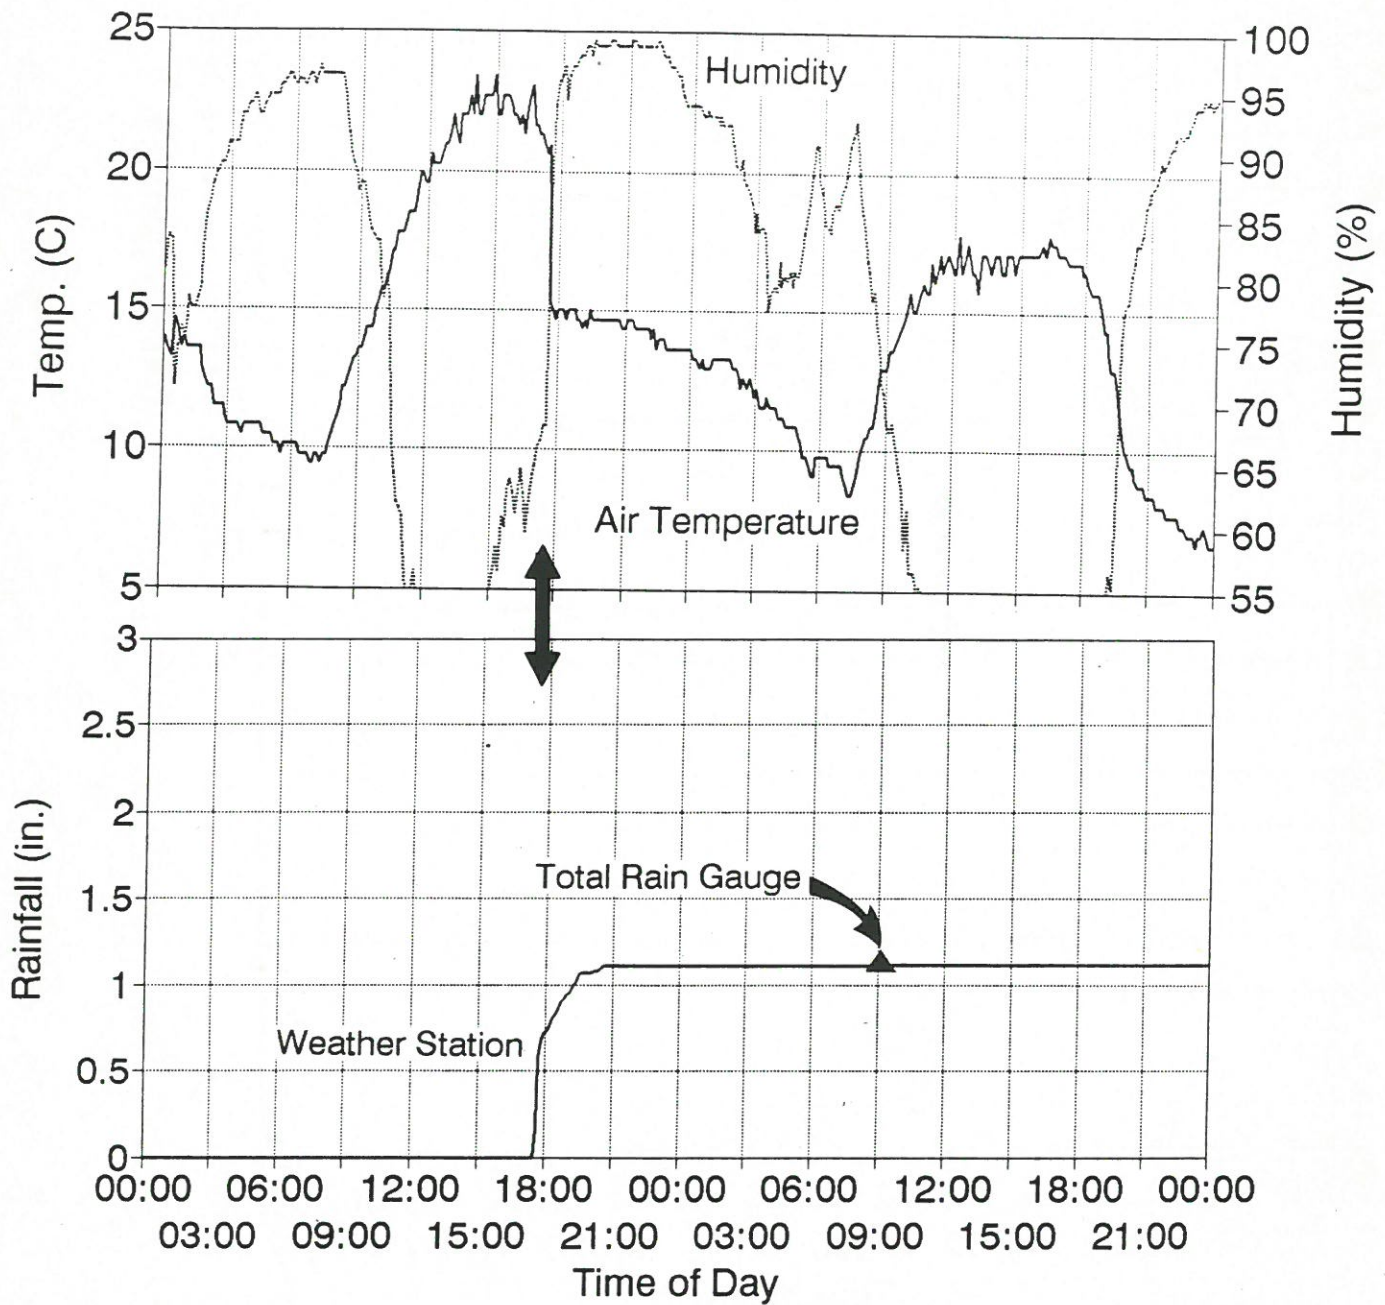
Figure 20. Graphs showing air temperature (top), humidity (top) and rainfall (bottom) at Lake Median weather station and BWI airport on September 16 and 17, 1990. Arrows indicate beginning of rain event.
