# Quarterfield Elementary School Safe Routes to School Accessibility Study: Existing Conditions and Recommendations

# Anne Arundel Safe Routes to School Accessibility Study

# Quarterfield Elementary Accessibility Study

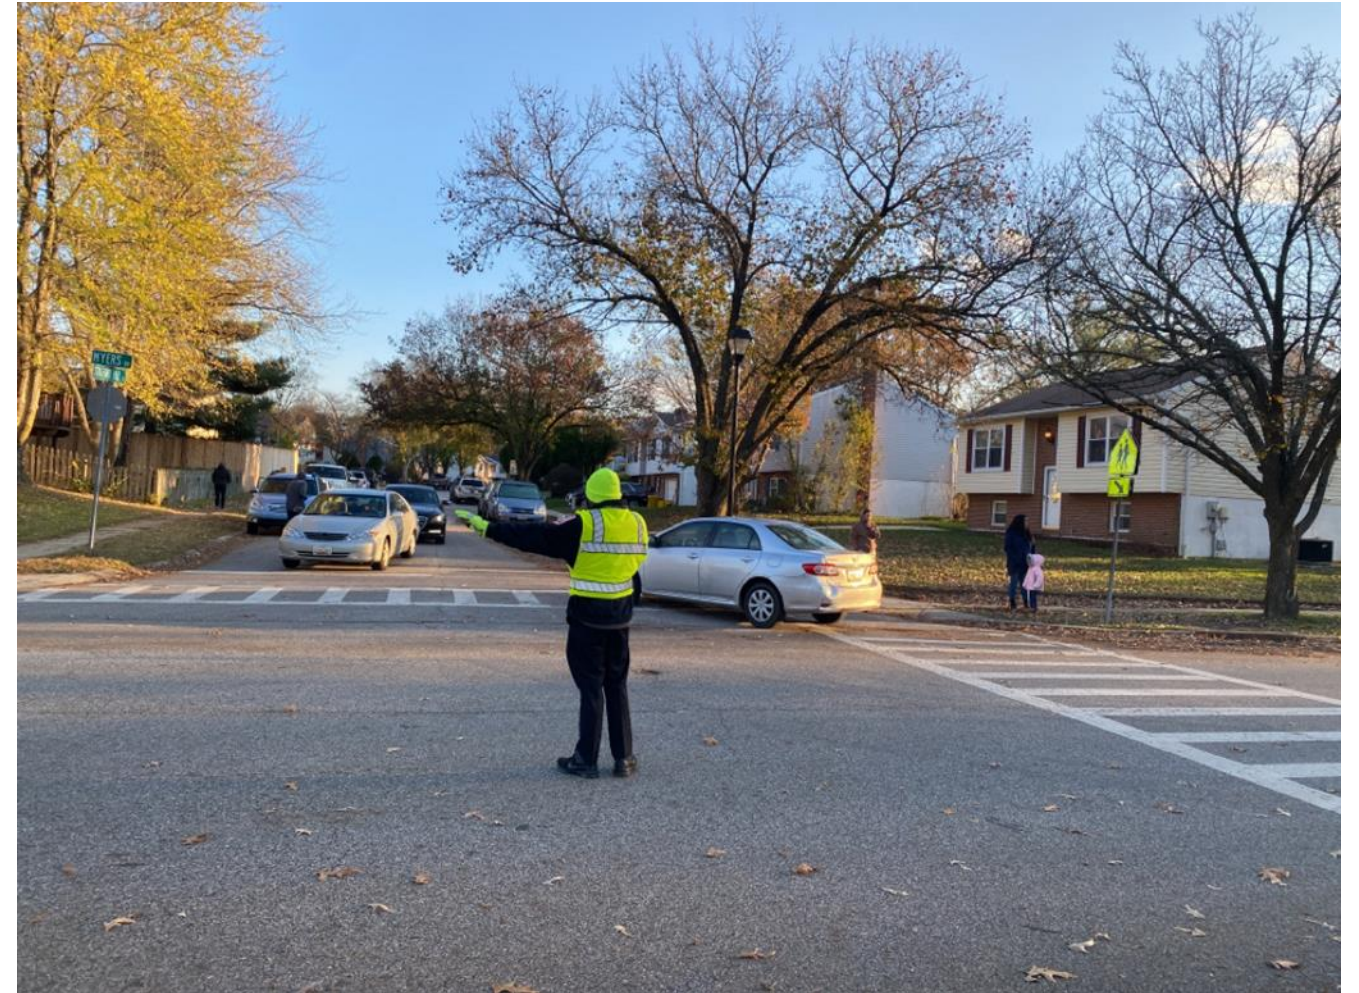
- One crossing guard is assigned to Quarterfield Elementary School, stationed at the intersection of Myers Drive and Stafford Hill Drive near the walk/bike entrance on the north side of the school.

The crossing guard at Myers Drive and Stafford Hill Drive.

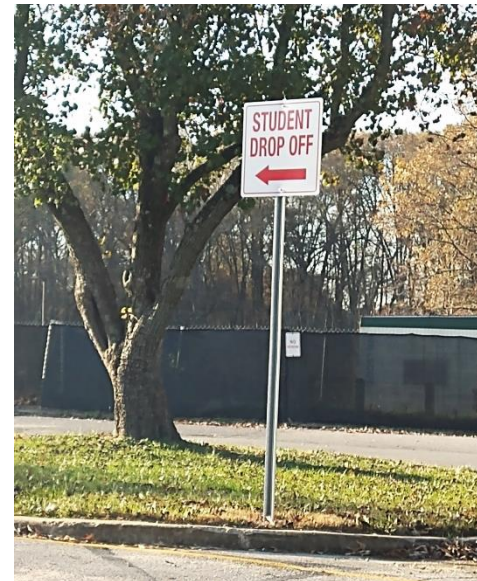
Signs directing drivers to the parent drop-off loop (left) and bus loop (right).

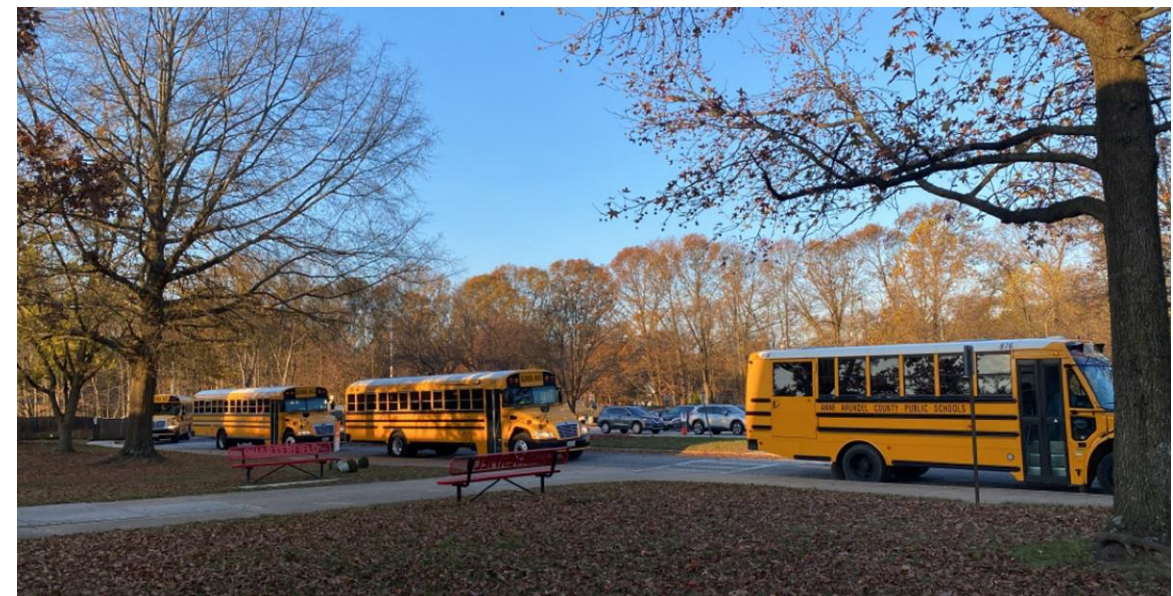
- Four buses were observed in the school driveway.

Buses waiting to drop off students during school arrival.

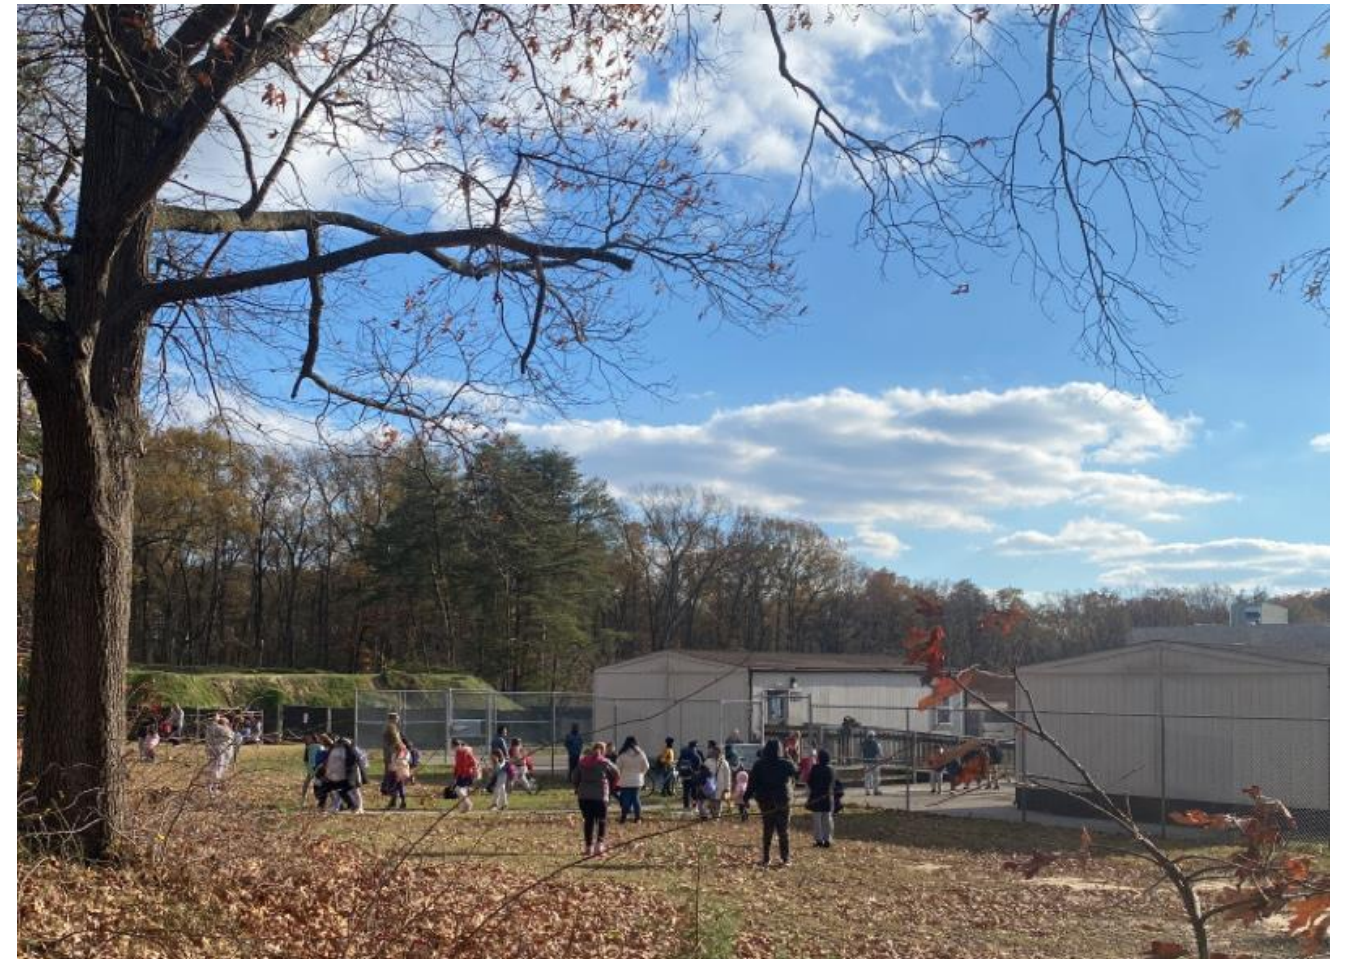
- Walkers were dismissed by grade (oldest to youngest) and exited via the north gate.
- Most of the students dismissed as walkers met parents and/or walked to cars parked along Myers Drive or Stafford Hill Drive.
- Approximately 30 students were observed using the shortcut to the northeast of the property; approximately one-third went to parked cars.
- No students were observed walking toward Quarterfield Road.

The walker/bicyclist gate at dismissal.

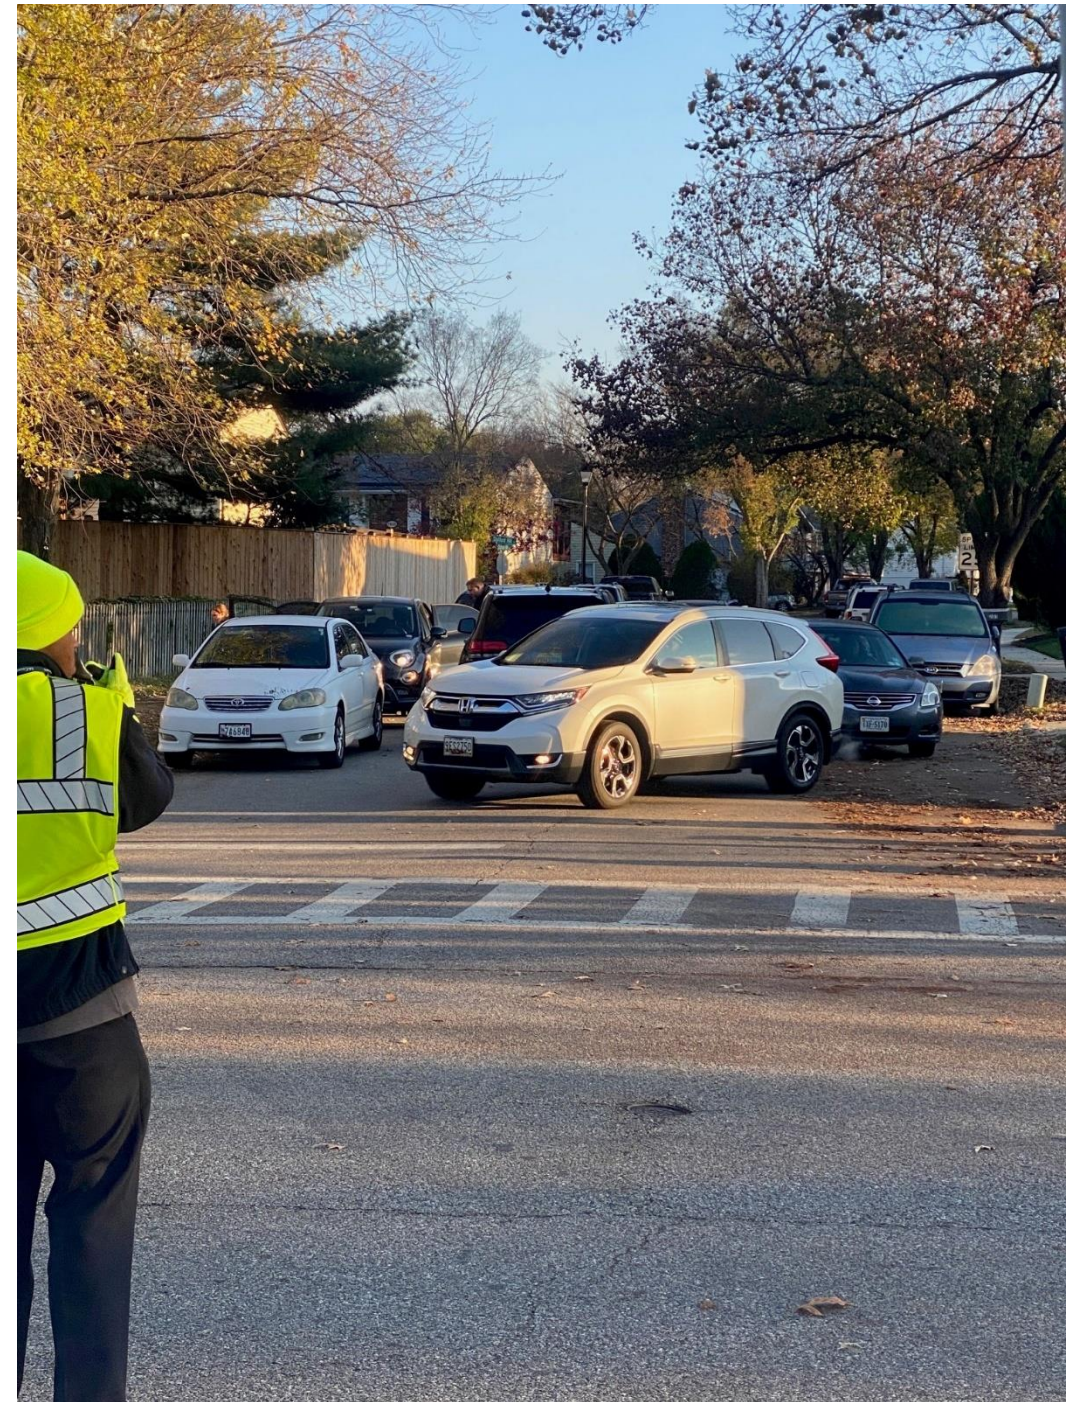
- By 2:15 there were approximately 20 cars lined up in the parking lot pick-up loop; at least 35 cars were parked along Myers Drive and Stafford Hill Drive north of the school.
- Numerous vehicular conflicts were observed on Myers Drive and Stafford Hill Drive.
  - Drivers pulled out of parking spaces and cut off other drivers.
  - Drivers double-parked.
  - Drivers parked in areas posted no-parking, in the intersection, or in the crosswalks.
  - The crossing guard communicated with drivers as needed to reduce conflicts for students walking and bicycling.

Stafford Hill Drive during dismissal

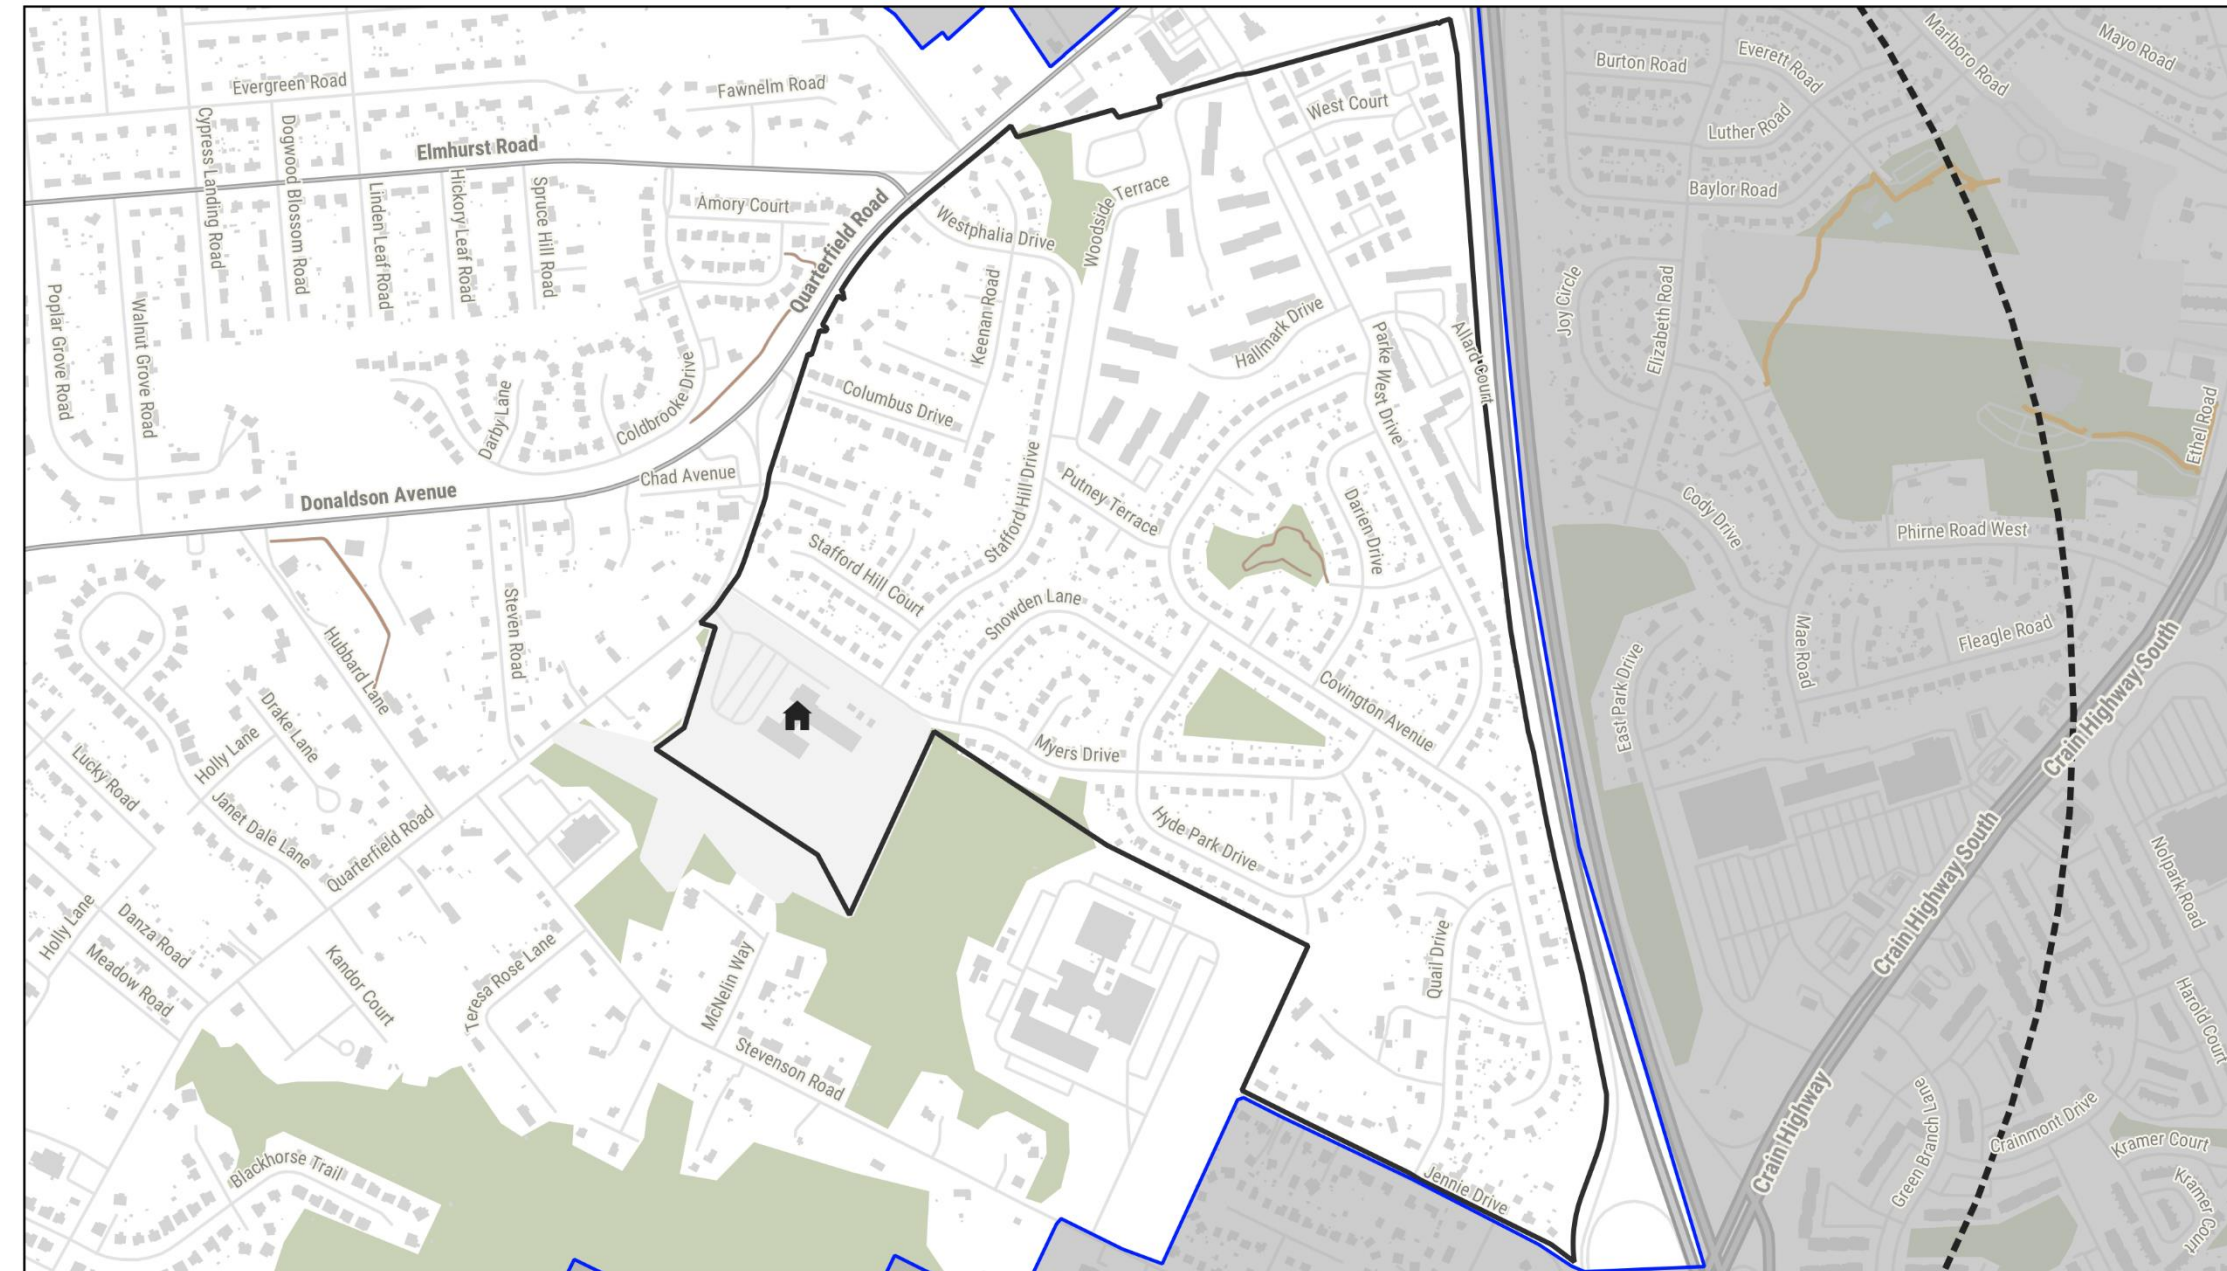
Quarterfield Elementary School - Existing Regional Trails, Park Trails, and Paths

Other than an internal park path several blocks from the school, no trails or shared use paths exist in the walk zone. There are currently no planned\* trails near the school.

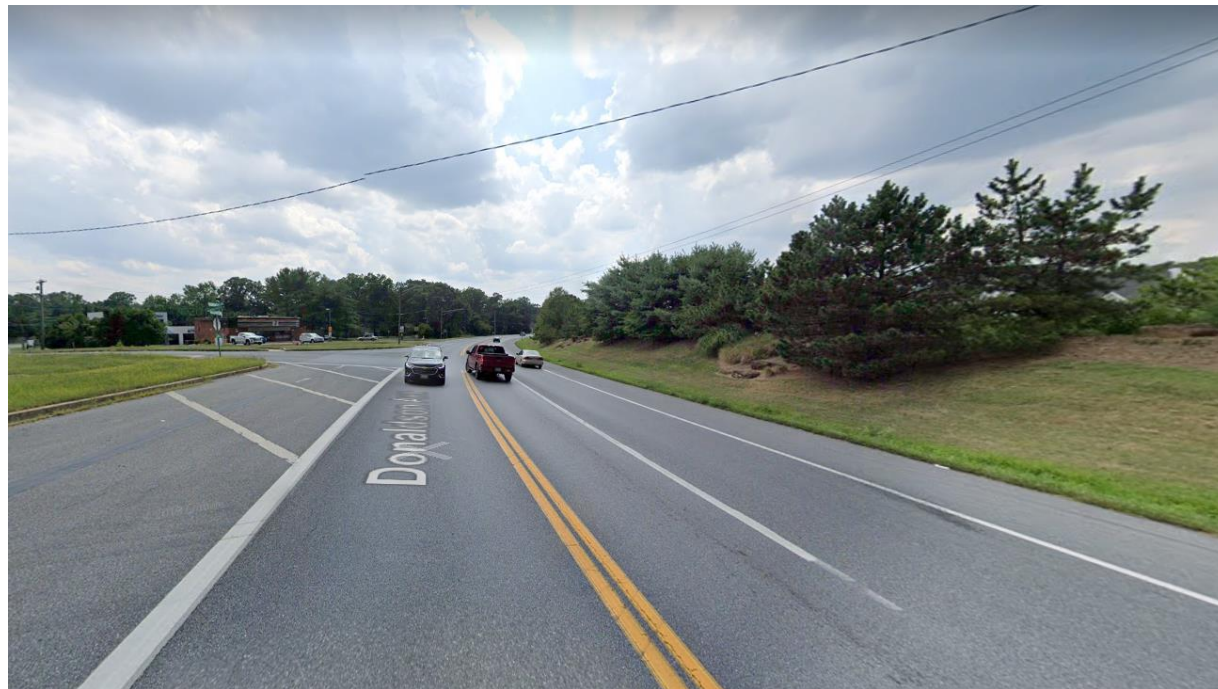
Many houses west of Donaldson Avenue and along Elmhurst Road may fall within a one-mile walking or bicycling distance from the school, but both roads lack pedestrian and bicycle facilities and present significant barriers to families choosing active travel modes. For long-term planning, the County could explore adding sidewalks and bike lanes or a shared use path on both roads, creating a path to connect Cold Brook Drive to Donaldson Avenue, and installing a traffic signal and pedestrian crossing facilities at the intersection of Donaldson Avenue and Quarterfield Road. Additionally, there is a recommendation for shared use path on Quarterfield Road/Donaldson Avenue in Walk & Roll Anne Arundel.

Intersection of Donaldson Avenue and Quarterfield Road via Google Maps

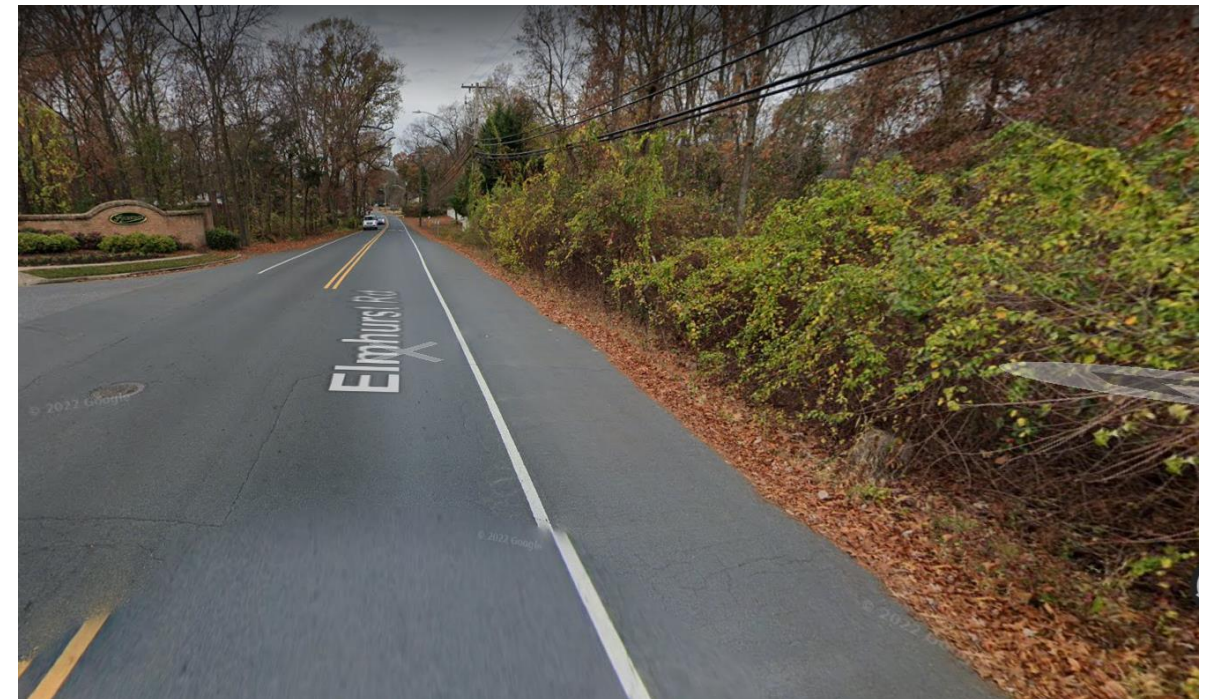
View of Elmhurst Road via Google Maps

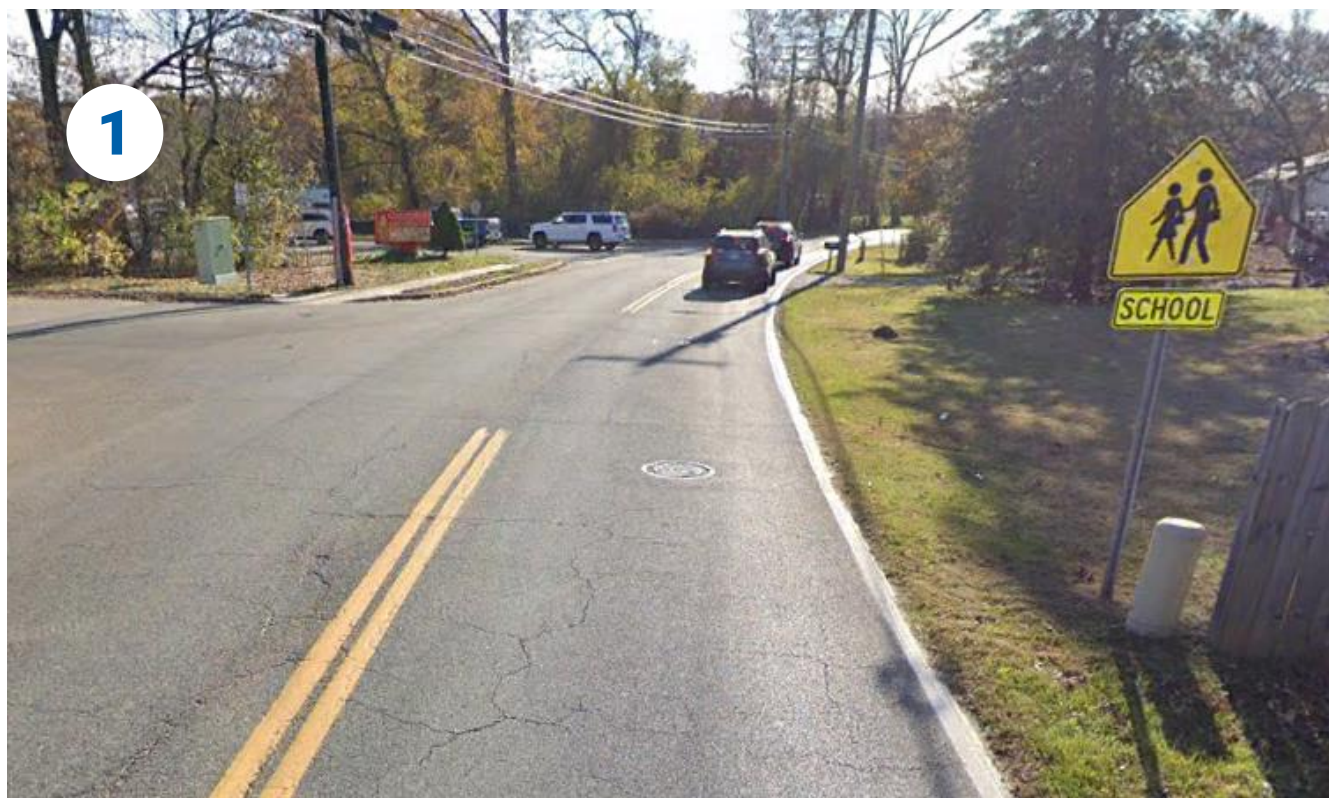
Quarterfield Road at Myers Drive.

| Map ID | Location | Facility Type | Issue | Recommendation | Potential Cost | Timeframe* |
|---|---|---|---|---|---|---|
| 1 | Quarterfield Rd (Steven Rd to Chad Ave) (Along key student walking route, Inside school zone) | 1a. School Zone Signs and Pavement Markings | School zone sign missing | Enhance school zone signage per MdMUTCD part 7: | | Short |
| | | | SCHOOL pavement marking missing | - Install new school zone sign (begin/end) | \$1,000 | |
| | | | School zone speed limit sign missing. | - Install new SCHOOL pavement marking<br>- Install new school zone speed limit sign | \$1,000<br>\$500 | |
| | | 1b. Speed Management | Observed motor vehicle speeds appear to exceed speed limit | Conduct a speed study to consider speed management measures or other modifications. | N/A | Long |

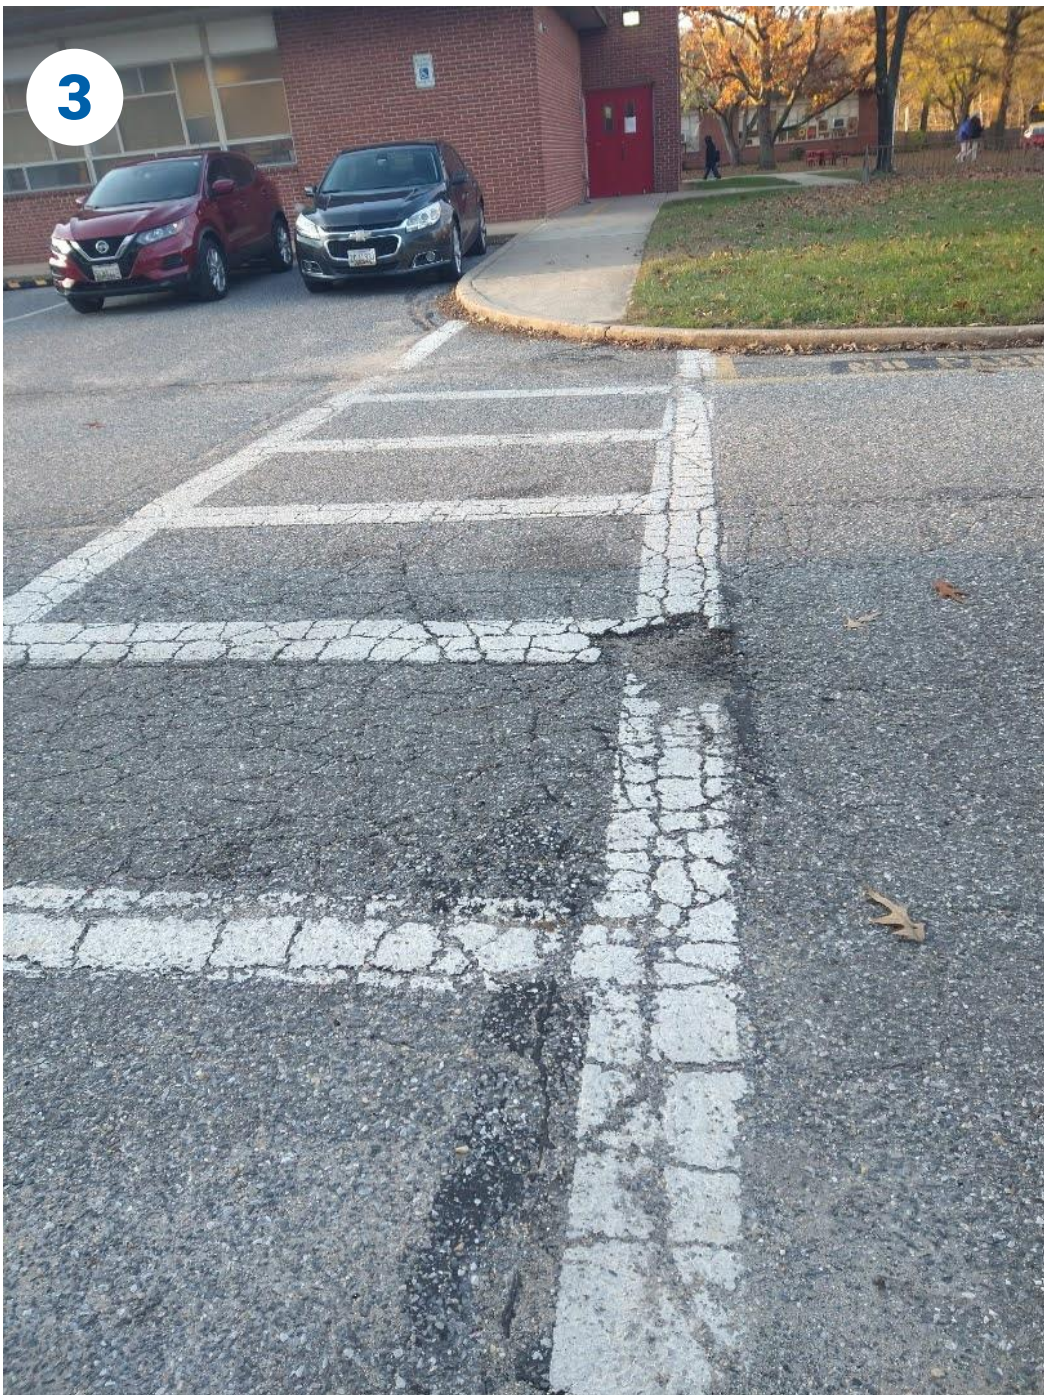
Crosswalk across north staff parking entrance

| Map ID | Location | Facility Type | Issue | Recommendation | Potential Cost | Timeframe* |
|---|---|---|---|---|---|---|
| 3 | Driveway to north staff parking lot (On school campus) | 3a. Crosswalk | Crosswalk markings faded | Remark existing crosswalk with high-visibility markings | \$800 | Short |
| | | 3b. Curb ramp | Missing ramps | Install new ramps | \$8,000 | Medium |

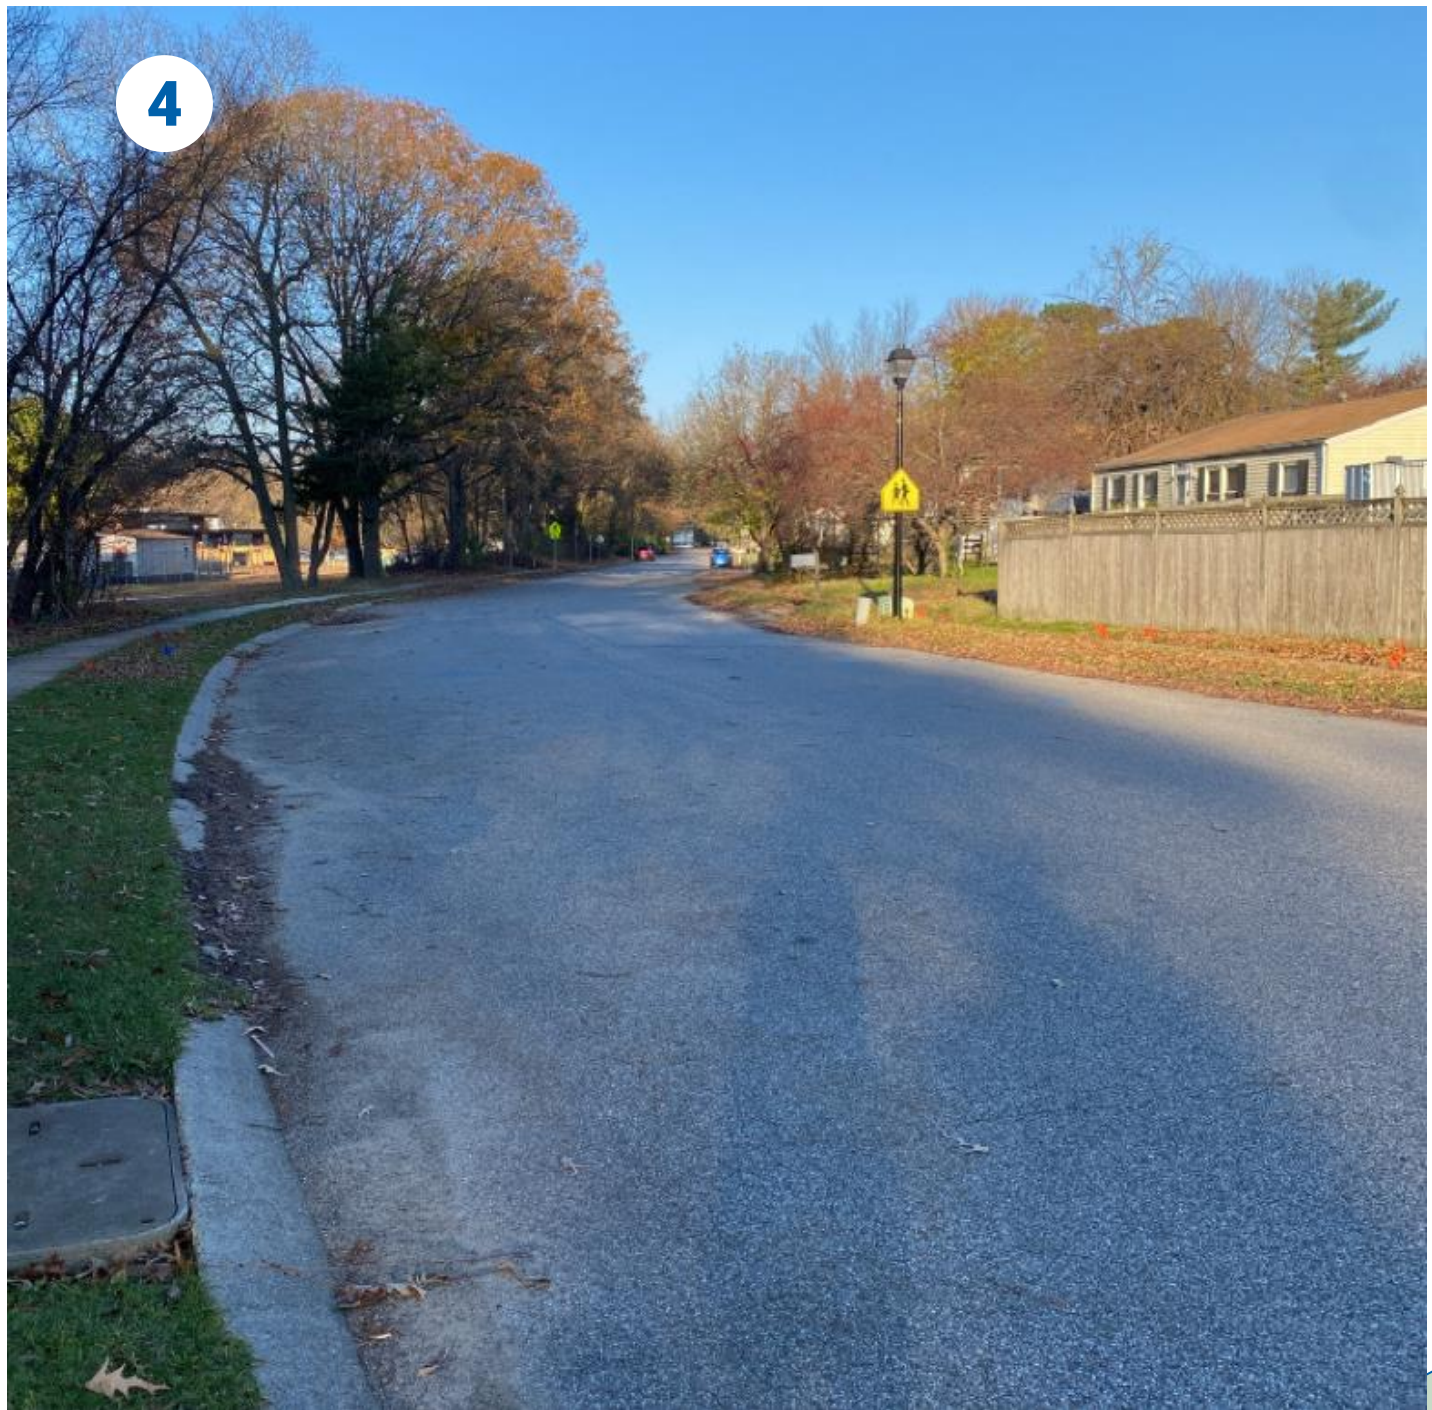
Myers Drive

| Map ID | Location | Facility Type | Issue | Recommendation | Potential Cost | Timeframe* |
|---|---|---|---|---|---|---|
| 4 | Myers Dr (Quarterfield Rd to Hyde Park Dr) (Along key student walking and bicycling route, Inside school zone) | Speed Management | Observed motor vehicle speeds appear to exceed speed limit | Conduct a speed study to consider speed management measures or other modifications | N/A | Long |

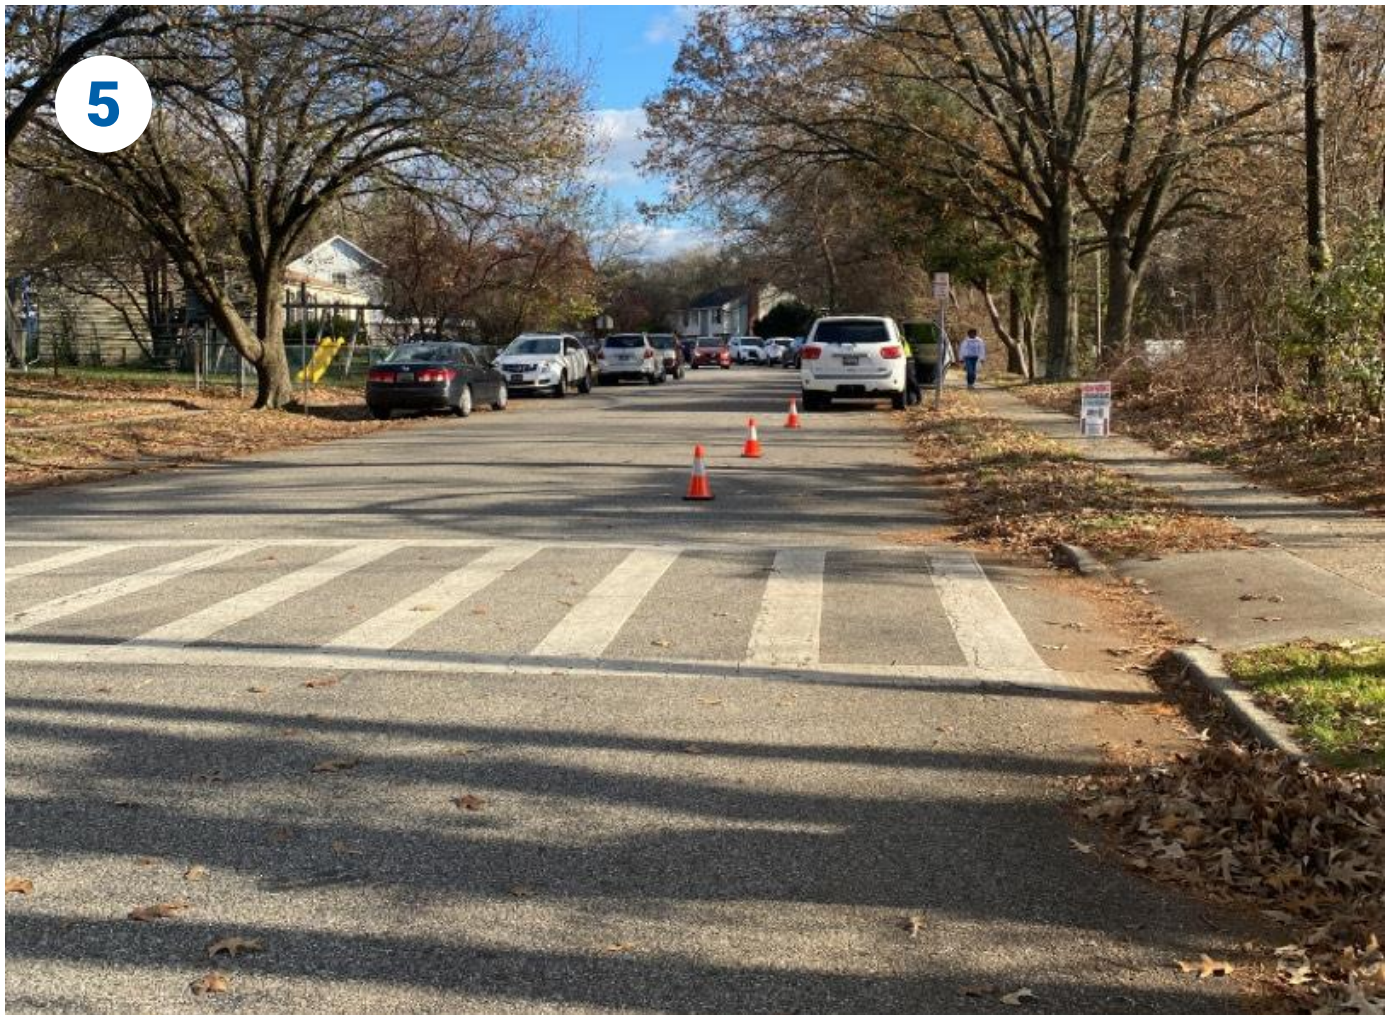
Crossing Myers Drive at Stafford Hill Drive

| Map ID | Location | Facility Type | Issue | Recommendation | Potential Cost | Timeframe* |
|---|---|---|---|---|---|---|
| 5 | Myers Dr & Stafford Hill Dr (Along key student walking and bicycling route, Inside school zone) | 5a. Curb ramp | Southeast ramp lacks detectable warning surface | Reconstruct or repair existing ramp | \$4,000 | Medium |

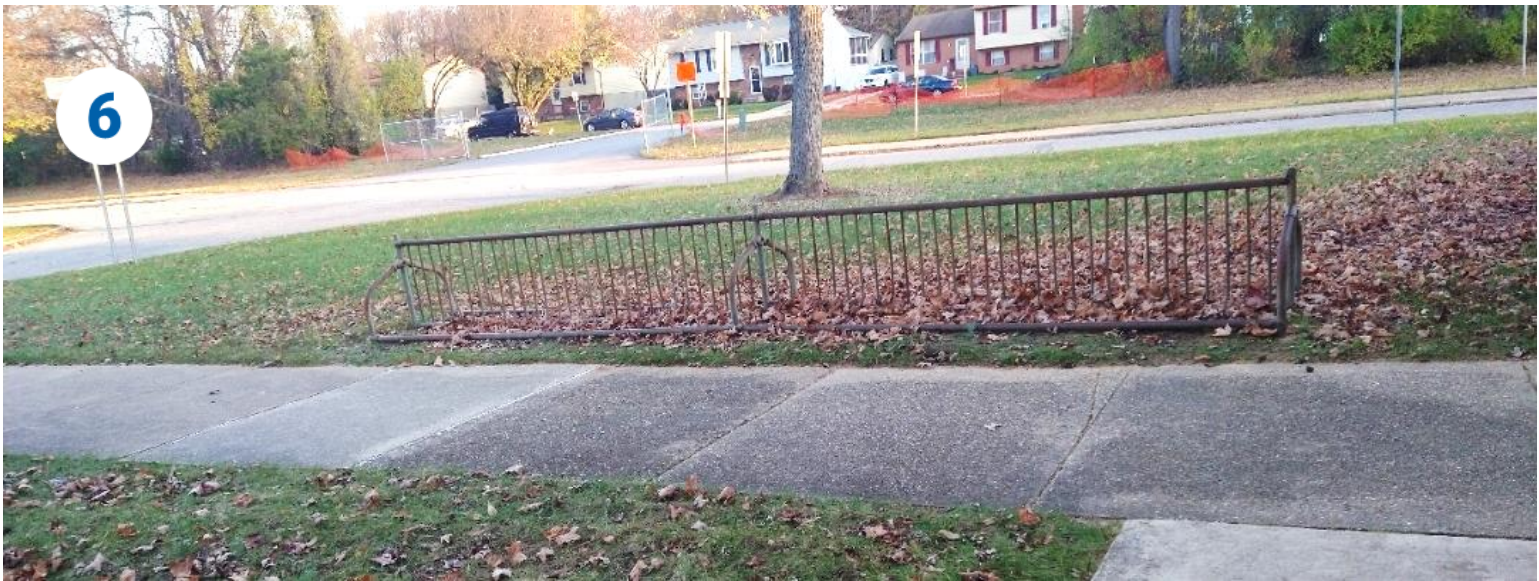
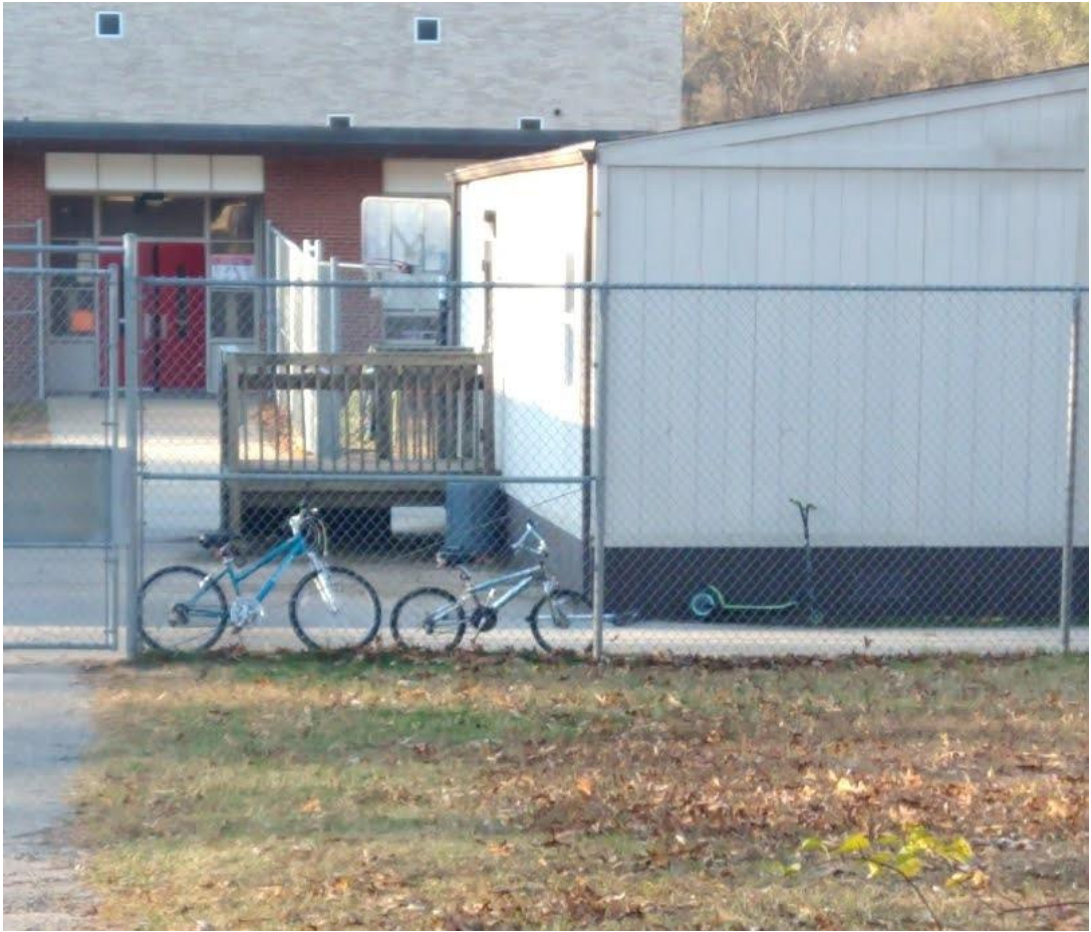
| Map ID | Location | Facility Type | Issue | Recommendation | Potential Cost | Timeframe* |
|---|---|---|---|---|---|---|
| 6 | Front of school (On school campus) | Bicycle rack | Existing rack does not allow locking of frame<br><br>New rack location needed — Bikes were seen at the side entrance leaning against the fence. | Replace existing rack with inverted U rack<br><br>Relocate bike rack location to side entrance used by walkers and bicyclists | \$175/per (quantity TBD) | Short |

Unused bike rack at front of school (top);  
bikes leaned against fence at north  
gate (bottom)

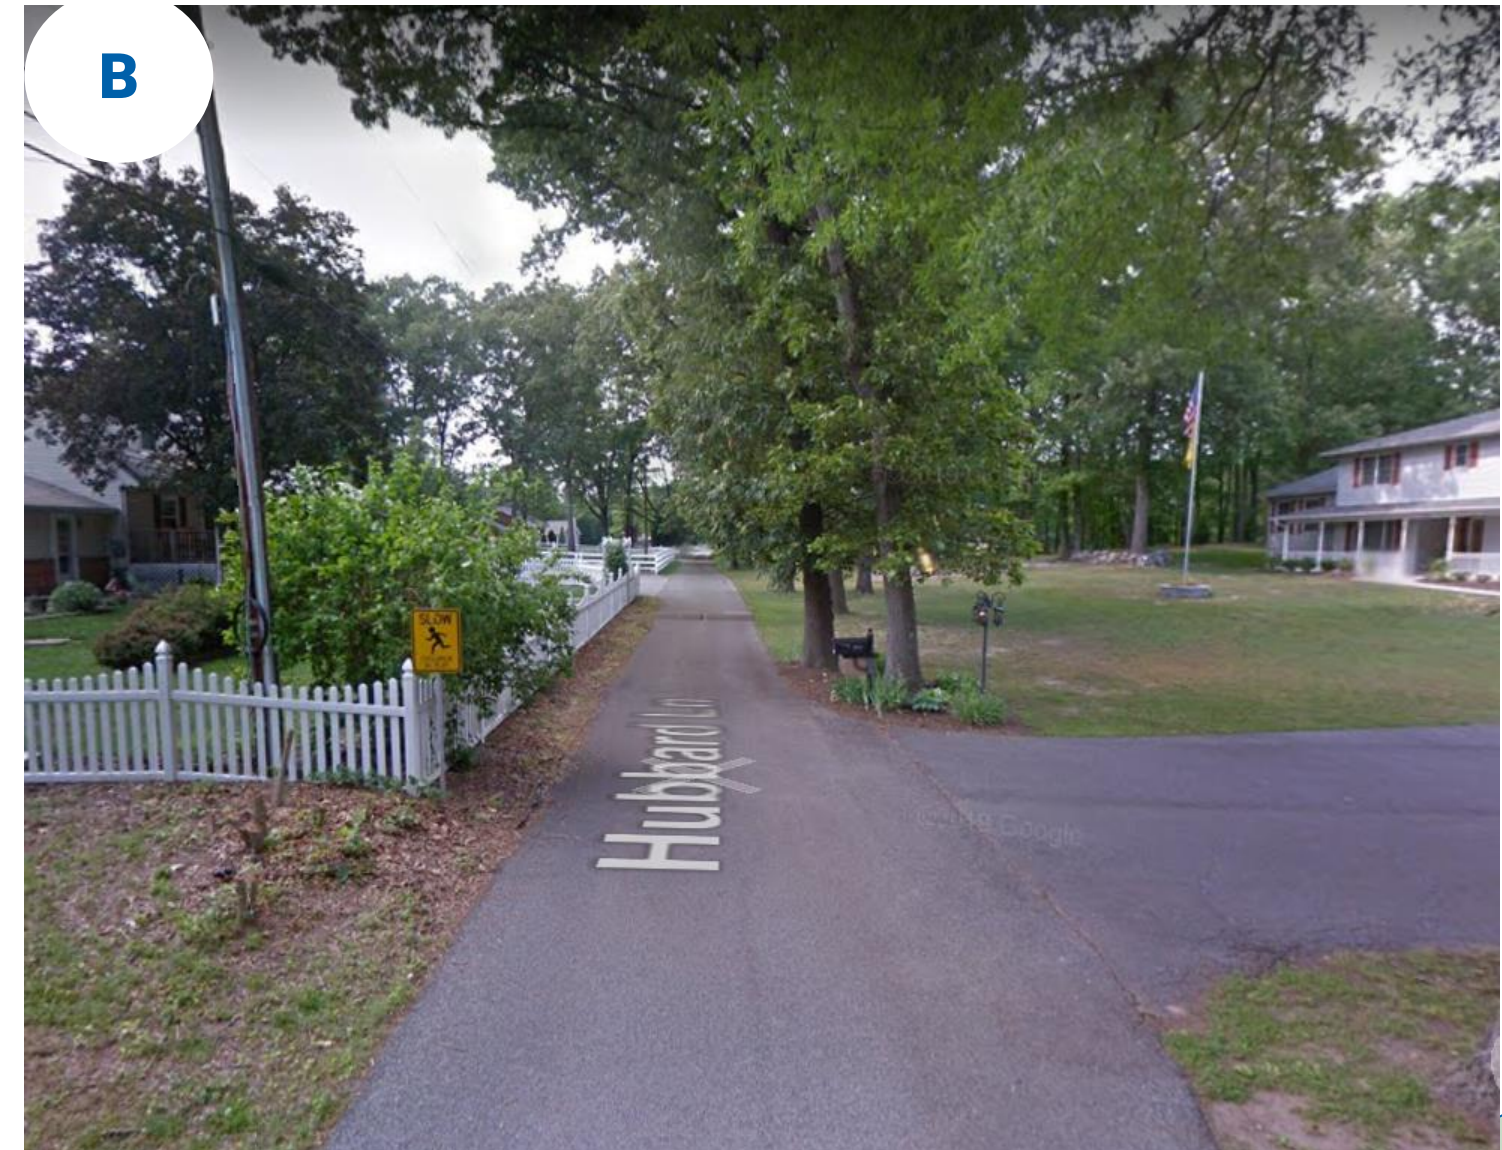
Hubbard Lane

| Map ID | Location | Facility Type | Issue | Recommendation | Potential Cost | Timeframe* |
|---|---|---|---|---|---|---|
| B | Hubbard Ln (Donaldson Ave to Quarterfield Rd) | Sidewalk | Missing sidewalk on both sides | Install new sidewalk**<br>ROW may make only one side feasible. | \$117,300 | Long |

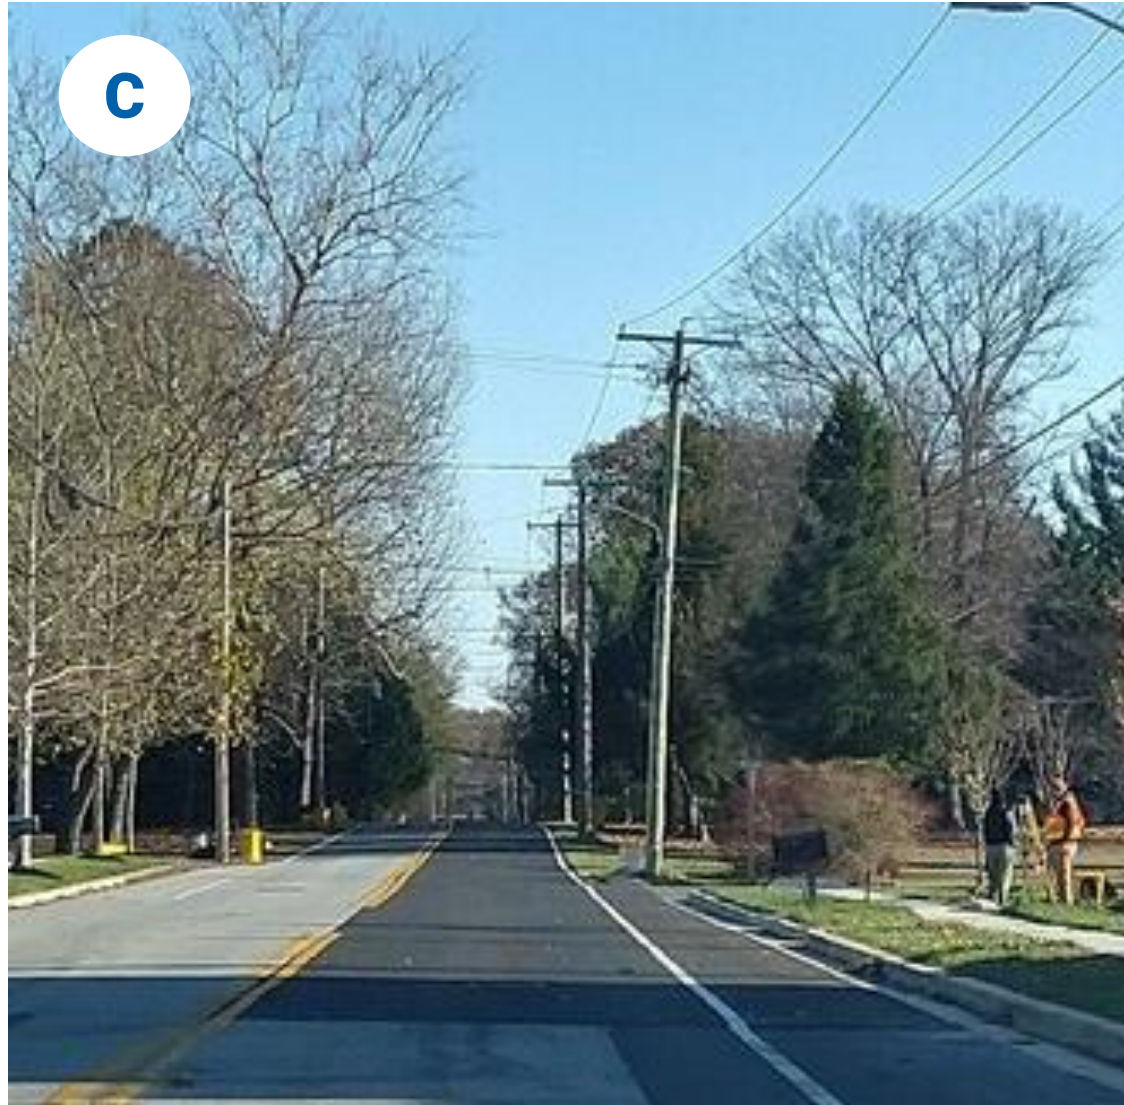
Quarterfield Road

| Map ID | Location | Facility Type | Issue | Recommendation | Potential Cost | Timeframe* |
|---|---|---|---|---|---|---|
| C | Quarterfield Rd (Garren Ct to Myers Dr) (Along key student walking route, partially inside school zone) | Sidewalk | Missing sidewalk.<br>There is discontinuous sidewalk along Quarterfield Rd south of Myers Dr. | Install new sidewalk**<br>Completing the sidewalk network along Quarterfield Drive could expand the school walk zone. | \$200,000 | Long |
