# Quarterfield Elementary School Safe Routes to School Accessibility Study: Existing Conditions and Recommendations

# Anne Arundel Safe Routes to School Accessibility Study

# Quarterfield Elementary Accessibility Study

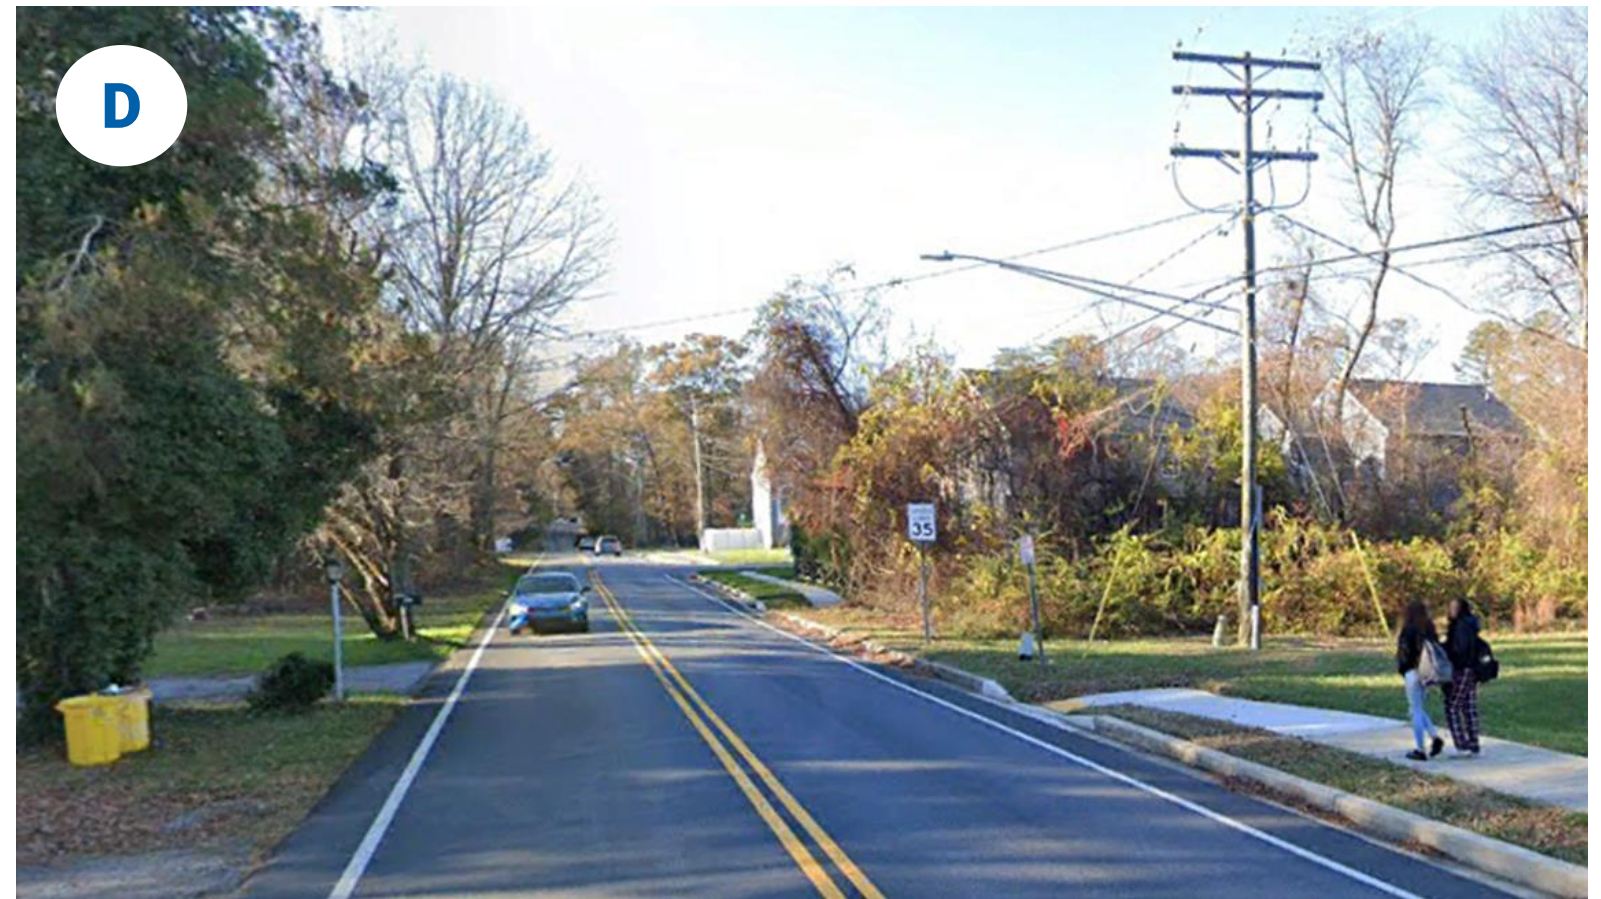
Stevenson Road

| Map ID | Location | Facility Type | Issue | Recommendation | Potential Cost | Timeframe* |
|---|---|---|---|---|---|---|
| D | Stevenson Rd (Grasons Ct to Quarterfield Rd) | D1. Sidewalk | Missing sidewalk<br><br>Small patches of sidewalk extend from newer developments but the majority of Stevenson Rd lacks sidewalks on both sides. | Install new sidewalk**<br><br>Completing the sidewalk network could expand the school walk zone | \$220,000 | Long |
