# Tyler Heights Elementary School Safe Routes to School Accessibility Study: Existing Conditions and Recommendations

August 17, 2023

# Anne Arundel Safe Routes to School Accessibility Study

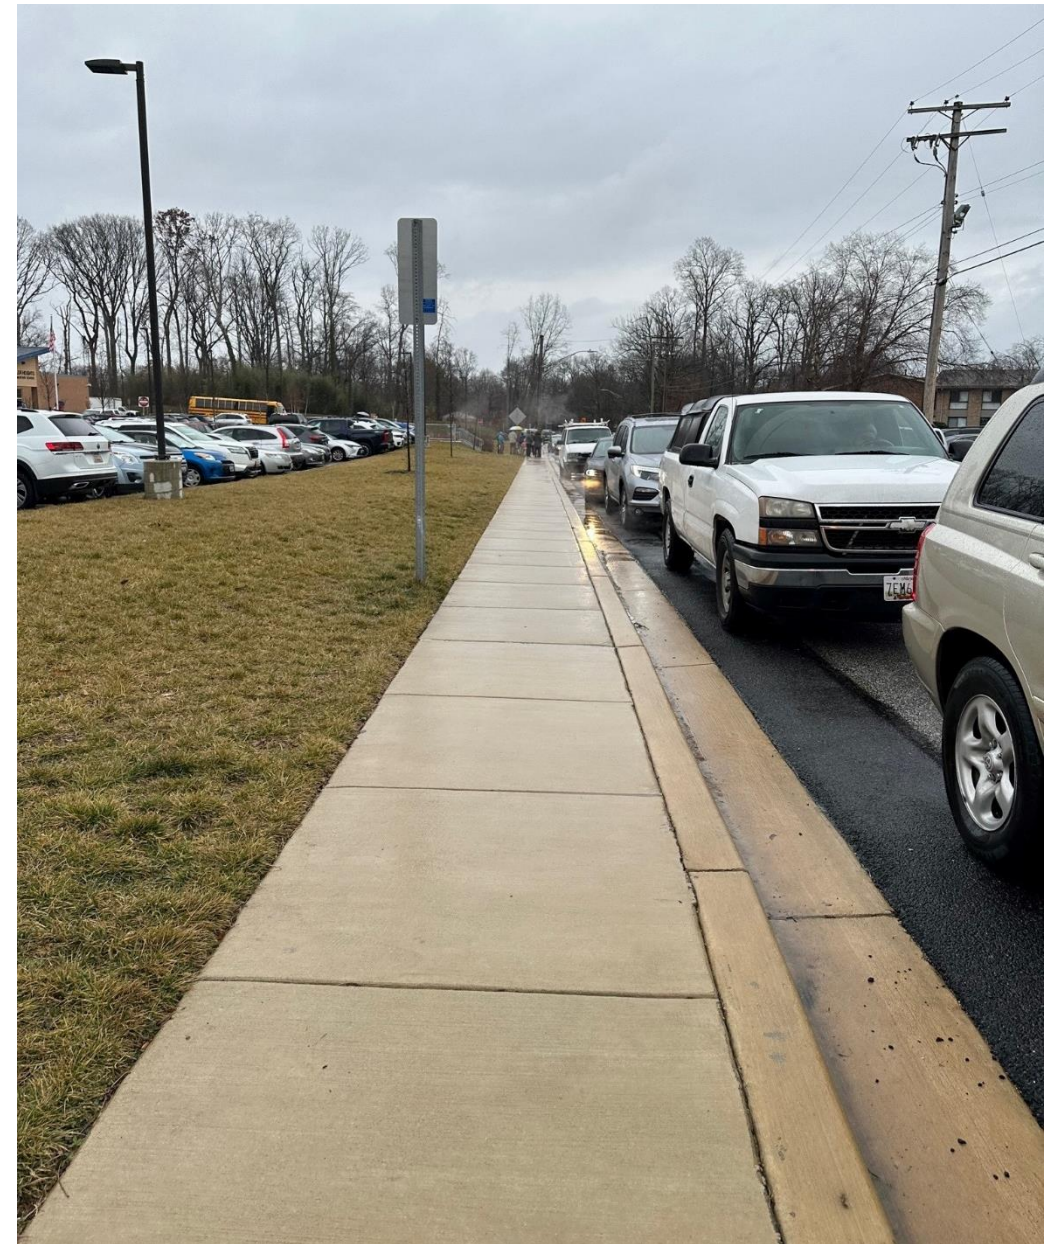
- By 2:20 there were numerous cars waiting in the school pick up line, which extended out of the driveway and onto Janwall Street.
- Parents were also observed parking along the street or in nearby parking lots and walking to the school to pick up their students, waiting outside of the school's main entrance until student walkers were dismissed.
- Vehicular and pedestrian traffic volumes in the immediate area of the school diminished by 2:40, and the school dismissal process appeared complete by 2:45.

The car pick-up line wrapped from the school driveway onto Janwall Street and past the front of the school building

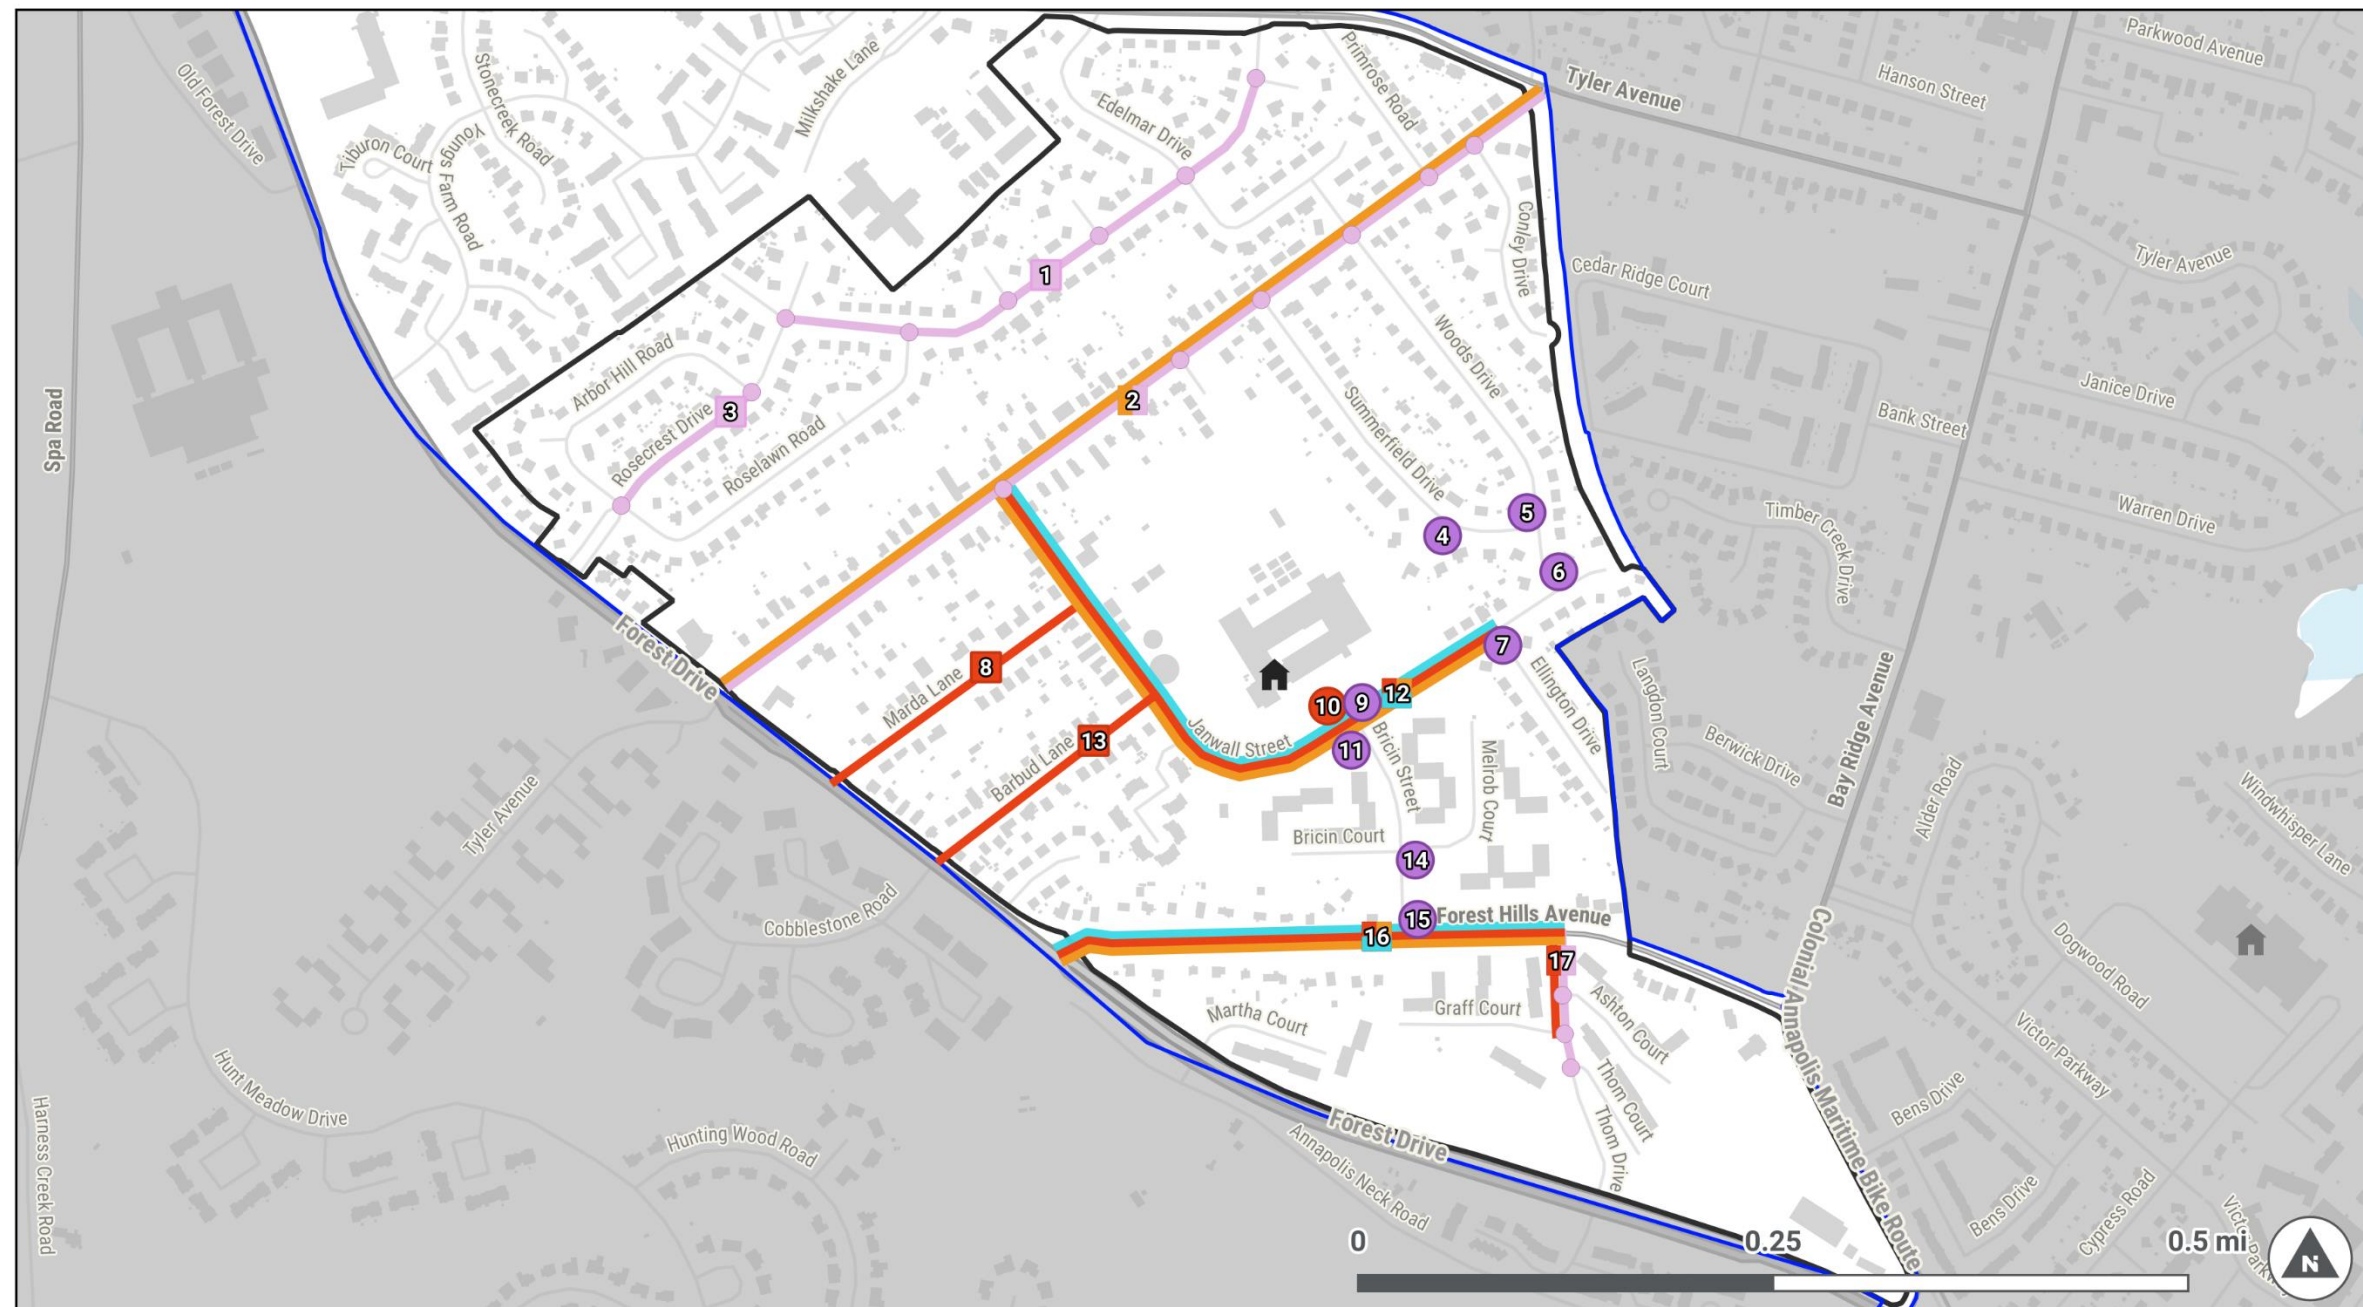
Tyler Heights Elementary School - Recommendations

The following tables summarize infrastructure recommendations within and outside of the current school walk zone as relevant. Key student walking or bicycling routes were identified based on information received from school administration, parent surveys, and school observations. Key routes are noted in the recommendation “Location” field.

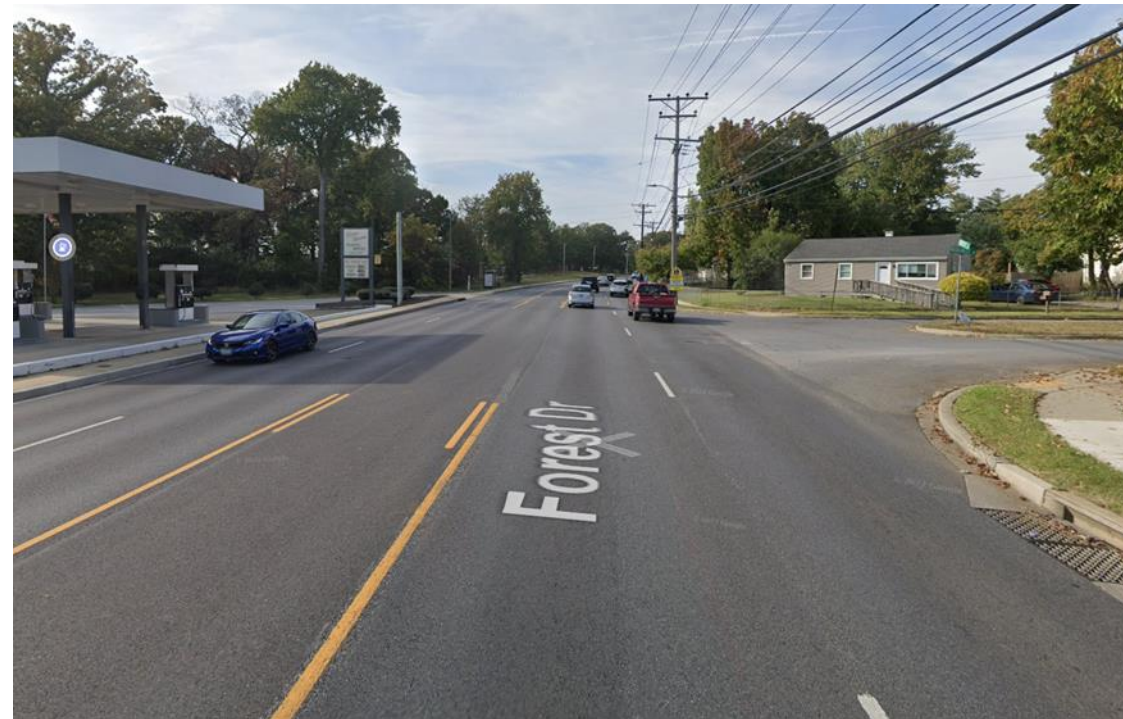
Forest Drive at Rosecrest Drive

- 2) Forest Drive is a four-lane road with a center turn lane, 40mph posted speed limit, and posted school crossing signs at Marda Lane, Tyler Avenue, Rosecrest Drive, and Youngs Farm Road. It spans the western perimeter of attendance boundary for Tyler Heights Elementary and is within the walk zone for Annapolis Middle School. Several houses along the east side of Forest Drive are currently excluded from the Tyler Heights Elementary walk zone. For long-term planning, the County could explore a road diet on Forest Drive and significant pedestrian and bicycle facility improvements along the corridor, including at key crossing locations. (Note: The County is conducting a multimodal safety study along Forest Drive within this area, including recommendations to improve safety for pedestrians and bicyclists along and immediately adjacent to the corridor.)

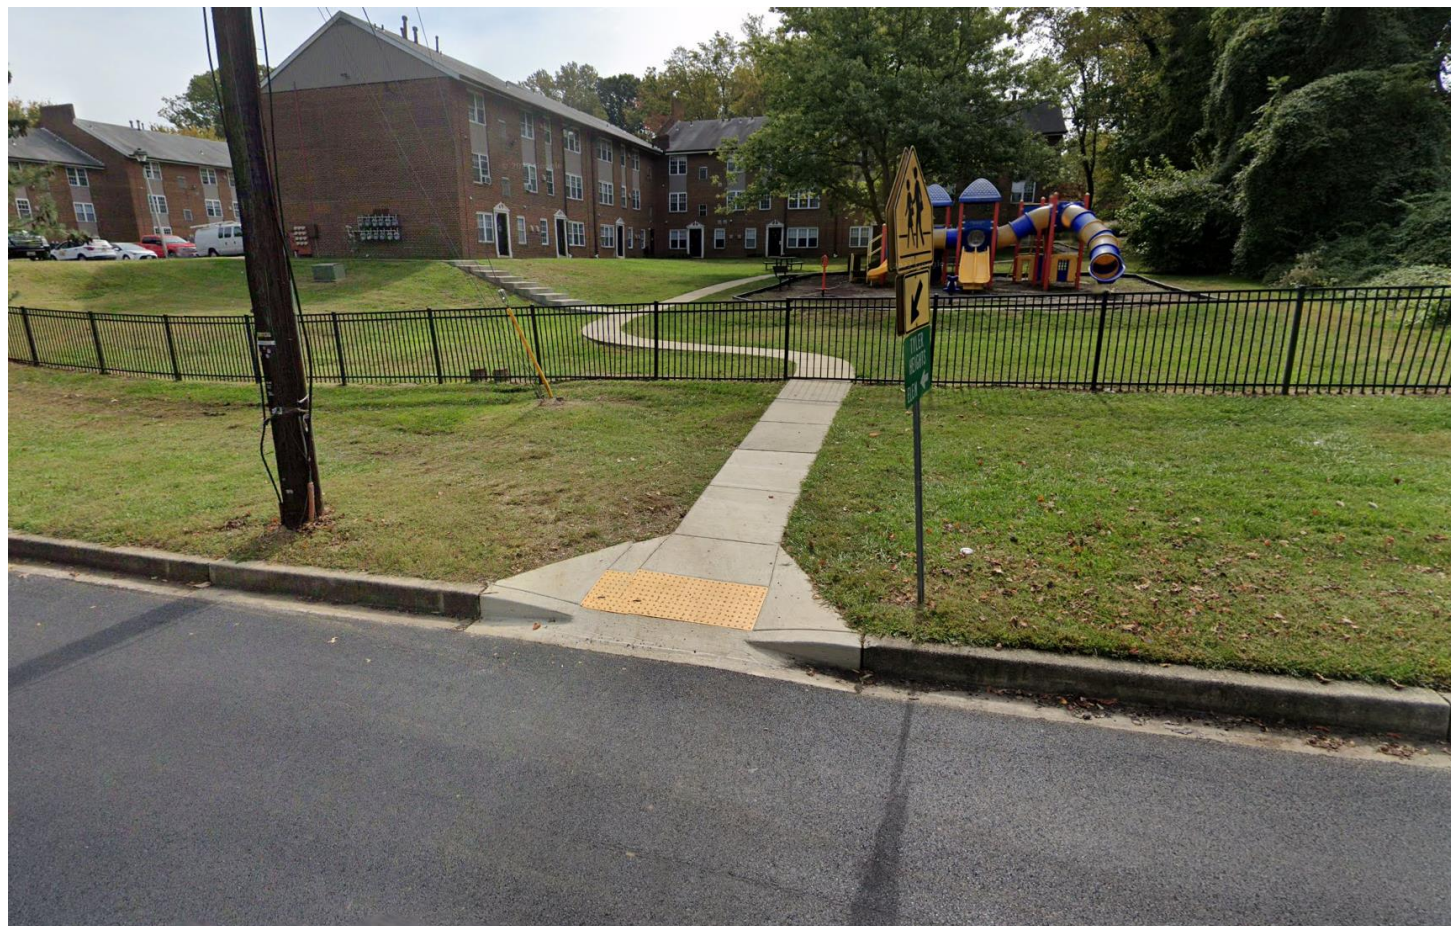
- 3) There is a fence around the apartment complex located south of Forest Hills Avenue, with no gate for pedestrian access even though a sidewalk exists and connects to Forest Hills Avenue near Bricin Street (where a crossing guard was located during school observations). While it is likely this is private property, the County could explore installing a gate to allow a direct connection for student walkers; currently, pedestrians have worn a path in the grass to access a gap between the gate and a private property fence.

Gate around apartment complex off Forest Hills Avenue

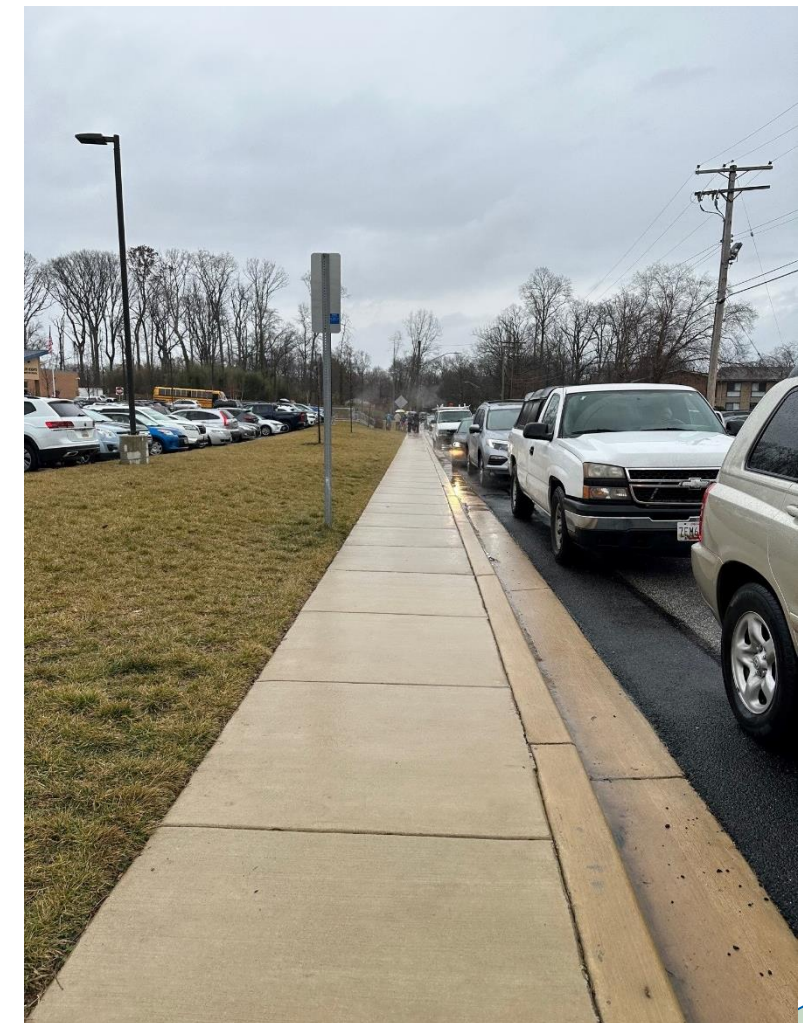
- 4) Parent drop off and pick up creates queues of cars within the school driveway/drop-off/pick-up lane, along Janwall Street, and along Bricin Street, which leads to unsafe driver behaviors such as blocking crosswalks. In addition, signs along Janwall Street imply that streetside drop off is encouraged (see Kiss & Goodbye image below), potentially leading some parents to avoid the on-campus drop off loop. AACPS and the County should conduct a more detailed traffic study (vehicle volumes, turning movements, etc.) around the school campus and explore measures to refine traffic patterns and minimize conflicts.

Car line on Janwall Street at dismissal

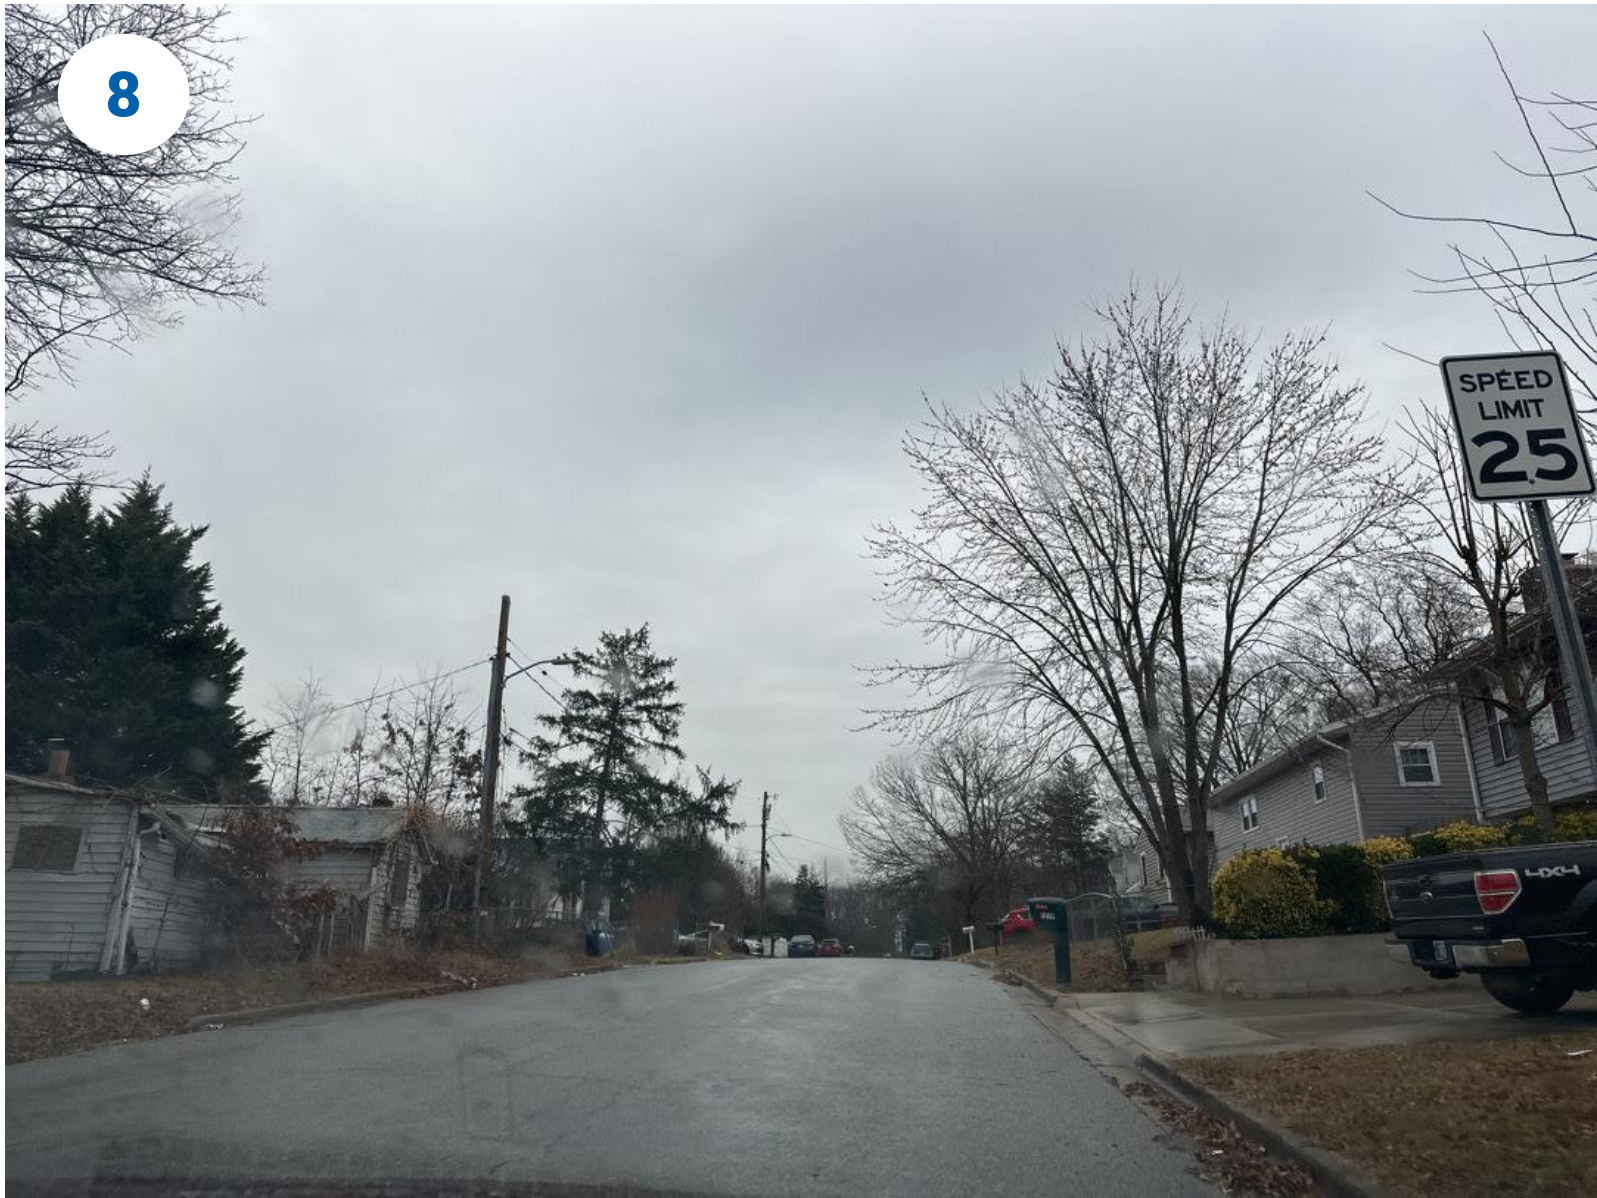
Marda Lane

| Map ID | Location | Facility Type | Issue | Recommendation | Potential Cost | Timeframe* |
|---|---|---|---|---|---|---|
| 8 | Marda Ln (Forest Dr to Janwall St) | Sidewalk | Missing sidewalk | Install new sidewalk**<br><br>Note: South side has 80ft of existing sidewalk | \$75,000 | Long |

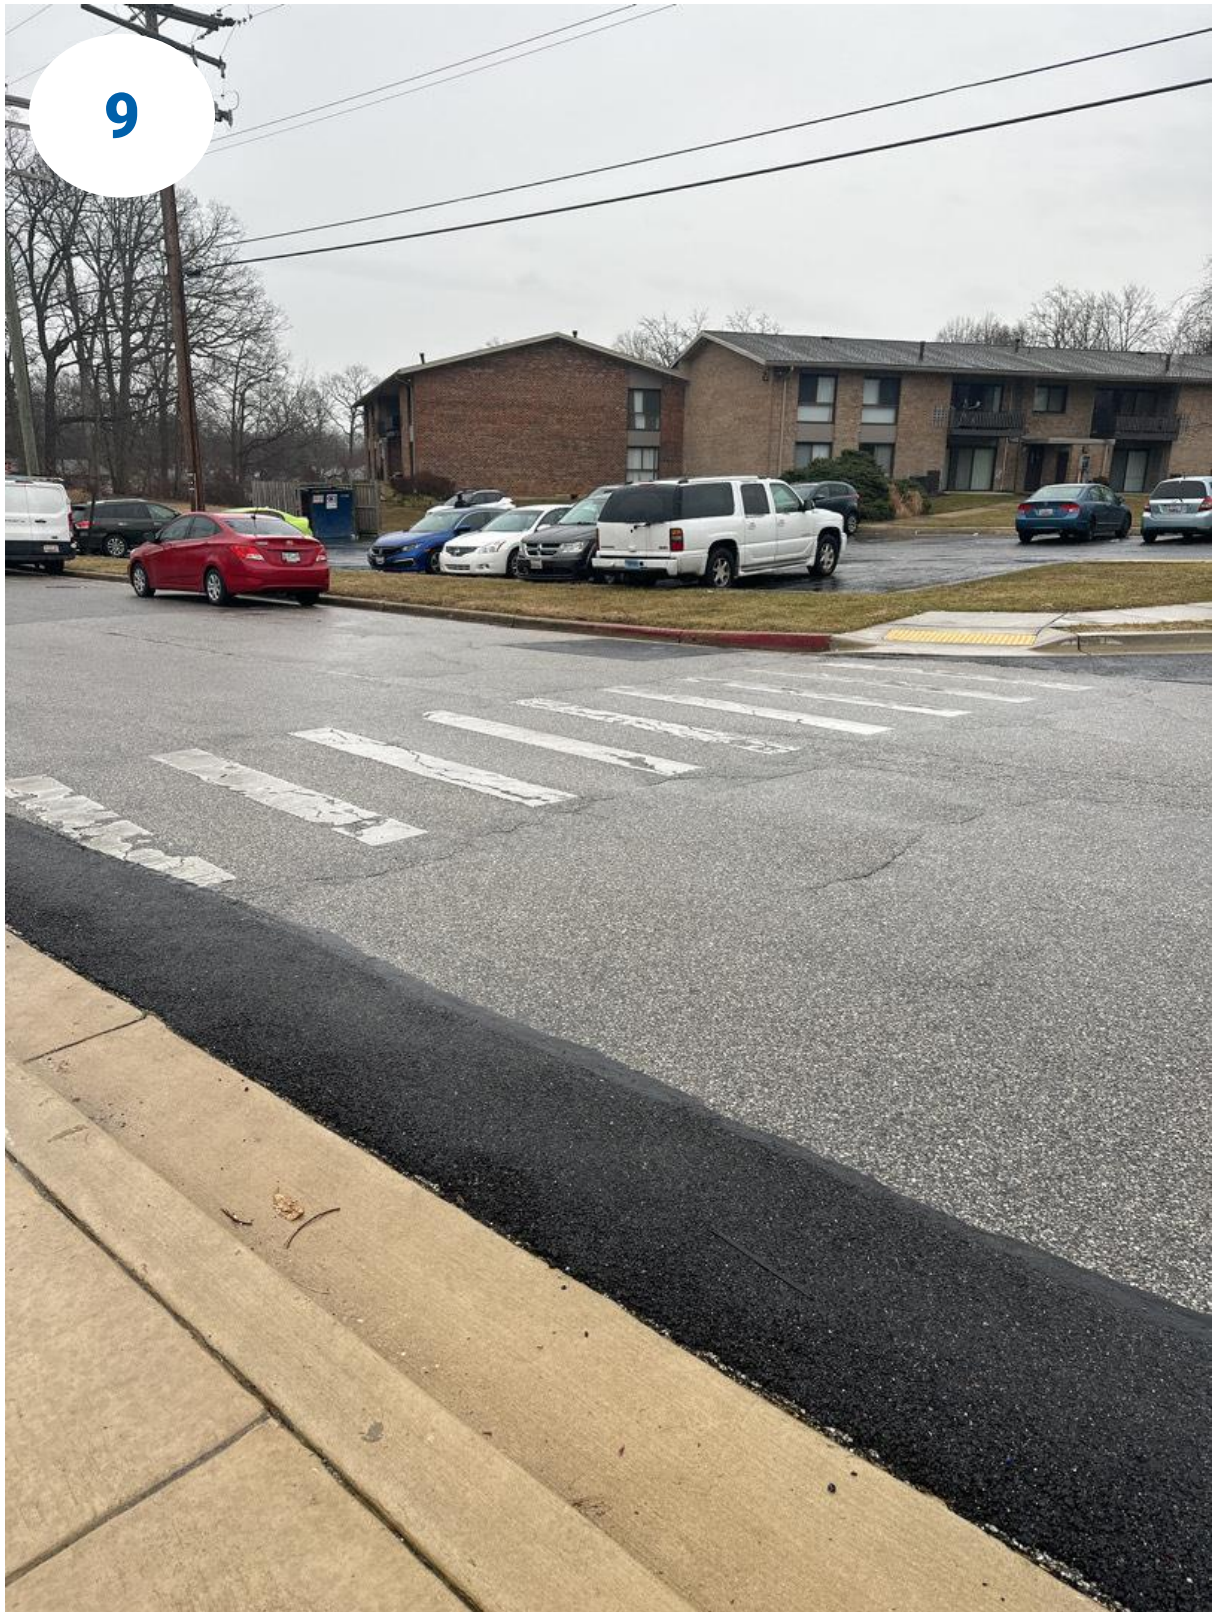
Janwall Street & Bricin Street

| Map ID | Location | Facility Type | Issue | Recommendation | Potential Cost | Timeframe* |
|---|---|---|---|---|---|---|
| 9 | Janwall St & Bricin St (Along key student walking route, Inside school zone) | 9a. Curb ramp | Northeast curb ramp is missing | Install new ramp | \$4,000 | Medium |

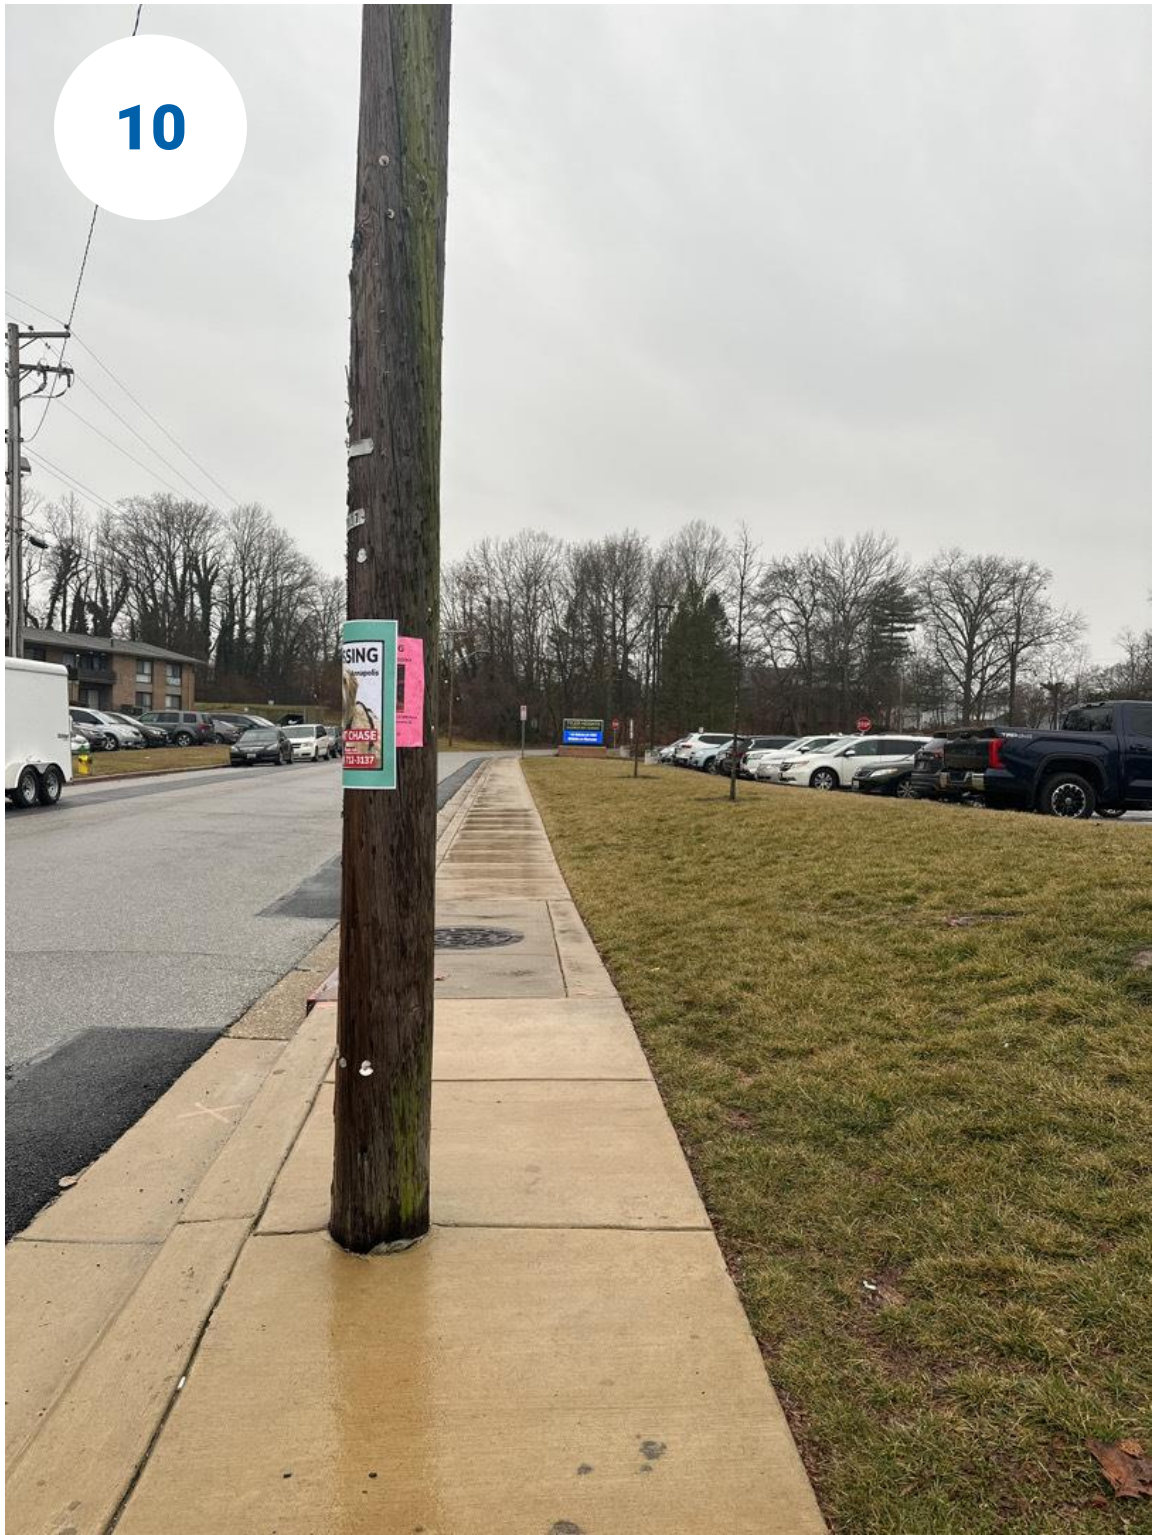
Sidewalk obstruction on Janwall Street

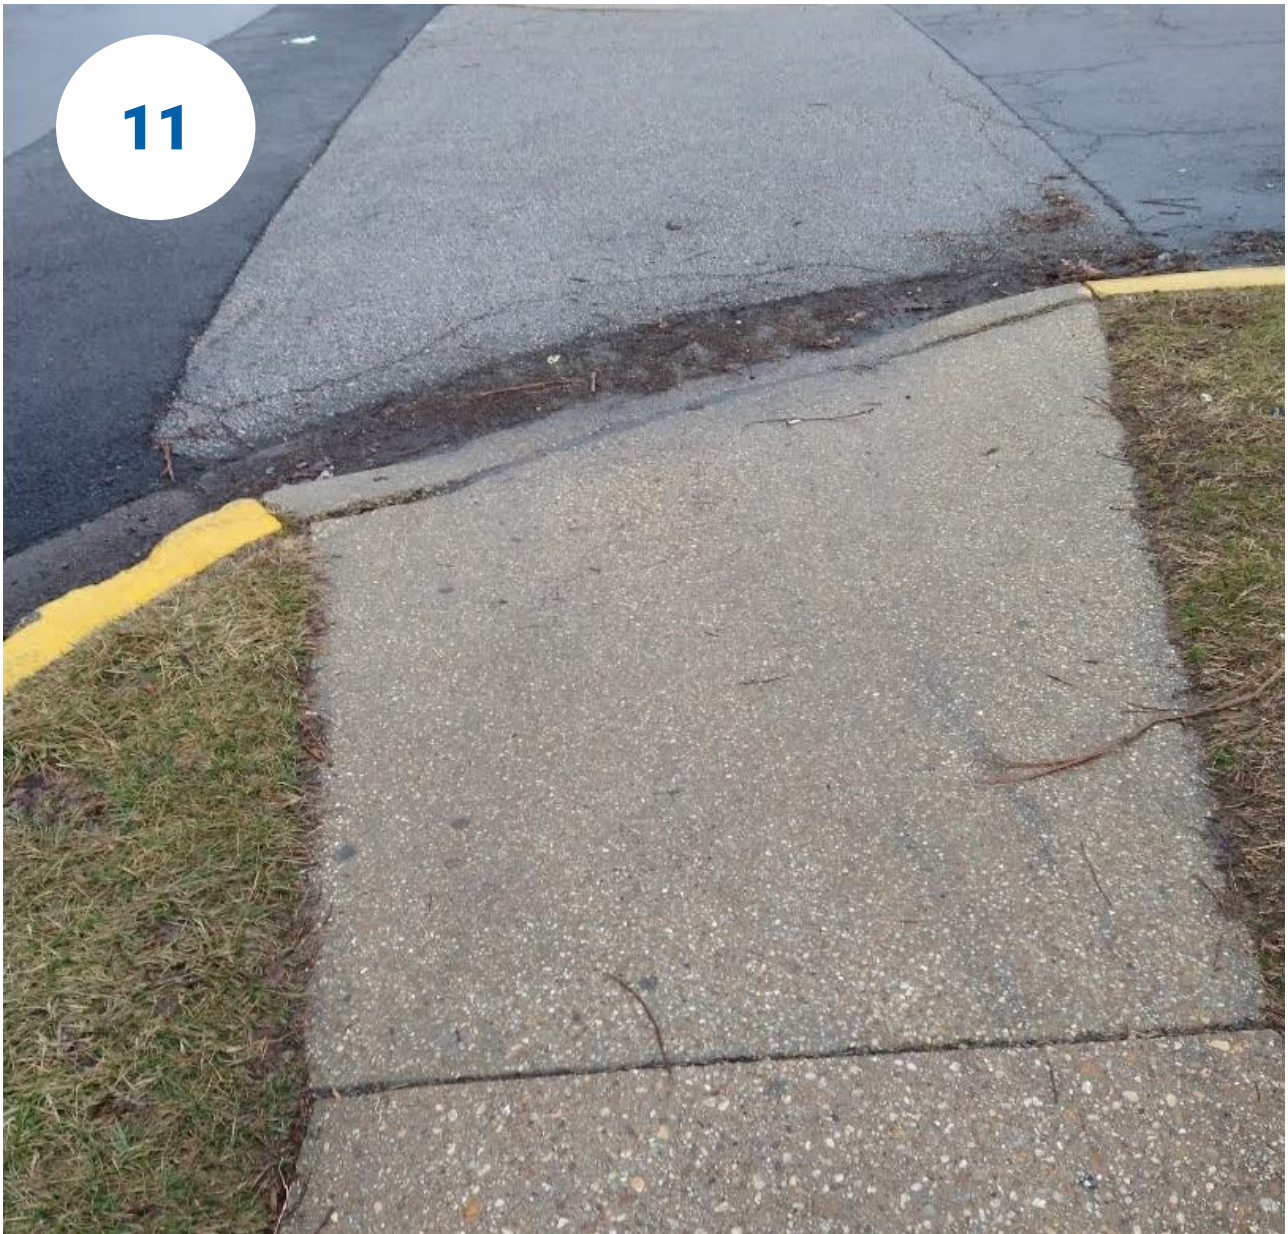
Bricin Street & Apartment Parking

| Map ID | Location | Facility Type | Issue | Recommendation | Potential Cost | Timeframe* |
|---|---|---|---|---|---|---|
| 11 | Bricin St & Apartment Parking Lot (Along key student walking route, Inside school zone) | 11a. Curb ramp | East and West curb ramps lack detectable warning surface | Reconstruct or repair existing ramps | \$16,000 | Medium |

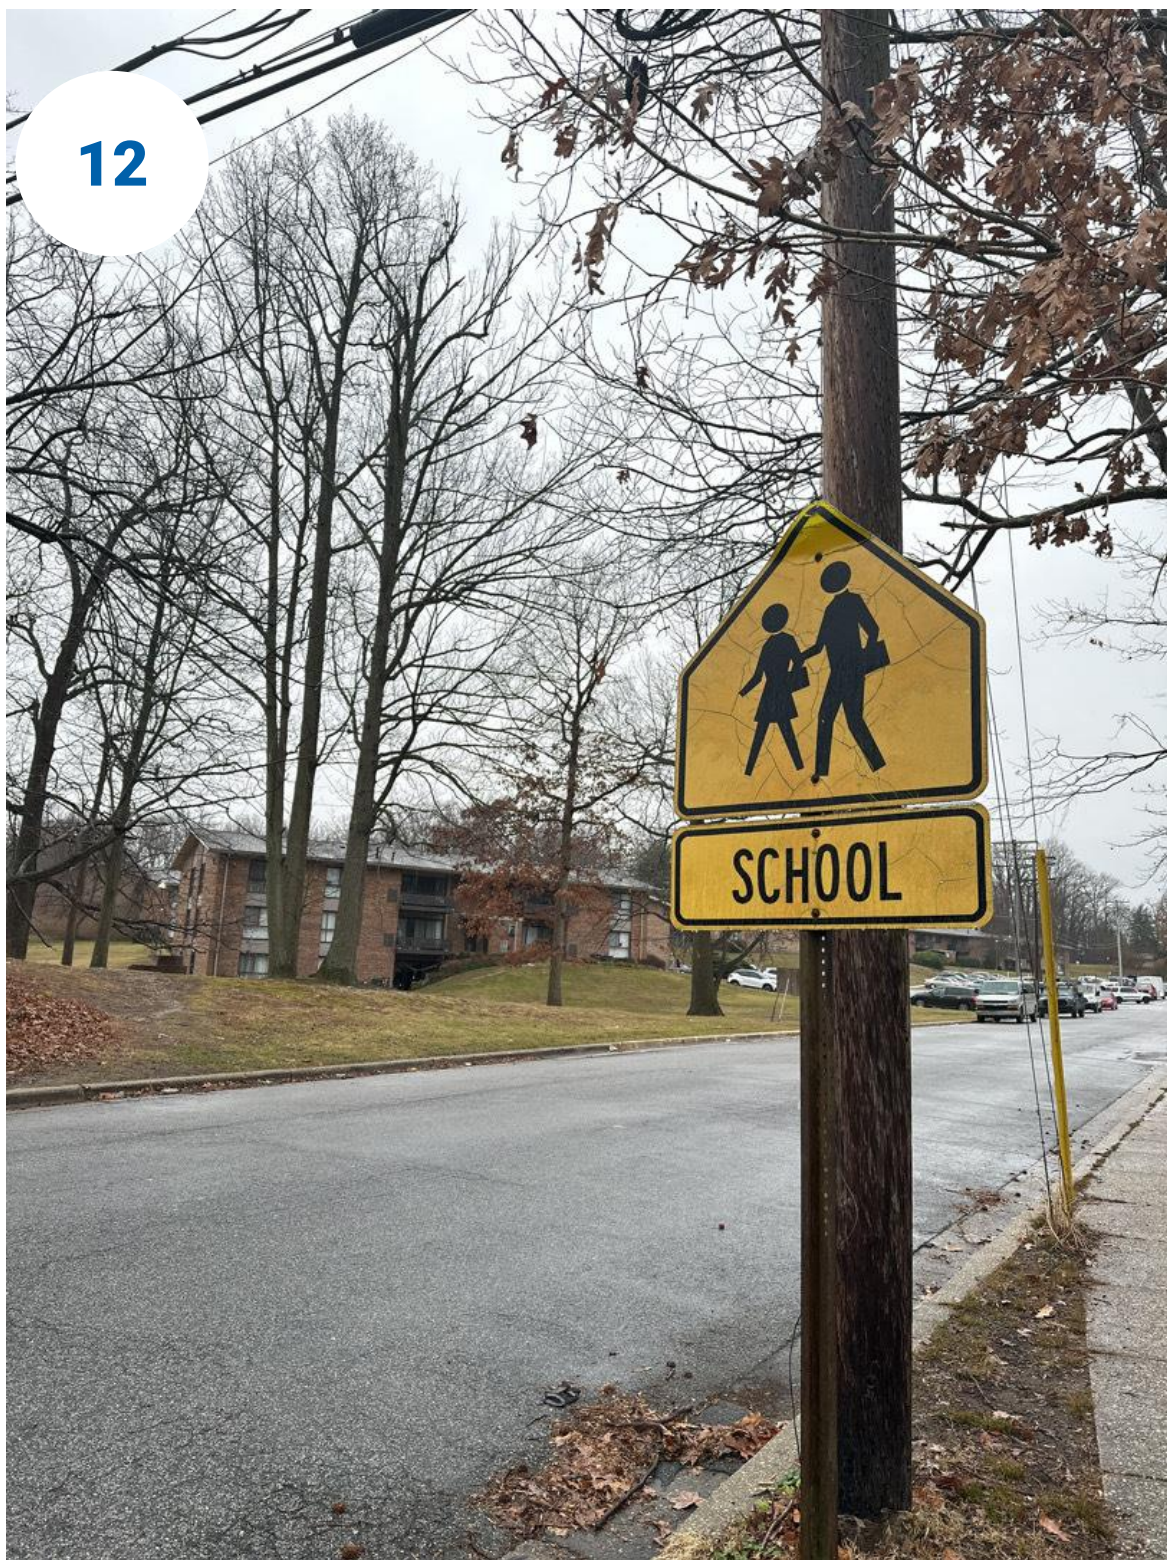
Janwall Street

| Map ID | Location | Facility Type | Issue | Recommendation | Potential Cost | Timeframe* |
|---|---|---|---|---|---|---|
| 12 | Janwall St (Tyler Ave to Ellington Dr) (Along key student walking route, Inside school zone) | 12a. Speed management | Observed motor vehicle speeds appear to exceed speed limit | Conduct a speed study to consider speed management measures or other modifications. | N/A | Long |
| | | 12b. School Zone Signs and Pavement Markings | Existing school zone sign deficient<br>Existing school advance warning sign deficient<br>SCHOOL pavement marking missing | Enhance school zone signage per MDMUTCD part 7:<br>- Repair or replace existing school zone signs (begin/end)<br>- Repair or replace school advance warning signs<br>- Install new SCHOOL pavement markings | \$1,000<br>\$500<br>\$1,000 | Short |
| | | 12c. Sidewalk | Missing sidewalk on the south side entirely, missing sidewalk on the north side from Tyler Ave to Marda Ln. | Install new sidewalk** | \$100,121 | Long |

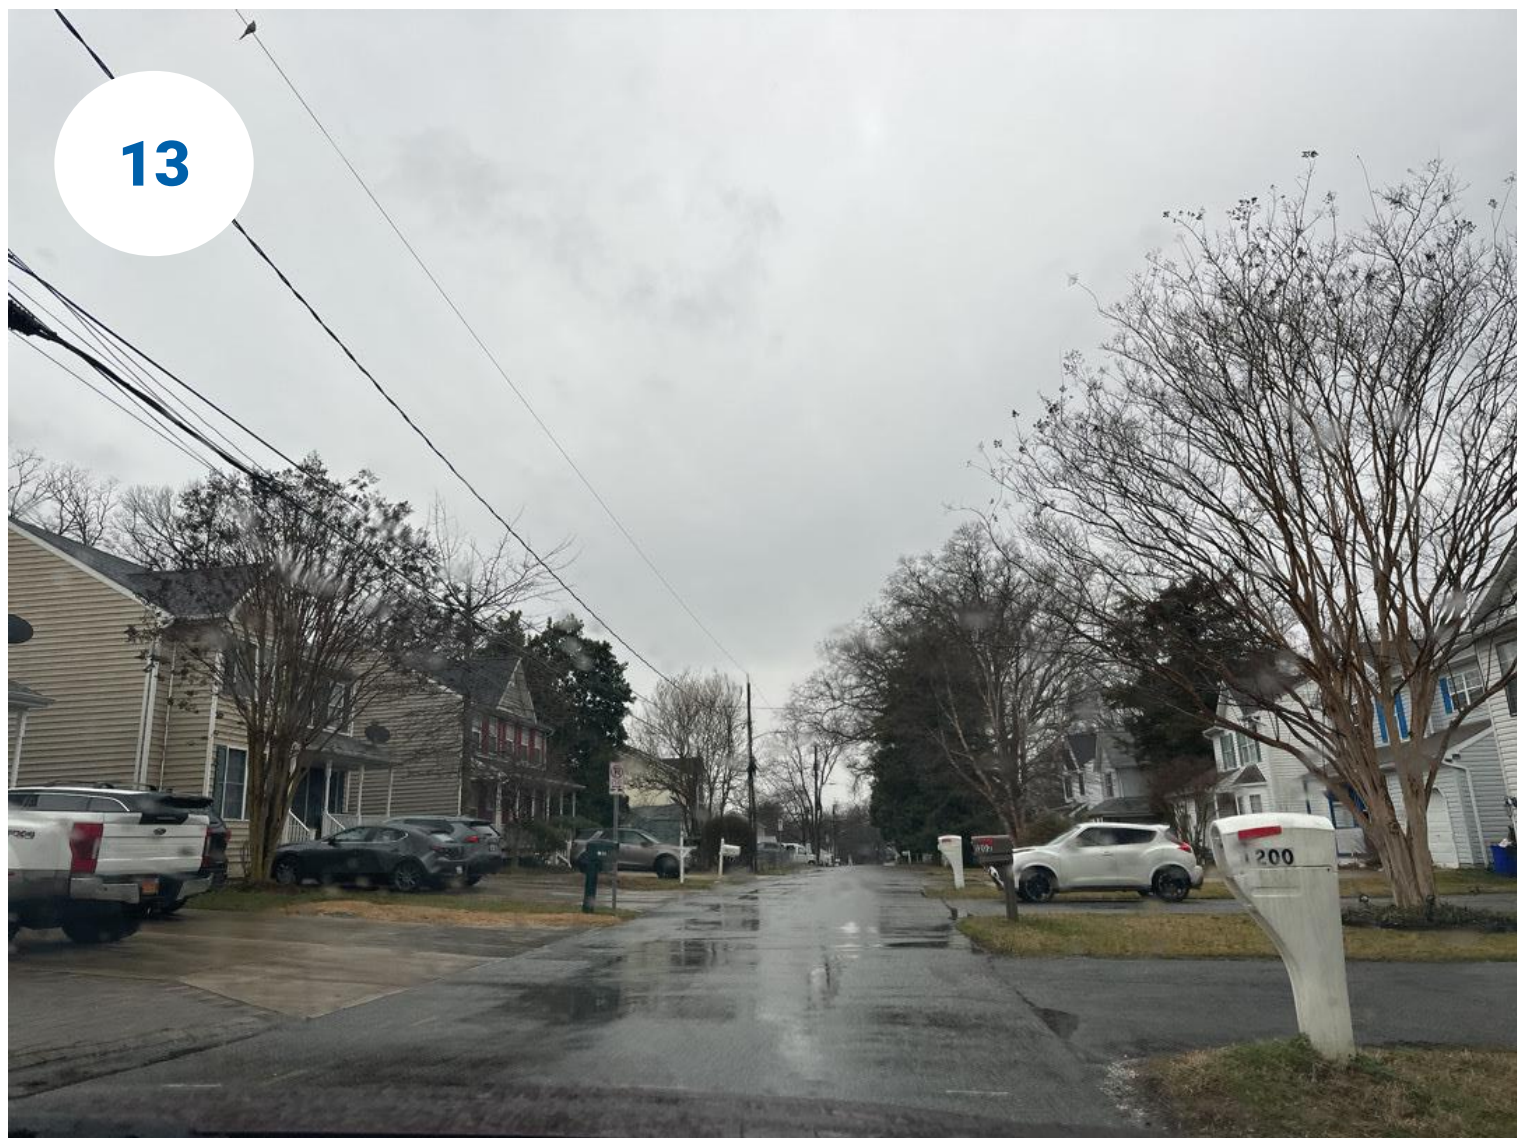
Barbud Lane

| Map ID | Location | Facility Type | Issue | Recommendation | Potential Cost | Timeframe* |
|---|---|---|---|---|---|---|
| 13 | Barbud Ln (Forest Dr to Janwall St) | Sidewalk | Missing sidewalk | Install new sidewalk** | \$68,395 | Long |

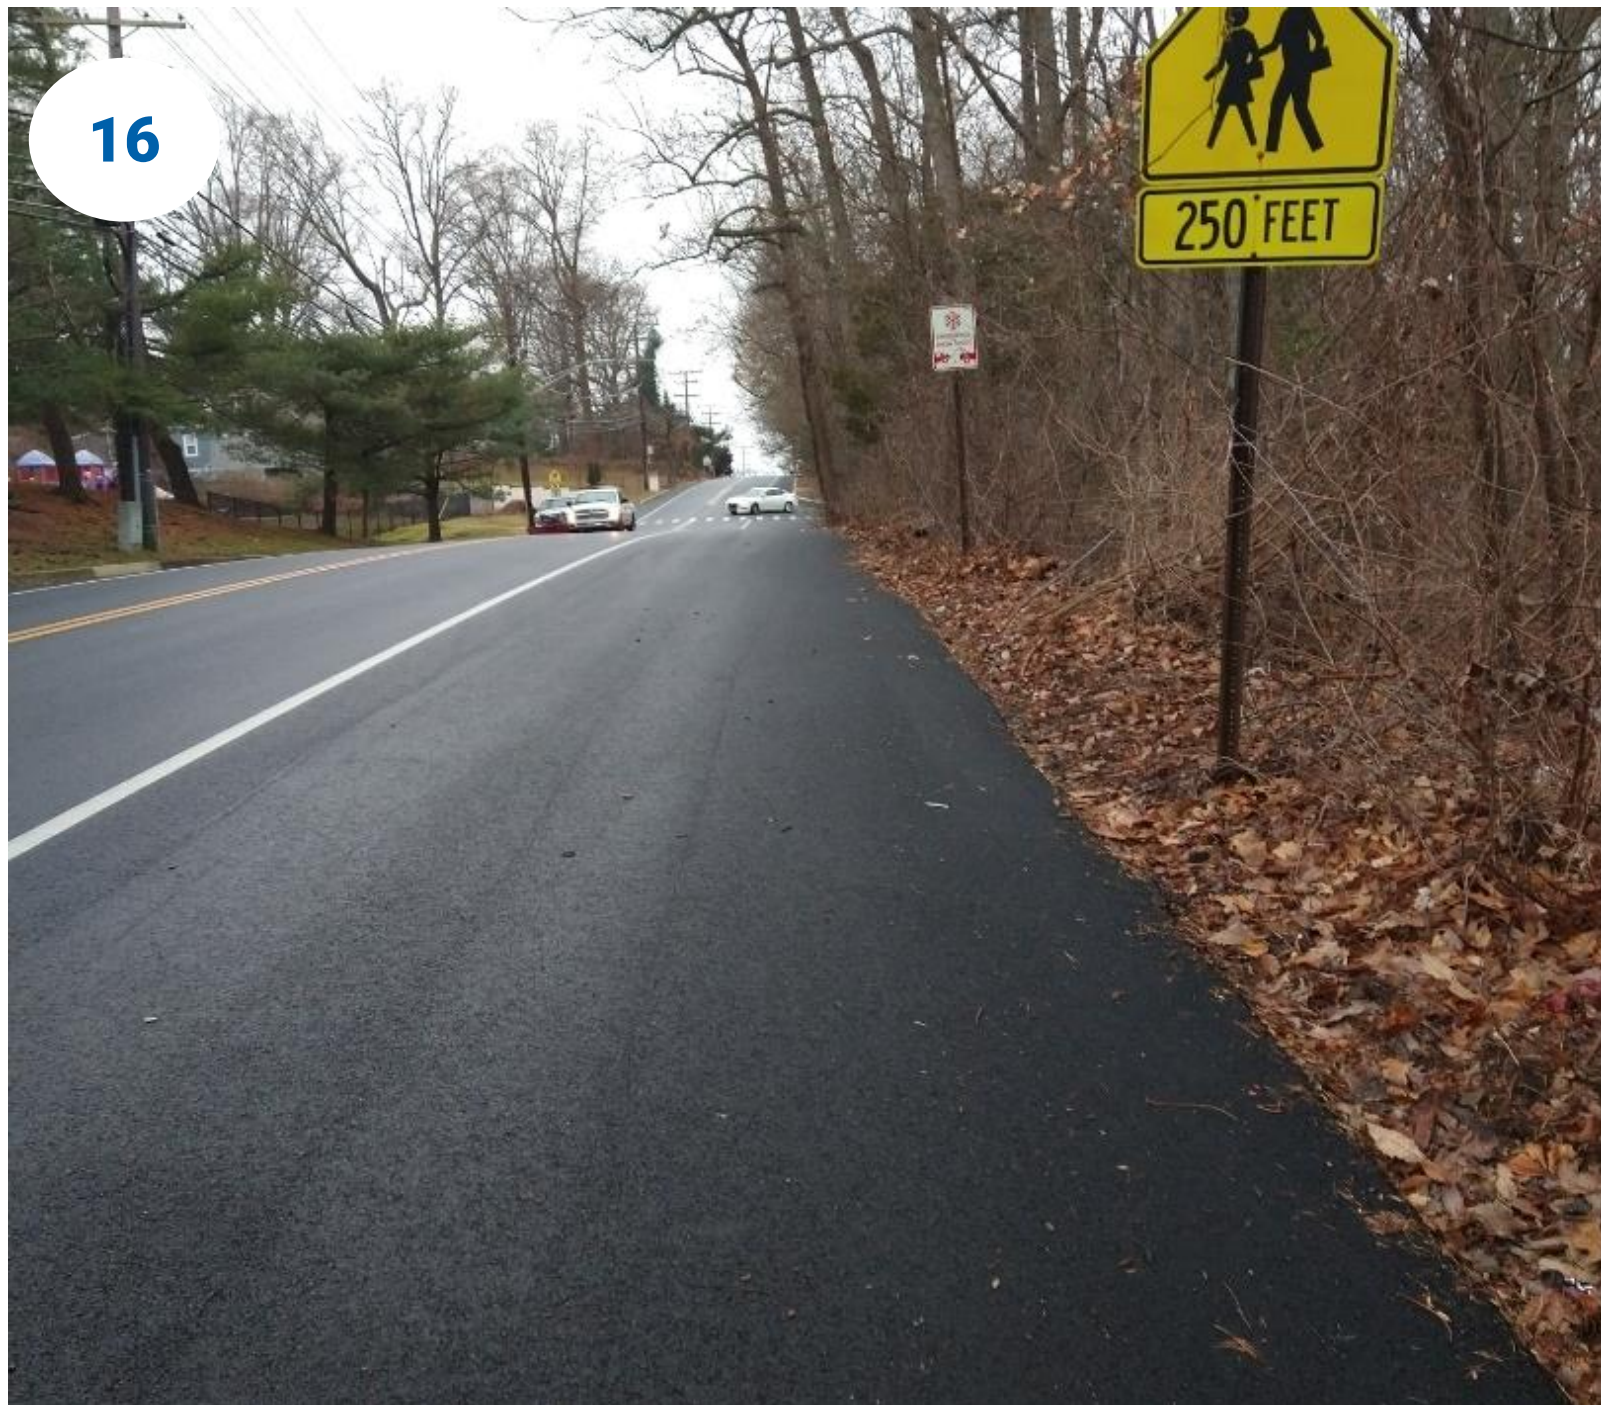
Forest Hills Avenue

| Map ID | Location | Facility Type | Issue | Recommendation | Potential Cost | Timeframe* |
|---|---|---|---|---|---|---|
| 16 | Forest Hills Ave (Forest Dr to Thom Dr) (Along key student walking route) | 16a. Sidewalk | Missing sidewalk | Install new sidewalk** | \$127,828 | Long |
| | | 16b. School Zone Signs and Pavement Markings | Existing school zone sign deficient<br><br>Existing school zone speed limit sign deficient<br><br>SCHOOL pavement marking missing | Expand and enhance school zone signage per MDMUTCD Part 7:<br>- Repair or replace existing school zone signs (begin/end)<br>- Repair or replace existing school zone speed limit sign<br>- Install new SCHOOL pavement markings | \$1,000<br><br>\$500<br><br>\$1,000 | Short |
| | | 16c. Speed management | Observed motor vehicle speeds appear to exceed speed limit | Conduct a speed study to consider speed management measures or other modifications. Reduce school zone speed limit to 20 mph. | N/A | Long |
